Incident Summary #II-1540107-2023 (#34754) (FINAL)

SUPPORTING INFORMATION	Incident Date	April 24, 2023	
	Location	Peace River Region	
	Regulated industry sector	Boilers, PV & refrigeration - Boiler and pressure vessel system	
	Impact	Qty injuries	0
		Injury description	N/A
	Damage	Injury rating	None
		Damage description	Extreme heat from an oil fire permanently deformed sheet metal, metal tubing, disintegrated fire-resistant materials, and melted sections of metal cladding of a wood waste fired thermal oil heater.
		Damage rating	Major
	Incident rating	Major	
Incident overview	The S-tube heat exchanger tube in a lumber mill's wood waste fired thermal oil heater failed, causing a leak. This leaked several hundred liters of thermal oil throughout the heater's convection section. The oil caught fire damaging a S-tube heat exchanger, industrial convection ducting, and a flue gas dust separator.		
INVESTIGATION CONCLUSIONS	Site, system and components	<p>This lumber mill's wood waste fired thermal oil heater is a type of indirect heating system used to transfer heat from a heat source to a thermal oil, which then transfers heat to generate electricity.</p> <p>There are seven components

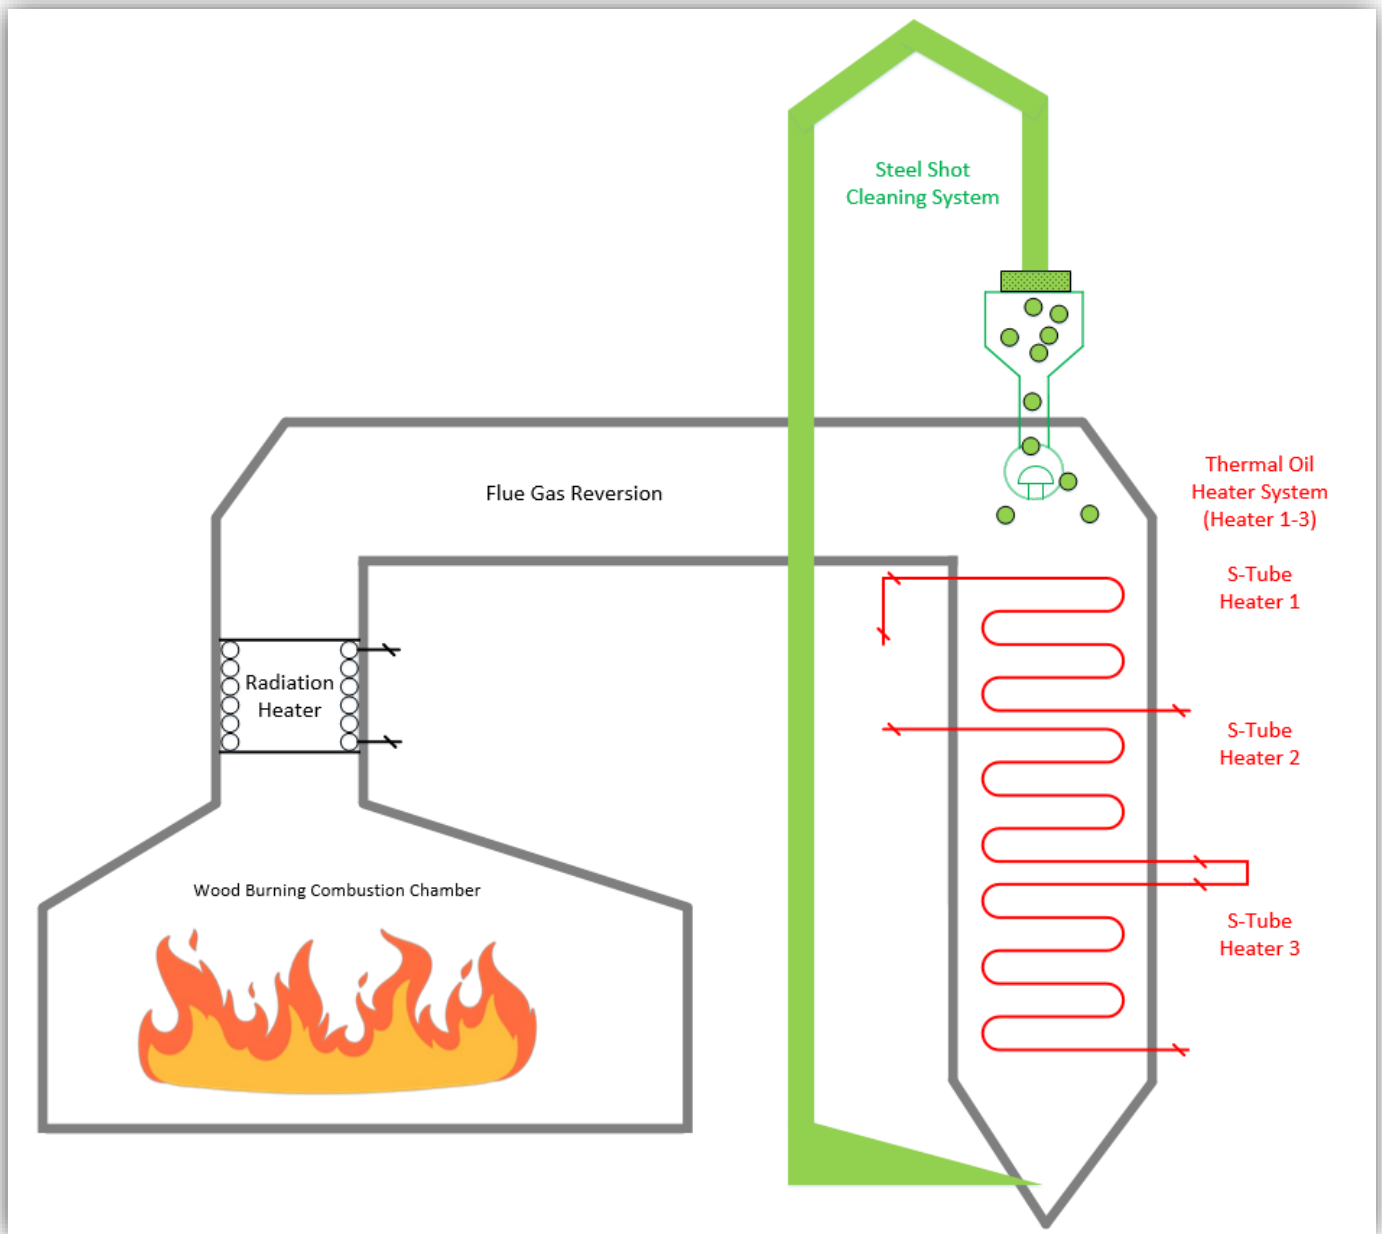
As flue gases are released from the furnace, they are drawn up through the center of radiant heater, turn 90 degrees traveling horizontally through a flue gas reversion section, then turn 90 degrees dropping vertically into the first of three S-tube heat exchangers in the convection chamber. While the flue gases travel through the convection chamber, heat is transferred to thermal oil flowing through each S-tube heat exchanger. That heat energy is transferred out by the thermal oil to be used in the generation of electricity. Once most of the heat energy is drawn out of the flue gases, cooled flue gases continue out of the convection chamber into a flue gas dust separator, where soot is removed from the heater ([Image 1](#)).

Image 1 – Diagram of heater.

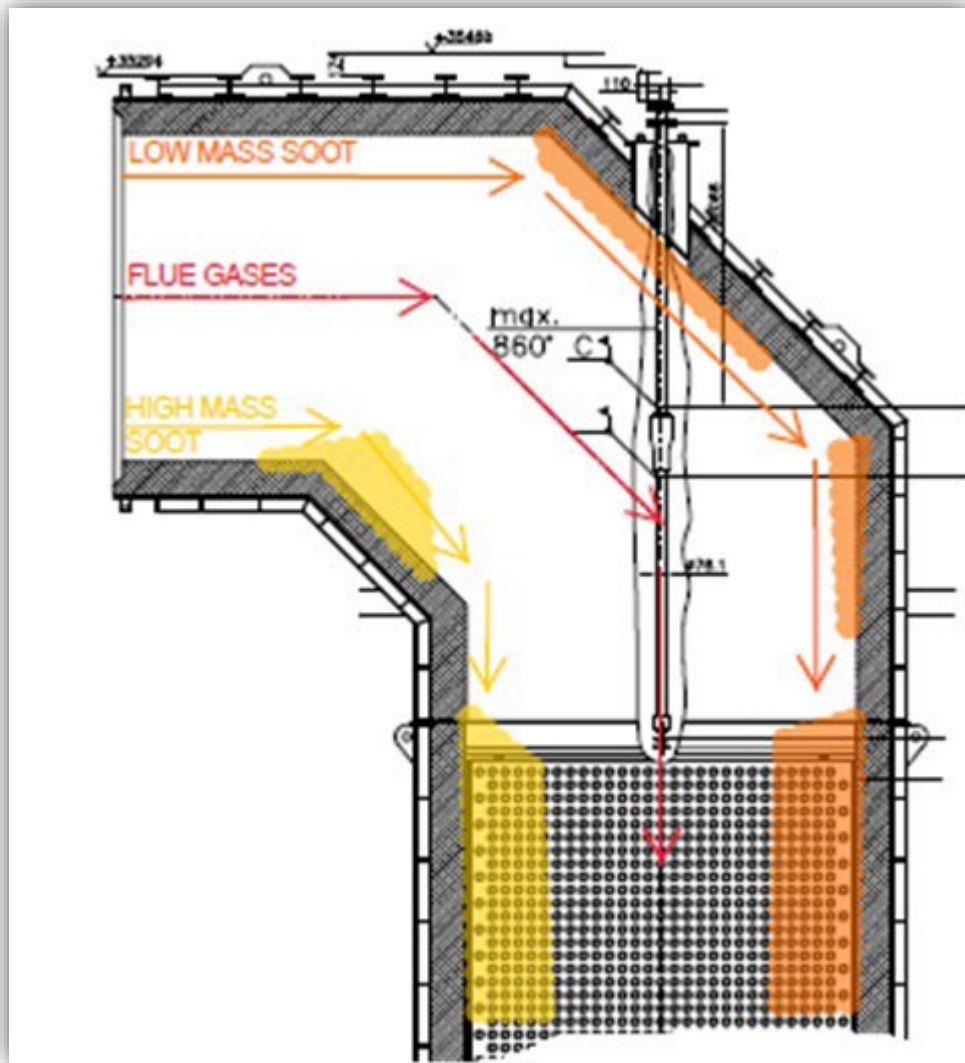
Over time, flue gases with moderate to high soot content will release soot throughout the flue gases path. Heavy or bonded soot will accumulate on the flue gas reversion floor or in low velocity areas of the convection chamber. Light or unbonded soot will accumulate on the ceiling and walls of the convection chamber since the S-Tube heat exchanger presents a partial barrier. Heavy and light soot typically will accumulate on or between the tubes ([Image 2](#)).

Image 2 – Diagram of soot accumulation and low velocity area.

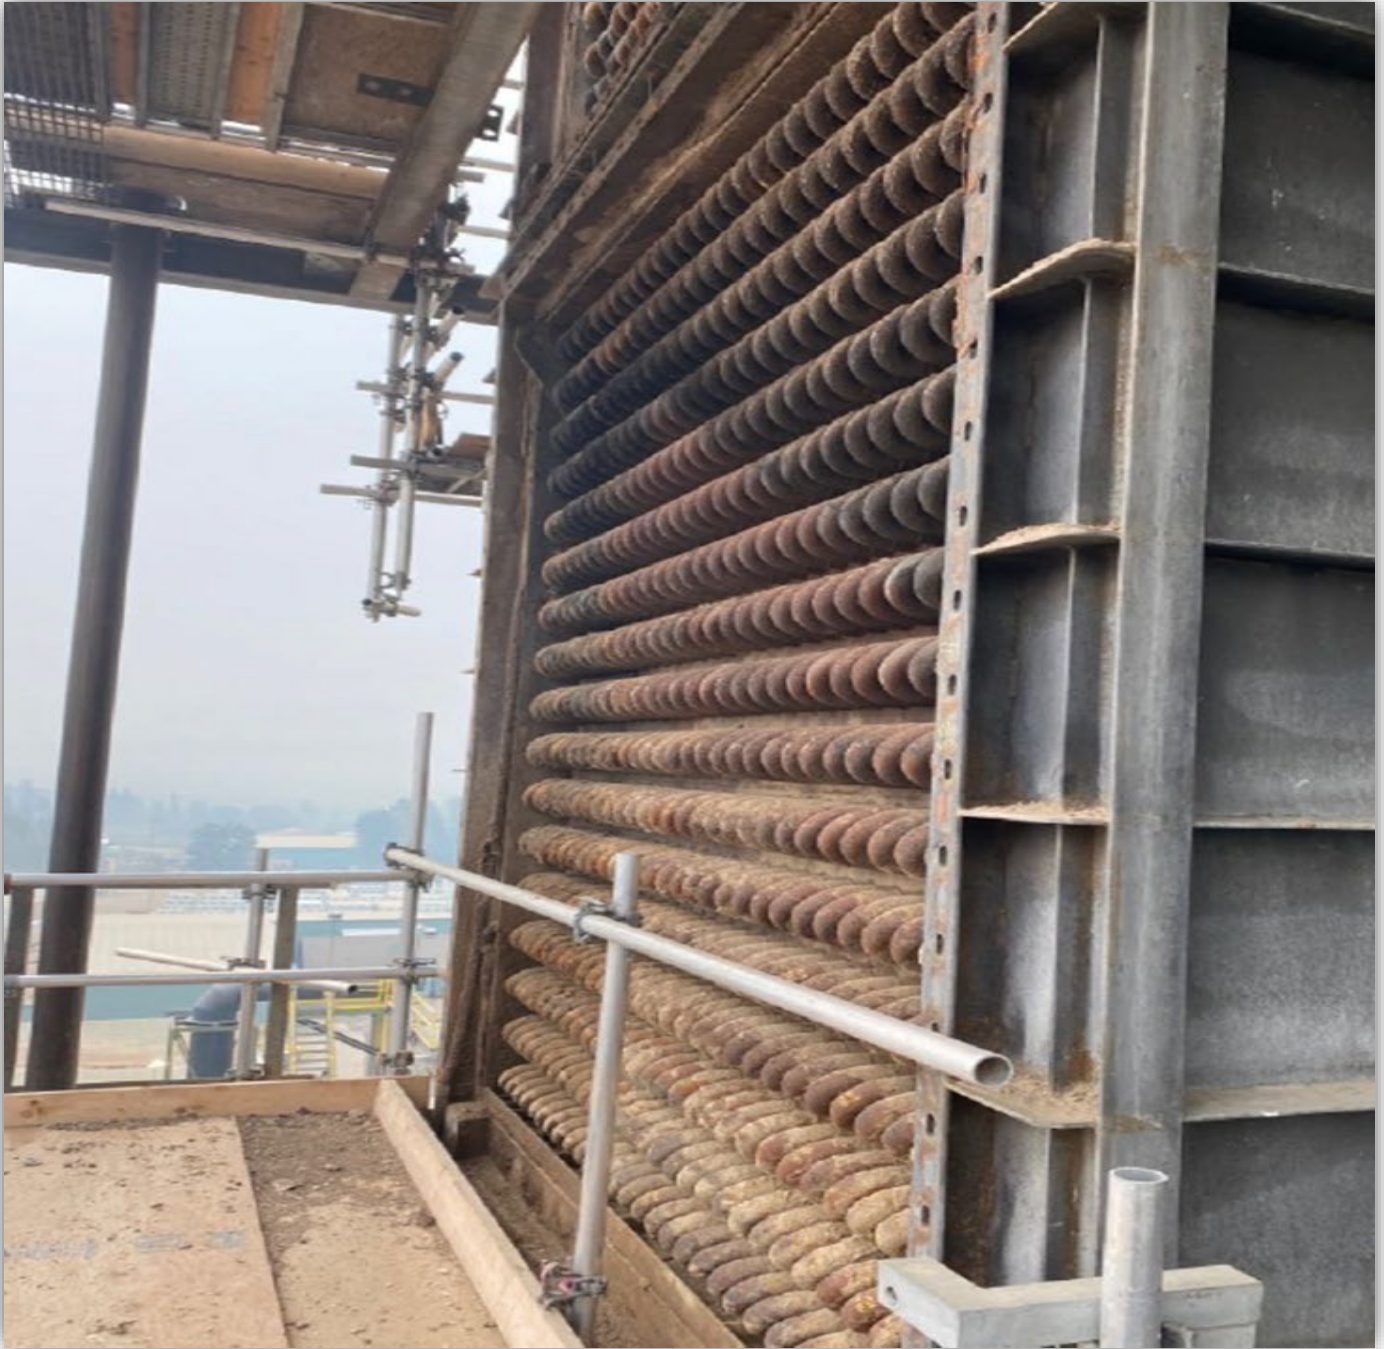
<p>Failure scenario(s)</p>	<p>With the shot drop cleaning system inoperable since commissioning in 2014, manual cleaning occurred every six-months for the convection chamber. Since cleaning happened only every six-months, soot would accumulate in low velocity areas. The areas most susceptible to accumulation of soot are the floor and ceiling at the end of the flue gas reversion section, the walls just before the first S-tube heat exchanger, and on or between the tubes of the first S-tube heat exchanger.</p> <p>Each six-month cleaning cycle allowed soot to accumulate or form blockages within the first S-tube heat exchanger, which likely resulted in incremental heat damage to the tubes of the first S-tube heat exchanger. In 2019, two tubes adjacent to the 2023 tube failure leaked, and these tubes were abandoned by capping the tubes at the thermal oil supply and return headers and plugging each end of the two S-tubes.</p> <p>Over time, soot continued to accumulate or form blockages every six months within the first S-tube heat exchanger until April 2023, when the induced draft broke through a weak point in the soot blockage igniting a secondary fire. Extreme heat from this fire eroded the microstructure of the metal tube until it failed, releasing several hundred liters of thermal oil.</p>

Image 3 – East side of failed S-tube heat exchanger.

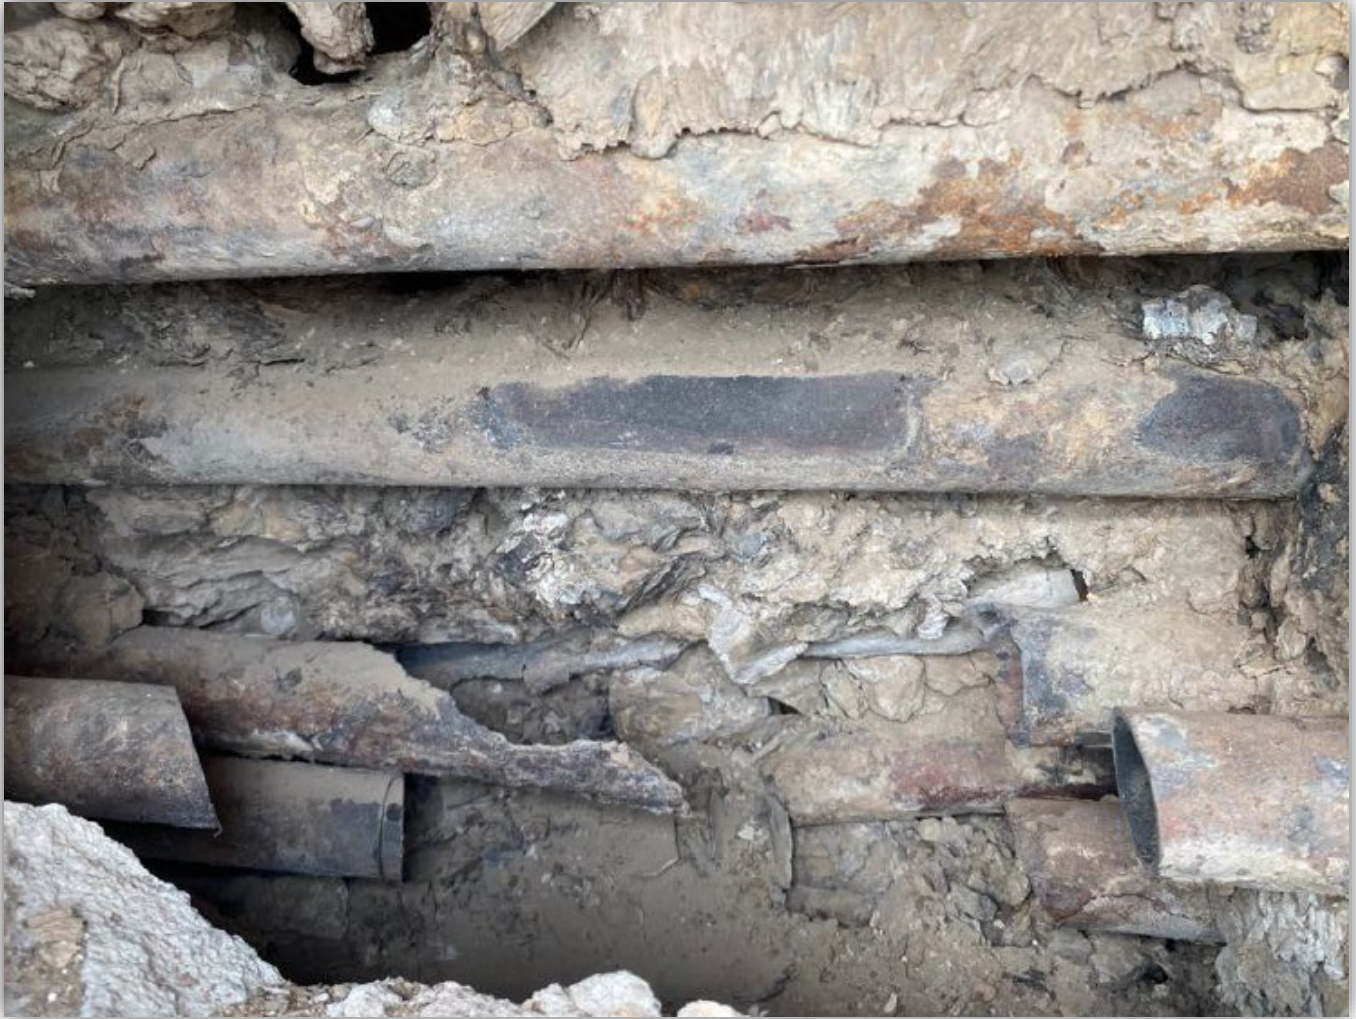
Image 4 - Location of tube failure.

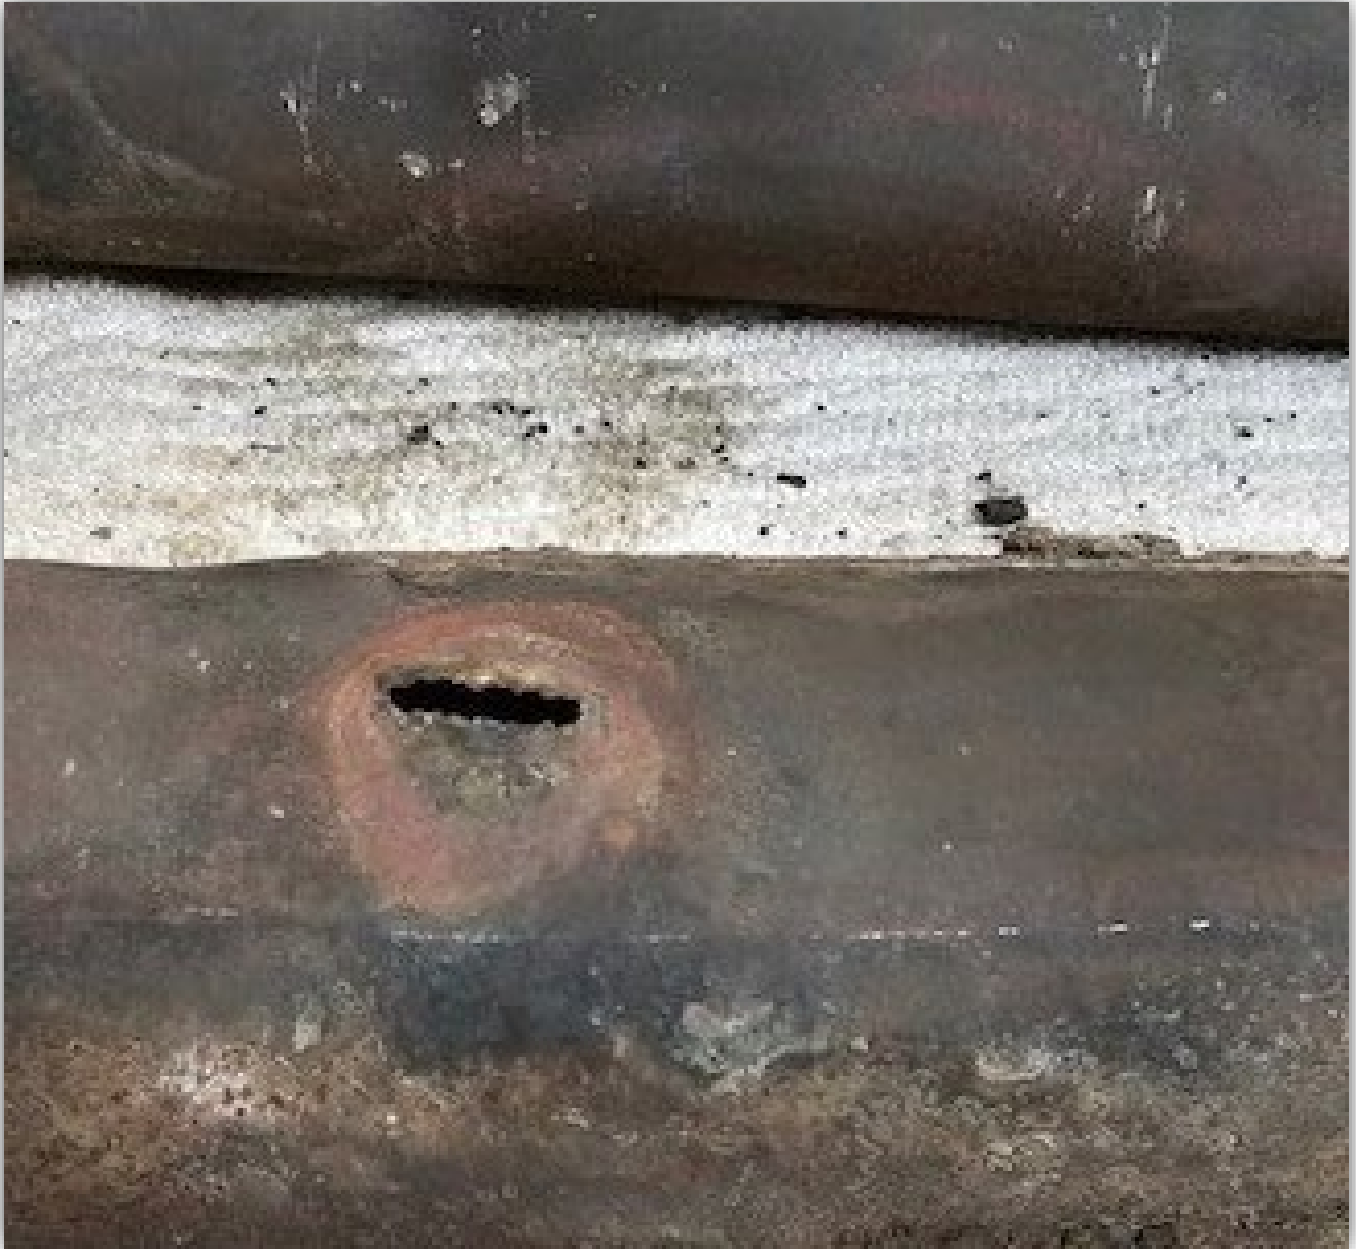
Image 5 - Face of failed tube.

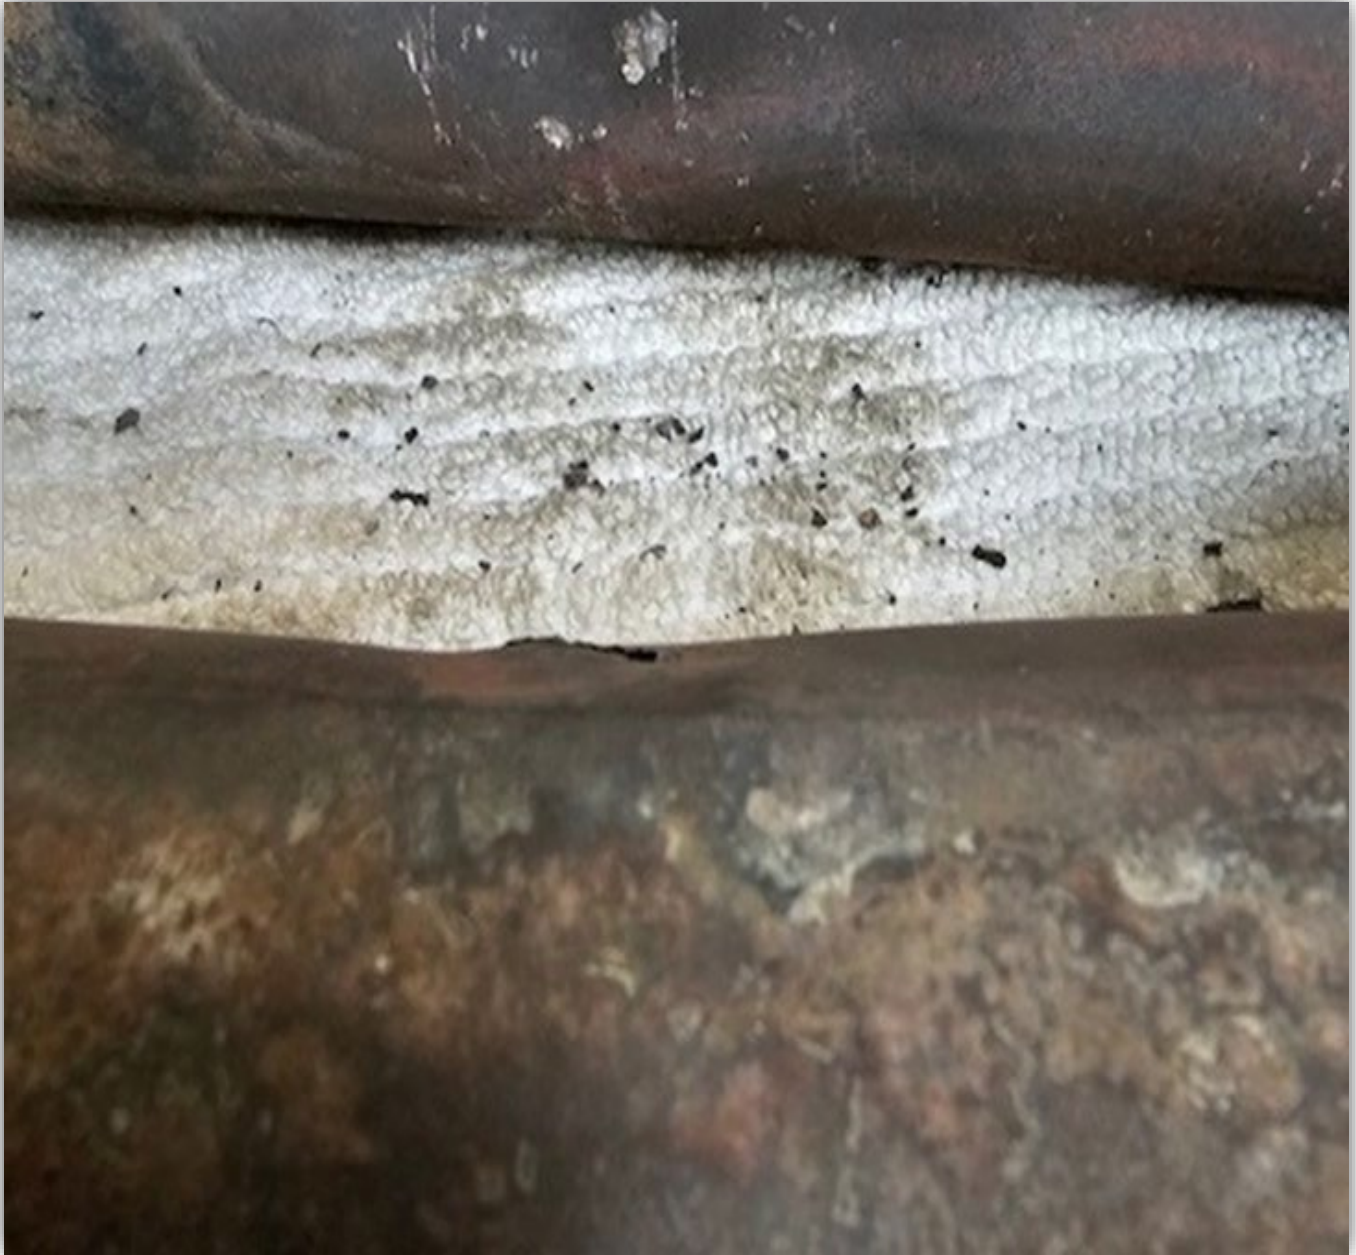
Image 6 – Side view of failed tube.

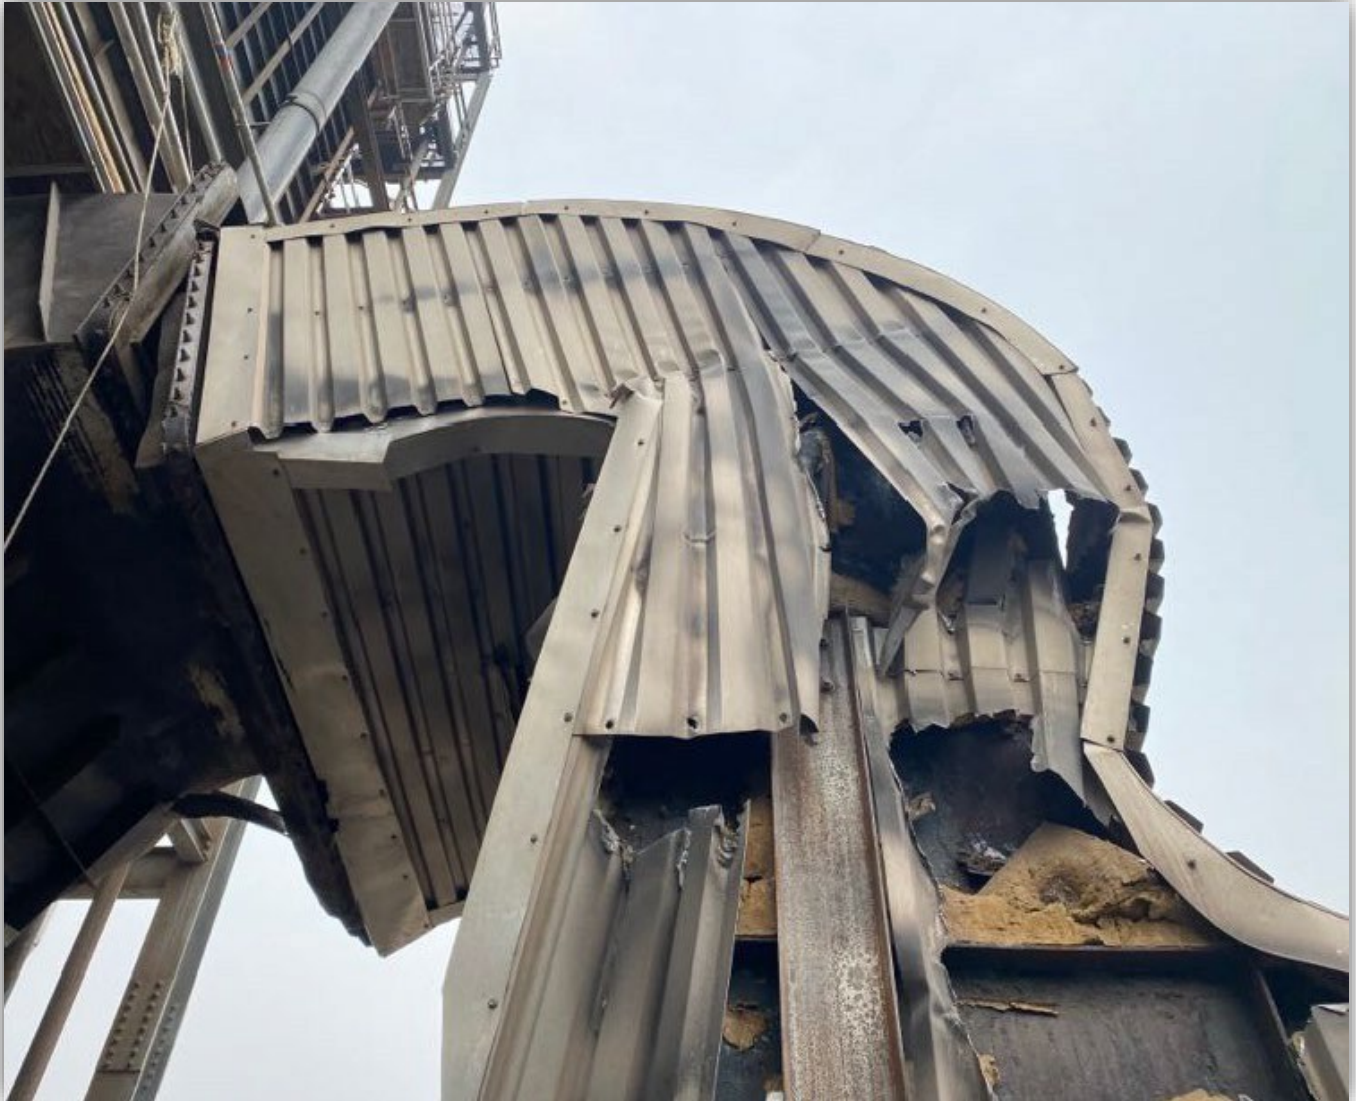
Image 7 – Damaged convection ducting.
