Incident Summary #II-2696202-2022 (#25660) (FINAL)

SUPPORTING INFORMATION	Incident Date	January 5, 2022	
	Location	North Vancouver	
	Regulated industry sector	Passenger ropeways - Above surface ropeway	
	Impact	Qty injuries	0
		Injury description	N/A
	Damage	Injury rating	None
		Damage description	Slight surface marks to the haul rope where the grip was pried off the cable, as well as gouges to the grip body as a result of the prying action.
		Damage rating	Minor
	Incident rating	Minor	
	Incident overview	Rope grip and carrier assembly inadvertently released from the haul rope, falling to the snow surface when entering the next compression tower sheave assembly, located on the unloaded side of the ropeway.	
INVESTIGATION CONCLUSIONS	Site, system and components	<p>In this ropeway configuration, the carrier assembly is attached mechanically to the haul rope using a mechanical grip.</p> <p>The grip attaches to the rope by encircling the haul rope with a grip body and grip jaw with a force designed by the manufacturer so that it will not move under normal operation. The rope grip is designed by the manufacturer with a profile that facilitates the function of the rope grip to pass smoo

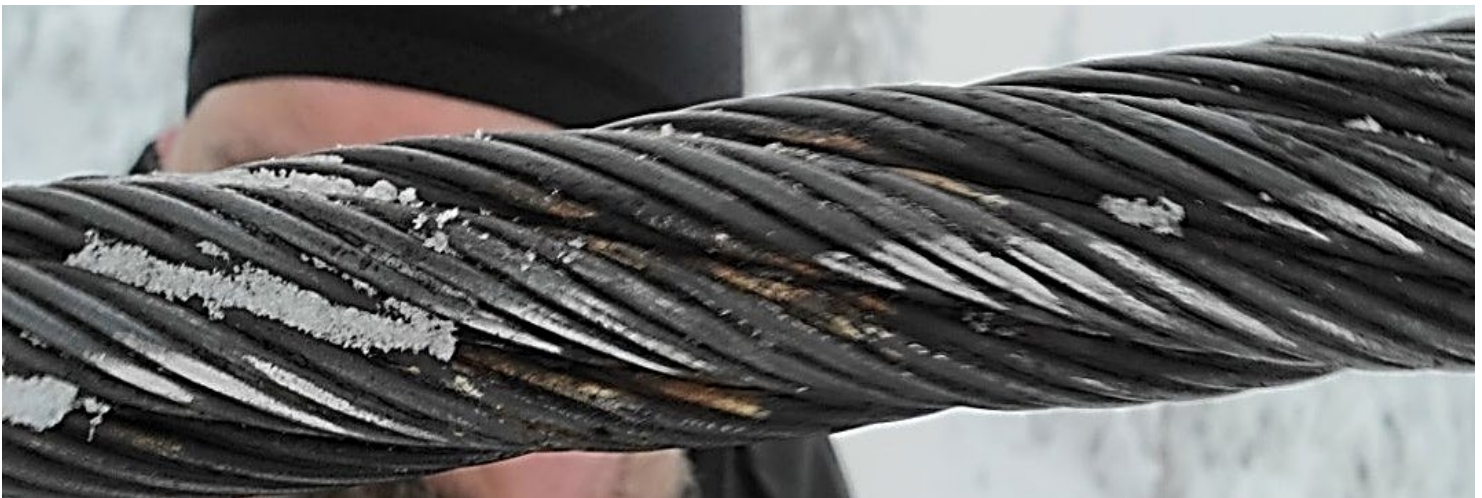
Photo 1 - Indications on haul rope post incident- bright marks where the grip jaw was dragged across the surface of the rope.

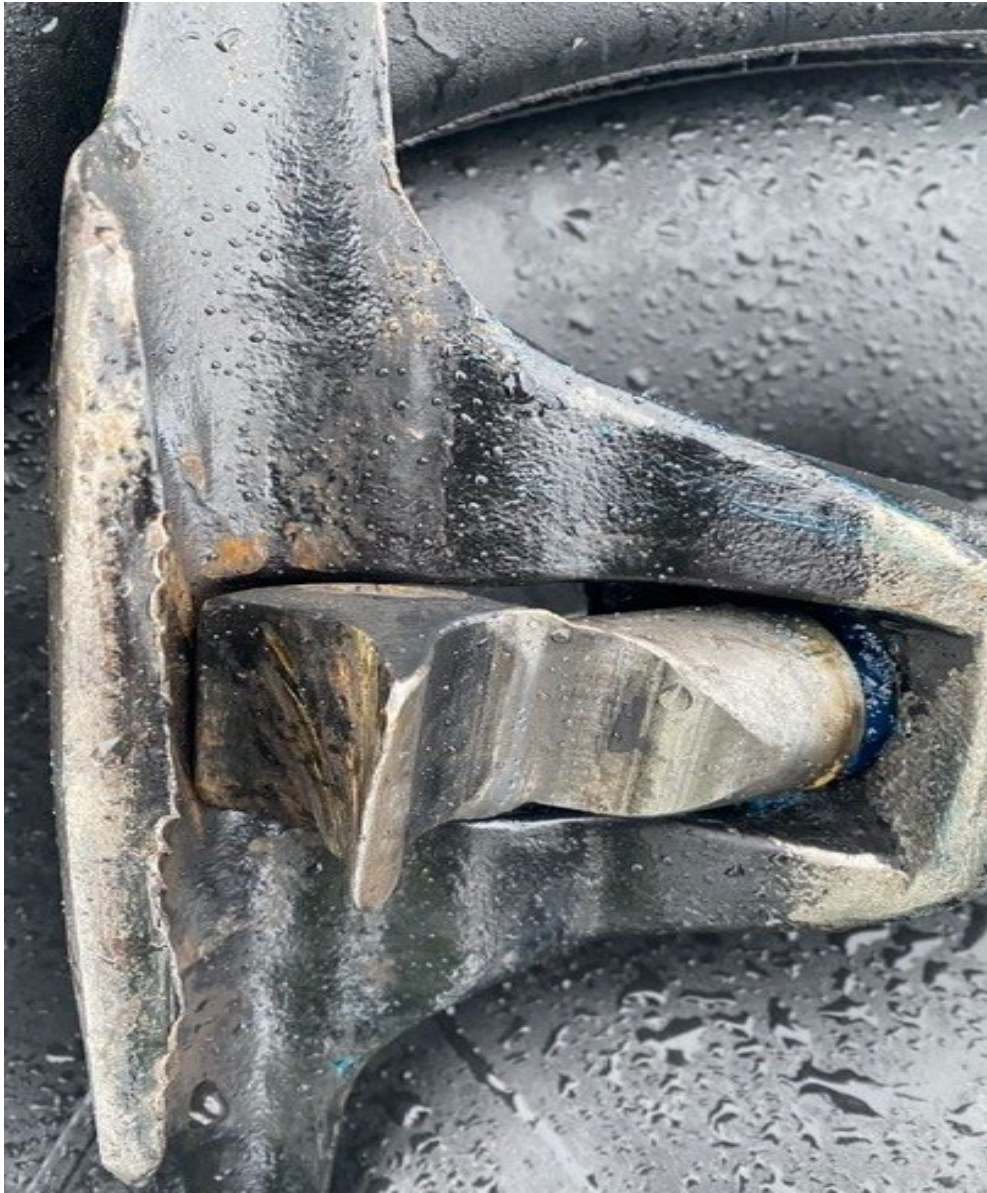
Photo 2 - Damaged grip and grip jaw post incident - rope lay indications found on grip components. The large grooves on grip are to manufacturers design and correspond to the lay of the haul rope.

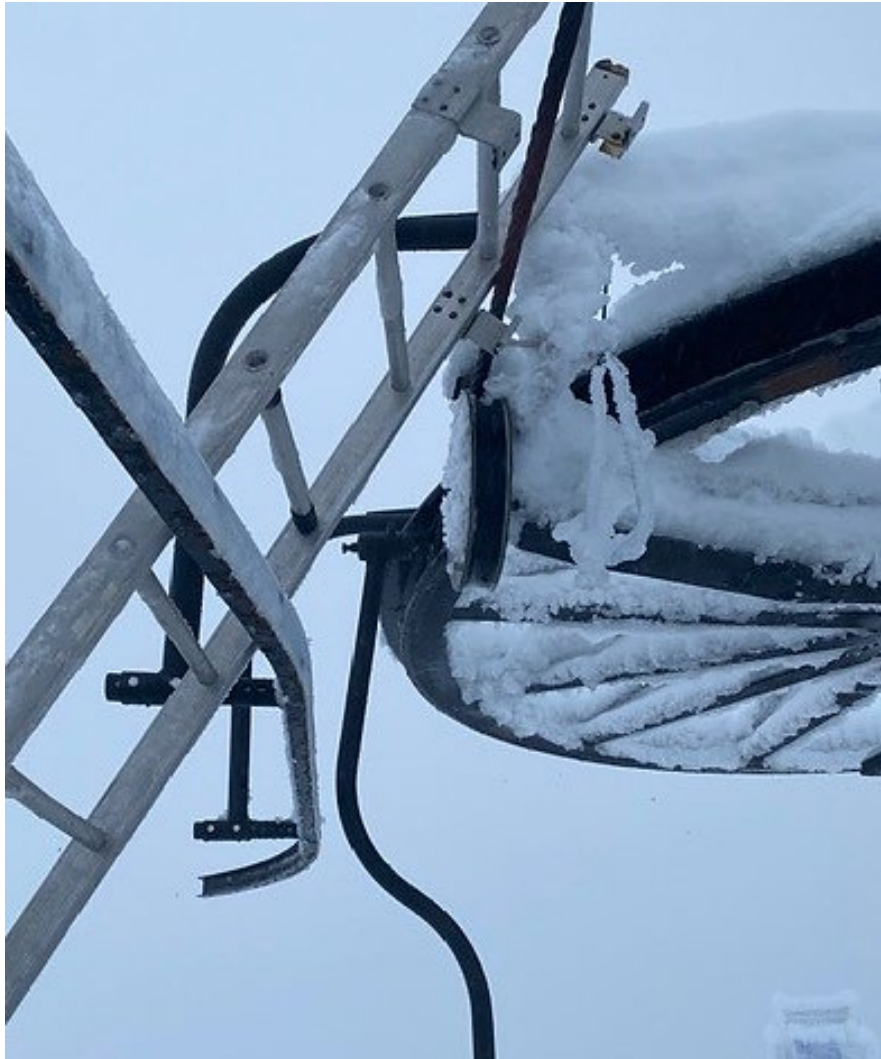
Facts and evidence	<ul style="list-style-type: none">• Observed marks on the haul rope at the area where the rope grip had been attached.• Observed gouging to the rope grip body and jaw.• Inspected the return terminal with the manufacturers representative and observed the guide that controls carrier swing as it enters the bullwheel was out of alignment.• Lift had been de-tensioned and return terminal had been removed for service the previous summer. This included the removal of the chair swing guide.• There were no documented procedures or specifications for proper adjustment of the return terminal chair guide rail.• Return bullwheel flange was observed to be correctly installed as per manufacturers specifications, with all bolted connections torqued.
Causes and contributing factors	<p>It is highly likely that the misaligned chair swing guide allowed a swinging carrier into the return bull, causing the grip to miss the bullwheel flange causing enough force to partially pry the grip of the haul rope.</p>

Photo 3 - Chair guide located at the top terminal, controls chair swing as the grip enters the bullwheel.

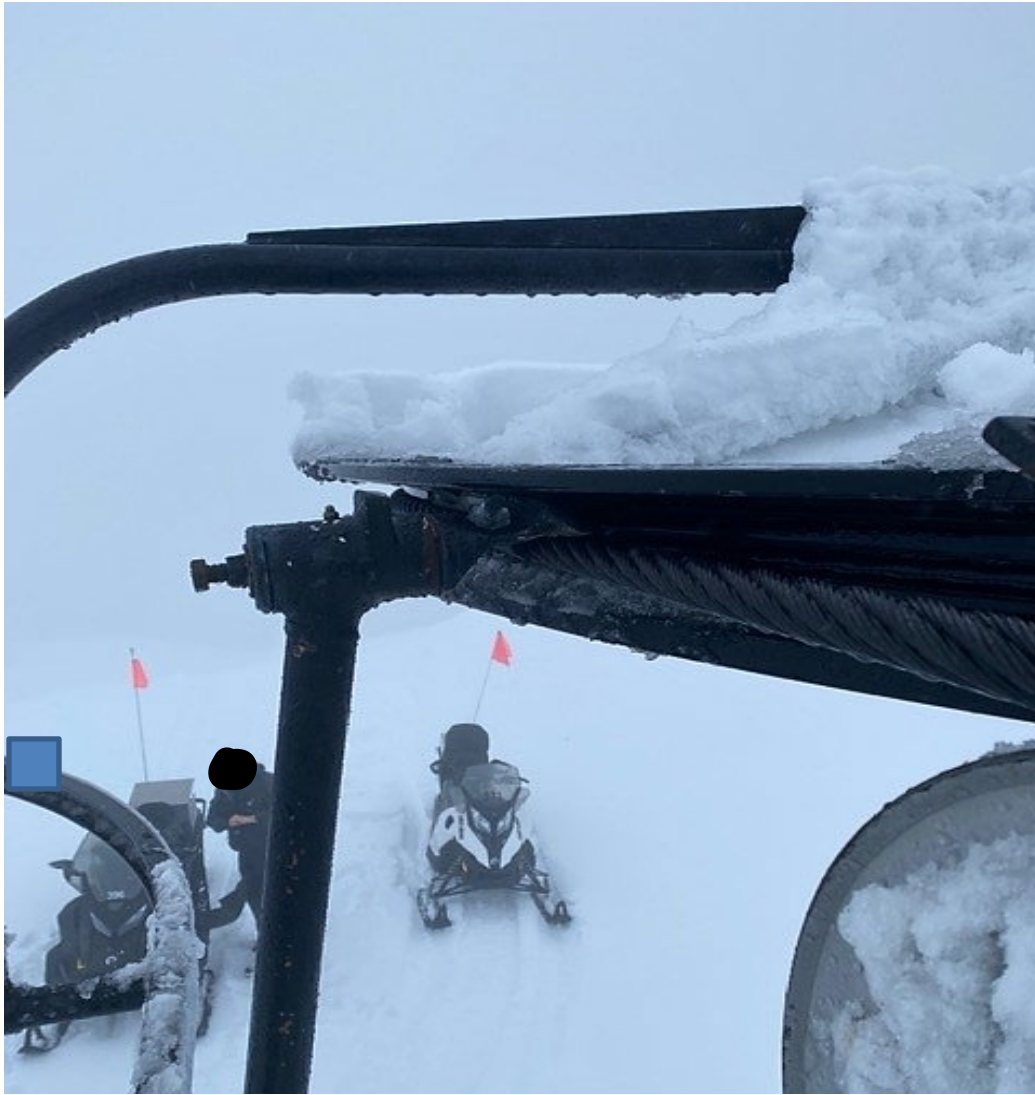
Failure scenario(s)	<p>During passenger unloading at the return terminal (during normal operation), excessive carrier swing as the chair approached the bullwheel caused the grip horn to remain outside of the designed contact point of the bullwheel flange.</p> <p>As the carrier travelled around the bullwheel, the cable applied enough force to pry the grip off the cable, using the out of position grip and bullwheel flange as a fulcrum.</p> <p>At this point, the grip was still partially attached to the haul rope and continued to travel down the lift line until it came into contact with the Tower 2 compression sheave assembly, on the downhill side of the ropeway. As it entered the compression sheave assembly, the partially attached grip became fully detached and the carrier fell to the snow surface.</p>

Photo 4 - Grip in correct position as it enters the bullwheel at the return terminal- grip horn and bullwheel flange designed to be in contact when the lift is in motion.

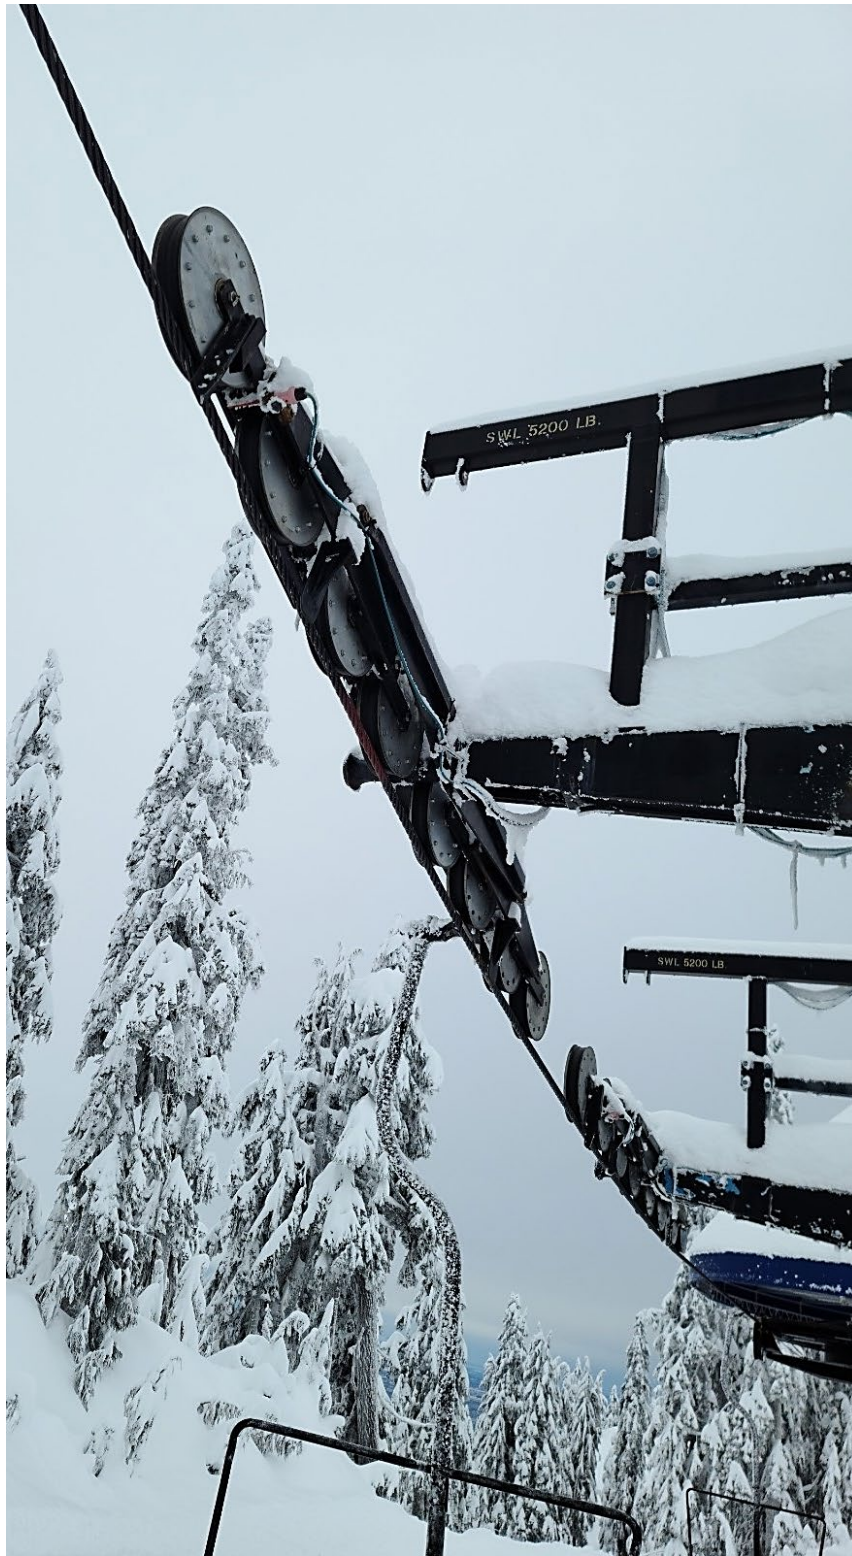
Photo 5 - Tower 2 downhill side where the unloaded carrier with the partially attached grip, contacted the compression sheave assembly, and fell to the snow.
