Incident Summary #II-962261-2020 (#16279) (FINAL)

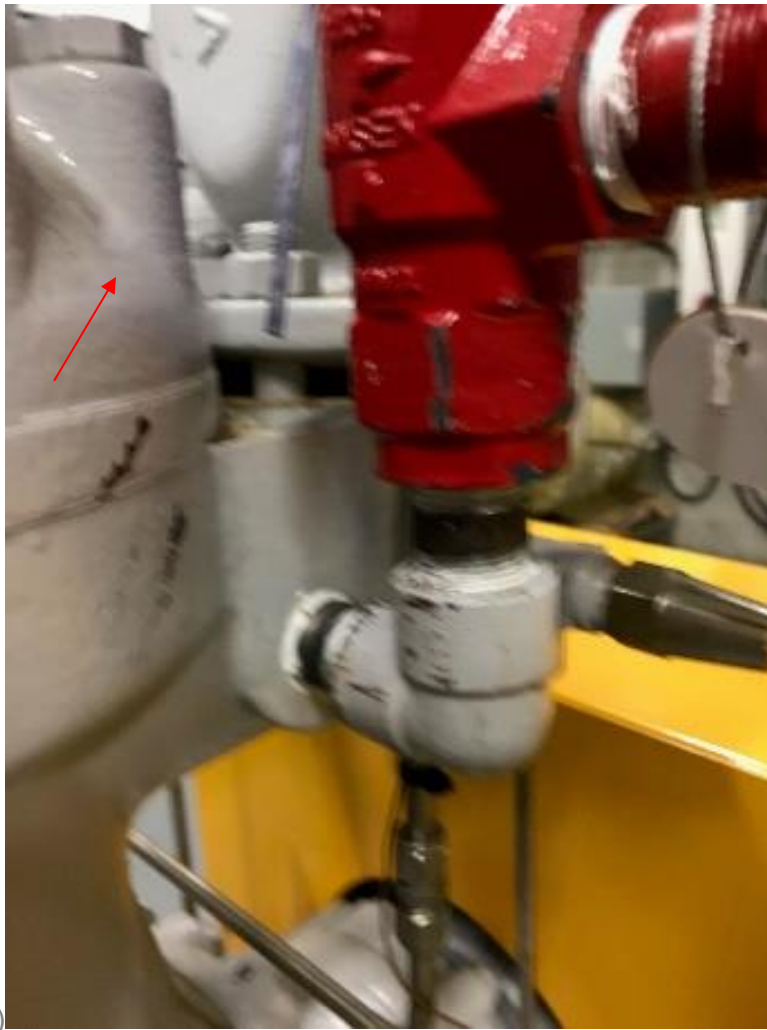
Causes and contributing factors	It is very likely that the leak, at the NPS 3/4 close threaded nipple, resulted when the nipple did not engage properly and vibrations from the operating compressor caused further disengagement.

Normal Pipe Size $\frac{3}{4}$ close nipple upstream of elbow.

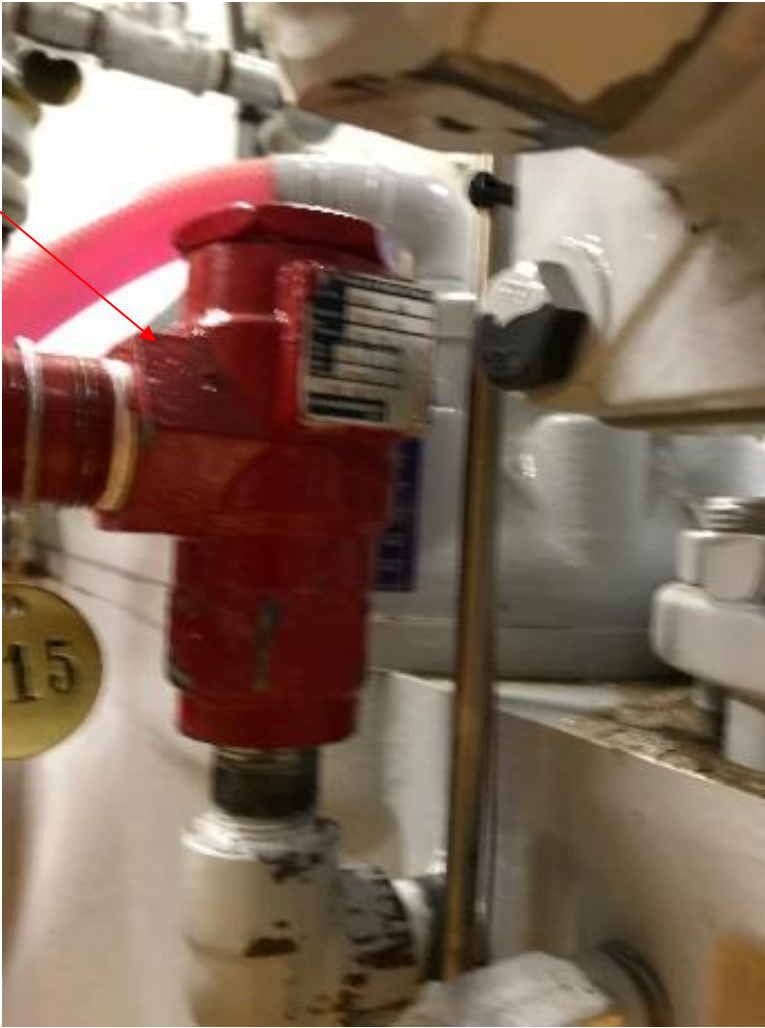
Side View of Normal Pipe Size $\frac{3}{4}$ close nipple upstream of elbow.
