## Incident Summary #II-848274-2019 (#12167) (FINAL)

SUPPORTING INFORMATION	Incident Date	May 5, 2019	
	Location	Revelstoke	
	Regulated industry sector	Electrical - Low voltage electrical system (30V to 750V)	
	Impact	Qty injuries	0
		Injury description	N/A
		Injury rating	None
	Damage	Damage description	A fire occurred in a residential garage being used for a marijuana/ vegetable grow operation causing significant damage to garage structure and damaging electrical wiring.
		Damage rating	Major
	Incident rating	Major	
Incident overview	A residential garage was used for a small grow operation using 'cord connected' equipment with extension cords and powerbars that caught fire and destroyed the residential garage attached to dwelling site.		
INVESTIGATION CONCLUSIONS	Site, system and components	The system was configured to operate using 'cord connected' equipment with extension cords and standard powerbars. The cord connected equipment being portable manual selectable timers to operate grow lights as well as circulation fans and filter fans to create an environmentally controlled area. Portable electric heaters were used to maintain a minimum temperature when lighting was not in ope

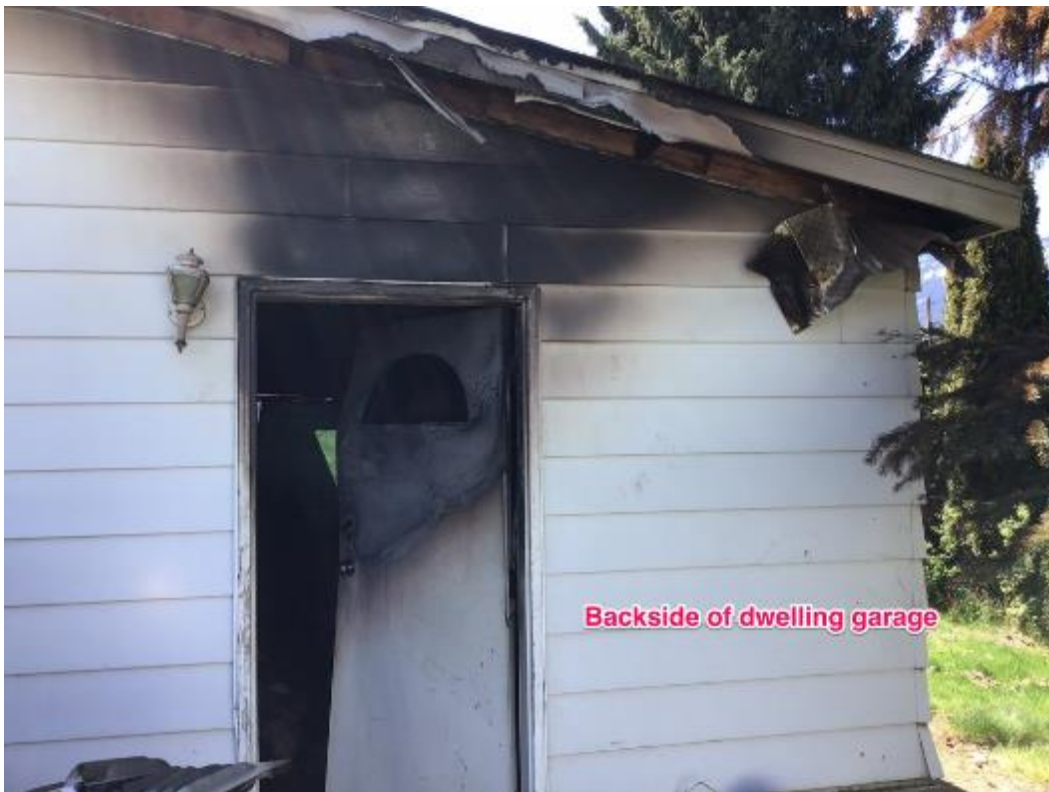
Photo 1: Burn marks and soot residue on door and outside wall due to fire within (photo by Fire/Rescue)

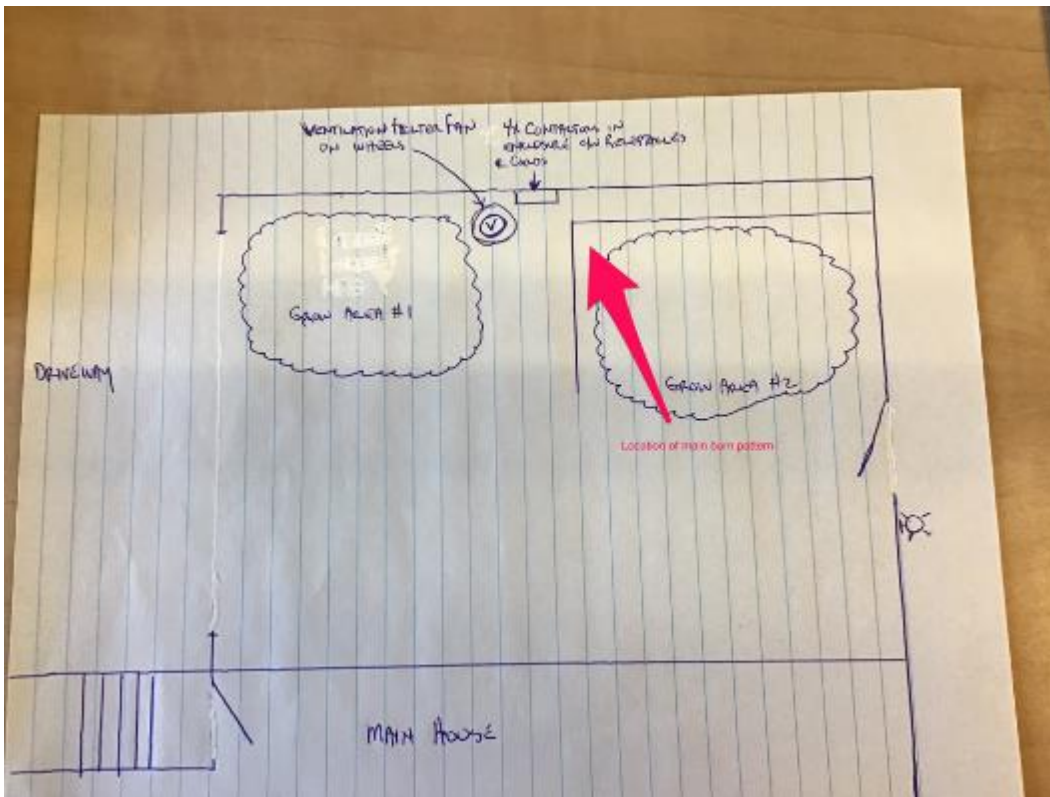
Photo 2: Diagram of layout with the garage.

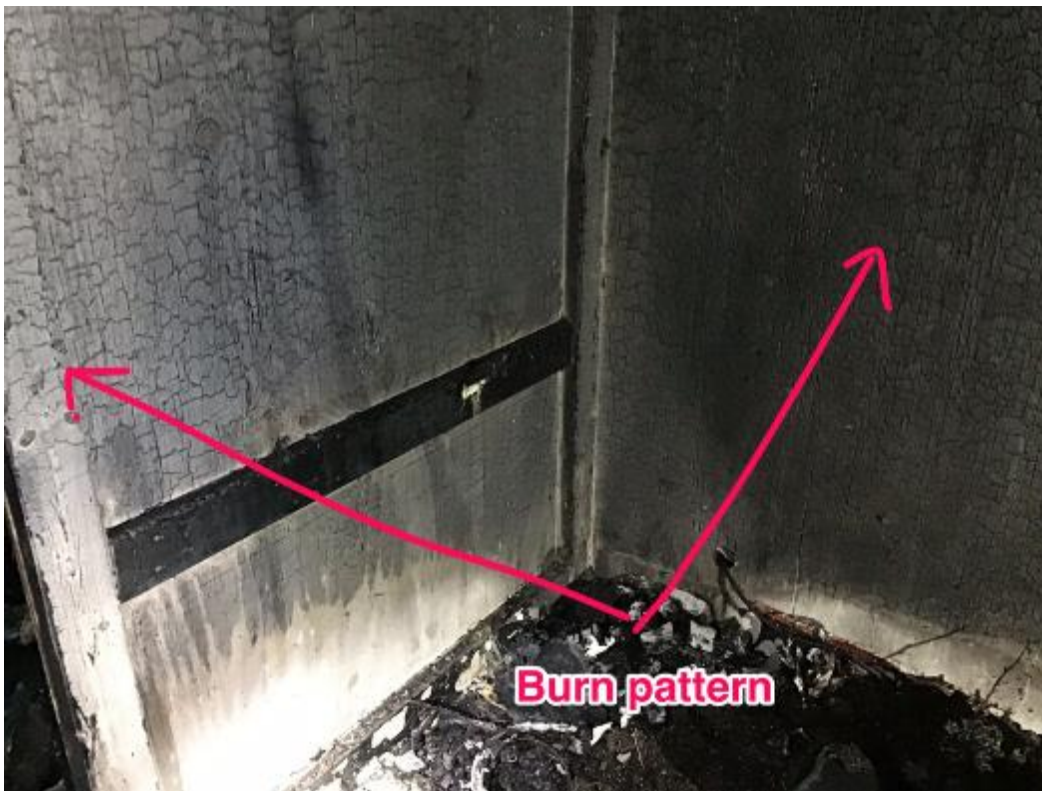
Failure scenario(s)	The operation of the system in the north grow area #2 used an electric space heater that was located at floor level with a circulation fan located approx. 24" above mounted to wall, plus ventilation fan and 1000 watt HID (high-intensity discharge) lampholder located above in the near vicinity. Post fire all these items were found at floor level. The heat damage appeared to be located around the electric fan-forced heater location where a burn pattern was present on the wall. It is possible that the circulation fan dropped off the wall from excessive heat due to the fire.	
	Facts and evidence	<p>Observations from inspection of the incident site and evidence/photos provided by the City of Revelstoke Fire and Rescue Services are summarized below:</p> <ul style="list-style-type: none"> <li>- The grow operation did not show signs of additional hard wiring methods. Extension cords and plug-in equipment was used throughout utilizing 3 receptacle locations in garage.</li> <li>- Burn pattern appeared to start at low level in corner of north grow area where heater was located.</li> </ul>

Photo 3: Burn patterns on the wall near the fire origin (photo provided by Fire/Rescue)

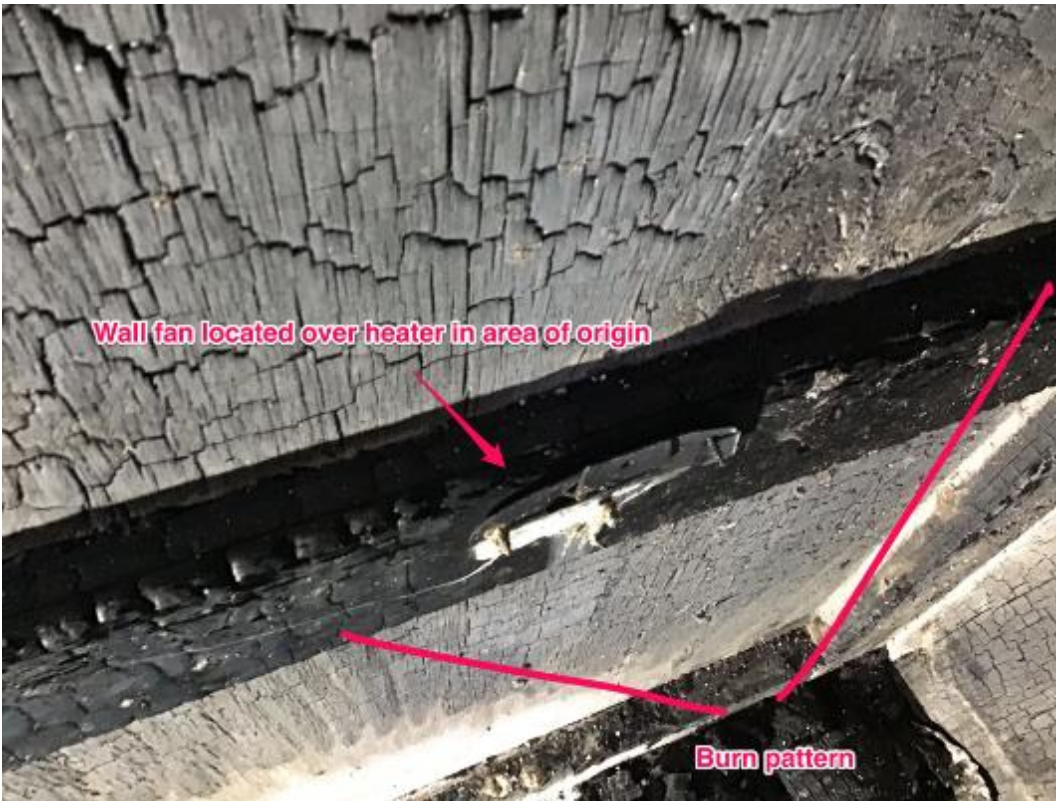
Photo 4: Burn pattern around location of wall mounted fan (photo provided by Fire/Rescue)

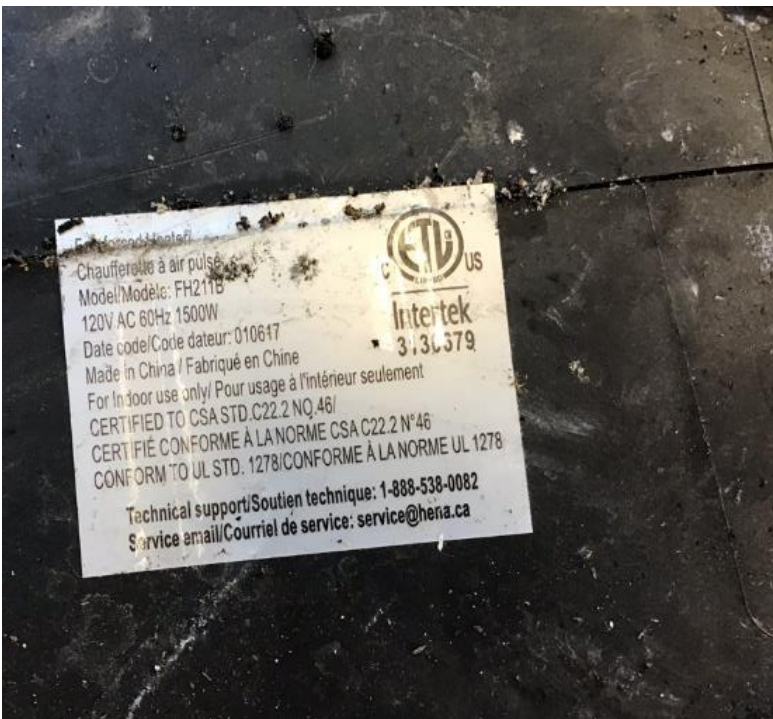
<ul style="list-style-type: none"><li>- The heater was a Classic, model FH211B and showed signs of extreme heat with melting of plastic enclosure. The heat level setting on the unit could not be determined due to excessive damage. Heater had built-in high limit and tip over switch features.</li><li>- Research on the heater in question found no published records of other fire related issues.</li><li>- A multiple outlet flexible cord and two mechanical timers connected showed signs of fire damage. Connection points of cord did not show evidence of electrical failure and hence not contributory to incident.</li><li>- Circulation fan appeared to have fallen from wall due to heat of the fire, landed on heater and melted/ fused together. The white plastic fan mount on wall showed no discoloration and did not appear damaged due to the fire.</li></ul>
Causes and contributing factors	The origin of the fire was likely surrounding the electric heater location at floor level in the burn pattern area. It is possible that a failure of the heater component or foreign object obstruction within the manufacturers 3 foot clearance requirement had created overheating and ignition.

Photo 5: Specification label on electric heater (photo provided by Fire/Rescue)

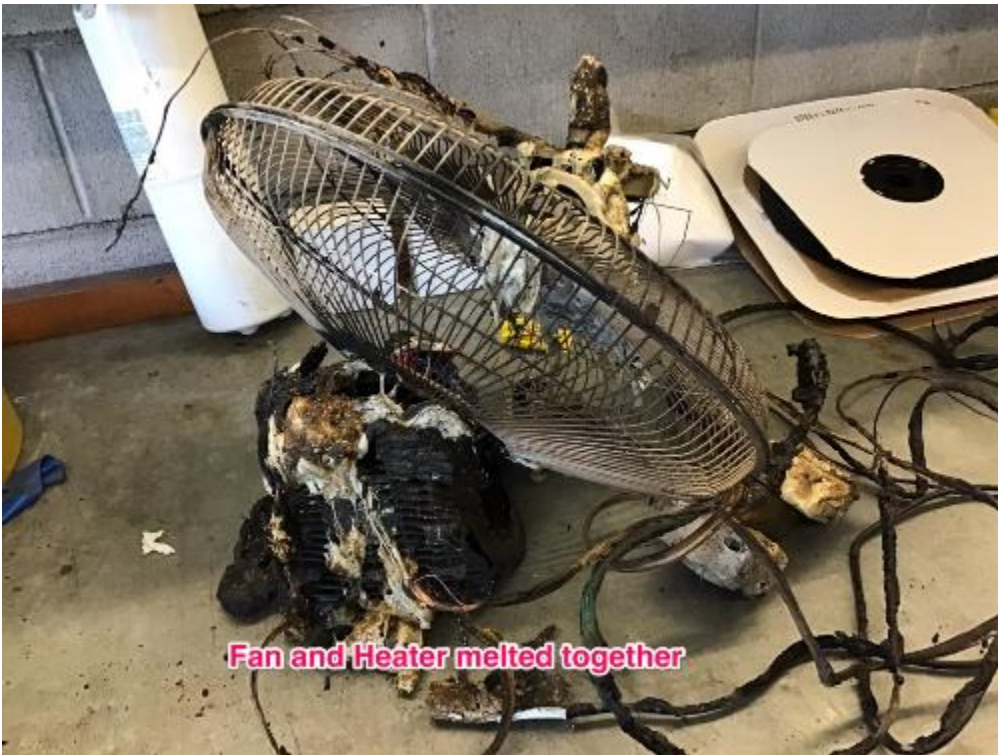
Photo 6: Electric fan and heater partially melted together (photo provided by Fire/Rescue)

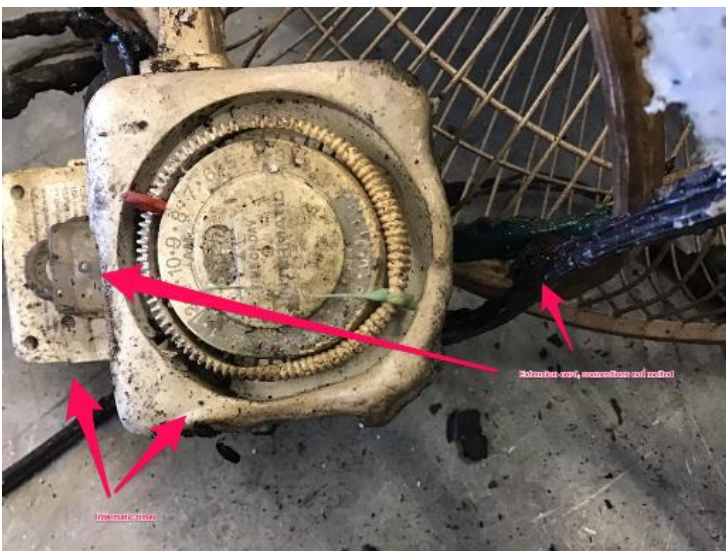
Photo 7: Timer for grow lights, partially heat damaged (photo provided by Fire/Rescue)

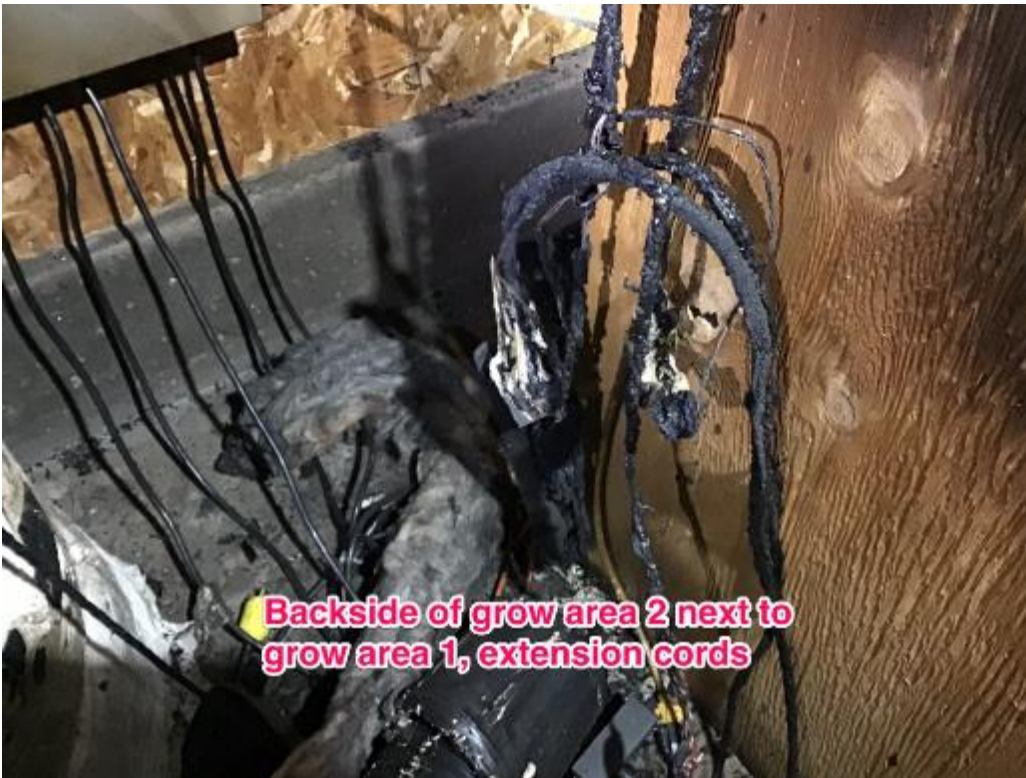
Photo 8: Extension cords used, significant heat damage (photo provided by Fire/Rescue)

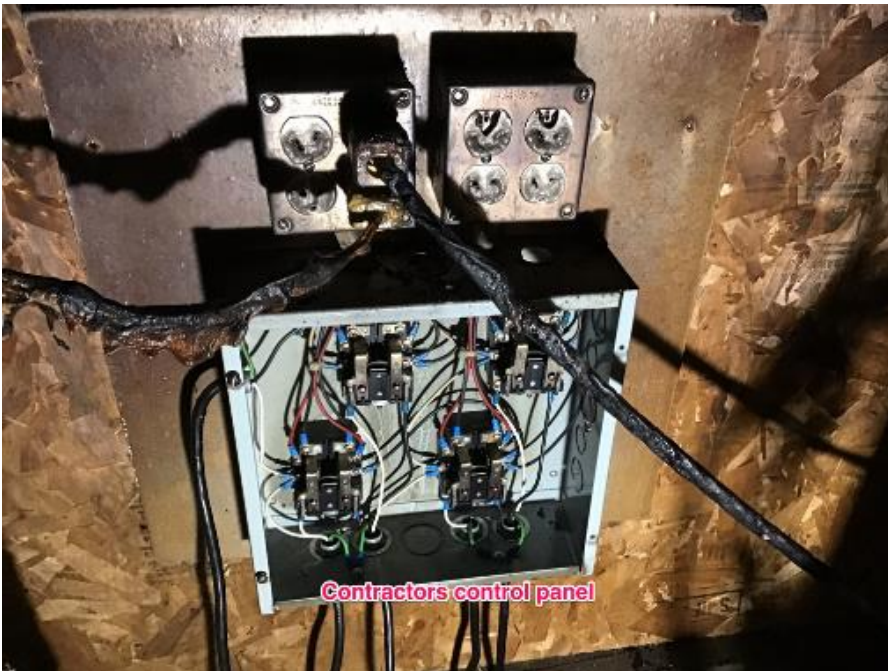
Photo 9: Extension cords heat damaged, wiring inside steel box are not damaged (photo provided by Fire/Rescue)

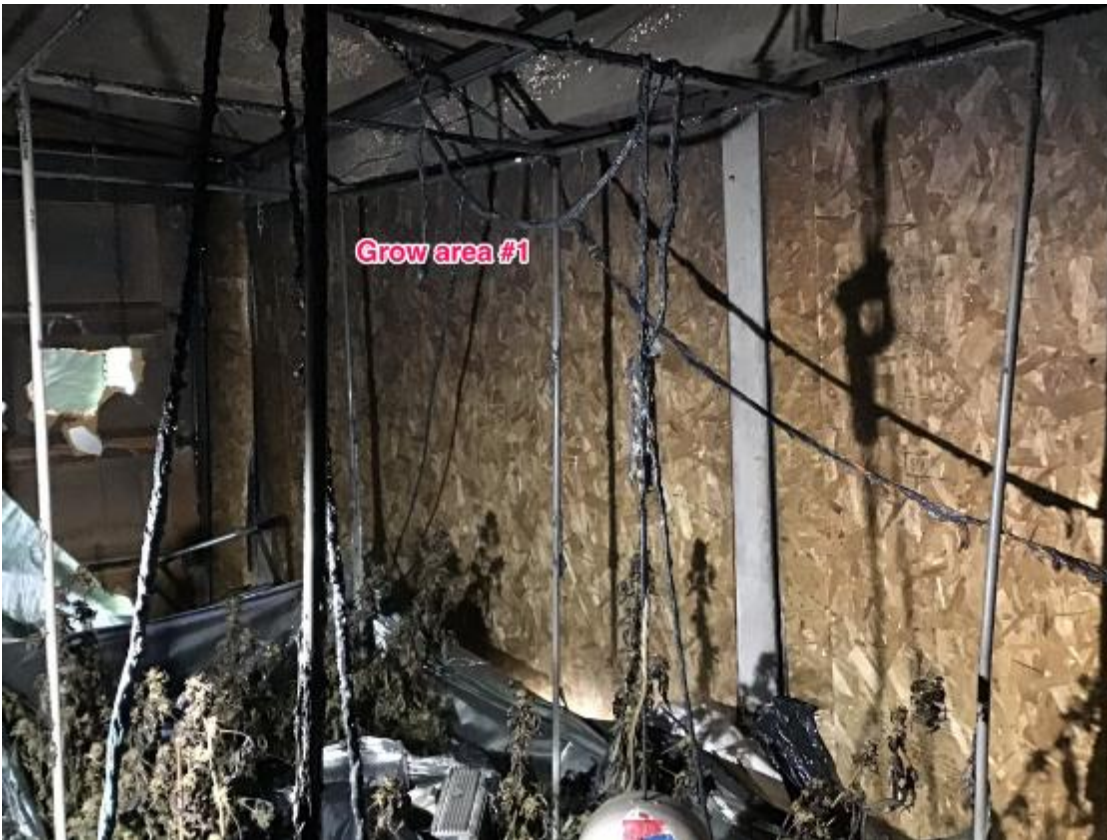
Photo 10: Fire damage in South grow area #1 (photo provided by Fire/Rescue)
