## Incident Summary #II-1672194-2024 (#44242) (FINAL)

SUPPORTING INFORMATION	Incident Date	January 29, 2024	
	Location	Prince George, British Columbia	
	Regulated industry sector	Electrical - Low voltage electrical system (30V to 1000V)	
	Impact	Qty injuries	1
		Injury description	A worker came into contact with a damaged electrical cable feeding an electric crane, receiving an electrical shock.
		Injury rating	Major
	Damage	Damage description	A flexible cable was damaged, exposing an energized conductor.
		Damage rating	Major
Incident rating	Major		
Incident overview	<p>A flexible electrical cable, fed from a 3 Phase 600 Volt 60 Amp disconnect and feeding an electric crane, sustained damage to the outer jacket and inner conductor sheath exposing the energized copper conductor. The cable was run along the floor to the edge of the lifting bay, then draped over the handrail into the lifting bay, up to the crane to retain the flexibility required. A worker was operating the crane using the control pendant, and while looking over the lifting bay, contacted the exposed, energized conductor, receiving an electrical shock.</p>

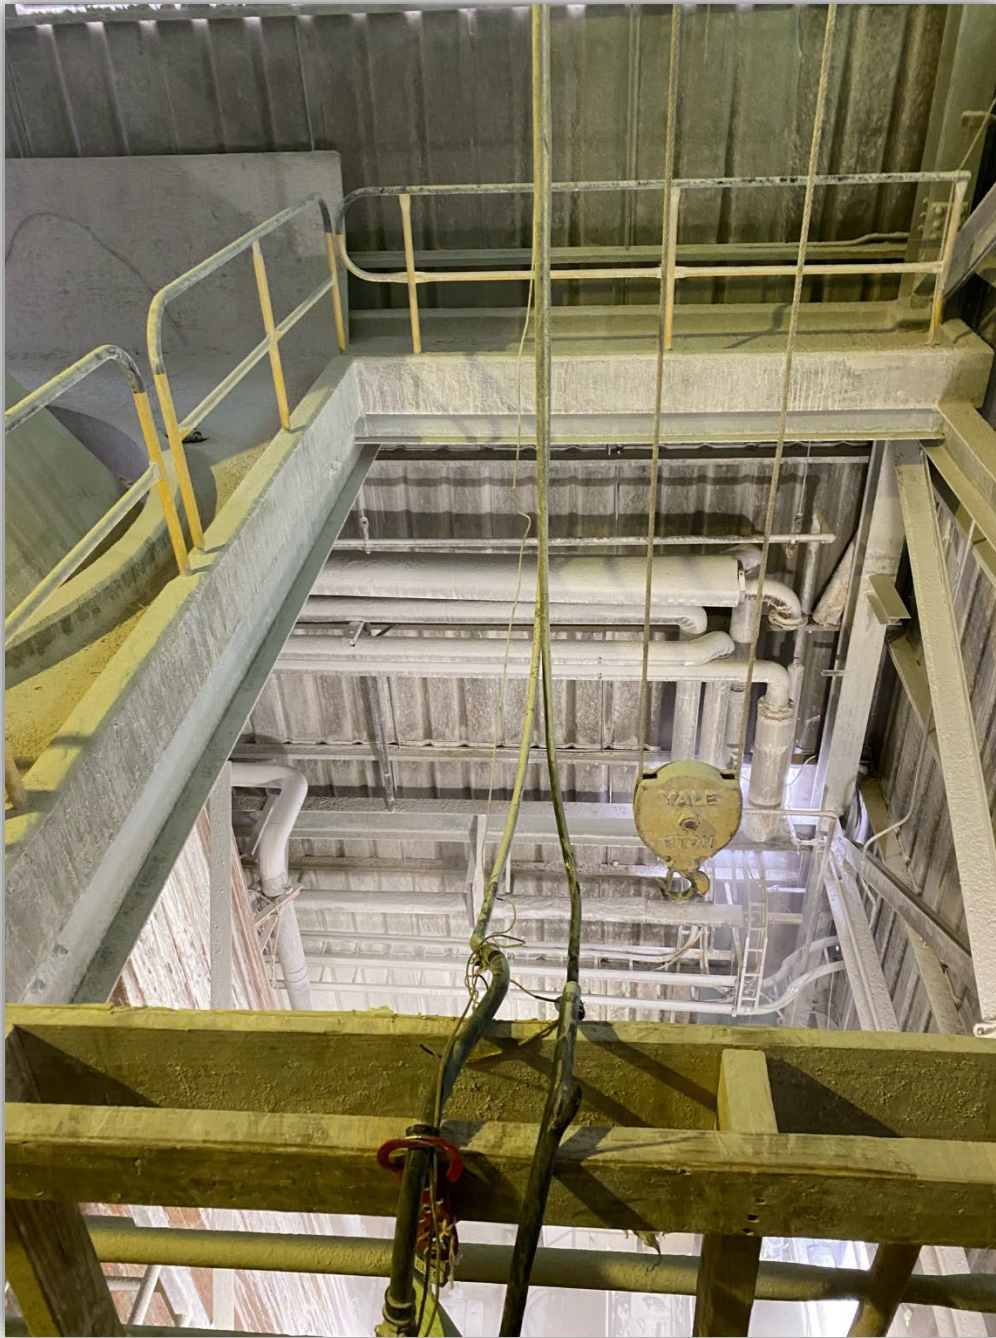
Facts and evidence	<p>The cable was viewed in the approximate location to contact the worker as they leaned over the railing at the lifting bay edge (<a href="#">Image 1</a>).</p> <p>The cable was shown with damage and an exposed energized conductor (<a href="#">Image 2</a> &amp; <a href="#">Image 3</a>).</p> <p>The crane was not provided with a take up device for cable slack. The cable was run along the ground to the disconnect.</p>
Causes and contributing factors	<p>It is highly likely that the power feeder cable slack not being taken up allowed the worker's body to contact the exposed energized conductor while guiding the crane hook through the lifting bay.</p> <p>An auto take-up device could have potentially prevented the cable from being damaged.</p> <p>The cable damage was likely caused when the crane moved past a piece of stationary equipment while dragging the cable. The cable likely was dragged across a sharp edge, creating the slice.</p>

Image 1 - Crane lifting bay with damaged cable and control pendant in the approximate location & position when incident occurred.

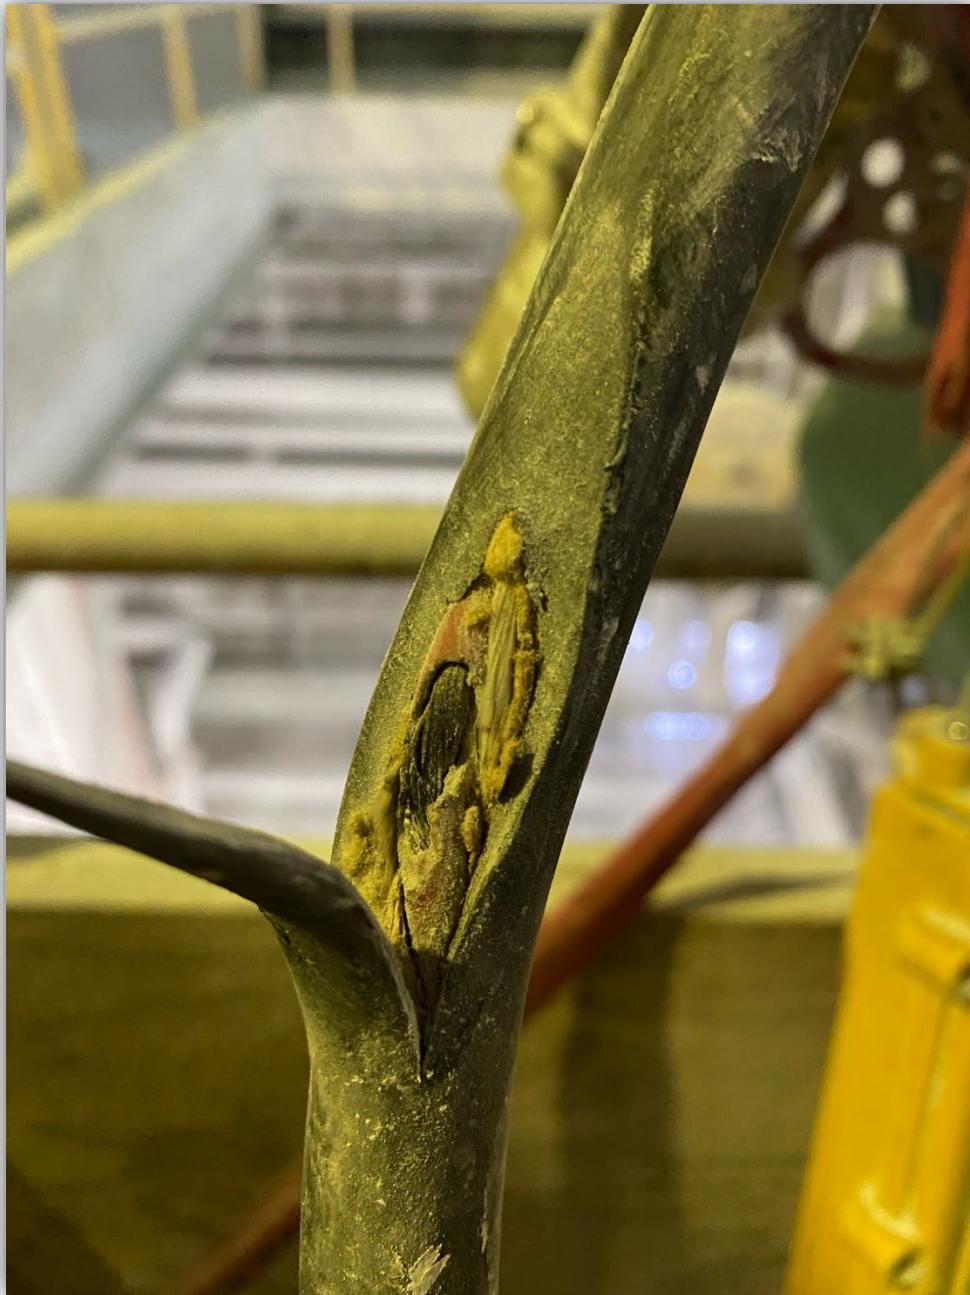
Image 2 - Close-up of cable damage and exposed conductor.

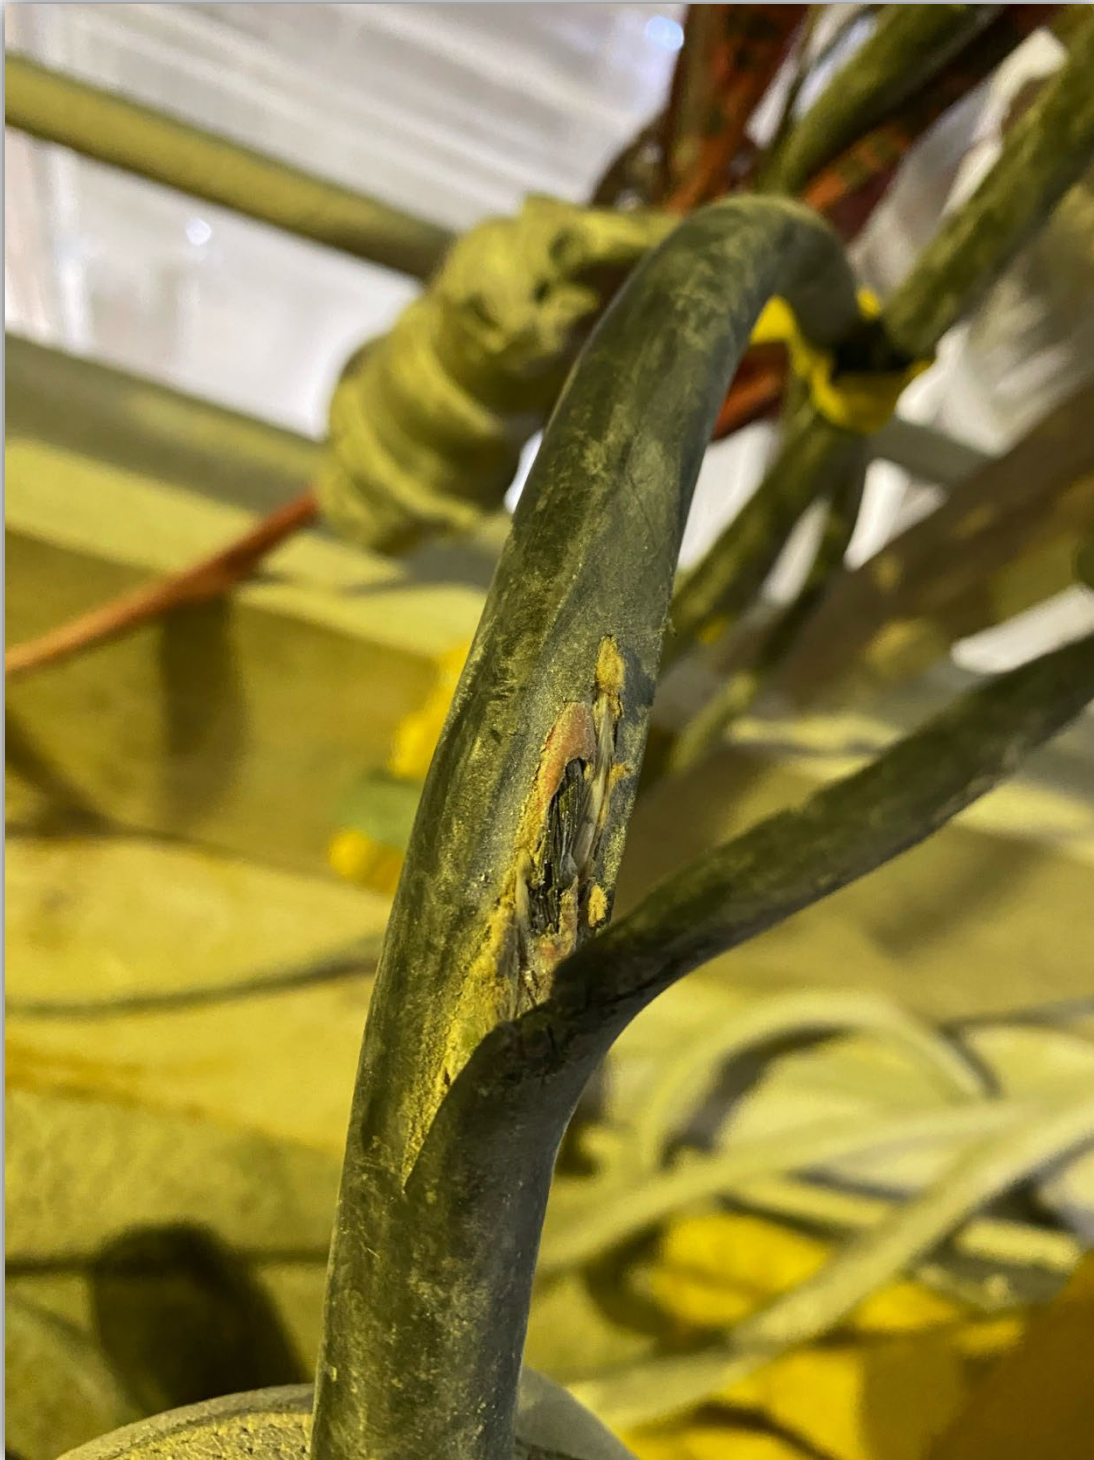
Image 3 - Close-up of cable damage and exposed conductor.
