Incident Summary #II-1672194-2024 (#44242) (FINAL)

SUPPORTING INFORMATION	Incident Date	January 31, 2024	
	Location	Prince George, British Columbia	
	Regulated industry sector	Electrical - Low voltage electrical system (30V to 1000V)	
	Impact	Qty injuries	1
		Injury description	A worker received a shock from damaged electrical cable feeding an overhead crane. The worker was treated for injuries but weeks later passed away possibly due to complications from the treatment. <i>*Cause of death (COD) is not determined by Technical Safety BC. The BC Coroners service conducts their own investigation to determine COD.</i>
		Injury rating	Fatal
	Damage	Damage description	A flexible cable was damaged, exposing an energized conductor.
		Damage rating	Moderate
	Incident rating	Severe	
Incident overview	At an industrial facility, a flexible electrical cable, feeding an overhead 5-ton crane, sustained damage to the outer jacket exposing an energized copper conductor. A worker was operating the crane using the control pendant, and while looking over the lifting bay received an electrical shock.

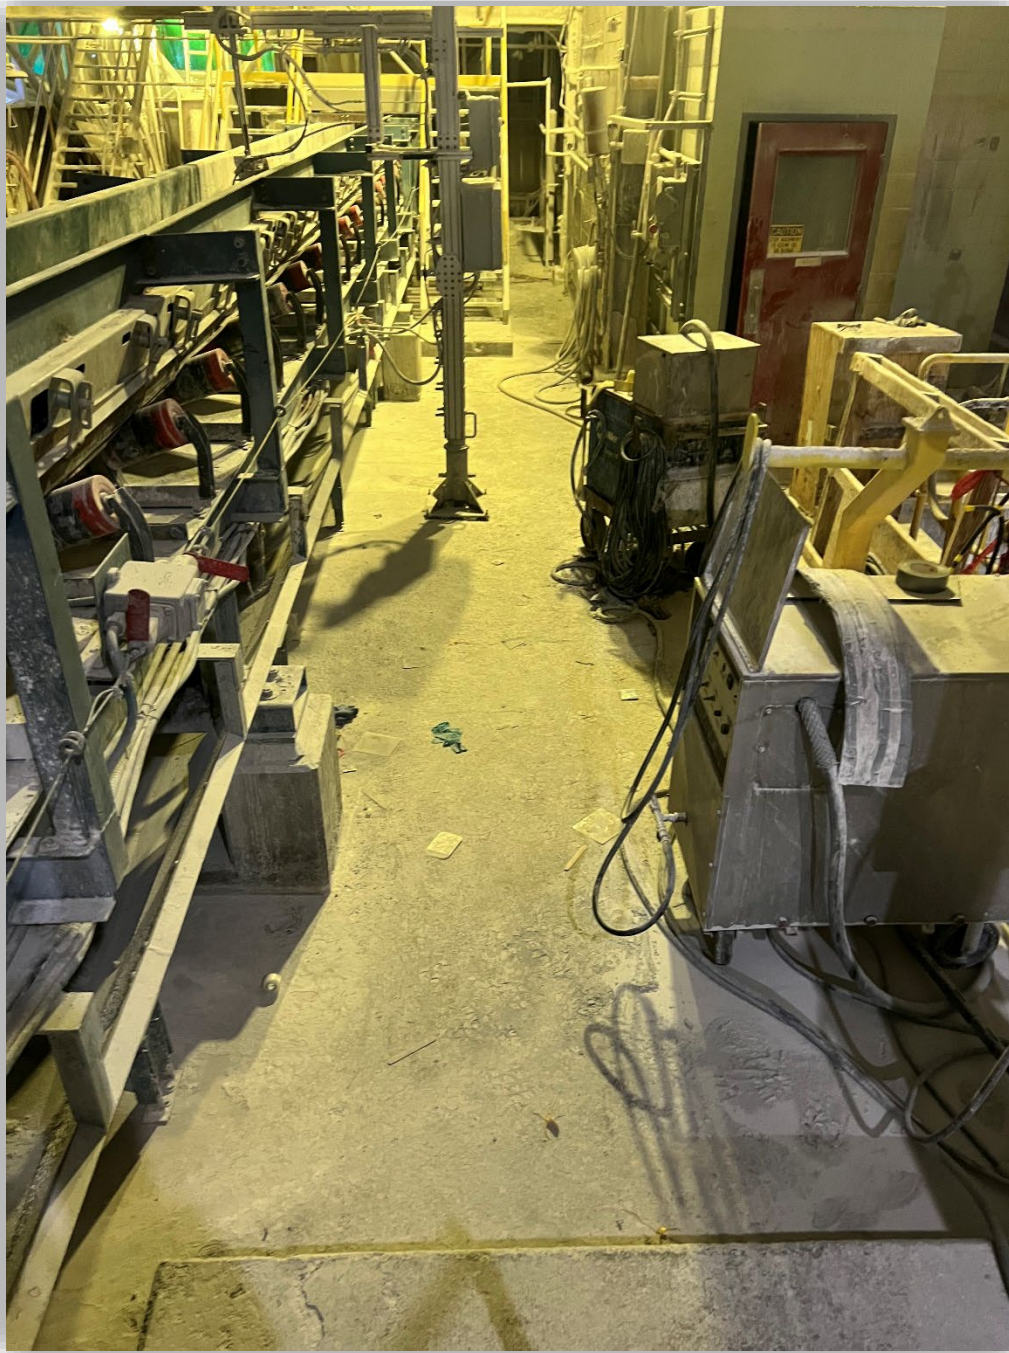
Image 1 – Area of work and equipment. Floor opening and overhead crane located on the right-hand side over the handrail.

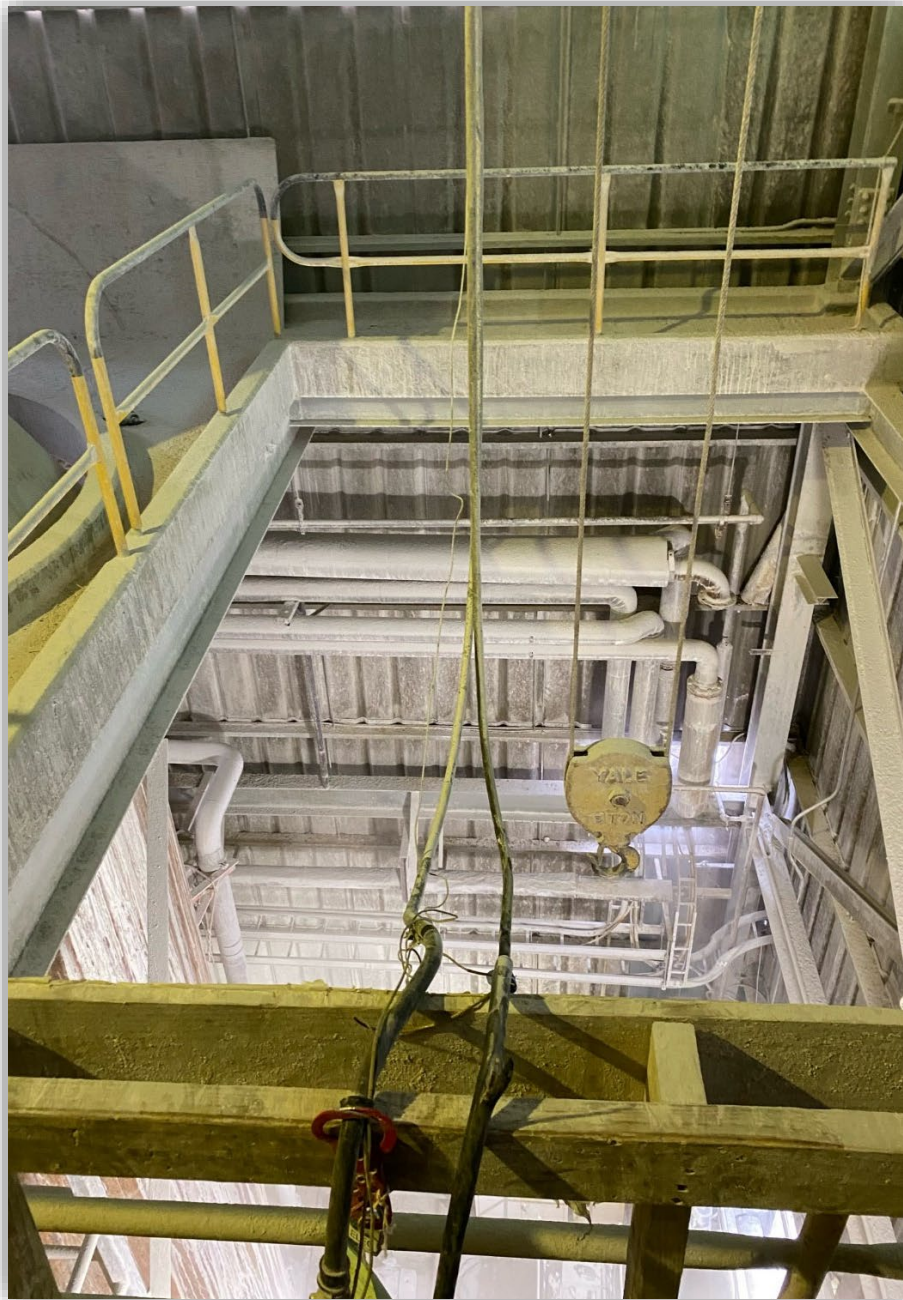
Image 2 – Crane lifting bay with damaged cable and control pendant in the approximate location and position when the incident occurred.

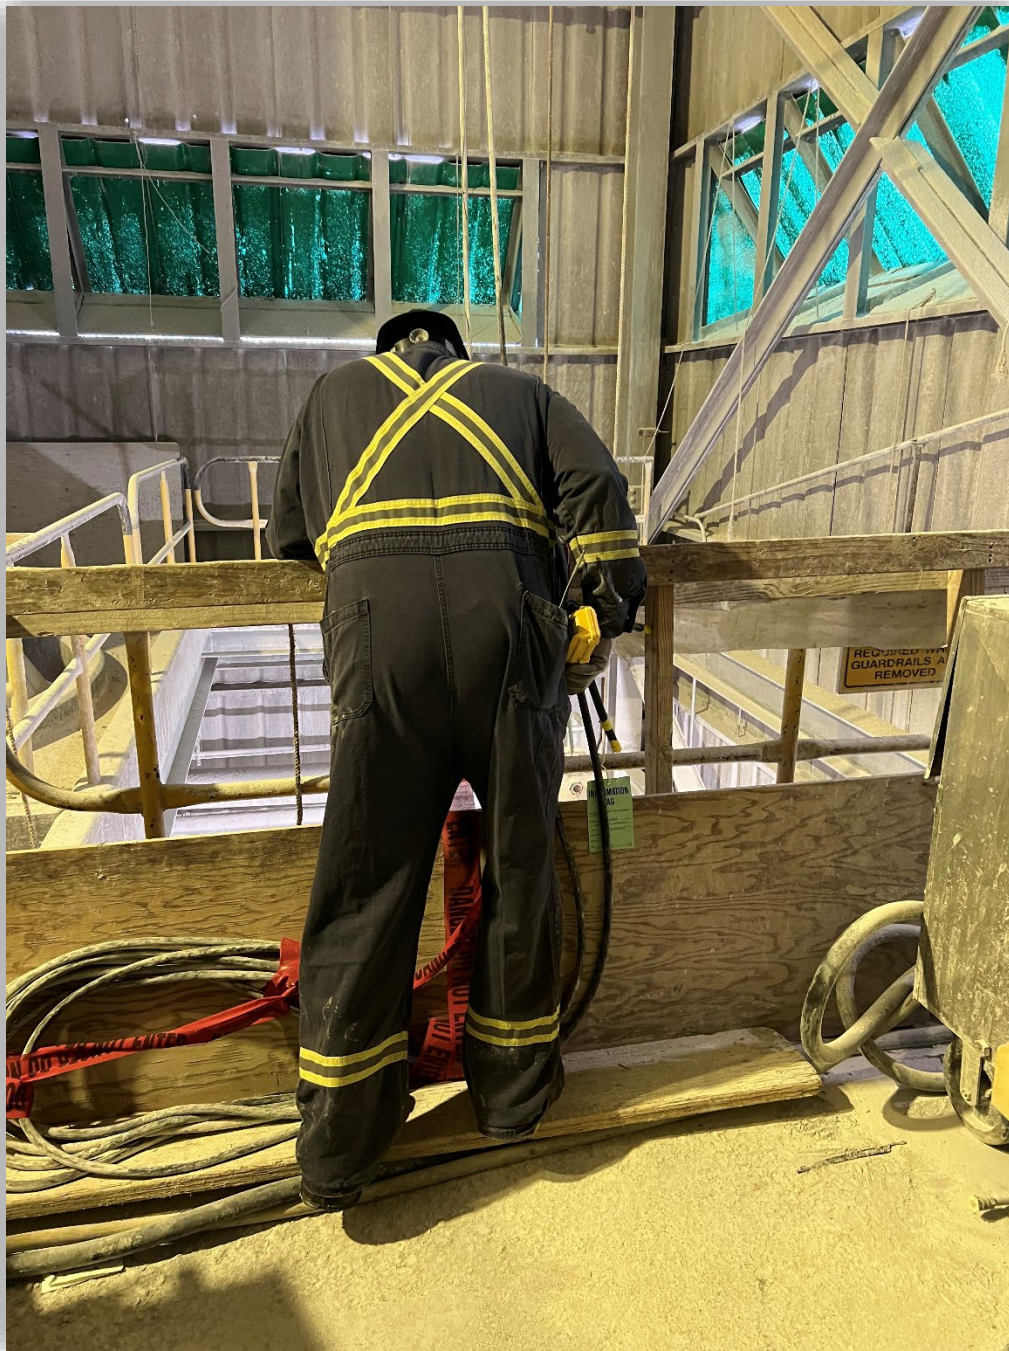
Image 3 – Approximate location and position of injured worker while operating crane. (*Situation recreated by another worker after the incident.*)

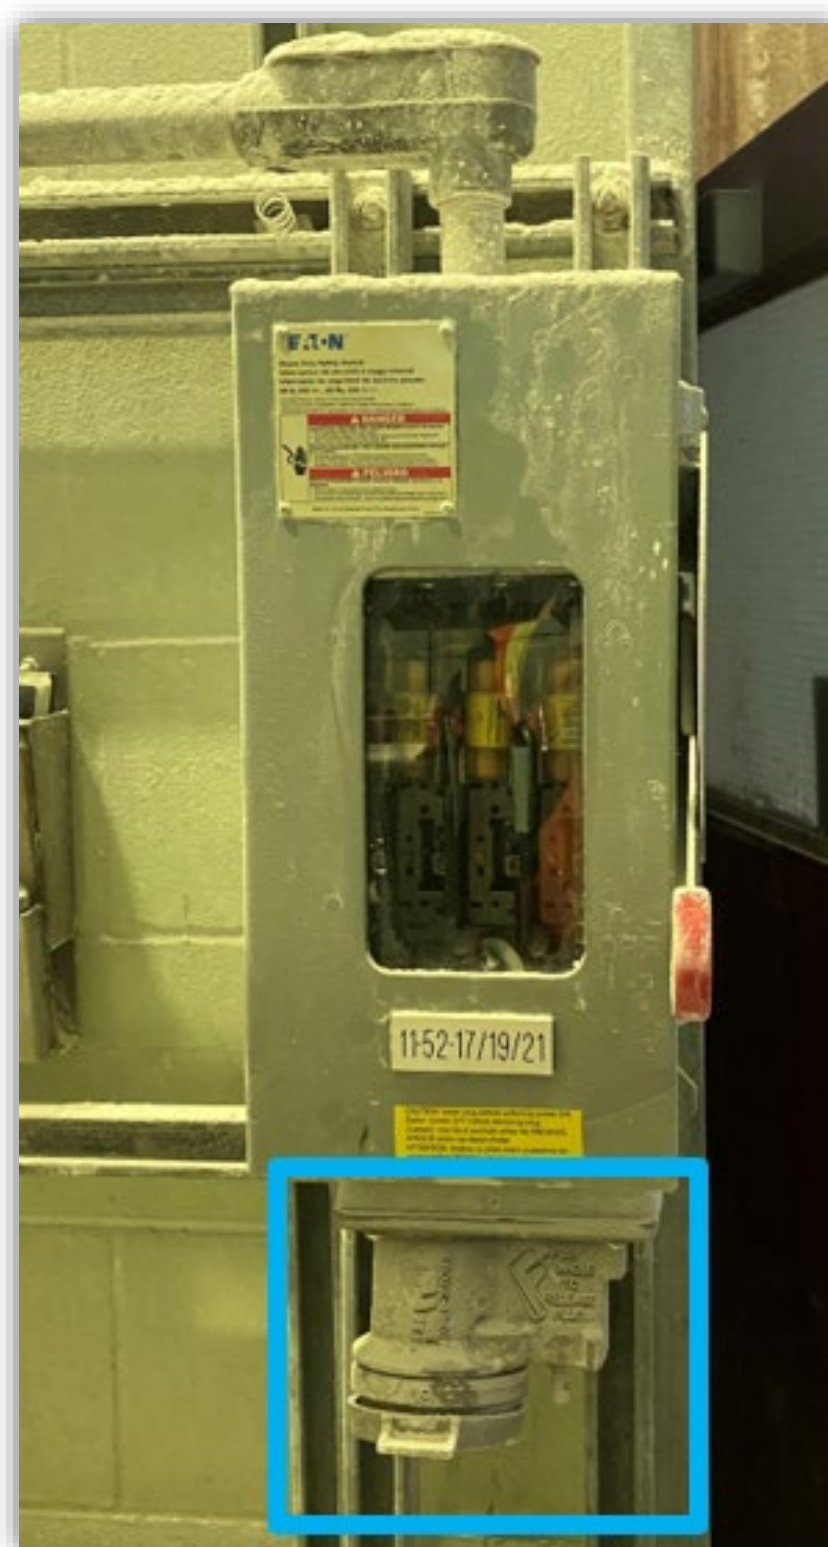
Image 4 – 600V disconnect used for the overhead crane. The crane electrical cable plug was inserted into the receptacle located at the bottom of the disconnect (box).

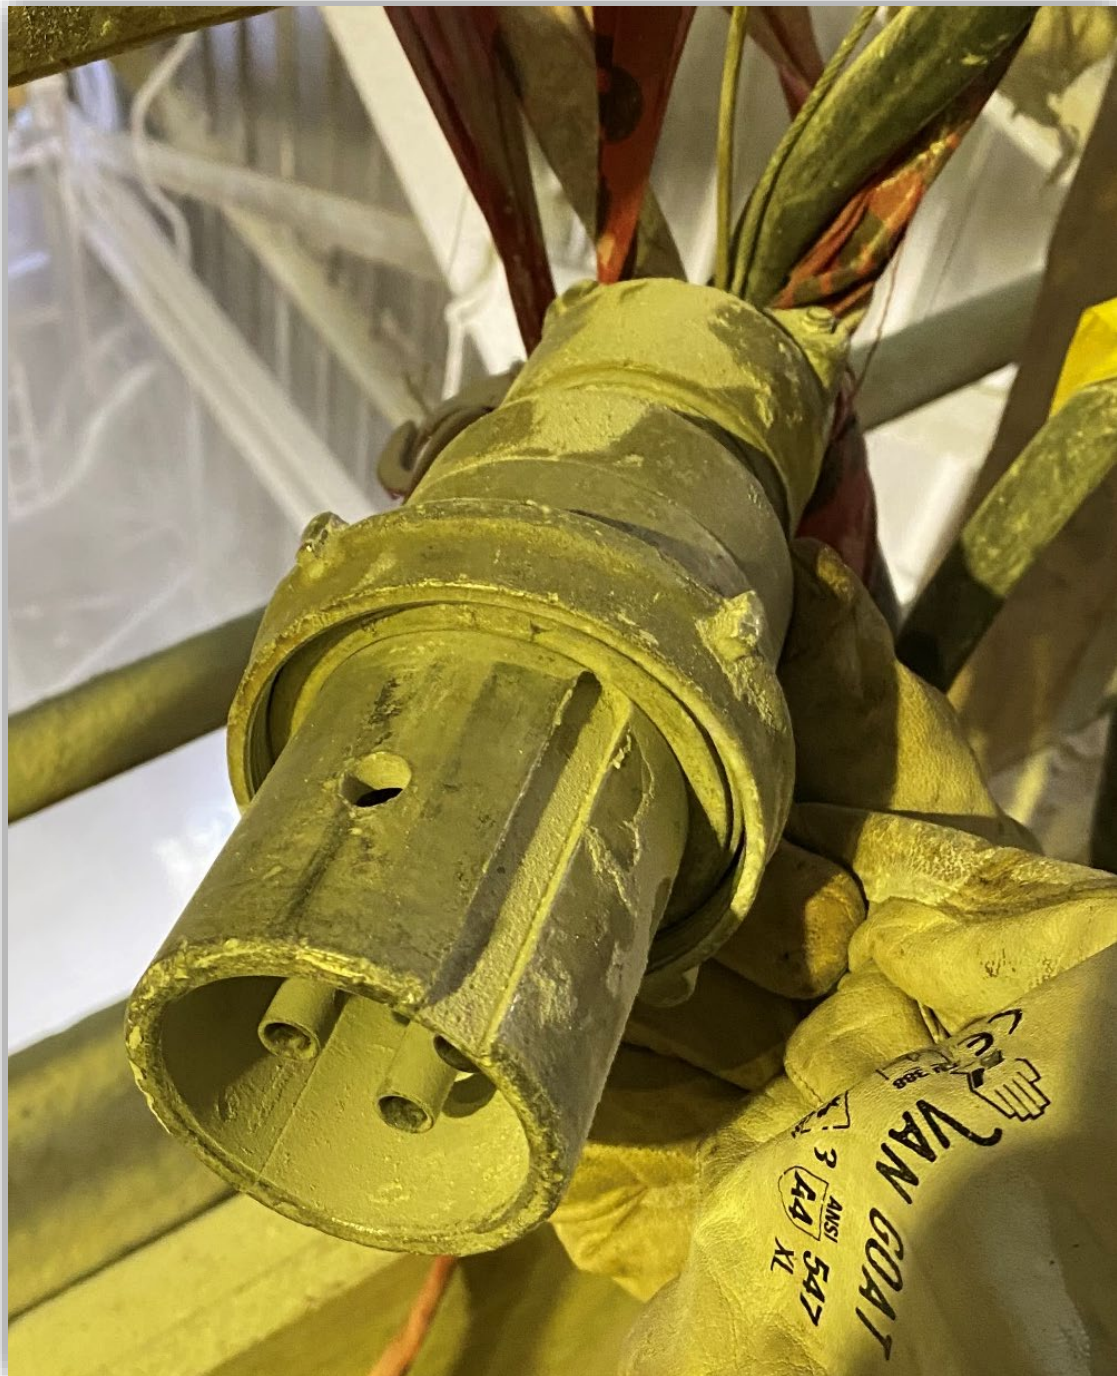
Image 5 – Plug end of the crane feeder cable disconnected from the receptacle after incident.

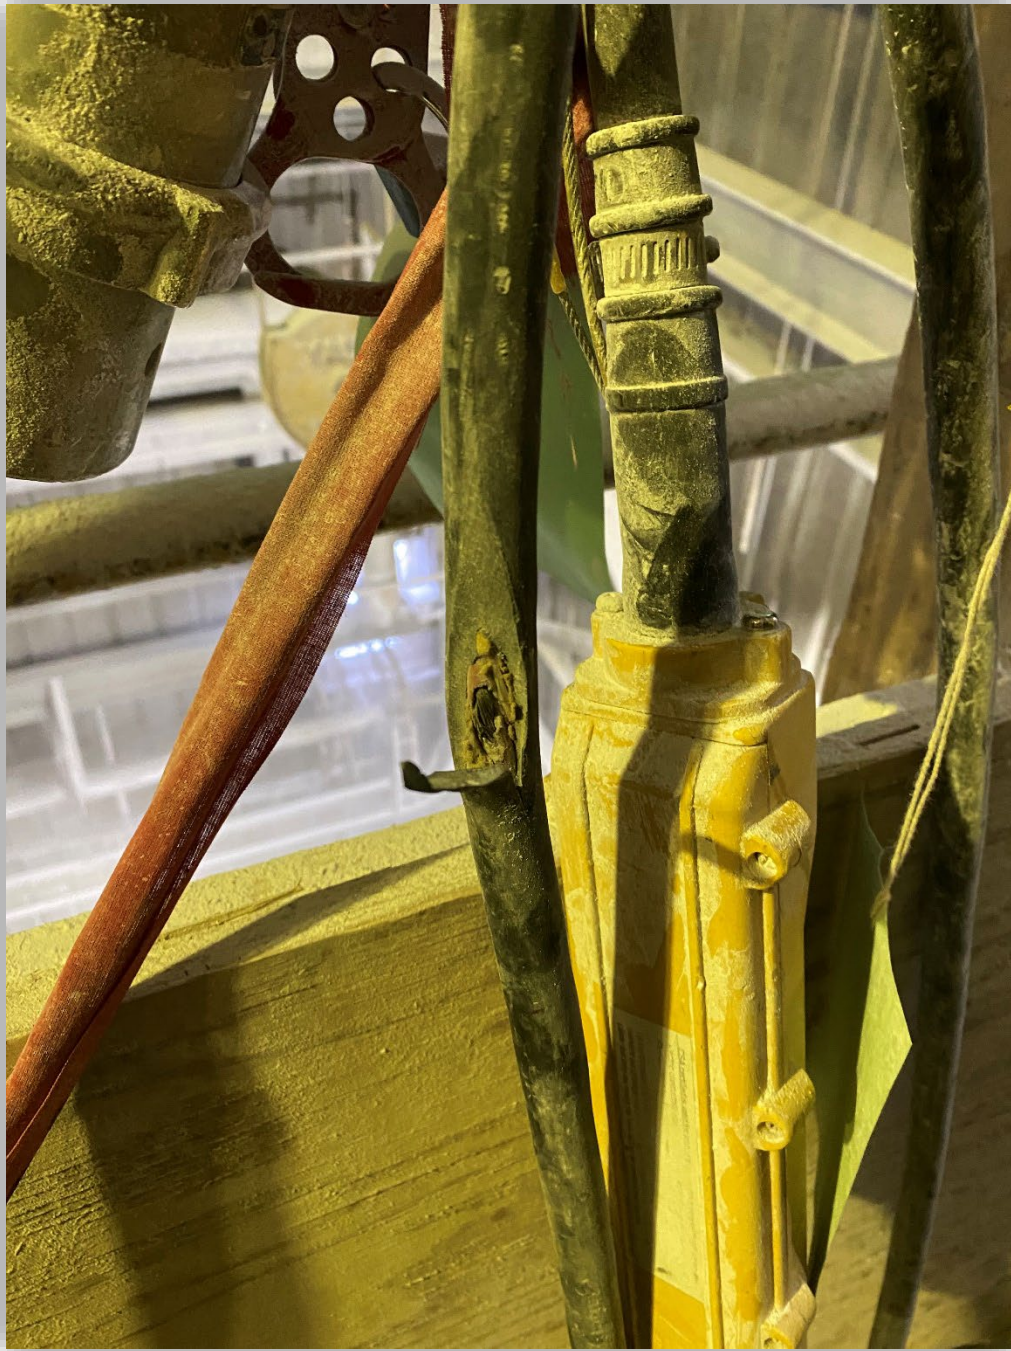
It is highly likely that the power feeder cable was damaged, and the exposed energized conductor contacted the metallic handrail energizing it and causing an electric shock to the employee when they contacted the handrail.

Image 6 – Crane operation pendant and damaged electrical cable on the handrail of the floor opening and overhead crane operation.

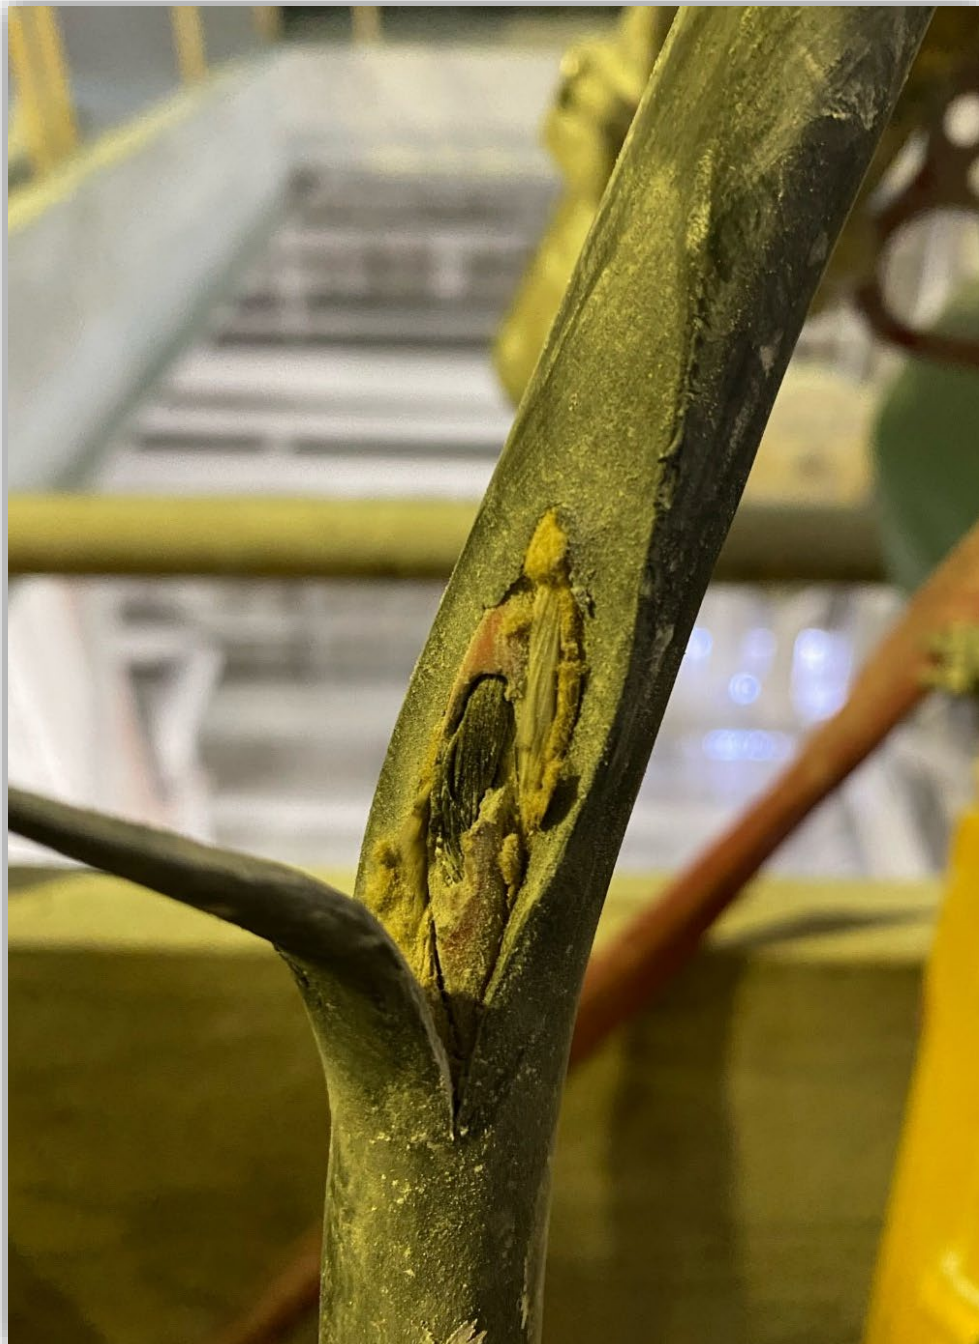
The electrical feeder cable for the crane was not permanently wired to the electrical system and instead used an industrial pin-and-sleeve style plug end that was plugged into a receptacle at a 600V 3ph 60A disconnect that is also occasionally used for other equipment at the facility such as welders and a heated pressure washer ([Image 4](#) and [Image 5](#)). The feeder cable for the crane did not have a festoon cable or other take up device as required to prevent damage to the cable and to keep it clear of the operating floor. There was no specific or dedicated location to wrap up or store the power cable for the crane. The cable was run along the floor to the edge of the lifting bay, then draped over the handrail into the lifting bay, up to the crane to retain the flexibility required. At some point in time the supply cable for the crane had become damaged near the metal handrail. The outer jacket of the cable had been sliced exposing one of the 600V electrical conductors ([Image 7](#) and [Image 8](#)).

Image 7 - Close-up of cable damage and exposed conductor.

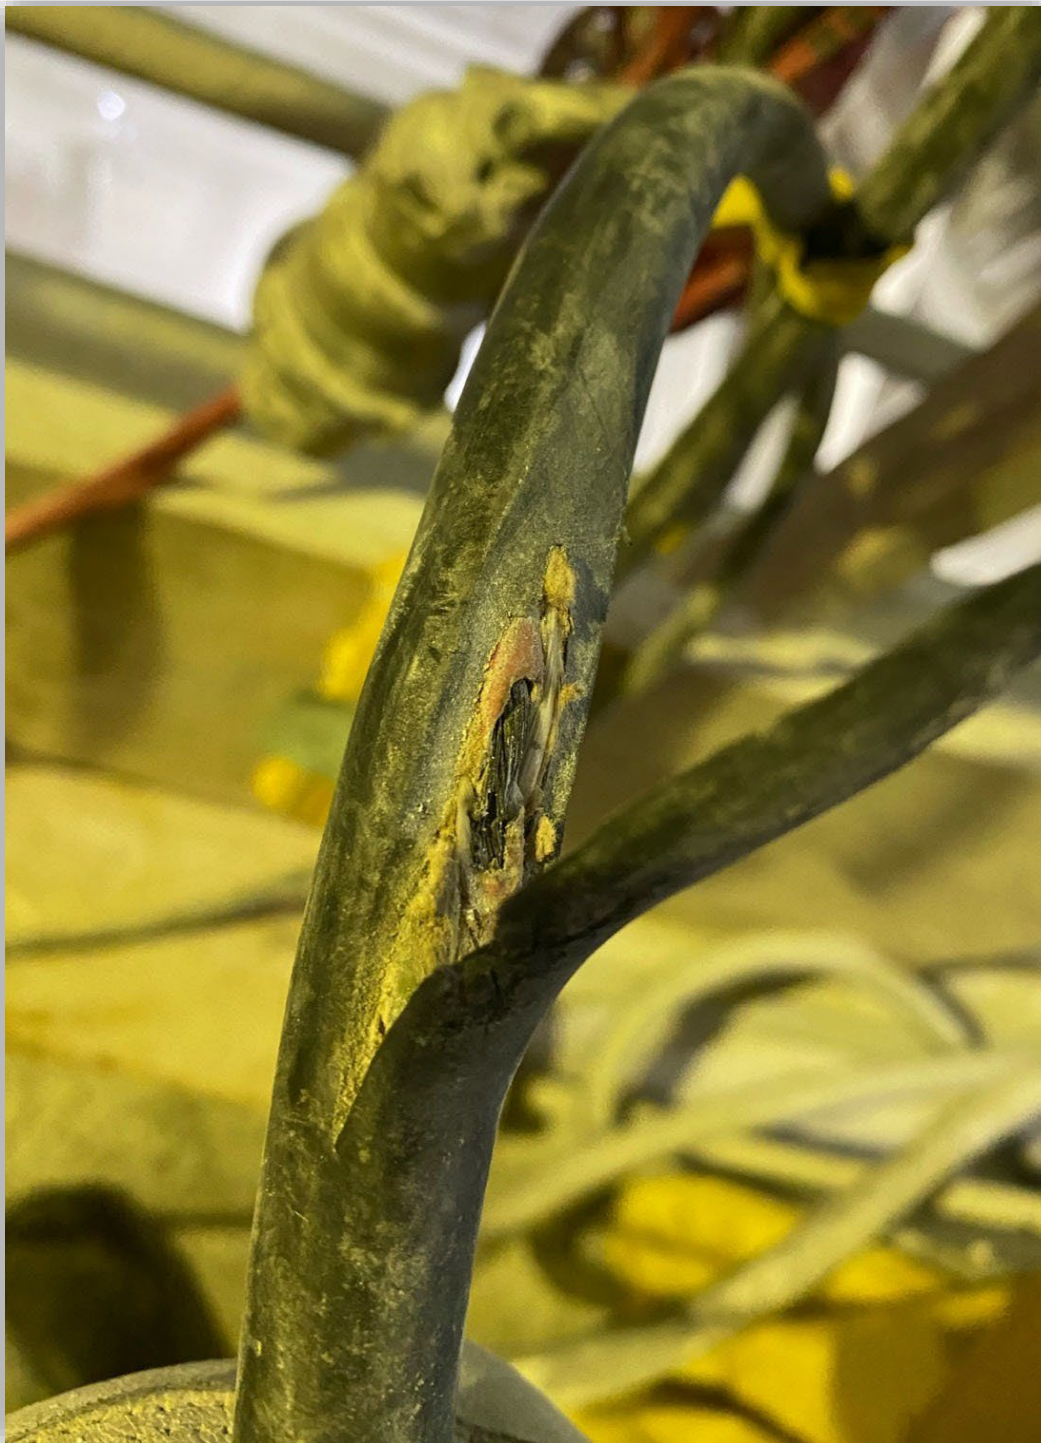
Image 8 - Close-up of cable damage and exposed conductor.
