Incident Summary #II-743660-2018 (#8546) (FINAL)

SUPPORTING INFORMATION	Incident Date	August 30, 2018	
	Location	North Vancouver	
	Regulated industry sector	Passenger ropeways - Above surface ropeway	
	Injury	Qty injuries	0
		Injury description	NA
		Injury rating	None
	Impact Damage	Damage description	The center axel of a bullwheel utilized in the haul rope tension system (counter weight) had become dislodged and wedged between the channel mounts which locates and supports the bullwheel axel.
			Multiple counterweight guide rollers assemblies utilized in keeping the haul rope counterweight level and allow for vertical movement were broken off of damaged.
		Damage rating	Major
	Incident rating	Major	
Incident overview	A mechanical reaction due to a sudden stop resulted in a significant torqueing force being applied to the haul rope tension system counterweight. The torqueing force caused multiple counterweight guides to fail and in turn cause the counterweight to tilt from its vertical position. The side loading to a bullwheel (due to the tilt) caused its axel to dislodge and become wedged between its channel mounts.

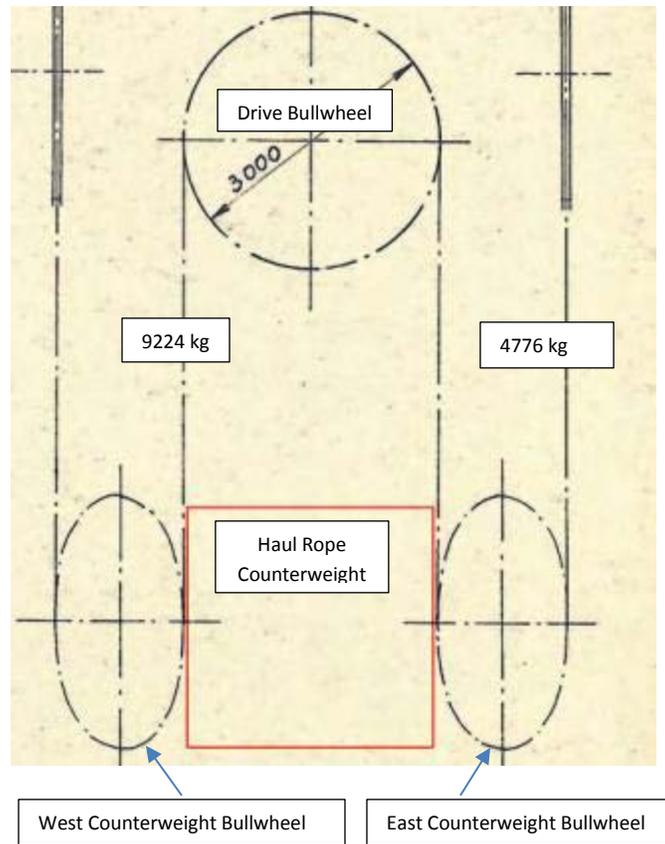
<p>A rope speed which exceeds the speed zone threshold will initiate an emergency stop (a high deceleration rate stop).</p>
<p>Failure scenario(s)</p>	<p>A sudden stop, due to carrier moving through a speed zone at an excessive speed, caused an emergency stop (high deceleration rate stop). The sudden stop caused a reaction in which a torquing force was applied to the haul rope counterweight. Counterweight guide rollers failed and this allowed the counterweight to tilt. This, in turn, caused a side load to the counterweight bullwheels resulting in a bullwheel axel to partially extract itself and become wedged between the bullwheel support channels.</p>
<p>Facts and evidence</p>	<p>Narrative of events and finding based on statements provided by operations and maintenance personnel:</p> <ul style="list-style-type: none"> • Operator on duty at the time of the incident indicated that, during the deceleration process one of the speed buttons utilized in slowing the ropeway did not function and that they needed to slow the lift by switching to a rheostat as an alternative speed control method. The operator indicates that by the time a slow was initiated by use of the rheostat an emergency stop occurred due to excessive speed in a speed zone. • Staff reported that the incident started when car 2 exceeding the threshold speed of a speed zone which resulted in an emergency stop. It was then noticed that something was wrong with the haul rope west counterweight bullwheel (bullwheel attached directly to counterweight). Initially it was thought to have been a damaged bearing and the cabin was brought down to the base to allow replacement of the bearing. • After further investigation by maintenance personnel it was determined that the shaft had dislodged from the bullwheel channel mount and had wedged in between the two mounts. • When maintenance personnel removed the tension of the haul rope to the west counterweight the bullwheel axel popped back into its mount in the steel support channels, however the channel had been bent in the process. <p>At the time of Technical Safety BC conducting onsite incident inspection, the haul rope tension had already been removed and counterweight bullwheel axel had been reinserted back into its mounting bore. Onsite incident inspection by Technical Safety BC identified that:</p> <ul style="list-style-type: none"> • A gouge mark near the outer diameter of the bullwheel. This provides evidence that indicated the bullwheel was rotating after it tilted. (see photo, figure 3) • A multiple number of the counterweight roller guides were found to be damaged (broken off from mounts). <p>Further review of this incident determined that the channels had been previously bent, which points towards a similar incident having occurred before (time of previous incident unknown). Also, in discussions with maintenance staff it was determined that historically it was common for the counterweight guides to become damaged and require repair or replacement.</p>

Figure 1, Haul Rope Tension Configuration, Emergency Stop Load Scenario.

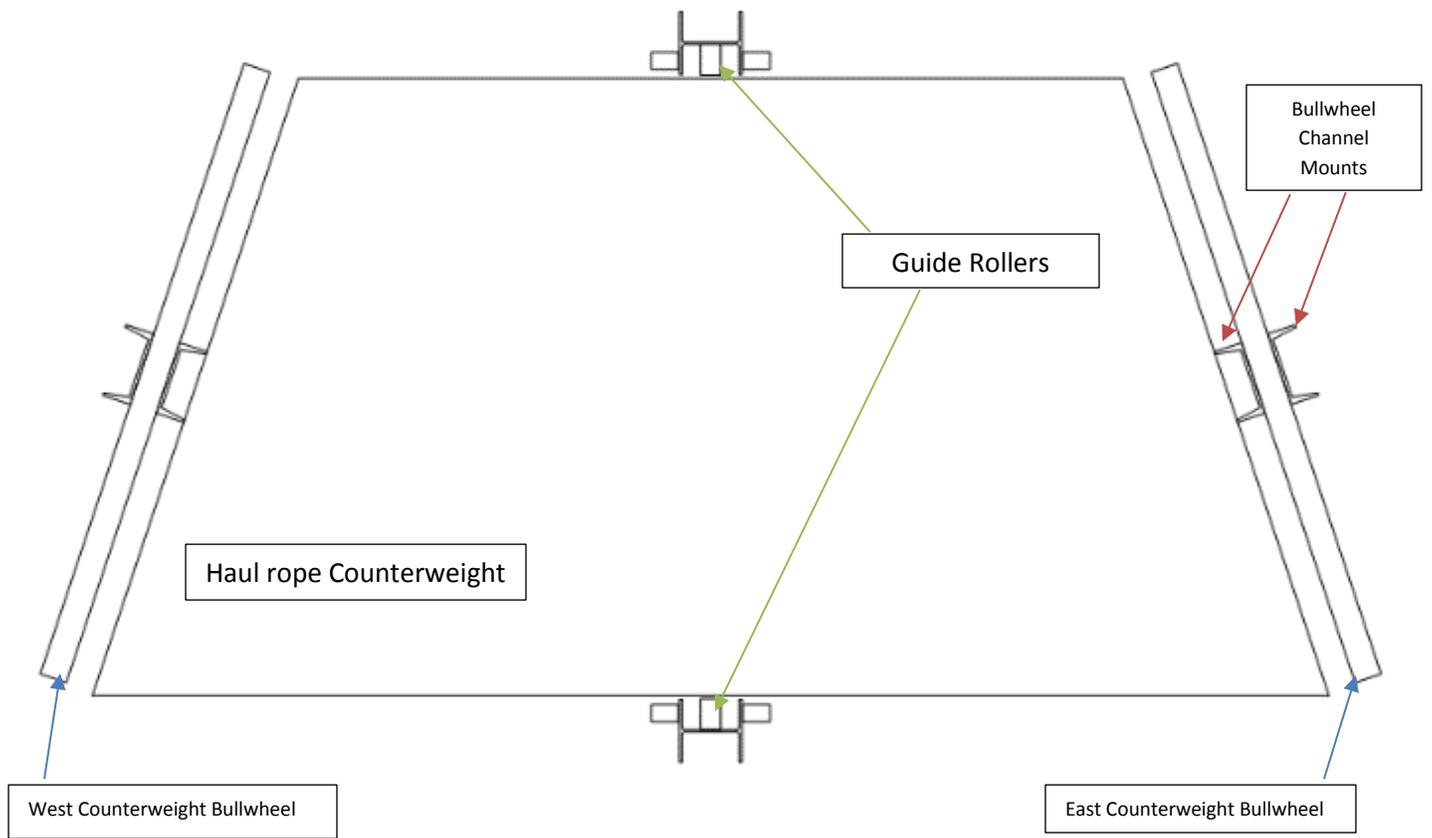
<p>Professional engineer conducting incident review indicated that:</p> <ul style="list-style-type: none"> The rope tension from the drive sheave is always unequal during operation based on the different types of loading cases. The largest difference in tensions based on the original line calculations is 4448 kg which occurs during an E-Stop. This difference in tension creates a torque on the counter weight and the guide rollers are meant to resist the movement and keep the counterweight level. (see figure 2) <p>It is expected that this force from the movement is what broke the guide rollers allowing the counterweight to tip. This resulted in a side load being transferred to the bullwheel mount channels. The channels were not designed to take any side load. They therefore deflected and caused one side of the shaft to extract itself from its mounting bore.</p>
<p>Causes and contributing factors</p>	<p>It is very likely that the torquing forces to the counterweight and the failure of the roller guides to maintain the level position of the counterweight caused the side loading to the bullwheel. That in turn caused the flexing of the bullwheel channel mounts and caused the bullwheel axel to partially extract itself from the bore of the mounting channel and the bullwheel in turn tilting from it vertical position.</p> <p>A contributing factor very likely is that the counterweight guiding equipment and the bullwheel mounting channels were not providing adequate structural support in resisting the torque forces encountered during the emergency stop situation.</p> <p>The failure of one of the speed buttons used to slow the ropeway may have also contributed to the incident, given that delays using the rheostat allowed an emergency stop to occur, which caused excessive forces resulting in bullwheel damage.</p> <p>Another possible contributing factor is that the bullwheel channels were not designed to take excessive side loading which may occur during an emergency stop.</p>

Figure 2, Haul Rope Counterweight Assembly

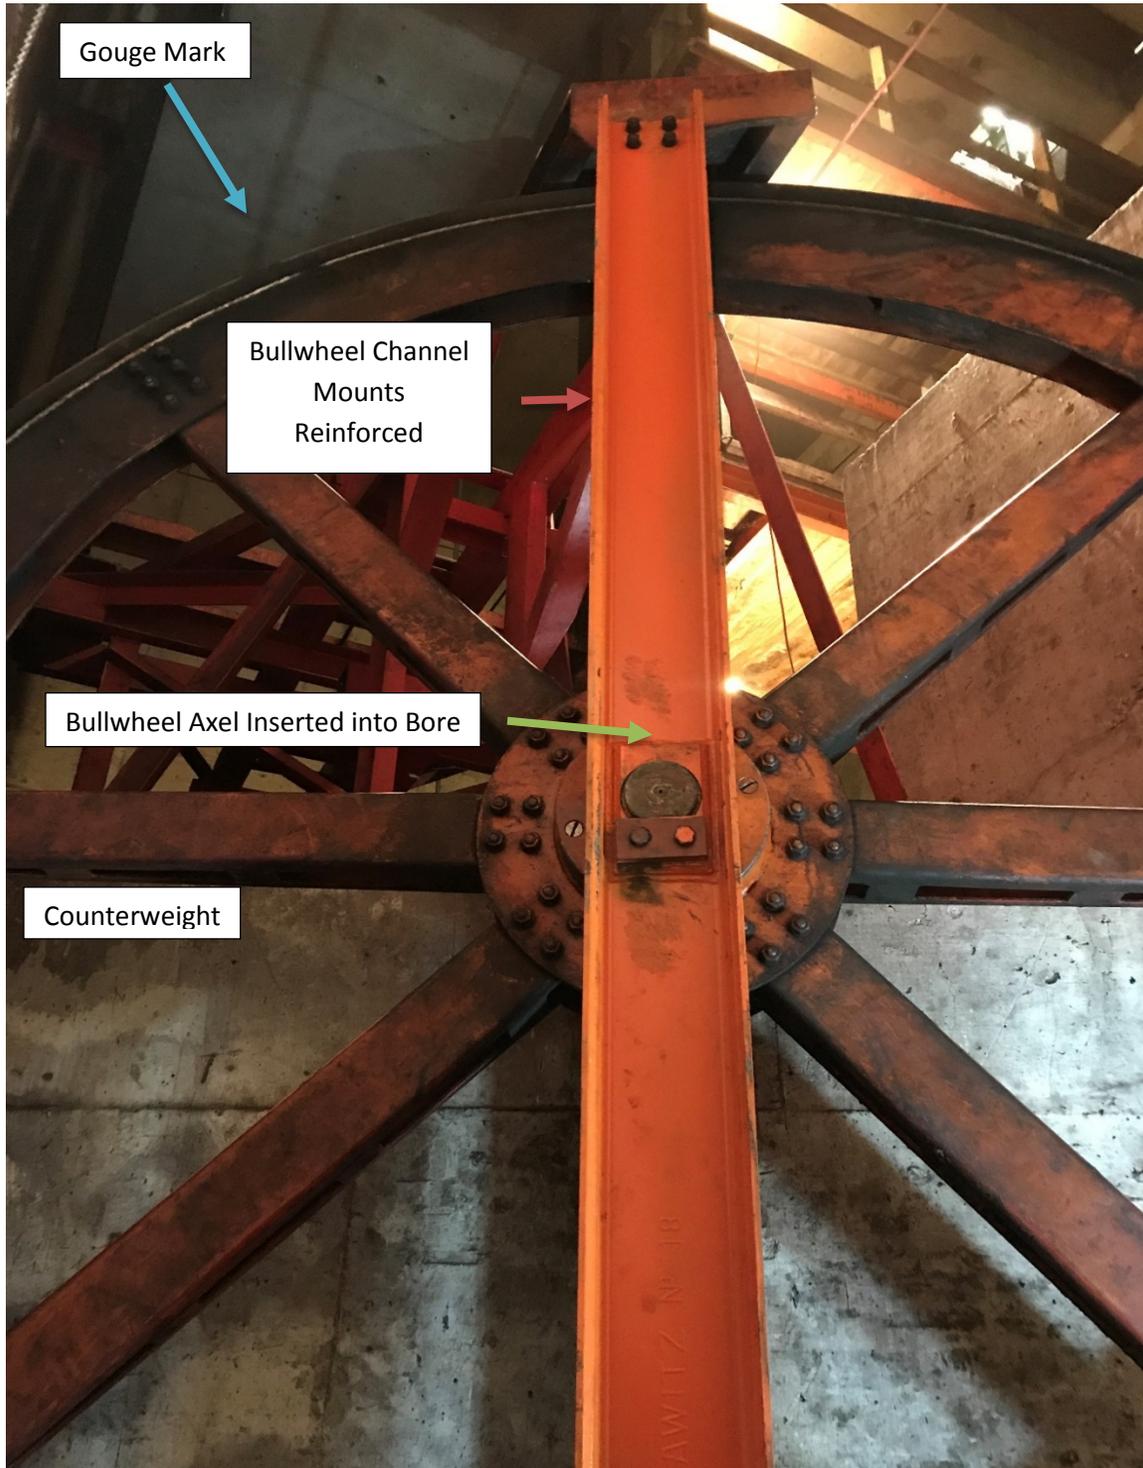
Figure 3, Photo of Gouge Mark in Outer Diameter of the Counterweight Bullwheel. (Photo taken after due to the incident extra reinforcement had been added to channel mounts)

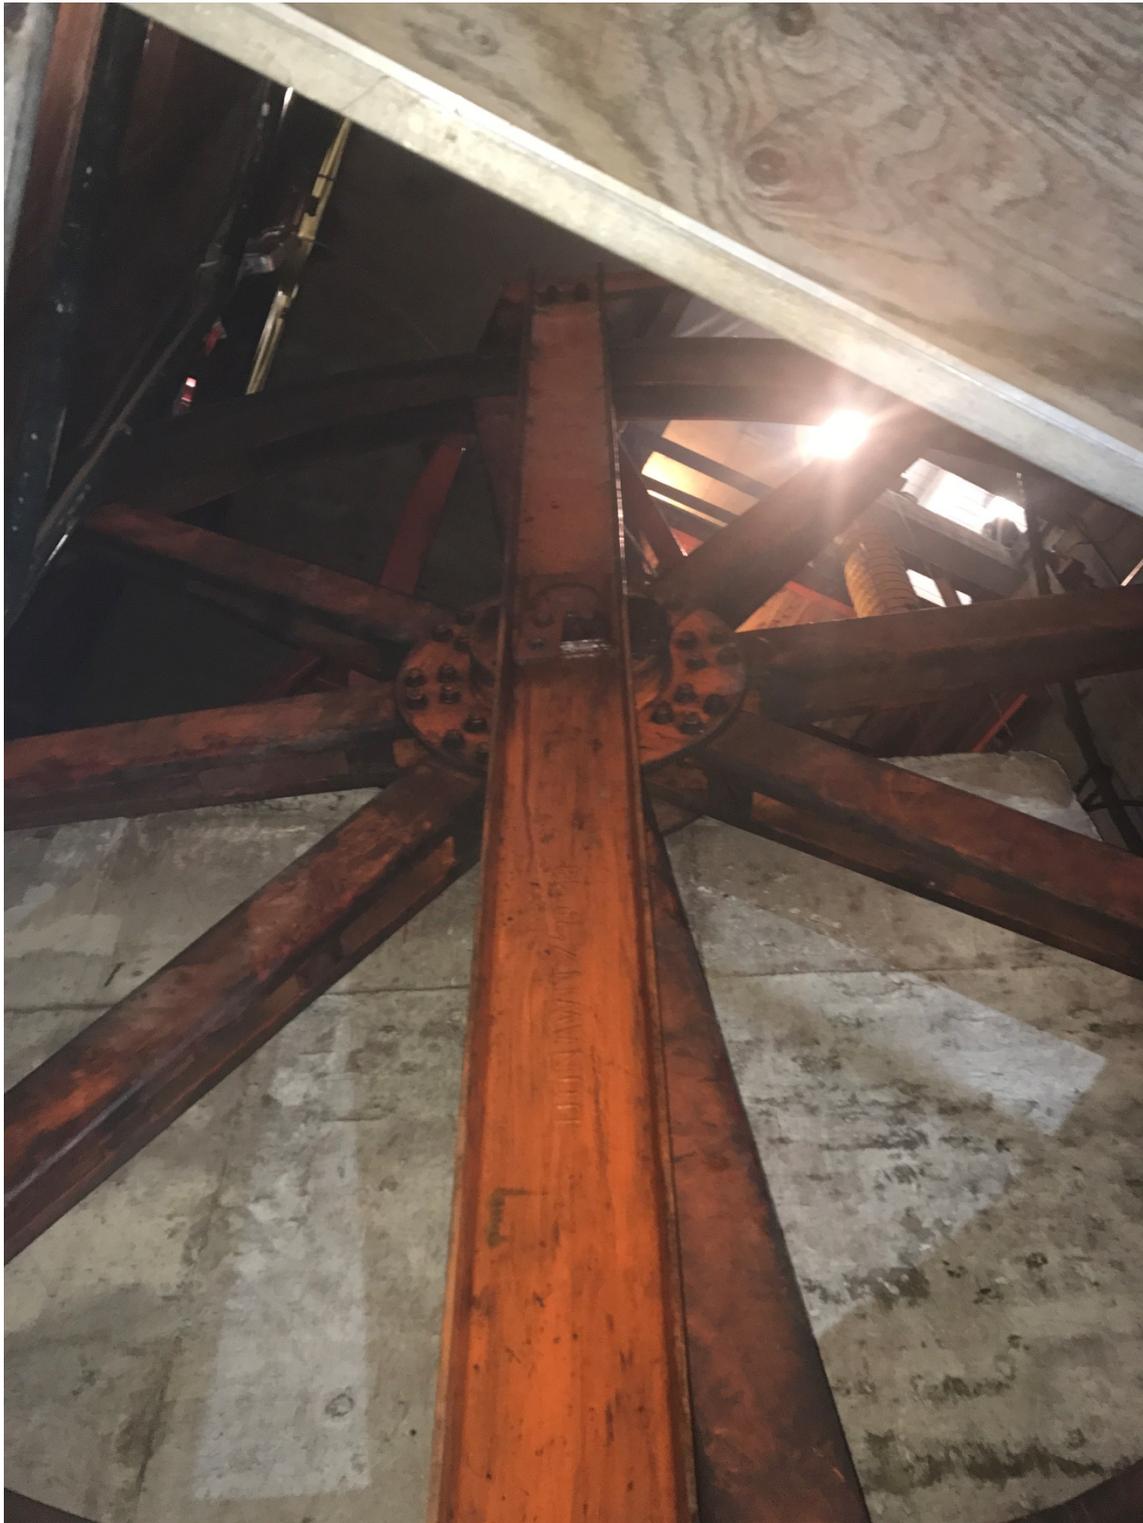
Figure 4, Photo of Bullwheel Configuration Prior to Upgrades
