Incident Summary #II-1200345-2021 (#22189) (FINAL)

SUPPORTING INFORMATION	Incident Date	November 19, 2019
	Location	Port Coquitlam
	Regulated industry sector	Electrical - Low voltage electrical system (30V to 750V)
	Impact	Qty injuries
		0
		Injury description
		None
		Injury rating
		None
INVESTIGATION CONCLUSIONS	Damage	Damage description
		Fire damage to the communications wiring, cable box and the wooden siding and ceiling in the carport area. Melting damage to the overhead cable TV and 120/240 Volt service conductors.
		Damage rating
		Moderate
		Incident rating
		Moderate
	Incident overview	
	An open service neutral condition related to a melted overhead conductor on a 120/240 Volt service resulted in a home's communication boxes, cables and the surrounding walls and ceilings being burnt due to a fire in the carport.	
INVESTIGATION CONCLUSIONS	Site, system and components	Overhead services:
		<ul style="list-style-type: none"> Overhead power and communications services for residential homes run from the utility pole systems, at height through the open air, to the house. The power service provides electricity from the pole mount power transformers to the home's main electrical

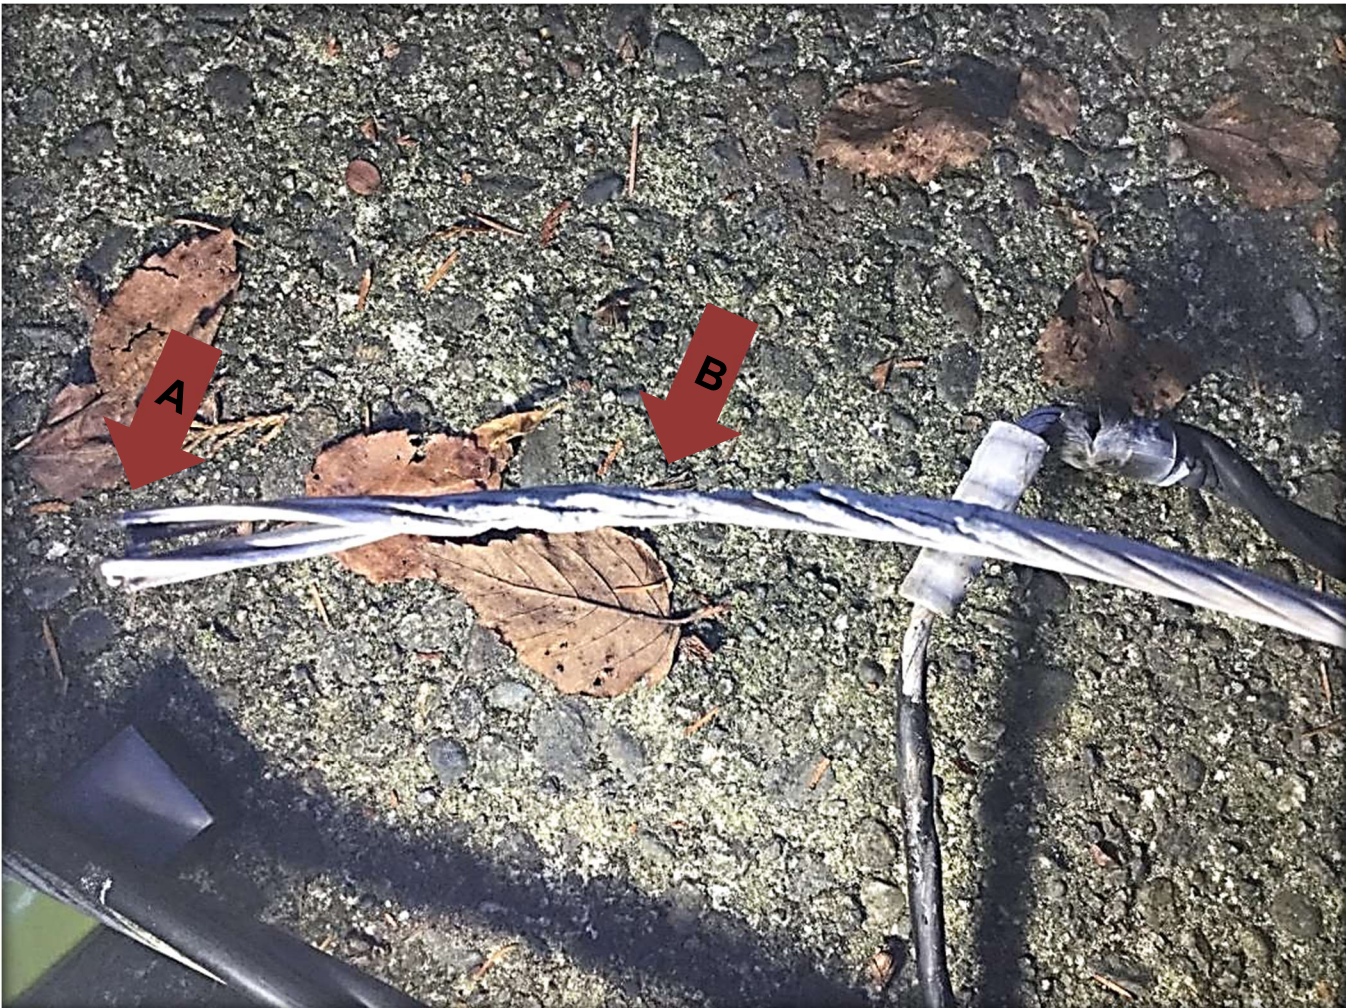
The incident occurred as the service neutral was melted and severed from shorting to a line conductor connector. This led to the communications bonding carrying the imbalance in line current and overheating until it caught on fire.

Lack of separation between the neutral and the service line conductor compression connectors was likely the cause of the incident.

Figure 1 - Neutral conductor melted end (arrow A) and neutral conductor abraded (arrow B).

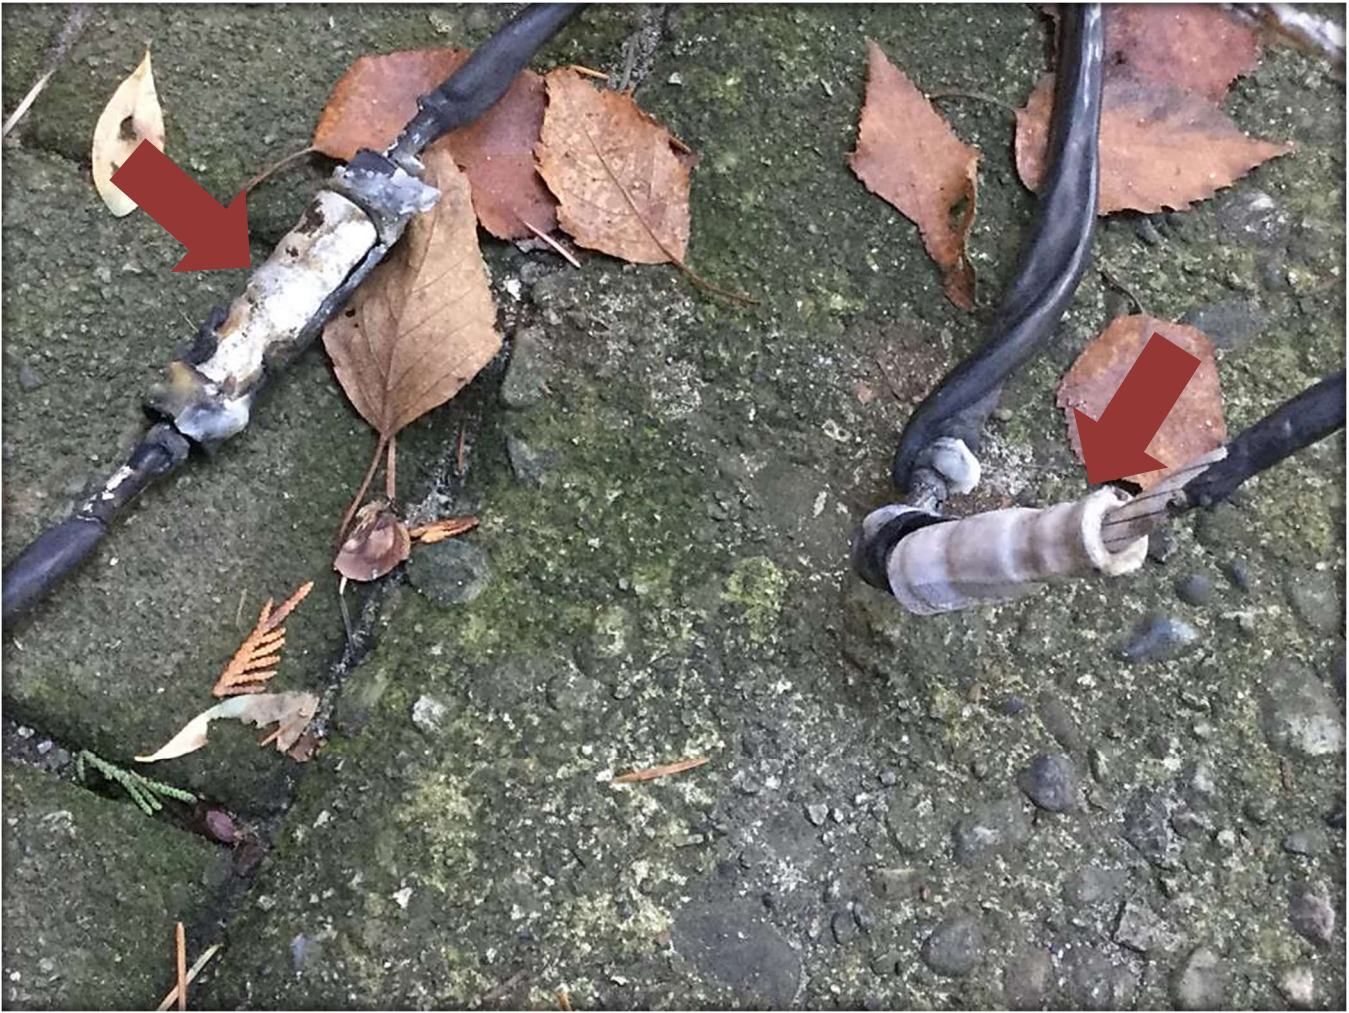
The line conductor compression connectors becoming bare from the elements, friction, and electrical arcing was a contributing factor to the melting and opening of the neutral conductor.

Figure 2 - 240 volt conductor compression connectors without insulation (arrows).

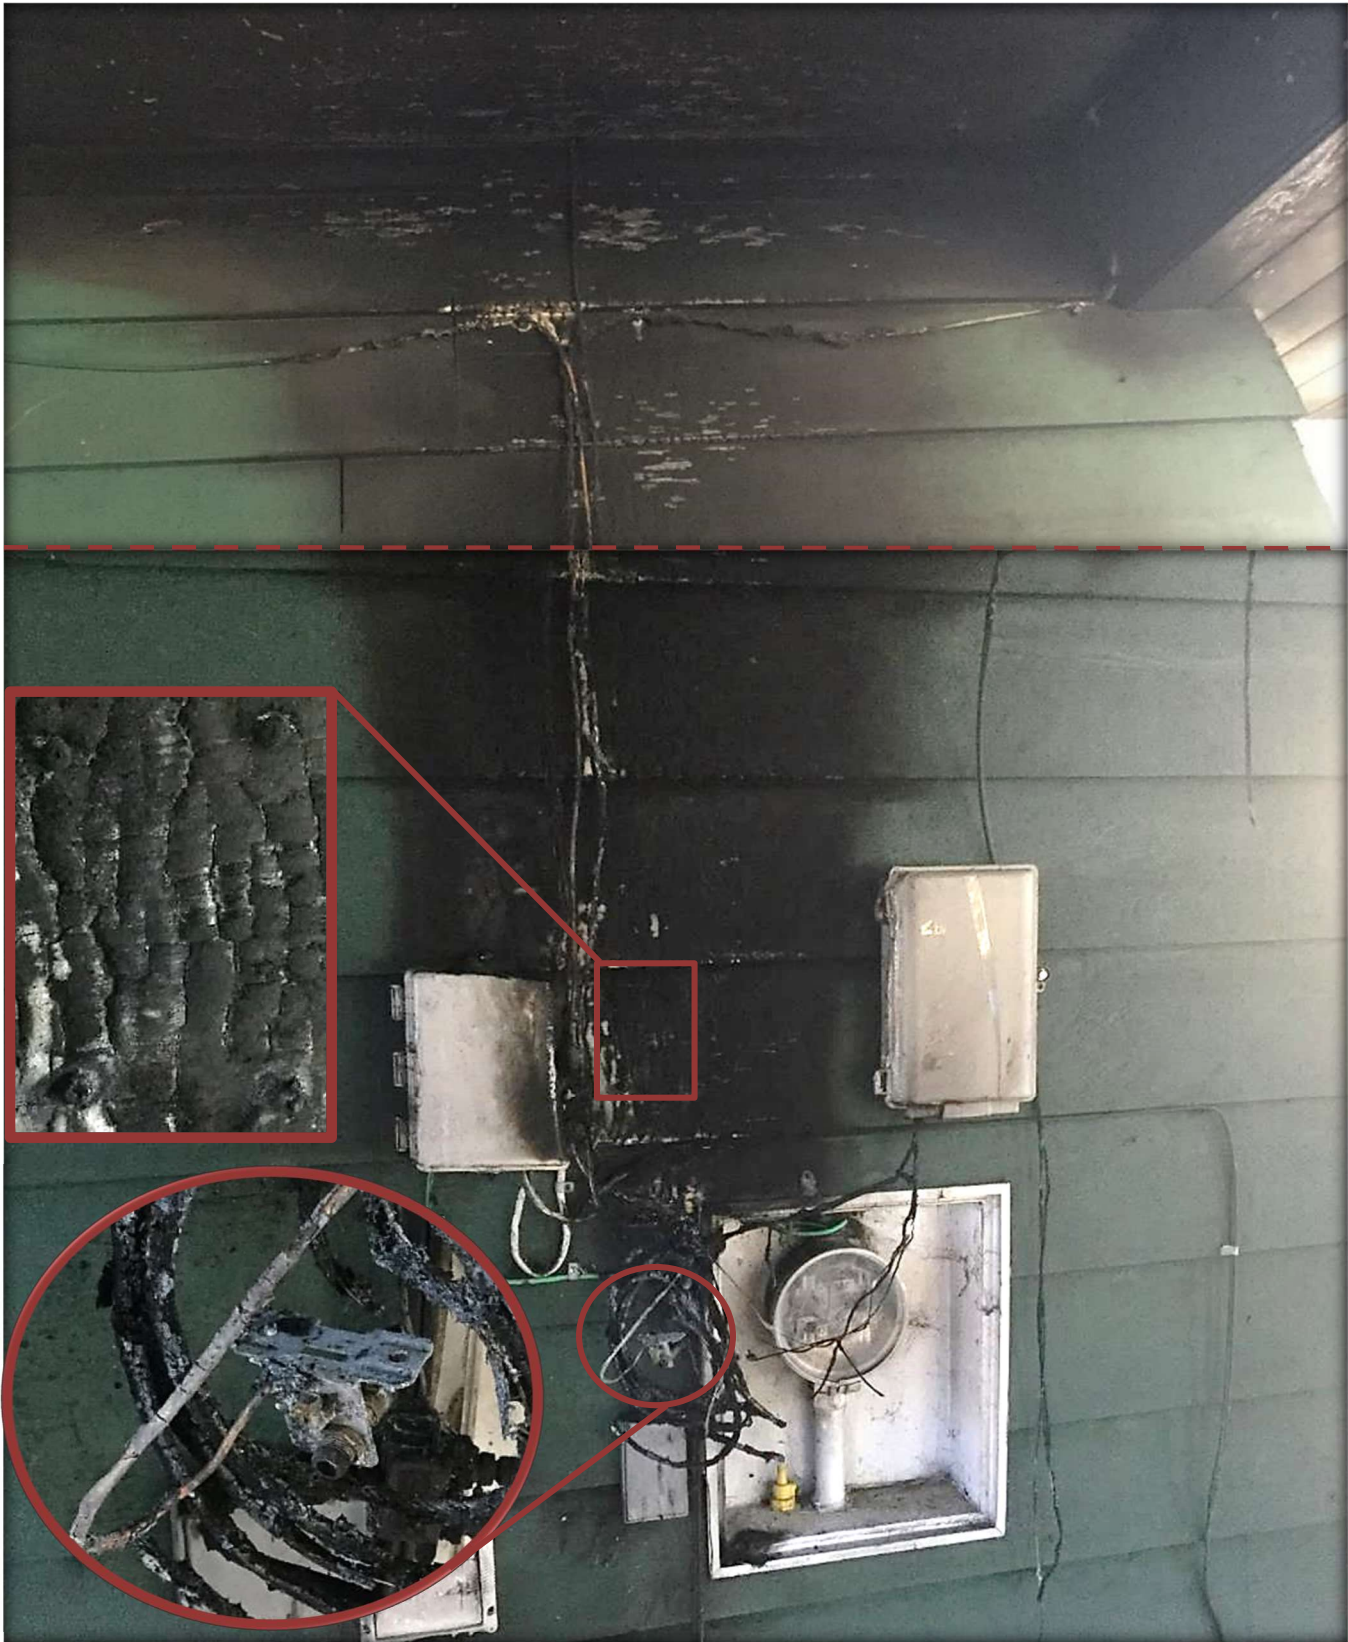
Figure 3a (top) - Fire damage to the upper wall & ceiling.

Figure 3b (bottom) - Fire damage to the wall, the cable box burnt away and mounting screws remaining (rectangles), cable TV bonding terminal, burnt and fallen cables (ovals).

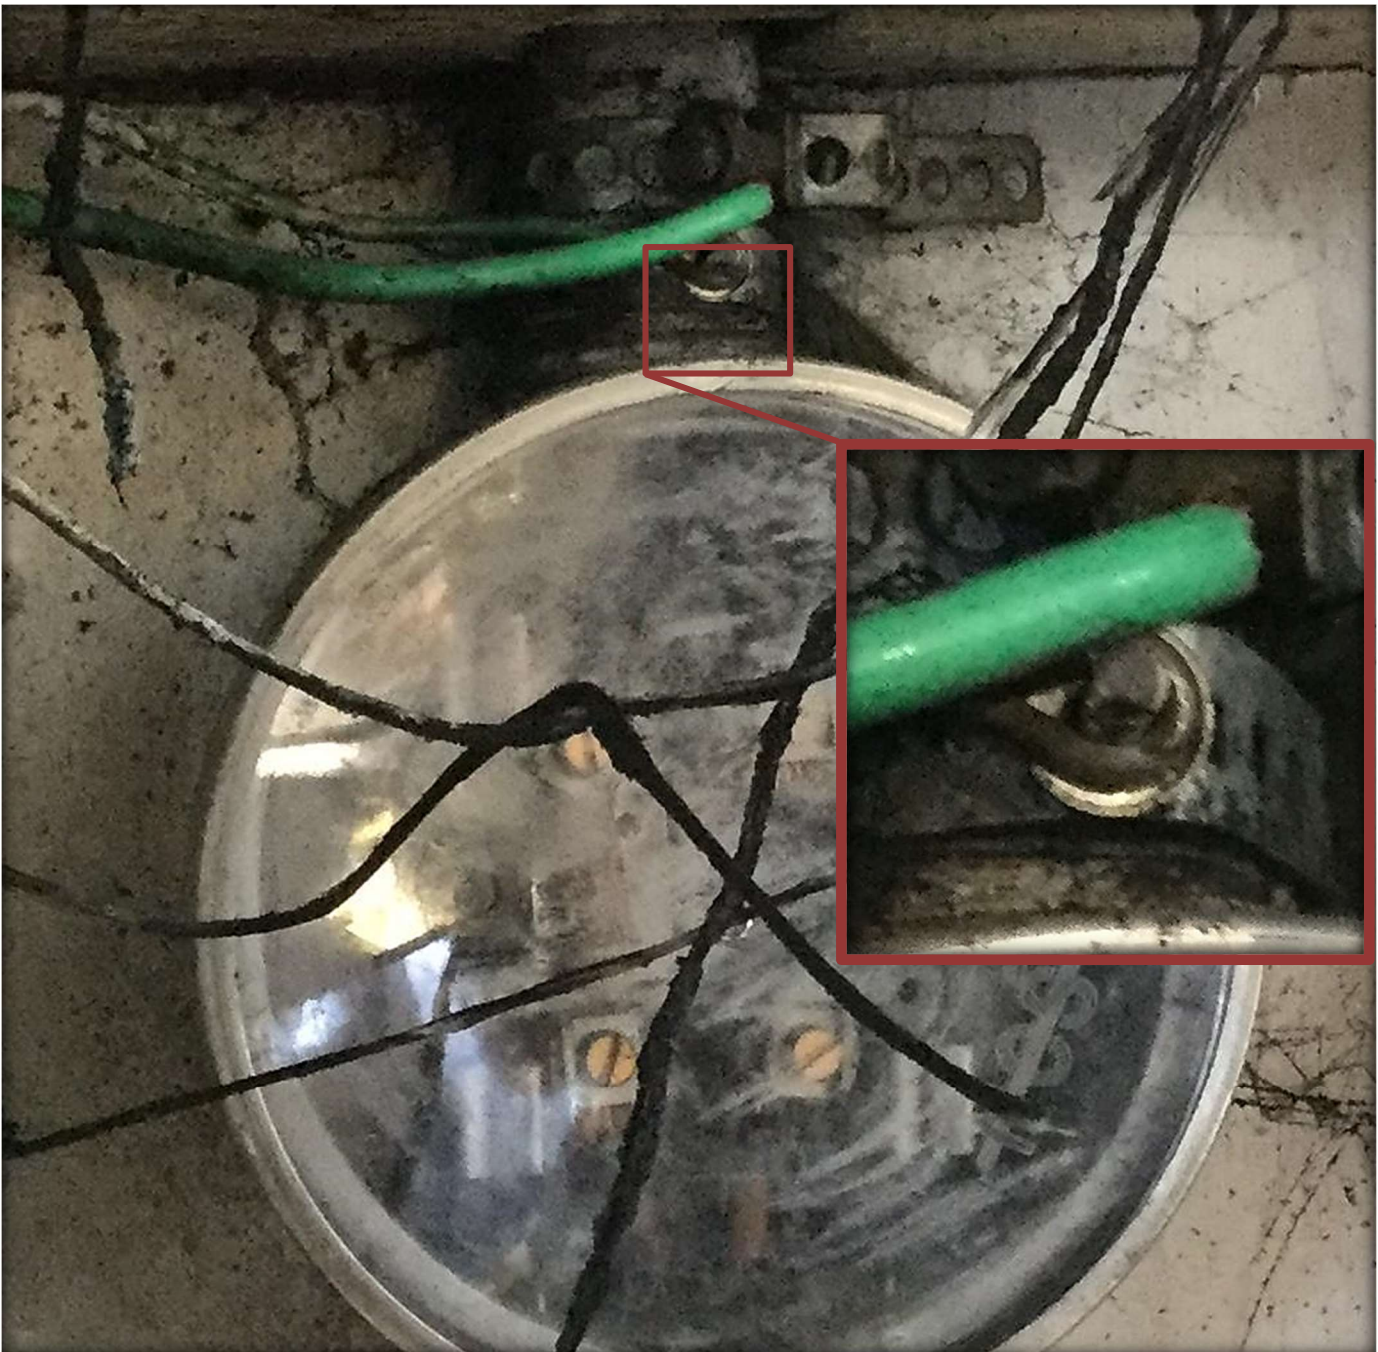
The cable TV bonding path completing the disconnected neutral circuit back to the power source was a contributing factor to the fire occurring.

Figure 4 - Cable TV bonding strap around the service conduit with no nut and a high resistance loose connection (rectangles).

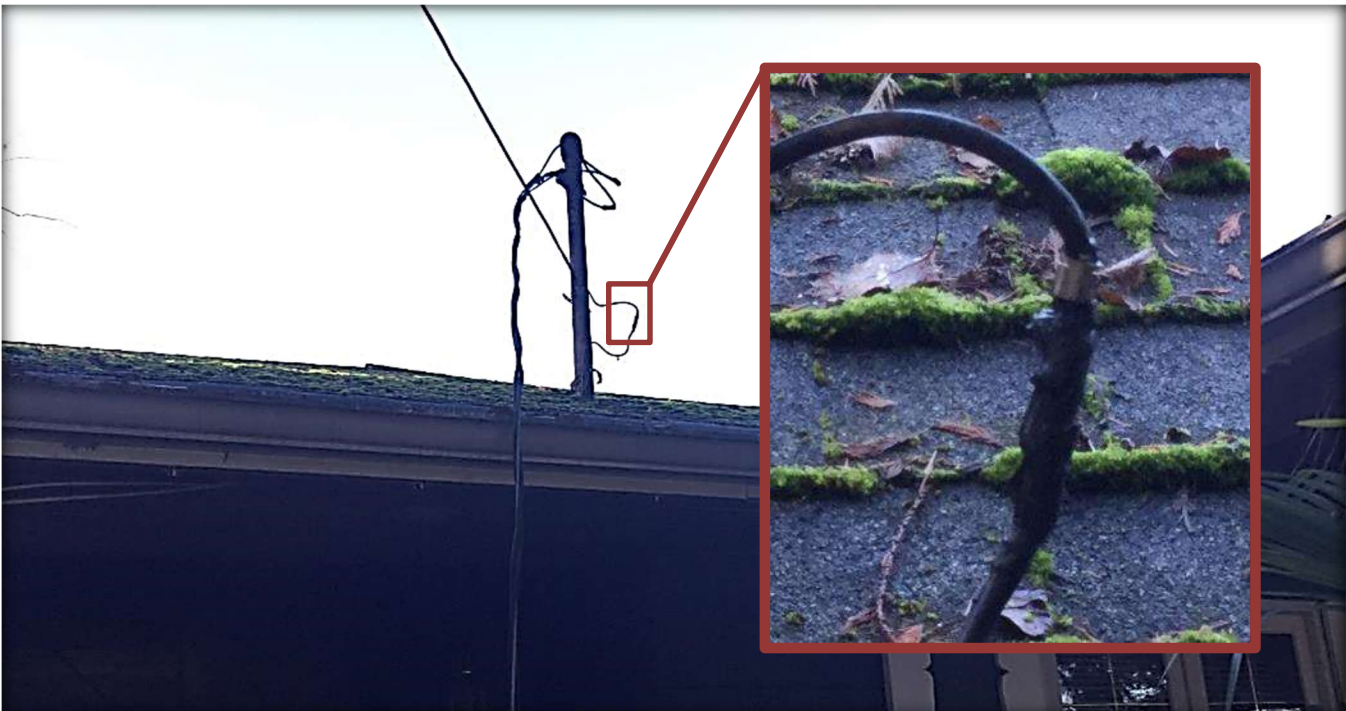
Figure 5 - Closeup of cable TV service drop splice with melted tape.

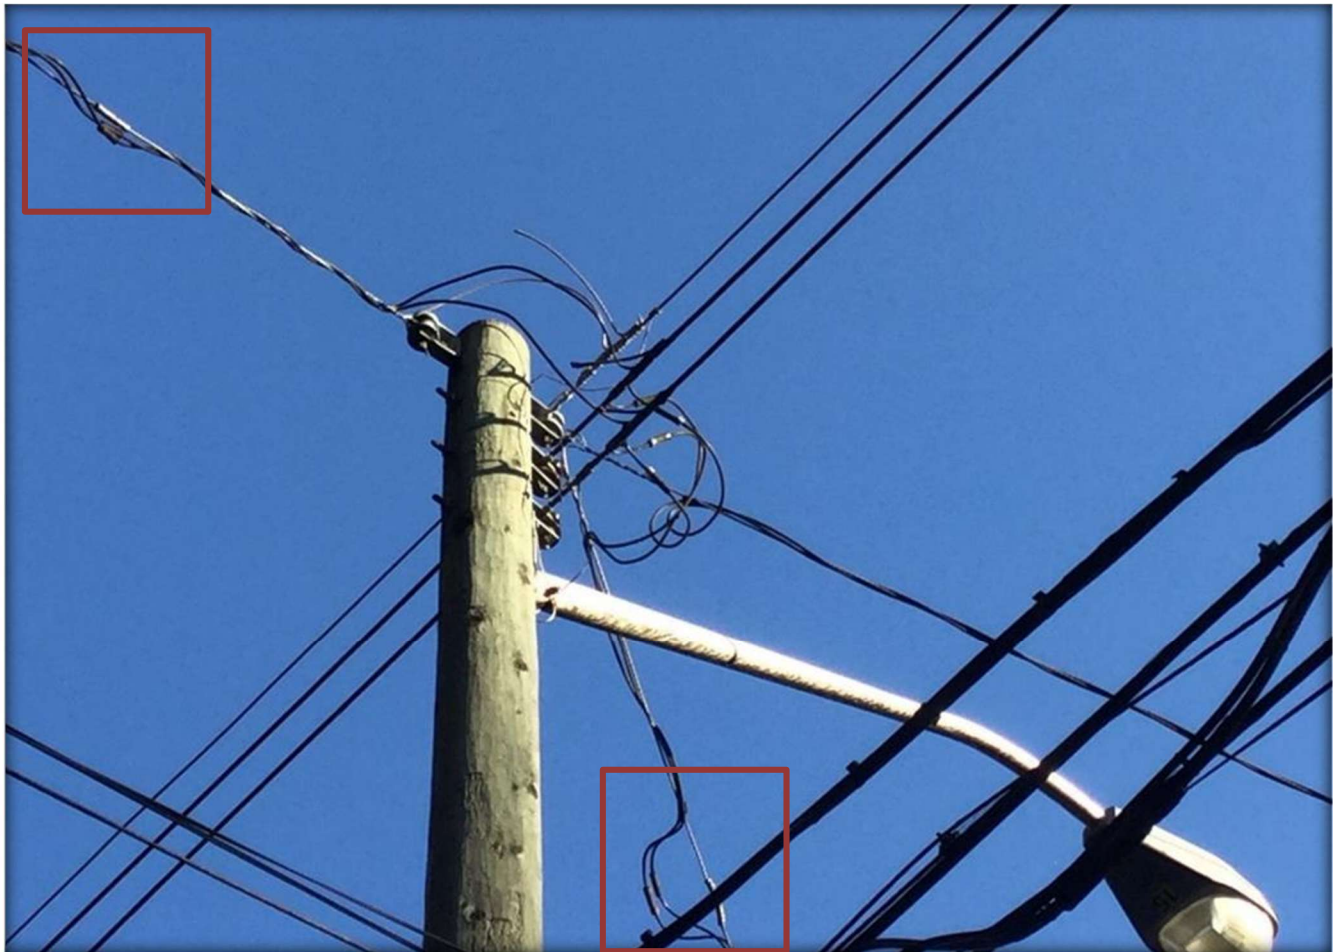
Figure 6 - Example line connectors, bottom square separated, top left square less separate.
