Incident Summary (II-651246-2018) (Final)

SUPPORTING INFORMATION	Incident Date	<i>February 12, 2018</i>	
	Location	<i>Gibsons, Sunshine Coast</i>	
	Regulated industry sector	<i>Electrical – Low Voltage Electrical System (30V – 750V)</i>	
	Impact Injury	Qty injuries	<i>None</i>
		Injury description	<i>None</i>
		Injury rating	<i>None</i>
	Impact Damage	Damage description	<i>The main floor of a single family dwelling suffered fire & smoke damage in the kitchen as well as the interior wall cavity directly above the panel-board in the downstairs exterior wall.</i>
		Damage rating	<i>Moderate</i>
Incident rating	<i>Moderate</i>		
Incident overview	<i>The extension cord connected to a temporary construction heater (installed to heat a single family dwelling at drywall stage) caught fire.</i>		
INVESTIGATION CONCLUSIONS	Site, system and components	<i>A temporary construction heater to heat a single family dwelling at drywall stage should be equipped with a CSA approved cord end and corresponding receptacle. Additionally, the construction heater should be fed with an appropriately sized circuit breaker with rated branch circuit conductors.</i>

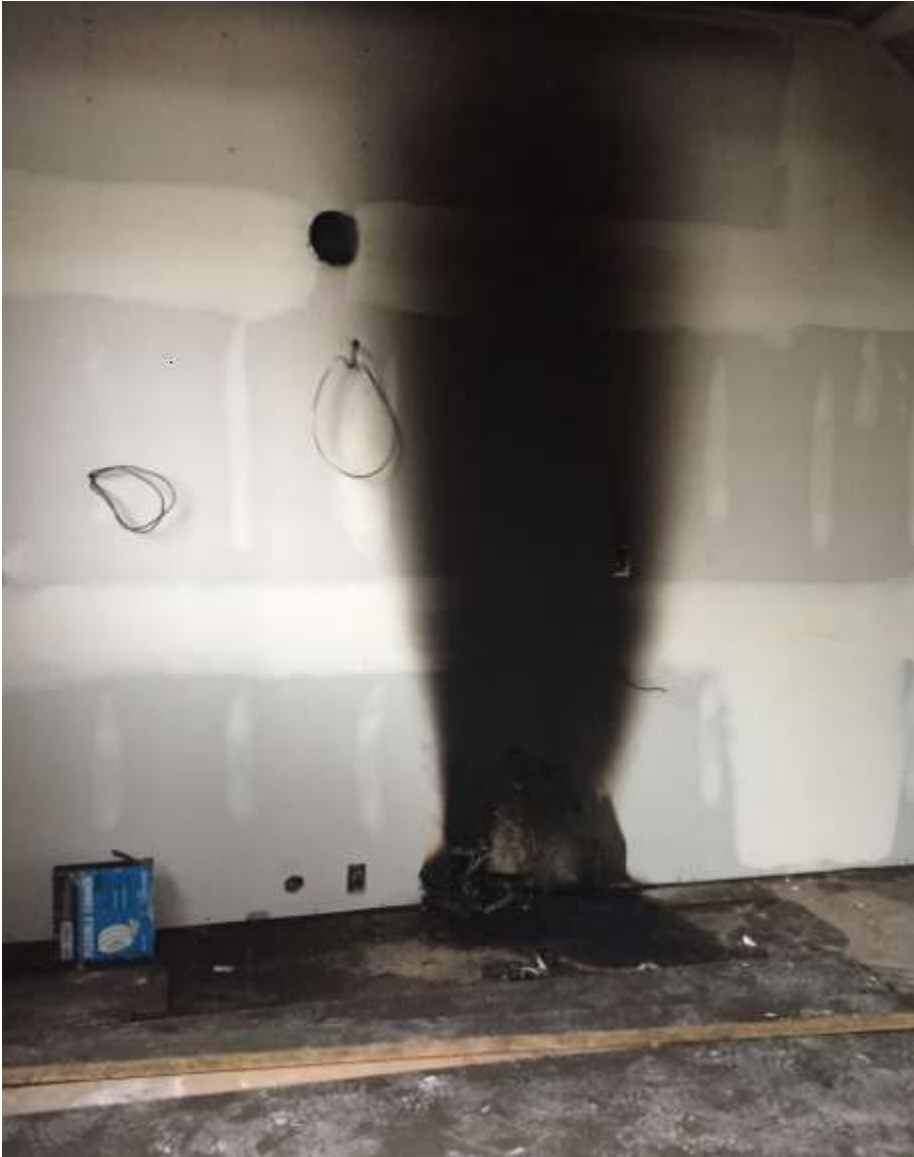
Failure scenario(s)	<i>Without the direct supervision of a qualified individual, a temporary construction heater was fed from a lite gauge (under-sized) copper extension cord which was hardwired into a range outlet. The branch circuit feeding the range outlet was fed with a 2 pole 40 amp circuit breaker with aluminium branch circuit conductors. The construction heater was rated for a 2 pole 30 amp circuit breaker. The extension cord was not rated for this type of installation.</i>	
	Facts and evidence	<p><i>Interview with General Contractor:</i></p> <ul style="list-style-type: none"> - <i>The general contractor described that the junctions were made to the electrical system at the range outlet which connected the temporary construction heater with an extension cord.</i> - <i>The general contractor stated that an unqualified individual connected the regulated to the electrical system without supervision.</i> - <i>The general contractor stated the cord and heater had deteriorated over time from use.</i>

Causes and contributing factors	<i>It is likely the junction made between copper and aluminium by an unqualified and uncertified individual created enough heat to spark the fire to track back onto the extension cord and then to the dwelling.</i>

Location of junction at range box a lite gauge (under-sized) copper extension cord

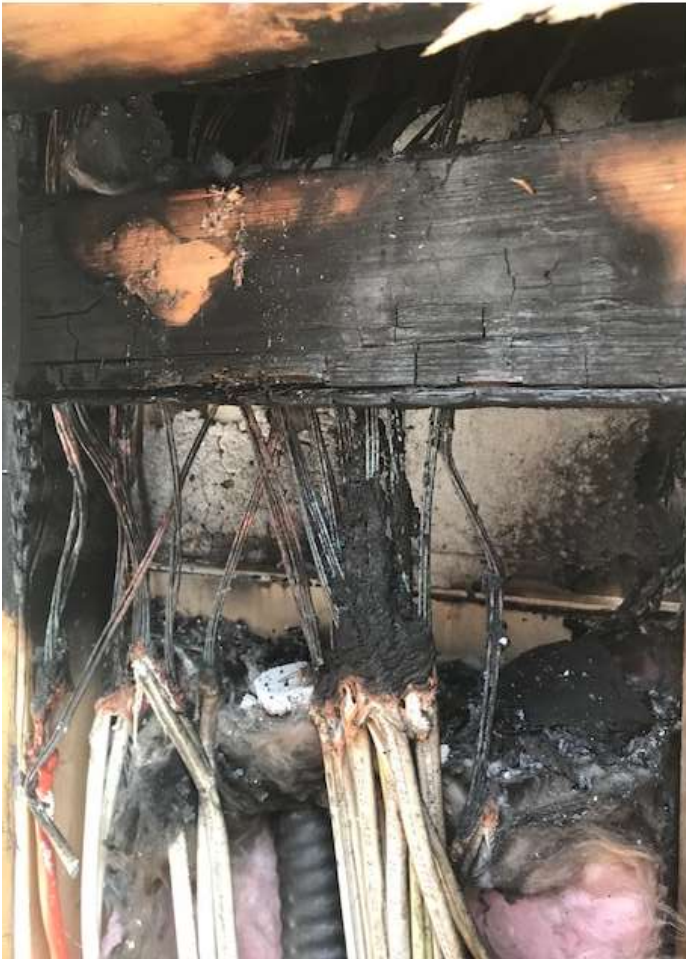
Resulting fire damage

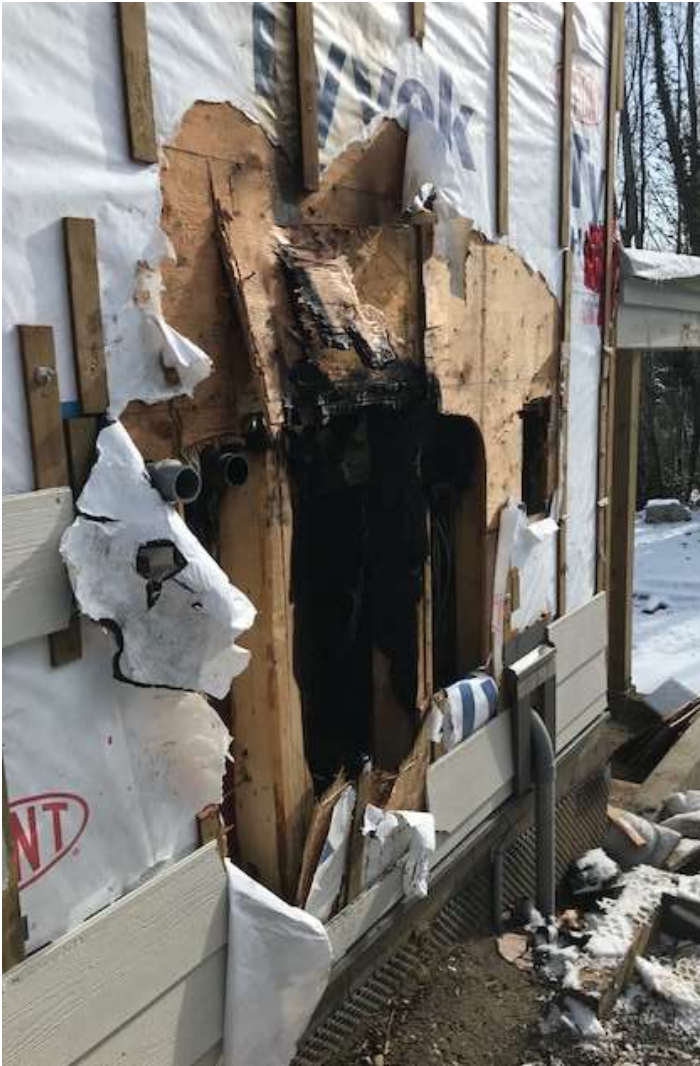
Resulting fire damage
