Incident Summary #II-783351-2018 (#9986) (FINAL)

SUPPORTING INFORMATION	Incident Date	December 2, 2018	
	Location	Whistler	
	Regulated industry sector	Passenger ropeways - Above surface ropeway	
	Impact	Qty injuries	2
		Injury description	Person 1 injuries reported as, sore neck, headache and symptoms of concussion. Person 2 injuries reported as, sore neck and body soreness.
		Injury rating	Minor
	Damage	Damage description	Damage to a cabin door opening mechanism. Including upper (lever) (Figure 3) and internal door operating mechanisms (cassette).
		Damage rating	Minor
	Incident rating	Minor	
Incident overview	A carrier being conveyed through the station stalled at the cabin door opening system due to the cabin doors not being free to move. At that point an attendant initiated an emergency stop. A carrier following the stalled cabin then bumped into the stalled carrier as the ropeway decelerated to stop.		
INVESTIGATION CONCLUSIONS	Site, system and components	<ul style="list-style-type: none"> A 2-section gondola with bottom, middle and top stations. Detachable grip where carrier grips detach from haul rope at the station and are conveyed via a system of tires and conveyor chains

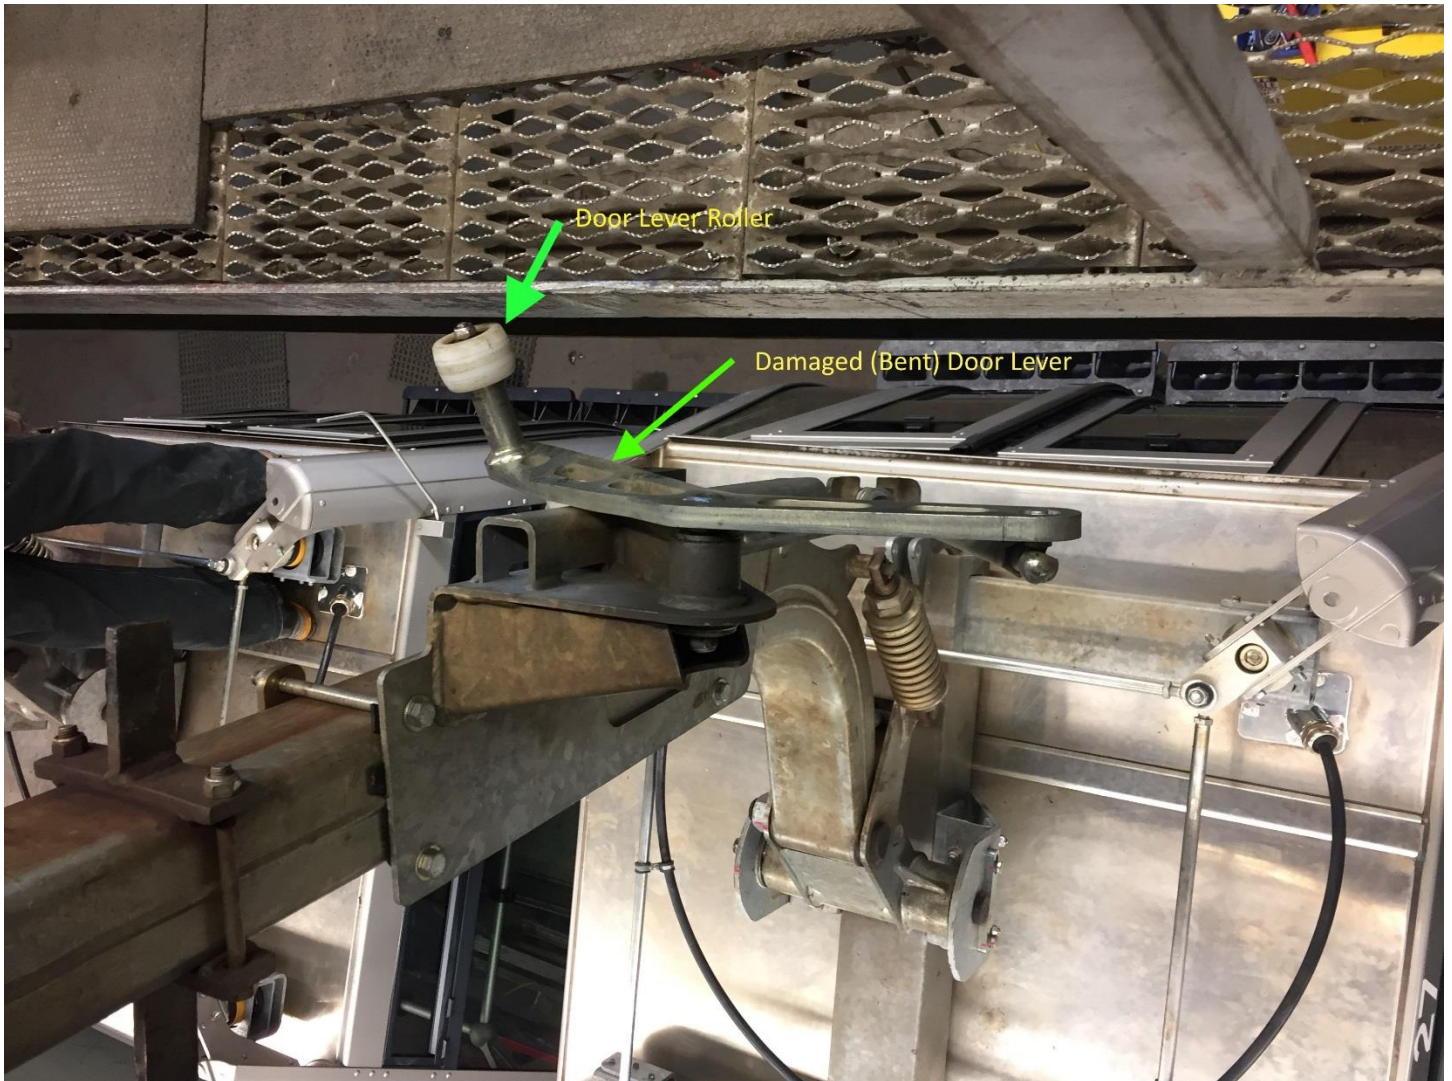
Figure 3. Looking Down at Carrier

Failure scenario(s)	Because the doors were not free to move, the carrier door opening mechanism sustained damage and stalled the carrier as it engaged with the door opening ramp. The adjacent following carrier then bumped into the stalled carrier as the ropeway decelerated to a stop.	
	Facts and evidence	<p>Narrative of the sequence of events based on the attendants description of the incident:</p> <ul style="list-style-type: none"> Incident occurred at the downhill side direction in the return station.

<p>Causes and contributing factors</p>	<p>Damage to the door opening mechanism likely due to the doors not being able to move freely. The snowboard placed in the door rack with the binding facing toward to the door could plausible have become entangled with the door and inturn preventing the doors from moving freely.</p> <p>Injuries to the passengers were likely are due to the impact of the carrier bumping into the stalled carrier.</p>
