## Incident Summary (5611812)(Final)

SUPPORTING INFORMATION	Incident Date		January 14, 2017	
	Location		Revelstoke	
	Regulated industry sector		Passenger Ropeway - conveyor	
	Impact	Injury	Qty injuries	1
			Injury description	Noticeable bruising to ankle
			Injury rating	Minor
	Damage		Damage description	None
			Damage rating	None
Incident rating		Insignificant		
Incident overview		<i>A foot passenger riding a ski conveyor attempted to exit the device off of the end of the conveyor. The passenger stepped into a safety relief plate mechanism. The passengers foot became stuck between the relief plate and the conveyor drive drum.</i>		
INVESTIGATION CONCLUSIONS	Site, system and components		<i>Ski conveyors transport passengers up-hill via a moving belt. At the top of the conveyor is a drive drum that propels the belt. The drive drum area has a protective safety switch called a trip plate. The trip plate is designed to stop the conveyor if an item becomes stuck at the drive drum area. Foot passengers are not intended to unload at the end of the conveyor. Foot passengers are to be instructed to unload off of the side of the conveyor prior to the drive drum.</i>

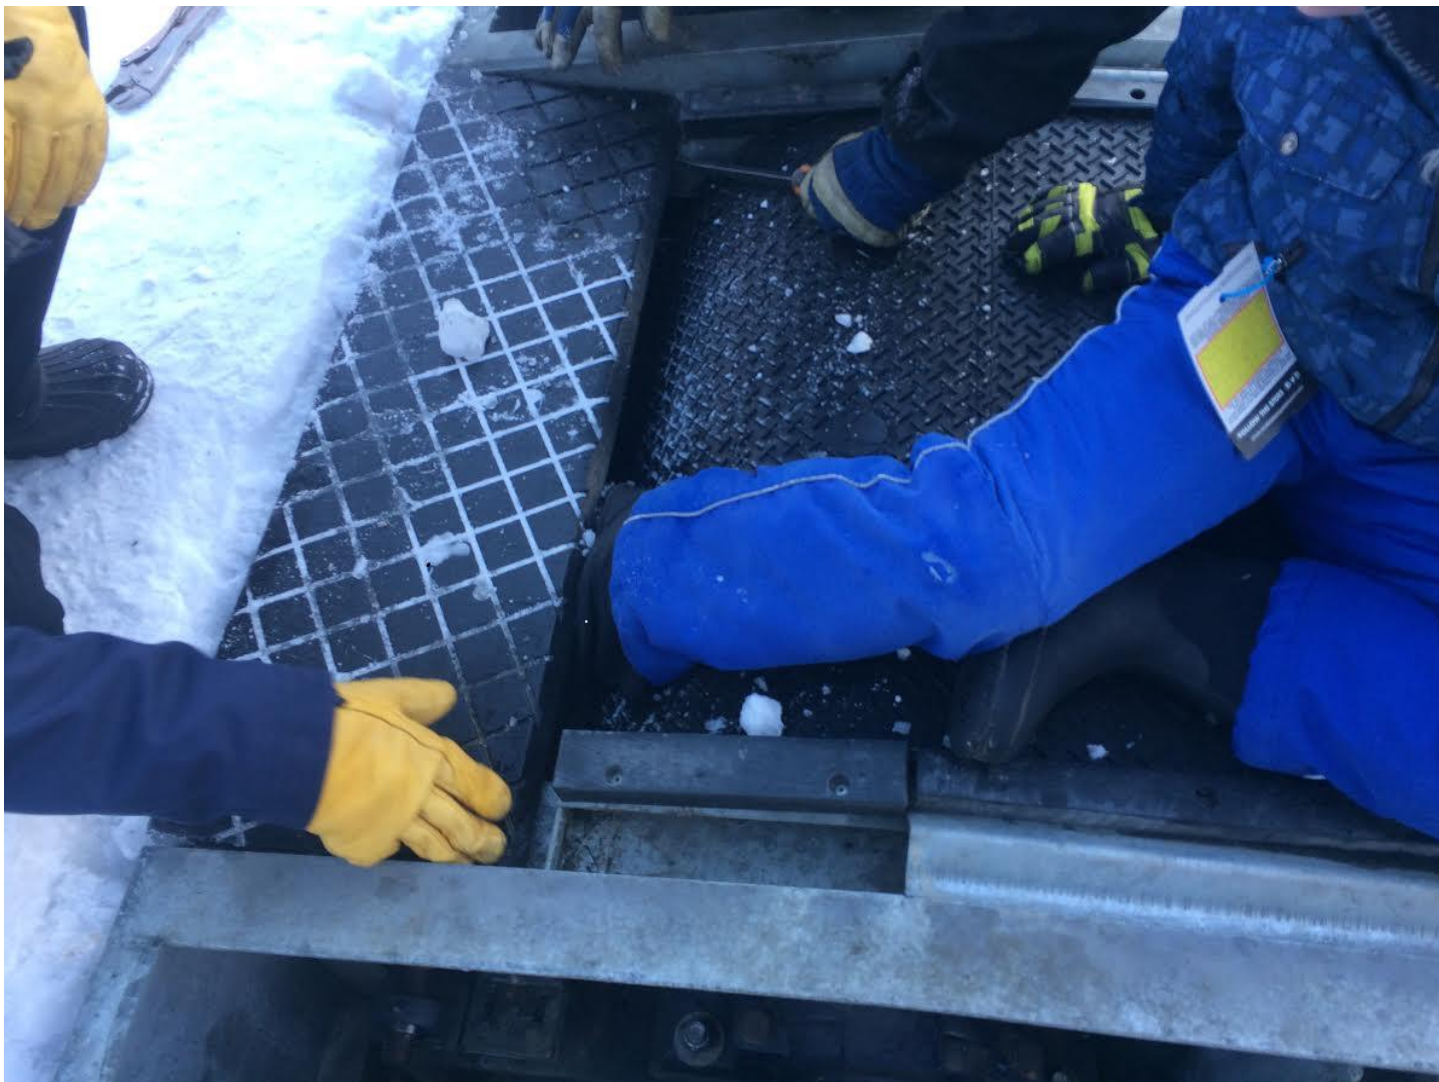
*Photos or diagrams (if necessary)*

Failure scenario(s)		<i>Insufficient snow conditions did not allow for foot passengers to unload off the side of the conveyor prior to the drive drum. The operator moved the exit point further down the conveyor where the passenger failed to exit at the adjusted unload point and attempted to unload at the drive drum.</i>	
	Facts and evidence		<i>- Operator stated that there was a lack of snow at the prescribed exit area. - Operator stated that they moved the exit point down-hill. - Operator stated that the person failed to unload and attempted to unload at the drive drum transition plate area. - Magic Carpet manufacturer's manual states that all foot passengers must exit off of the side of the conveyor, not over the drive drum transition plate.</i>	
	Causes and contributing factors		<i>It is likely that the passenger did not understand where the proper unloading area was. It is likely that miscommunication between the operator and the passenger contributed to the passenger stepping into the trip plate.</i>
