Incident Summary #II-1295456-2021 (#25240) (FINAL)

Incident Date	November 23, 2021 (#25240) (FINAL)
	Location	Prince George
	Regulated industry secto	Gas - Natural gas system
NOI	Qty injuries	0
RMAT	다. Injury 도 <u>description</u>	N/A
NFO!	Injury rating	None
SUPPORTING INFORMATION	⊆ _v Damage description C Damage rating	Venting dislodged from boiler allowing products of combustion and condensate to enter the mechanical room.
PORT	Damage rating	Minor
SUPF	Incident rating	Minor
5,	Incident overview	A natural gas fired boiler experiencing explosive detonations from delayed ignition exhausted products of combustion including carbon monoxide (CO) into the mechanical room when the venting system was blown apart from the force of the detonations.
INVESTIGATION CONCLUSIONS	Site, system and components	 Site and system The multi unit care home facility utilizes natural gas boilers including two IBC hydronic boilers with sealed venting systems (Cat IV). The boilers use the combustion of natural gas to heat water which is circulated to heat coils through out the building and is controlled by a direct digital control (DDC) system. Boiler components The boiler ignitor applies an electrical arc t

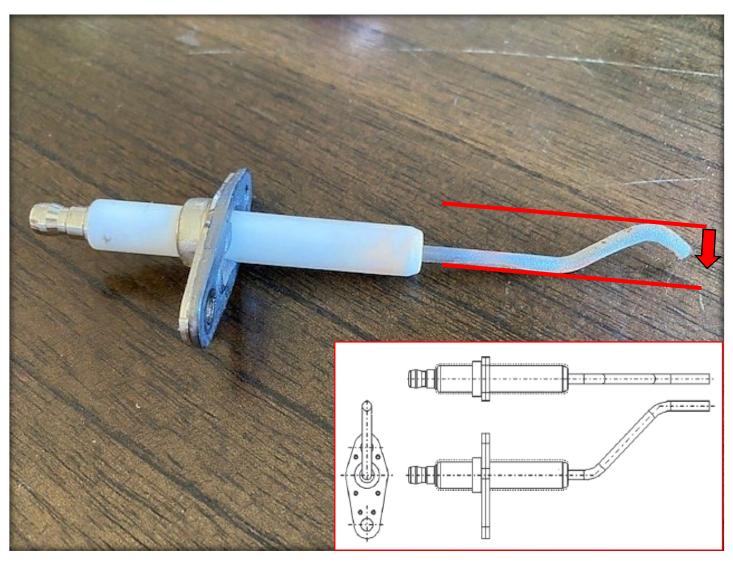
- The boiler manufacturer identified issues with the original ignitors and issued a discontinuation of P-340 single prong ignitors that applies to the SL G3 boiler at this site as well as other models on their website on January 22, 2021, including the following wording:
	"Effective immediately, the P-111B double-prong ignitor (Figure 1) replaces the P-340 single-prong ignitor. The P-111B is the new standard for the SL-series boilers as it combines an improved metallurgic formula for longevity with the convenience of a factory-set spark gap." Link: P-111B change
Causes and contributing factors	The gap between the single prong ignitor and the burner very likely exceeded the maximum recommended gap leading to the delayed ignition inside the boiler burner chamber. The delayed ignition likely caused the boilers venting to become dislodged.

Image 1 – Ignitor removed from the boiler after the incident. Offset bent away from parallel (arrow) compared to as built drawing.

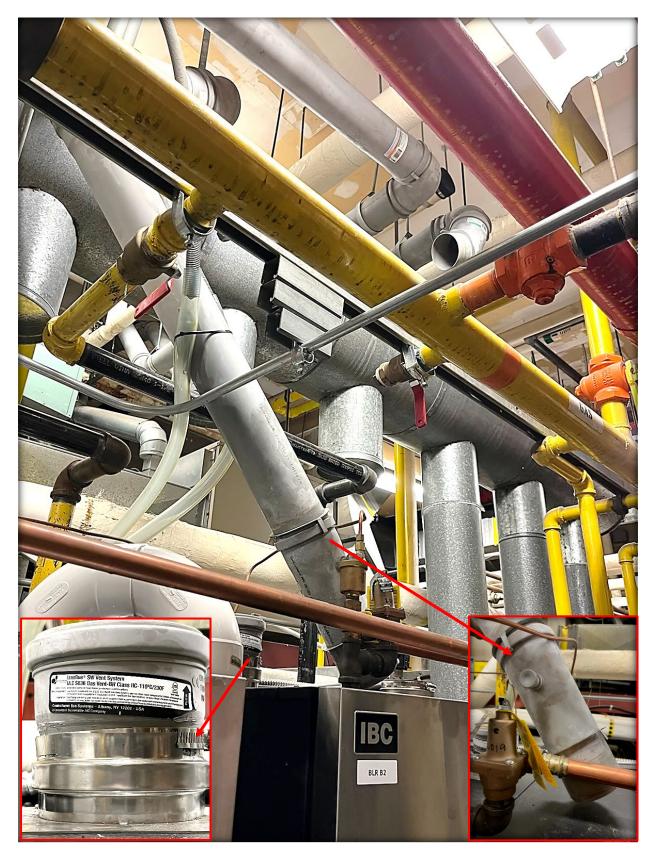
Image 2 – Boiler B2 after the incident with the venting system disengaged and knocked over.

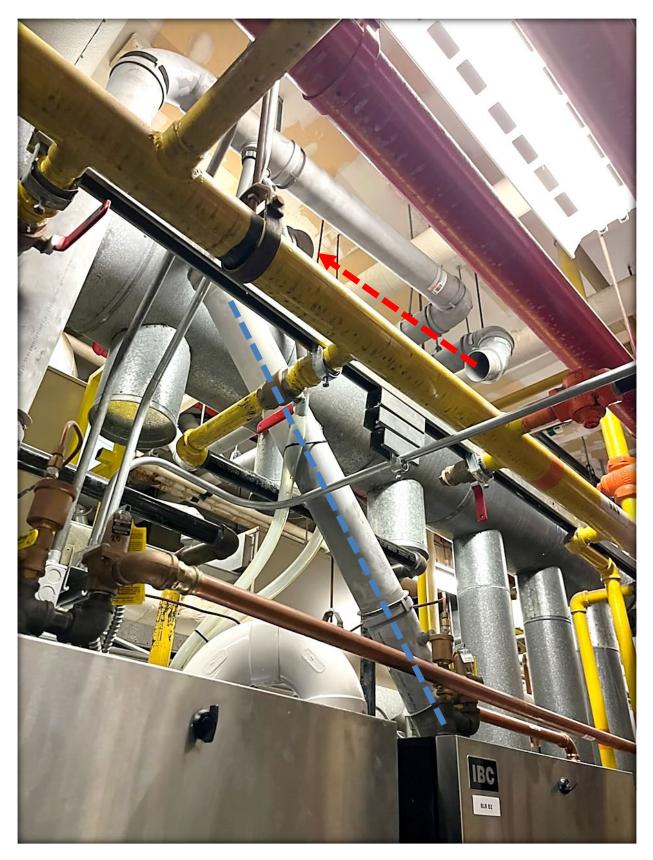
Image 3 – Boiler B2 venting system disengaged (red line) and knocked over (blue line).
