Incident Summary #II-796777-2019 (#10525)

SUPPORTING INFORMATION	Incident Date	November 24, 2018	
	Location	Lazo	
	Regulated industry sector	Refrigeration system	
	Impact	Qty injuries	0
		Injury description	None
		Injury rating	None
	Damage	Damage description	Two studs at the flanged connection between the suction service valve and the compressor failed causing an uncontrolled ammonia release, (Figure 1).
		Damage rating	Minor
Incident rating	Minor		
Incident overview	The bolted flanged connection on the suction of a reciprocating compressor failed causing an uncontrolled release of ammonia into the machinery room. The ammonia detection system worked as designed activating the ventilation system and alarming the appropriate parties. The leak was isolated and no injuries resulted.		
INVESTIGATION CONCLUSIONS	Site, system and components	<p>The flange connected an ammonia suction valve to the compressor using nuts fastened onto studs passing through the flange, (Figure 2). The stud fasteners are subject to vibration from the compressor to which it is mounted, causing a cyclic loading condition on the studs. Threaded studs are susceptible to fatigue failure under cyclic loading.</p> <

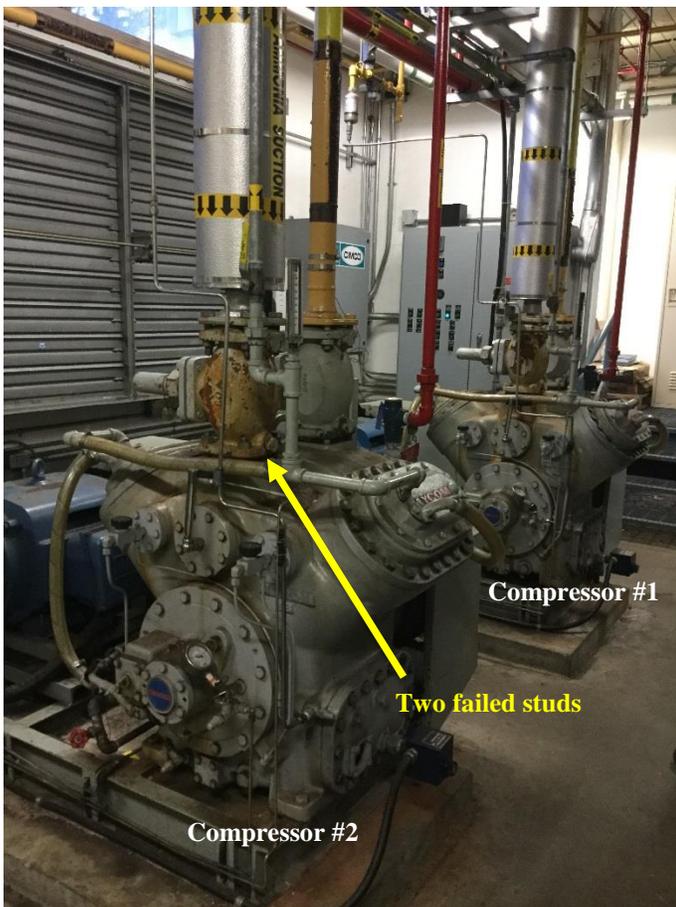
<p>Facts and evidence</p>	<p>The leak was determined to be at the ammonia suction flanged connection of compressor #2 between the service valve and the compressor. Soap solution and litmus paper were used to find the leak. Compressor #2 was shut down and isolated using the suction and discharge service valves. The ammonia levels in the machinery room dropped rapidly.</p> <p>Reciprocating compressor #2 was in operation for 16 years. The gasket and studs/nuts at the failed connection are believed to be original. No evidence could be found to show that the nuts were properly torqued at the time of original installation. The suction piping above compressors #1 and #2 is supported in the vertical direction with no support provided in the horizontal direction at this location. Neither of the compressors appeared to exhibit excessive vibrations at the time of the incident investigation. Compressor #1 was completely rebuilt in August 2016 and compressor #2 was completely rebuilt in June 2018. Approximately 15 lbs of ammonia was released during the incident. The plant does not have a vibration analysis program in place and there have been no obvious signs of excessive vibration noted by the plant personnel.</p> <p>Most of the fracture face of stud #1 (Figure 4) and approximately half of the fracture face of stud #2 (Figure 3) was discolored. The discoloration is likely a corrosion product which developed on the metal surface of the partially fractured studs as a result of being exposed to a corrosive environment prior to final failure. Both fracture surfaces indicate a slow progressing damage mechanism. Both fracture surfaces indicate the initiation points at the root of the threads. No necking was noted at the location of both fractures, which would be present if the studs failed due to sudden stress overload. Analysis of stud #1 and #2 fracture surfaces found indications of fatigue cracking followed by sudden overload failure. Stud #2 showed two separate initiation points with discoloration in each area. This suggests reverse bending fatigue failure as the failure mode. Stud #1 showed a single area of initiation indicating unidirectional bending fatigue. The fatigue cracking likely initiated during long term cyclic loading. No visual indication of cracking was found on the two remaining studs at the failed connection.</p> <p>Cyclic loading throughout the 16 year life likely caused fatigue cracking to slowly propagate through the thickness of the two studs that failed. The weakened studs allowed the gasket to lose its seal causing the ammonia release. Final fracture occurred when the studs were tightened at the time of the release.</p>

Figure 1: General location of the leak.

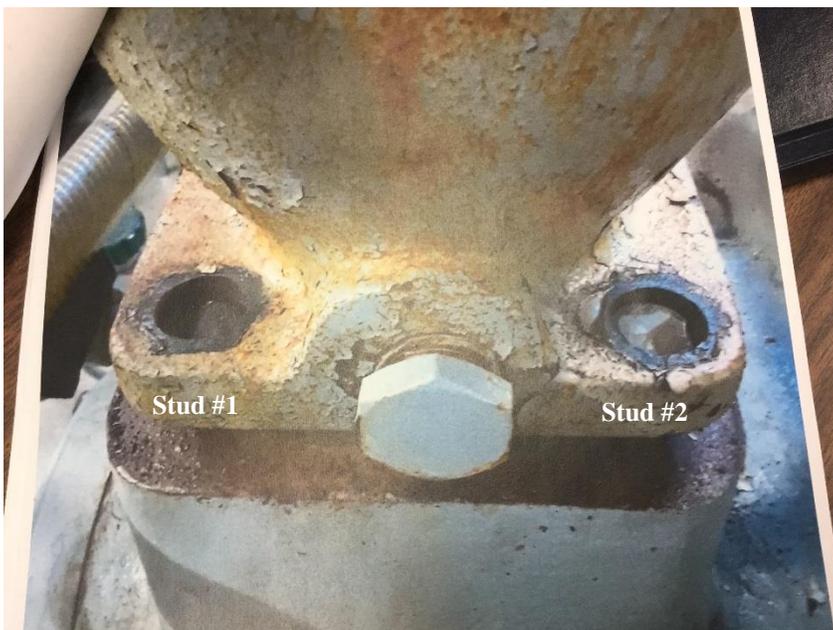
<p>Causes and contributing factors</p>	<p>Cause:</p> <ul style="list-style-type: none"> - Stress concentration at the suction valve to compressor connection along with cyclic loading likely caused a fatigue failure of two of the studs. <p>Contributing Factors</p> <ul style="list-style-type: none"> - Lack of support in the horizontal direction of the suction piping above the compressors may have increased the amplitude of the cyclic loading. <p>Early detection of the leak may have been possible if the required regular testing for leaks was carried out.</p>

Figure 2: Broken studs. (The nuts and part of the stud is not shown)

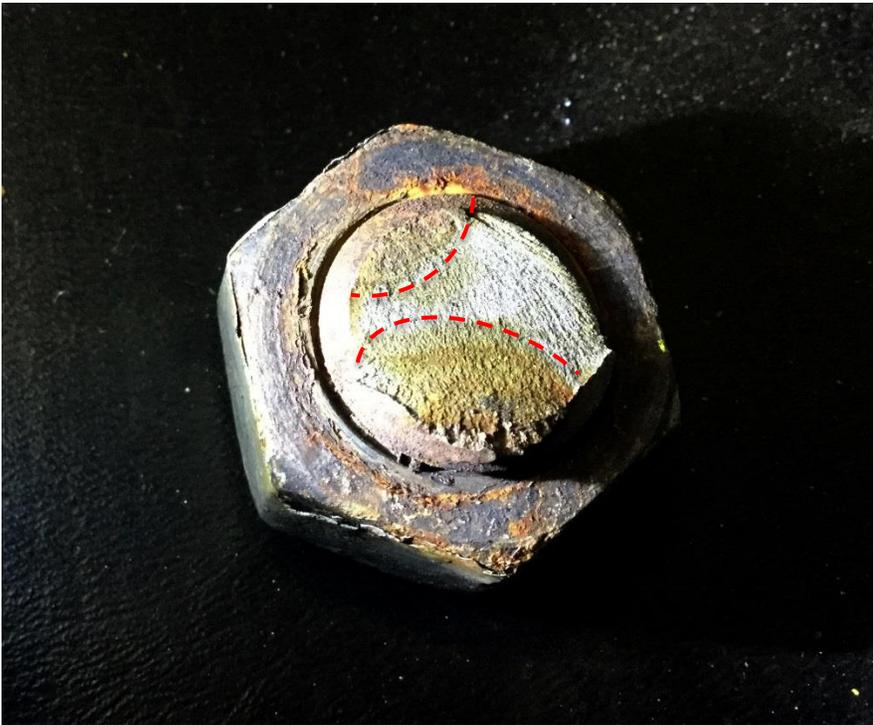
Figure 3: Fracture face of stud #2. The red dashed lines indicate the discoloration at the two separate initiation points.

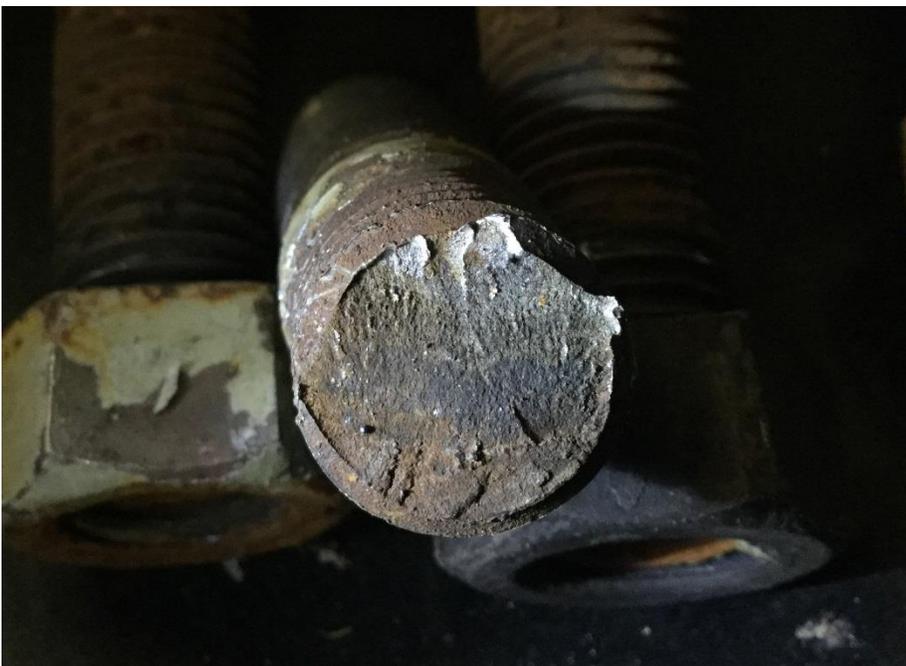
Figure 4: Fracture face of stud #1

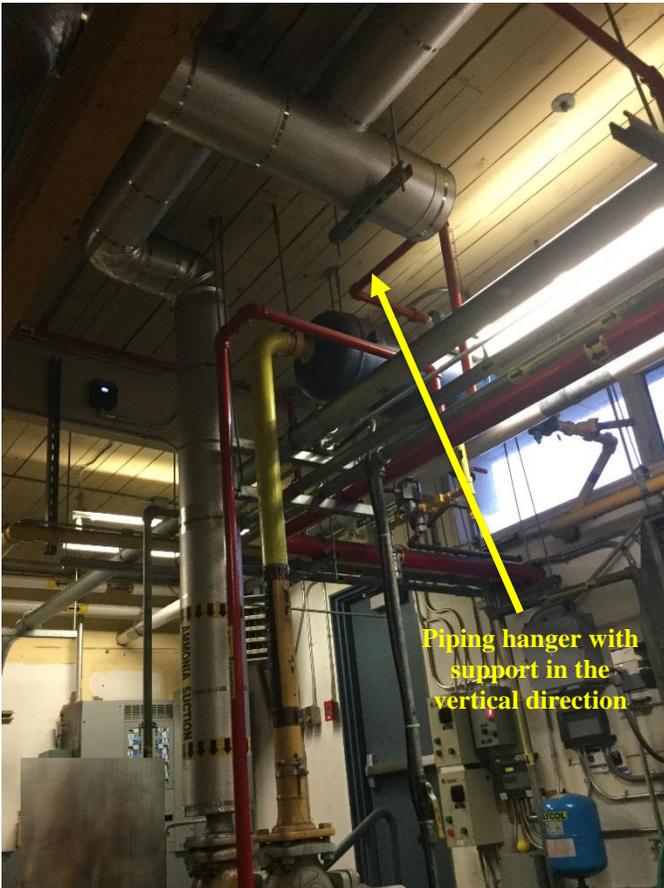
Piping hanger with
support in the
vertical direction

Figure 5: No supports in the horizontal direction on the suction piping above compressor #2.
