## Incident Summary #II-723226-2018 (#8084) (FINAL)

SUPPORTING INFORMATION	Incident Date	July 25, 2018	
	Location	Abbotsford, BC	
	Regulated industry sector	Boilers, PV & refrigeration - Refrigeration system	
	Impact	Qty injuries	0
		Injury description	None
		Injury rating	None
	Damage	Damage description	A rubber gasket failed in a packaged ammonia compression refrigeration unit. Approximately 15 pounds of ammonia released into machinery room.
		Damage rating	Minor
	Incident rating	Minor	
Incident overview	Ammonia vapors leaked from a damaged mechanical seal gasket at the manhole cover of an oil separator inside the machinery room. The ammonia leak detector in the engine room triggered an audio-visual alarm and high speed ventilation intended to exhaust the ammonia from the room . The building was evacuated immediately.		
INVESTIGATION CONCLUSIONS	Site, system and components	<p>Ammonia is an ideal industrial refrigerant for large plants such as cold storages, ice plants, packing plants, skating rinks and breweries because it is inexpensive, operates at low temperatures, and is very efficient. Ammonia used for refrigeration is essentially pure ammonia without water and is known as

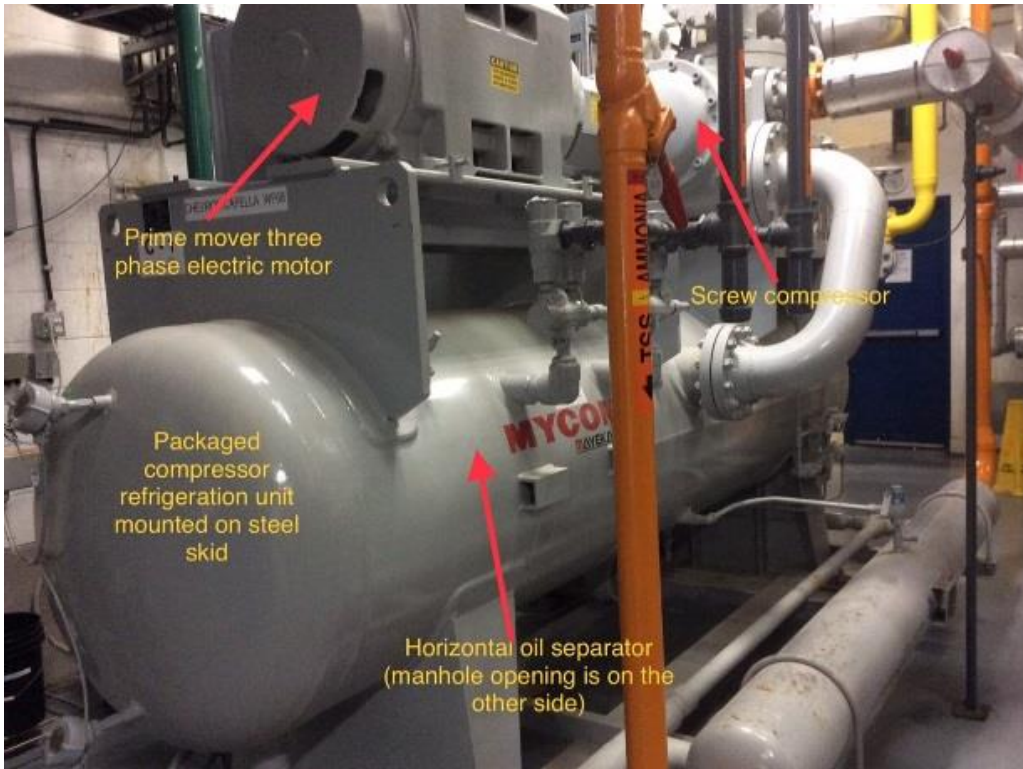
Photo 1: Packaged Refrigeration System

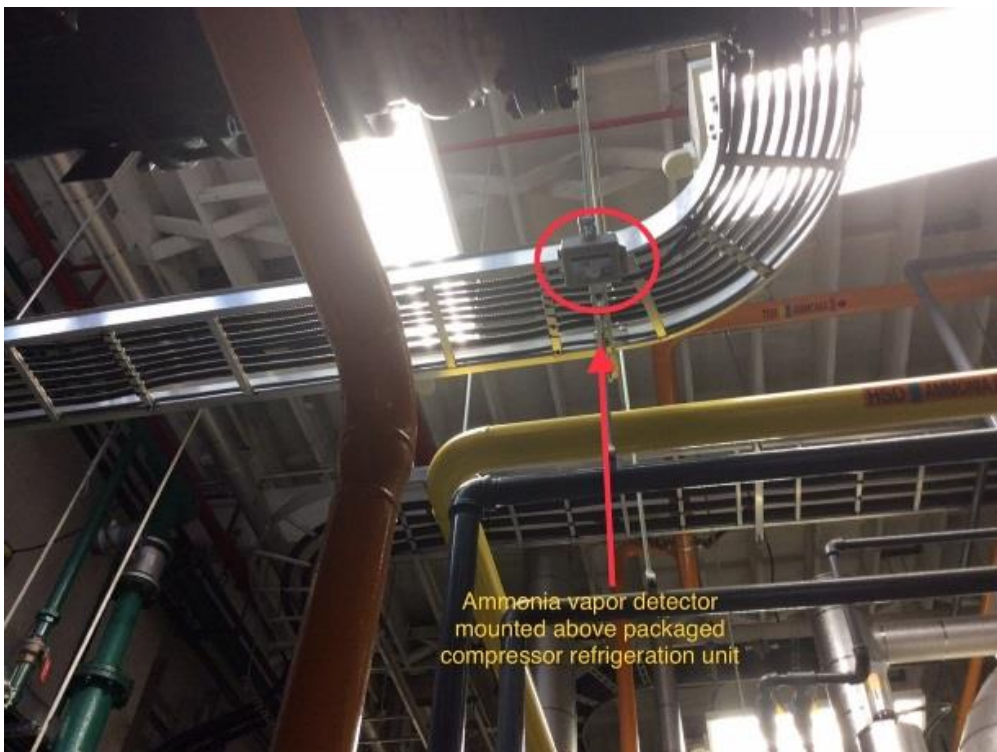
Photo 2: Ammonia Leak Detector Installed

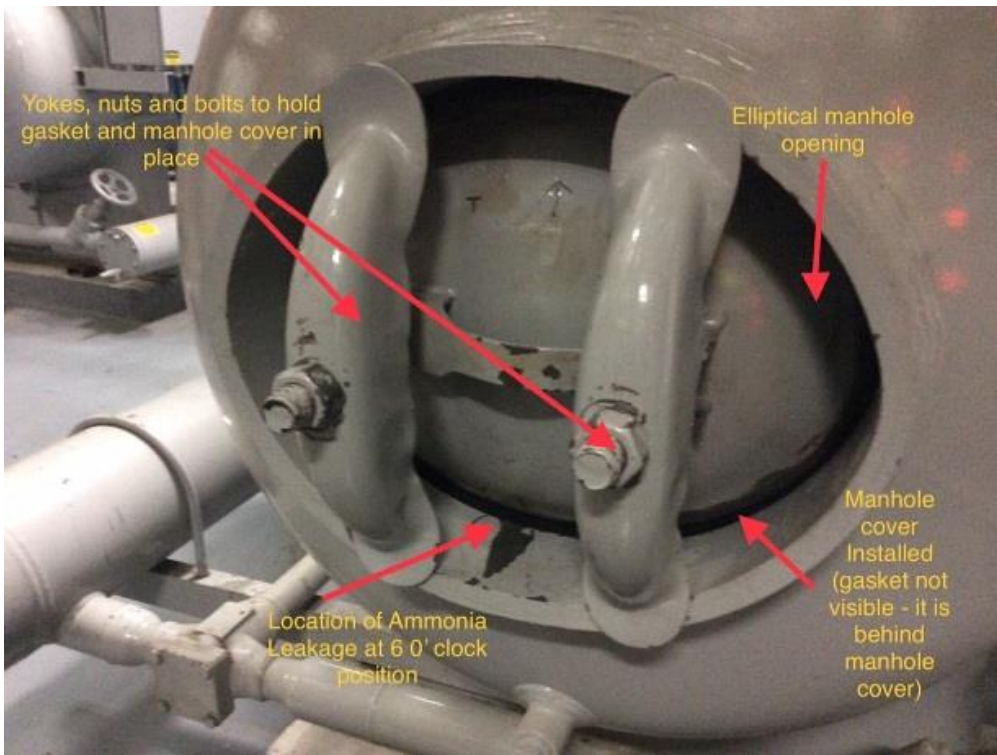
<p>Facts and evidence</p>	<p>Chief engineer and maintenance supervisor were interviewed and their statements are as follows;</p> <ul style="list-style-type: none"> <li>• The seal was damaged/ruptured at the 6 o'clock position.</li> </ul> <p>Licensed contractor and refrigerant parts supplier was contacted, points are as follows;</p> <ul style="list-style-type: none"> <li>• Licensed contractor is aware this is second similar recorded incident in industrial ammonia plants.</li> <li>• The equipment manufacture is currently investigating possible causes of gasket failure.</li> <li>• Gasket material is rubber compound and compatible with ammonia, however it deteriorates when placed in service.</li> <li>• Contractor and parts supplier ruled out possibility of gasket failure due to incorrect installation practice.</li> <li>• In rare cases, gasket failed before recommended service life.</li> <li>• When removed, gasket was found damaged – damage patterns showed failure and rupture of gasket material at bottom portion from where ammonia leaked.</li> </ul> <p>Refer to photographs attached:</p> <ul style="list-style-type: none"> <li>• Packaged compression refrigeration unit</li> <li>• Ammonia leak detector</li> <li>• Manhole assembly.</li> </ul>

<p>Causes and contributing factors</p>	<p>It is likely that the rubber gasket deteriorated while in service and provided a path for ammonia release. Evidence was not available to rule out faulty installation as a possible cause or contributing factor.</p>

Photo 3: Manhole Assembly
