Incident Investigation Report

Passenger Bobsleigh Experience

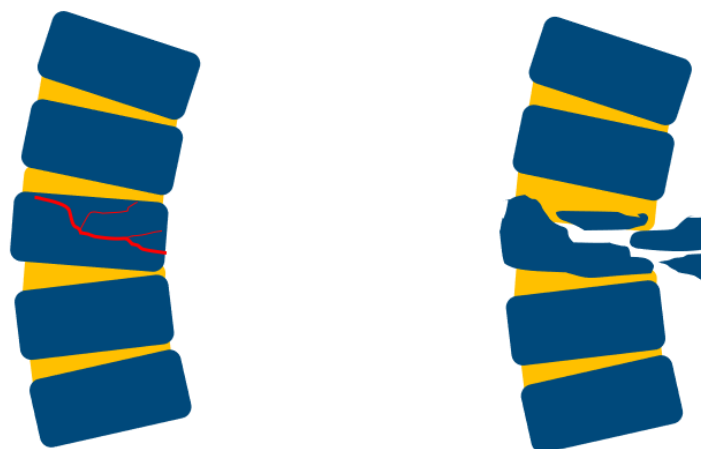
Figure 2 -Representation of the fracture type experienced in the November 2023 incident

1. Both fractures consisted of anterior wedge fractures to a vertebra. In simpler terms, anterior is in reference to the front side of the vertebrae, and the fracture occurred at an angle forming a wedge from front to back. See the diagram below:

3. Anterior wedge fractures, as seen in these two cases, occur due to a combination of vertical loads being placed on the spine along with loads from flexion (i.e. the forward curvature of the spine that occurs when leaning forward). Vertical loads on the spine are expected due to acceleration resulting in “g-forces” on the patrons.

In summary, it is likely that a combination of the magnitude and duration of applied loads from the ride, as well as the posture of the occupants dictated by the ergonomics of the bobsleigh, particularly in seating position 4, likely resulted in the vertebrae tolerance of these two individuals being exceeded and the subsequent fractures occurring.
