Incident Summary #II-832375-2019 (#11598) (FINAL)

SUPPORTING INFORMATION	Incident Date	March 27, 2019	
	Location	Sidney	
	Regulated industry sector	Electrical - Low voltage electrical system (30V to 750V)	
	Impact	Qty injuries	1
		Injury description	Worker received an electrical shock
		Injury rating	Insignificant
	Damage	Damage description	N/A
		Damage rating	None
Incident rating	Insignificant		
Incident overview	A construction labourer was helping a journeyman electrician locate the other end of a conduit he was working on. The labourer without being instructed to do so pushed a conductive metal measuring tape into a unmarked conduit that he assumed to be a spare conduit. This conduit was not a spare, but rather led to the energized portion of the kiosk.		
INVESTIGATION CONCLUSIONS	Site, system and components	Energized electrical kiosk in an active construction site with spare unmarked and uncapped spare conduits.	
	Failure scenario(s)	An individual was trying to confirm where a spare underground conduit located outside of a power kiosk led to. The individual pushed a metal measuring tape into the unmarked uncapped conduit that led to an energized portion of kiosk.

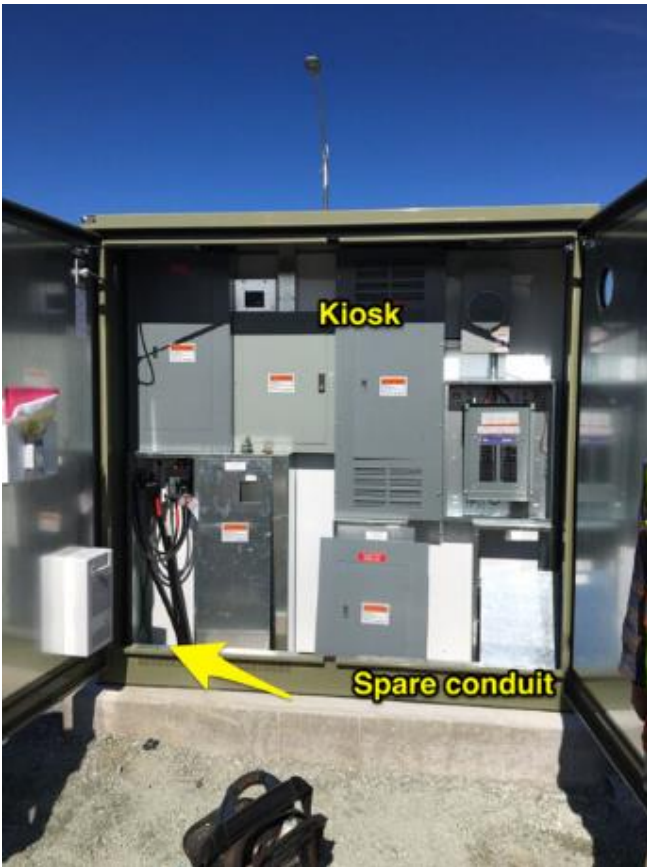
Photo 1: Electrical kiosk containing a spare conduit

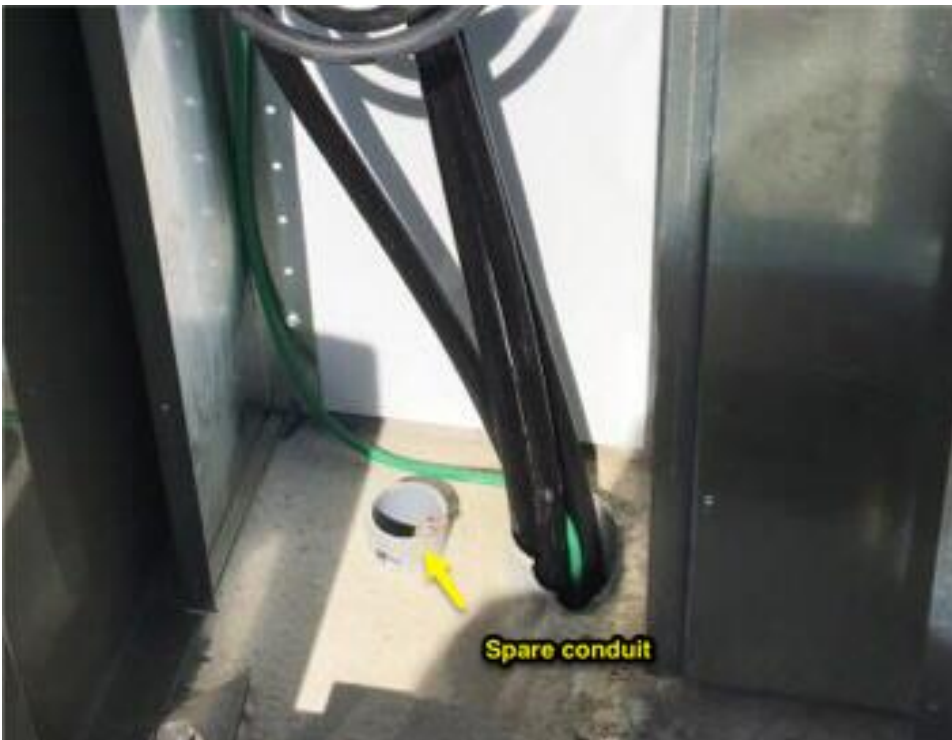
Facts and evidence	<ul style="list-style-type: none"> - Both ends of spare conduit were exposed at time of assessment, no caps were present. - Spare conduit had no markings of any kind at time of assessment. - Canadian Electrical Code (CEC) requires that spare or unused raceways that terminate in enclosures be capped (CEC 12-940). 	
	Causes and contributing factors	The electrical shock incident was due to a worker inserting a metal measuring tape into an unknown conduit that led to an energized component. Contributing factors included non-compliance with the Canadian Electrical Code by the conduit being unmarked and uncapped.

Photo 2: Spare conduit on floor of kiosk

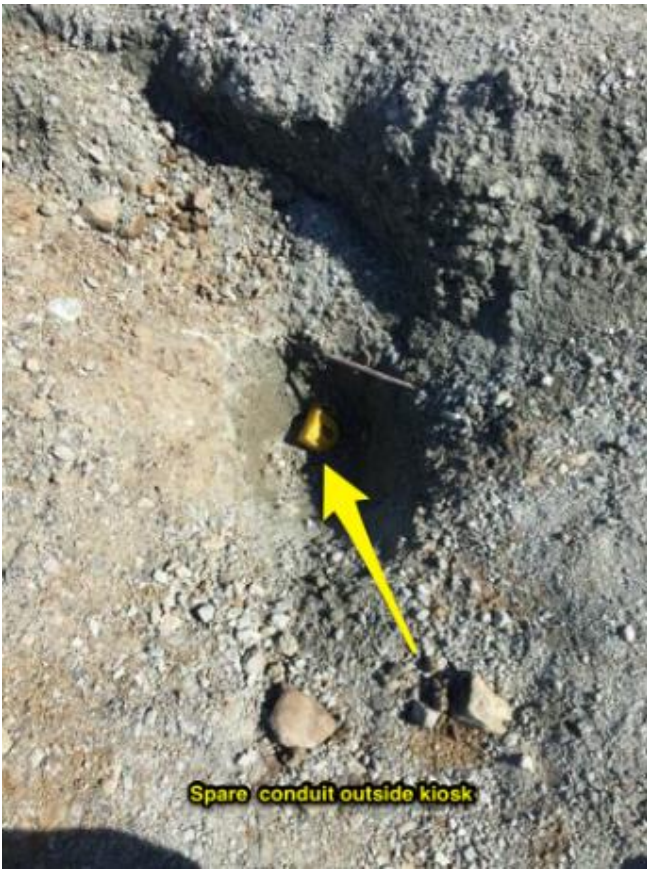
Photo 3: Other end of spare conduit leading to kiosk
