Incident Summary #II-1295505-2021 (#25242) (FINAL)

SUPPORTING INFORMATION	Incident Date	November 30, 2021	
	Location	Pitt Meadows	
	Regulated industry sector	Electrical - Low voltage electrical system (30V to 750V)	
	Impact	Qty injuries	0
		Injury description	N/A
		Injury rating	None
	Damage	Damage description	Underground raceways of a private electrical system were damaged along with an ungrounded (347-Volt) phase conductor within one of the raceways.
		Damage rating	Minor
	Incident rating	Minor	
Incident overview	During construction of a new playground an existing privately owned underground electrical system was damaged while installing the new playground structure.		
INVESTIGATION CONCLUSIONS	Site, system and components	<p>Underground electrical installations can be made up of cables and raceways which can transport power from one location to the next. Electrical raceways are channels designed for holding cables, wires, conductors and busbars.</p> <p>The location of underground electrical systems and services is vital not only for the physical protection of direct burial cables and raceways but also for identifying the installation location for alterations or projects requirin

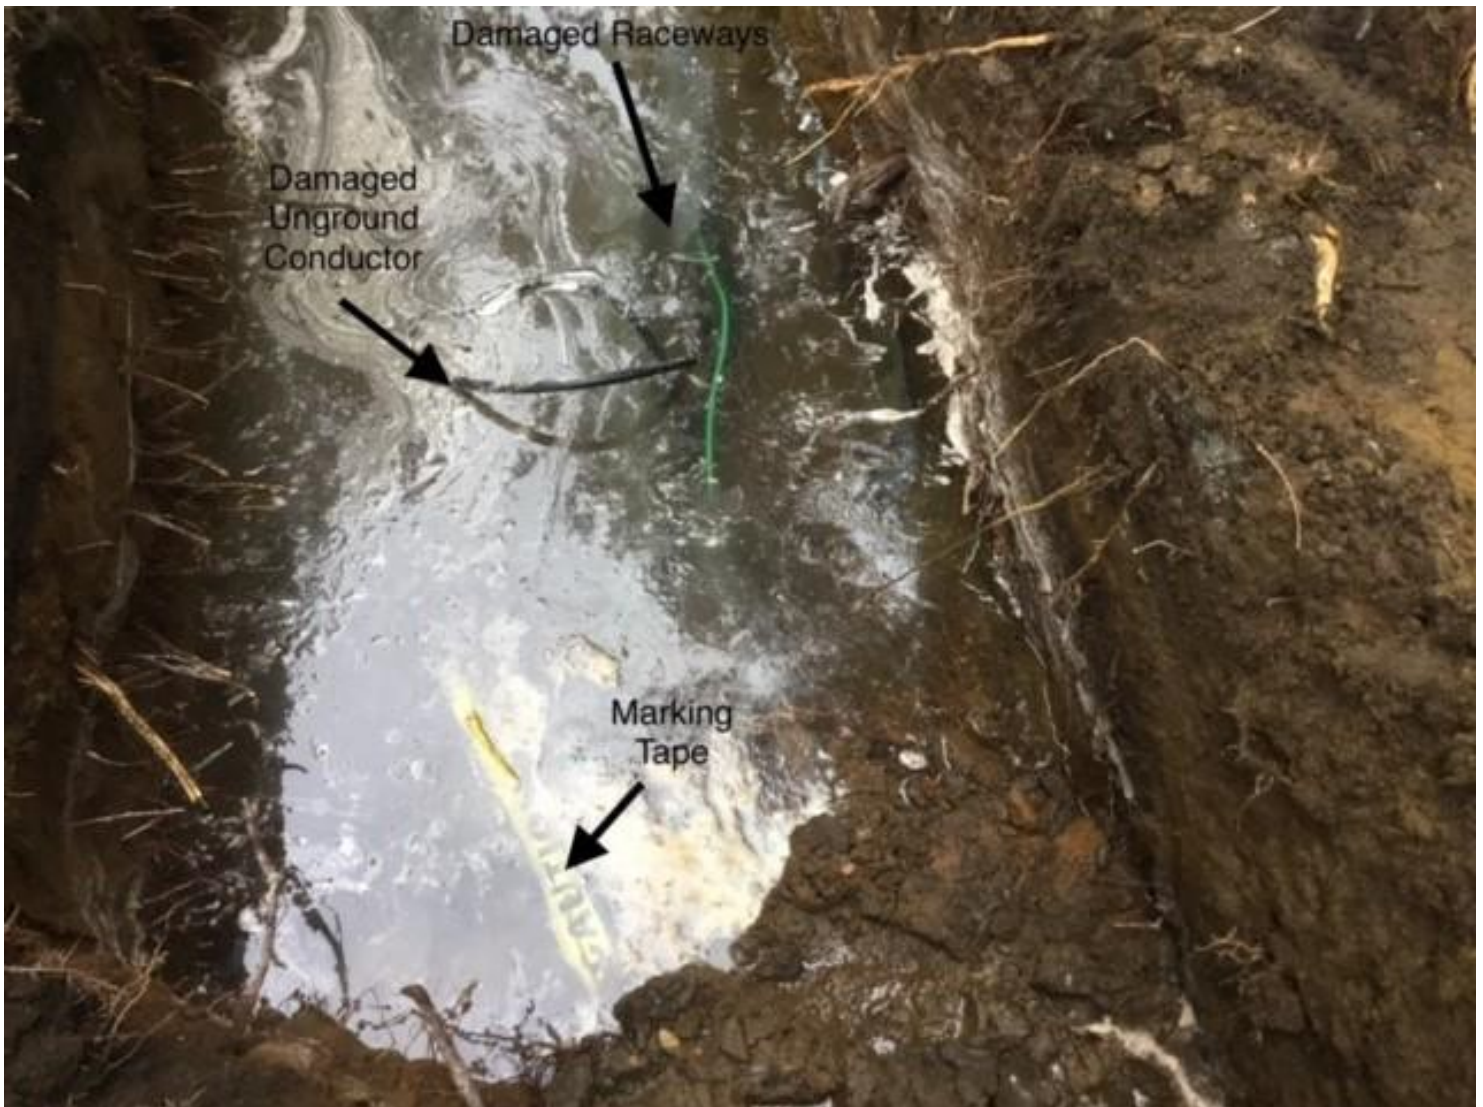
<p>were then notified and the rest of the electrical system was de-energized and locked off until repairs could be made.</p>
<p>Facts and evidence</p>	<ul style="list-style-type: none"> -The contractor stated that while excavating with an auger to install a new playground an underground electrical raceway was damaged. This was noticed when the auger was being removed from the ground pulling up the marking tape and a single conductor. -Evidence in the excavated trench of the damaged raceways (Image 1) -A lug was observed to be broken off the meterbase which was feeding power to the conductor that was damaged within the damaged raceway (Image 2). -A statement was given that no one was hurt and no arcing or other signs of electrical failure (smoke / sparking / noises) were noticed in the area of the incident. This statement along with observation of the broken lug in the meterbase provides evidence that when the conductor was being pulled on by the auger it broke the lug off in the meterbase, which would have de-energizing the conductor preventing further damages and injuries. -Marking tape was provided for the underground electrical raceways (Image 1). -Drawings were stated to be available showing location of the underground electrical system.

<p>Causes and contributing factors</p>	<p>Drawings of the location of the underground electrical system were available and the raceways were provided with marking tape. The failure was likely caused by the contractors not identifying the location of the underground raceways and taking steps to avoid it.</p>

Image 1 - Location of damaged underground electrical system.

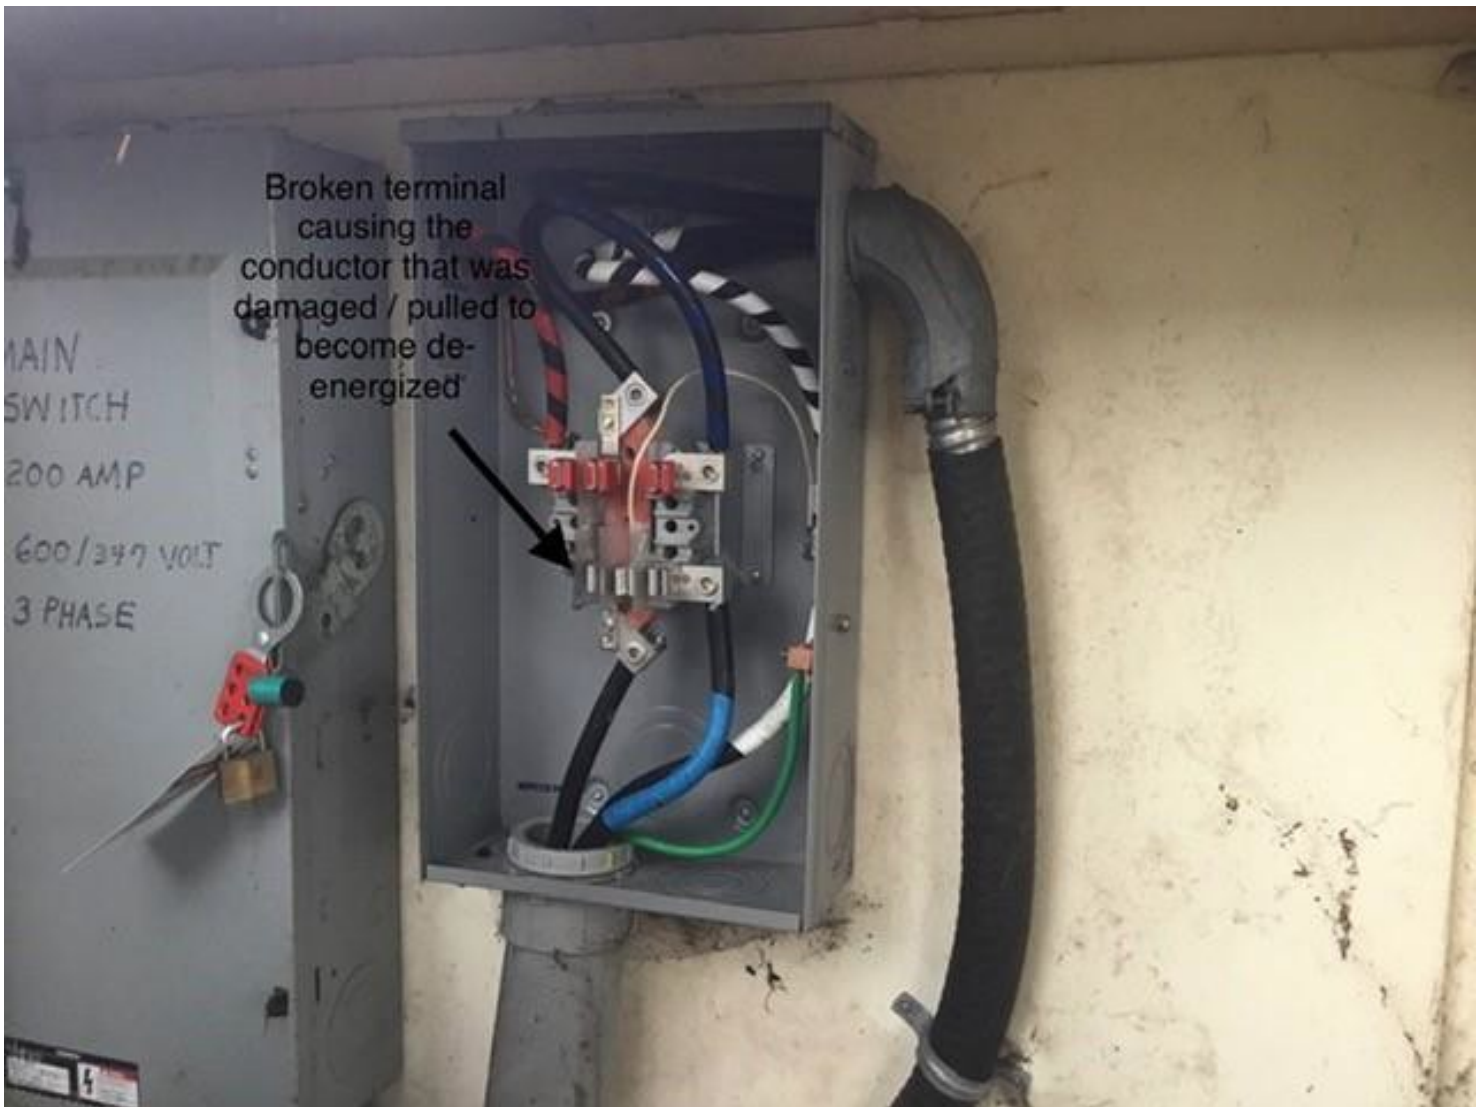
Failure scenario(s)	<p>While excavating with an auger for the installation of a new playground, an existing underground private raceway system was damaged. This installation fed power underground from a park power kiosk to a public washroom.</p> <p>While the auger was being used to dig it contacted and damaged the raceway containing electrical conductors. When the operator removed the auger from the earth one of the ungrounded (live) conductors within the damaged raceway was pulled up with the equipment. The strain and force being put on the conductor by the excavation equipment broke it away from the electrical equipment it was being fed from which caused the conductor to become de-energized. The proper personal</p>

Image 2 - Location of power feeding the underground system that was damaged and the terminal that was broken off by force causing the conductor to be de-energized.
