Incident Summary EDII-705475-2018 (7588) FINAL				
SUPPORTING INFORMATION	Incident Date		<i>June 7, 2018</i>	
	Location		<i>Vancouver</i>	
	Regulated industry sector		<i>Elevating – Construction elevator</i>	
	Impact	Injury	Qty injuries	<i>1</i>
			Injury description	<i>Teeth and jaw injuries</i>
			Injury rating	<i>Moderate</i>
	Damage		Damage description	<i>N/A</i>
			Damage rating	<i>None</i>
Incident rating		<i>Moderate</i>		
Incident overview		It was reported to Technical Safety BC that a person on a <i>Construction elevator</i> had his head entrapped between the construction elevator railing and the fixed supporting beam, resulting in teeth and jaw injuries.		
INVESTIGATION CONCLUSIONS	Site, system and components		A construction elevator is a temporary elevator device installed on the exterior of the building under construction. Construction elevators transport material and people up and down the building as its being constructed. The construction elevator has an access hatch that allows a person to access the top of the elevator car. The top of the elevator car has a metal railing around the perimeter of the car to protect workers while performing work on top of the car. The

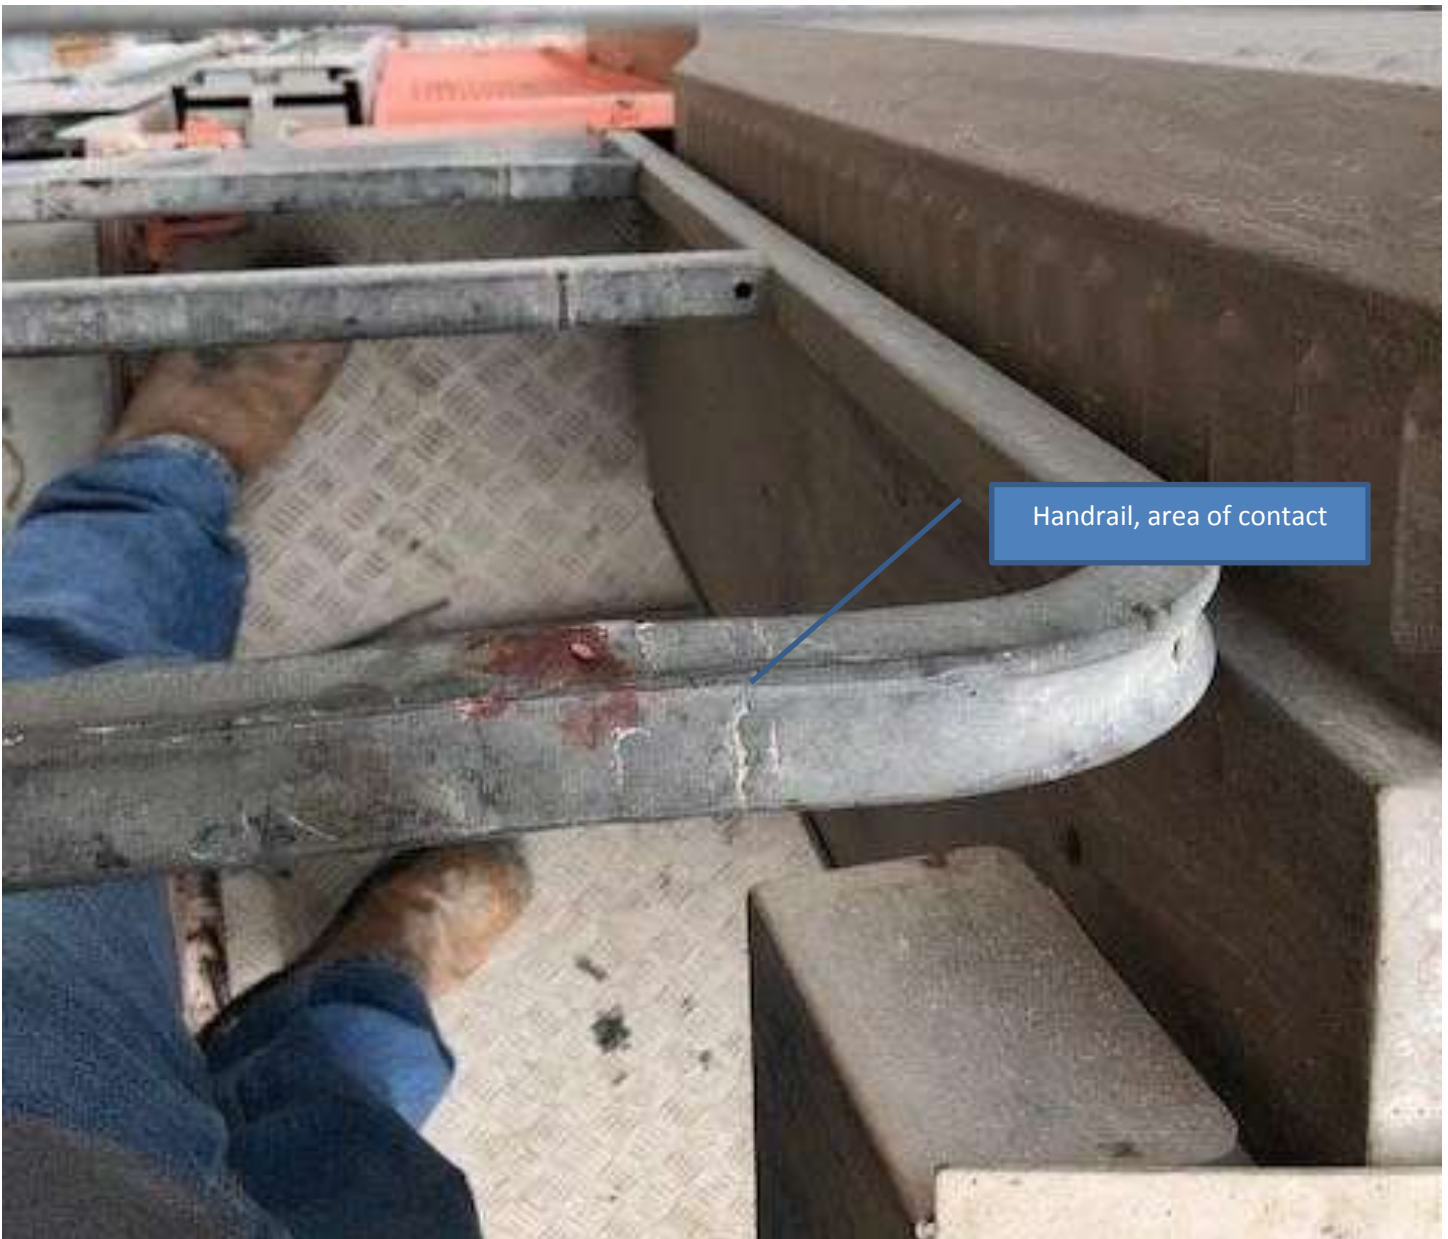
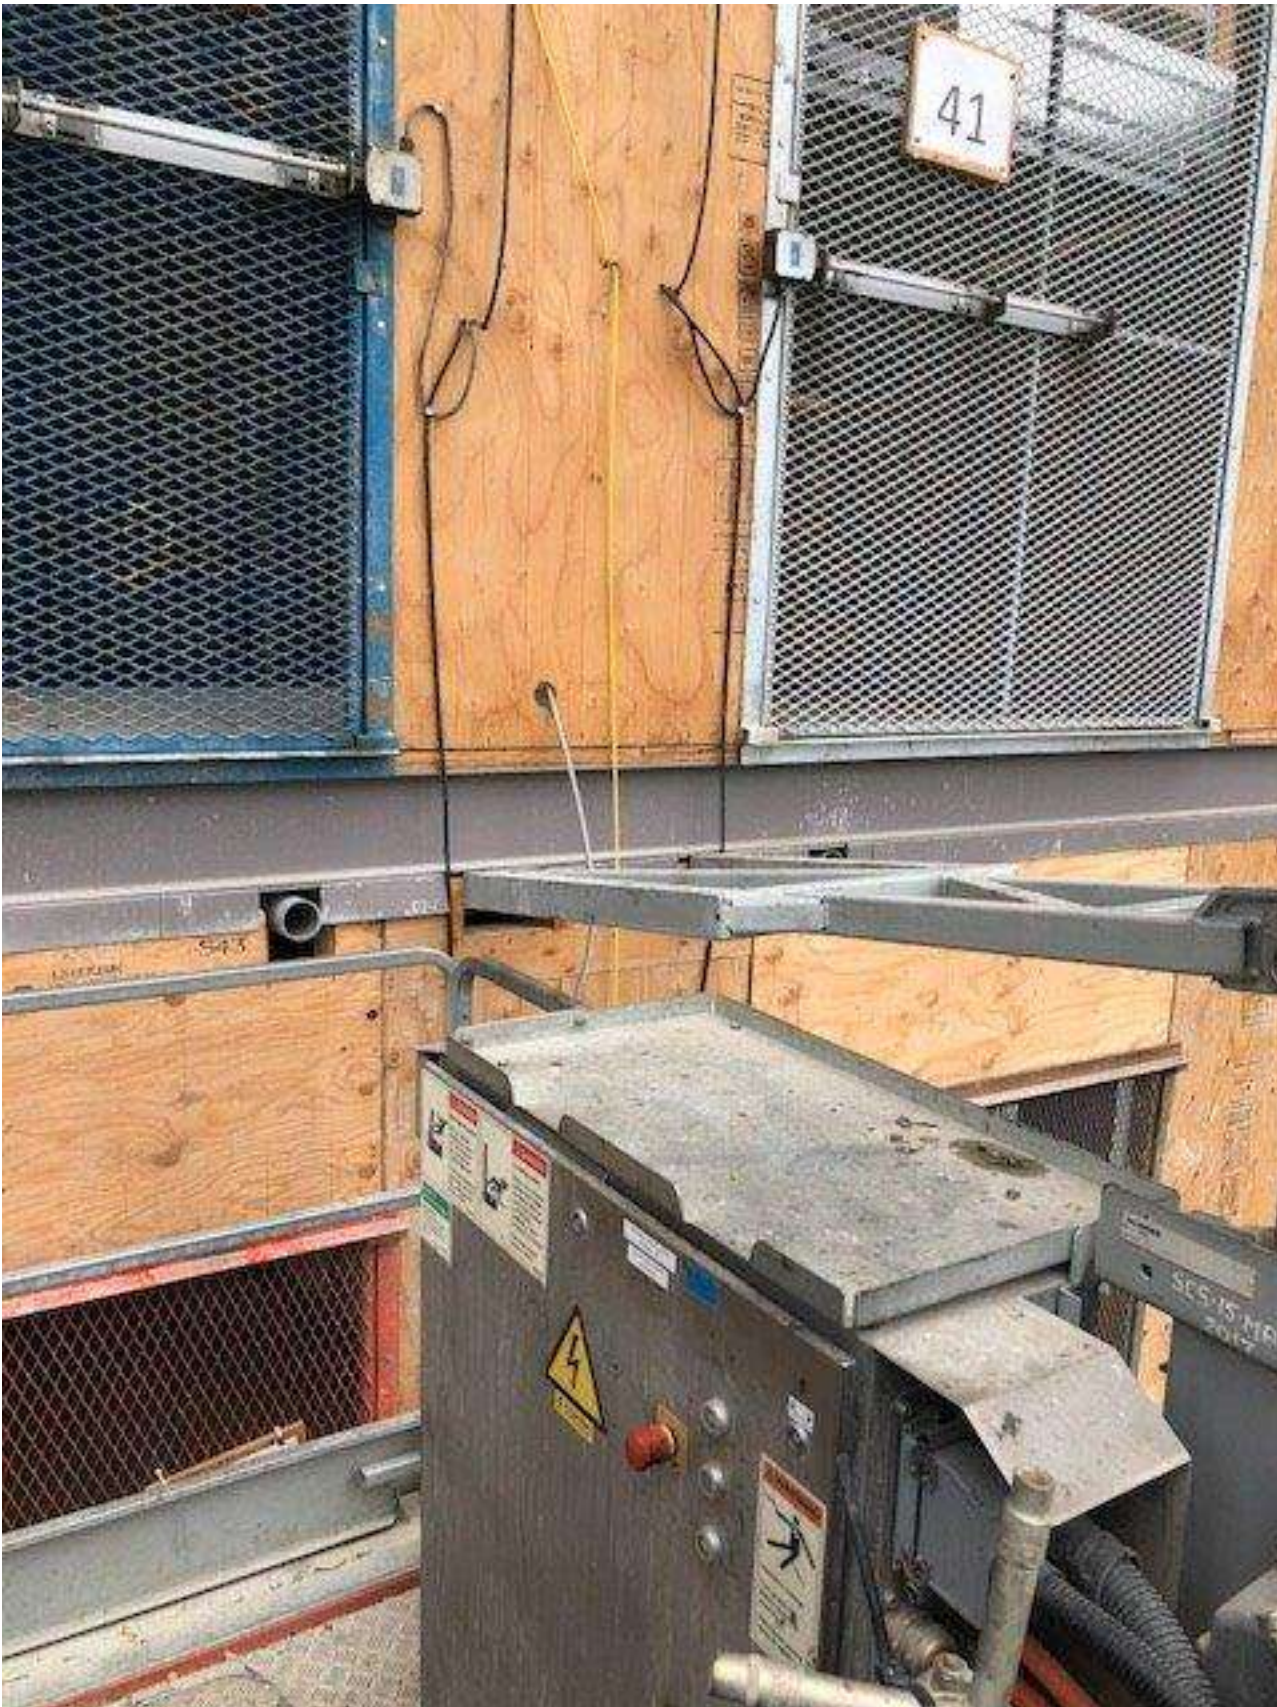
Failure scenario(s)		A hoist operator, who was untrained to access restricted areas, accessed a restricted area of the elevator (top of the construction elevator car). The person positioned their head above the handrail, and a mechanic in a car below activated the controls and moved the car, causing the back of the head of the person to strike the stationary member (mast brace), which forced his jaw and teeth into the hand railing of the construction elevator.	
	Facts and evidence		<p>Based on interviews with Mechanics that were on site at the time of the incident.</p> <ul style="list-style-type: none"> • Hoist operator was on roof of hoist during servicing to provide radio communication to the crane operator and first aid attendant if needed. • Mechanic in training (MIT) was going to move hoist in the up direction, before moving the MIT made sure everyone in the area was clear of hazards and proceeded to move the hoist. • MIT was being properly supervised and taken every proper precaution for safety. • While the MIT was moving the hoist he heard a scream to stop which he did immediately. • After stopping the hoist it was found that the hoist operator had moved into a pinch point between a mast brace and a handrail. <p>Pictures attached from Site visit.</p>

It's highly likely that the incident occurred because an unauthorized personnel (hoist operator), accessed the top of a construction elevator while regulated work was being performed.

It is highly likely that a contributing factor was that the unauthorized personnel (hoist operator), was not aware of the hazards associated with being on top of a construction elevator while in motion.
