Incident Summary II-1703922-2024 (#45823) (Final)

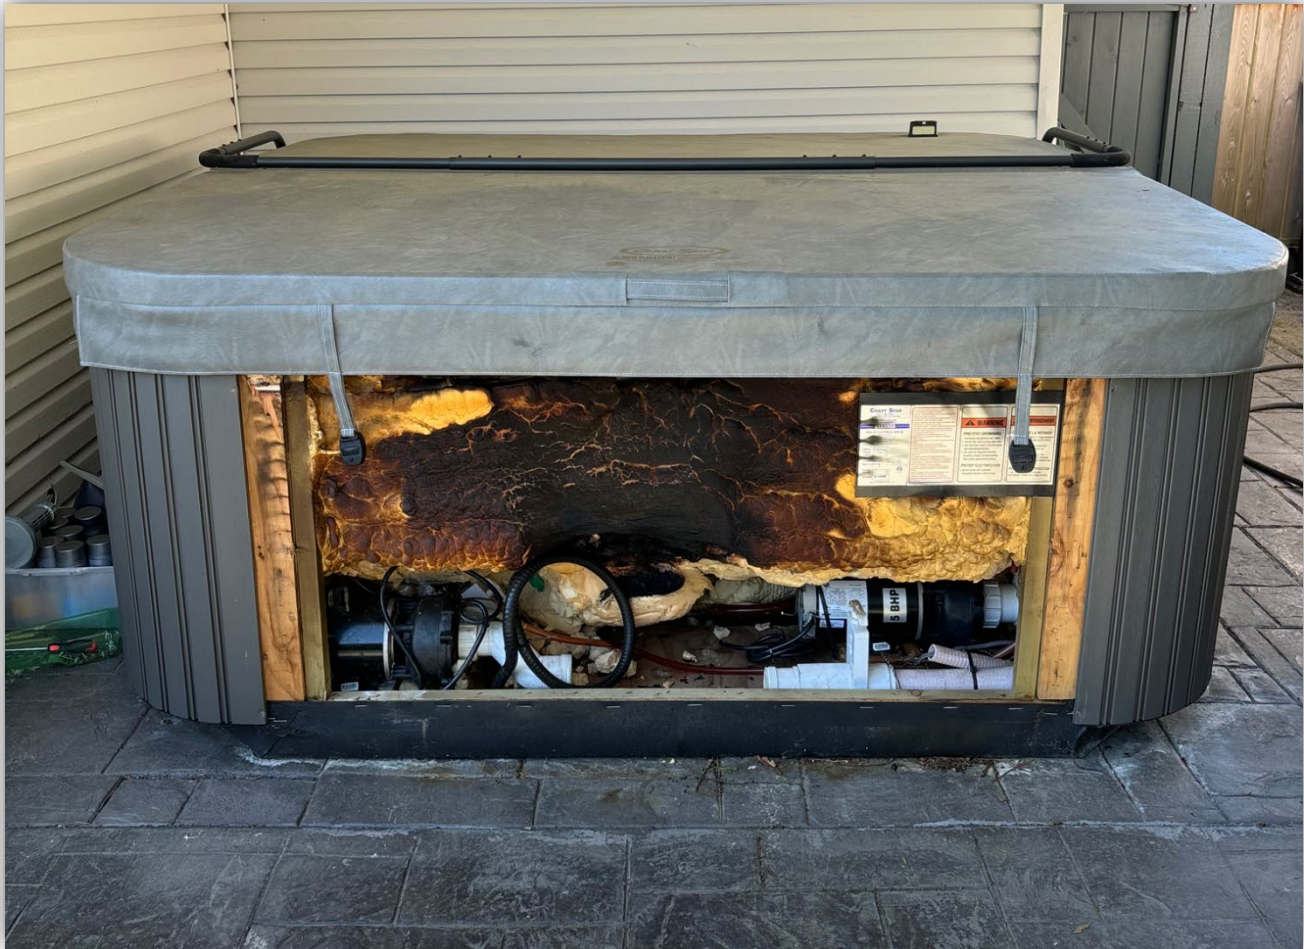
Image 1 – Damaged hot tub.

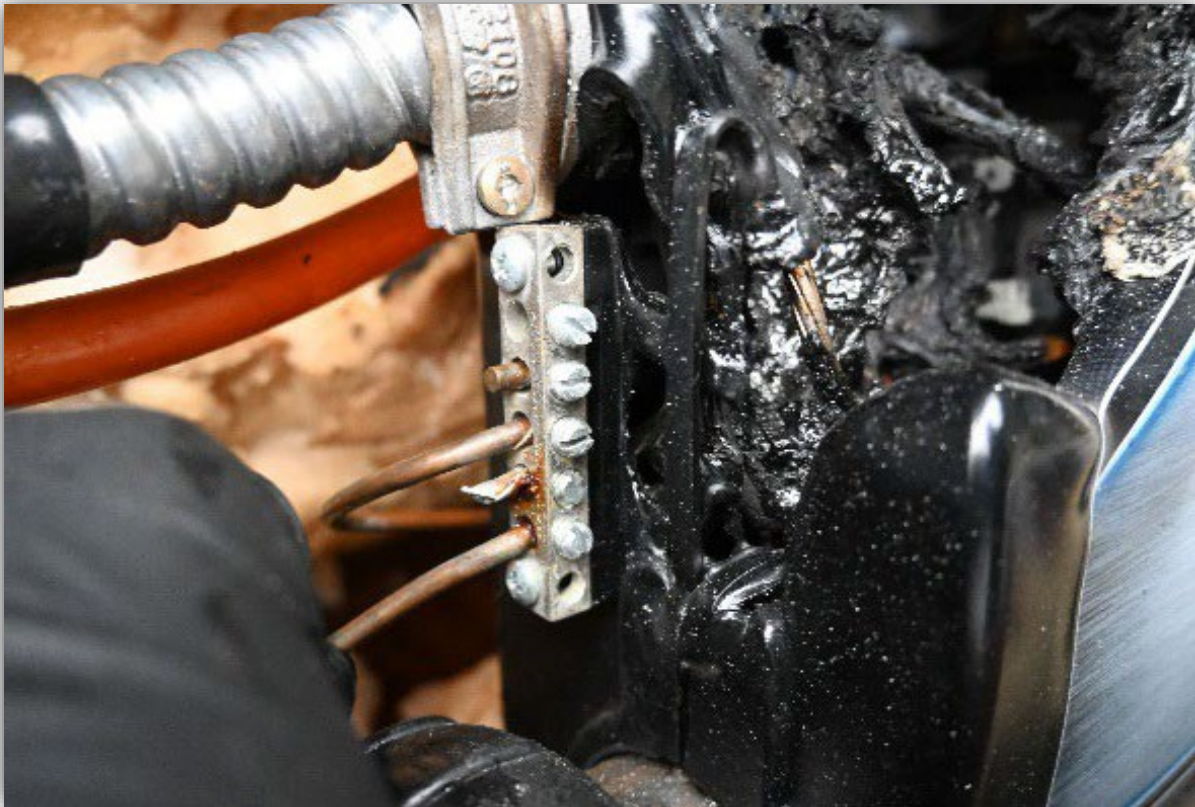
Image 2 - Aluminum cable installed to hot tub controller.

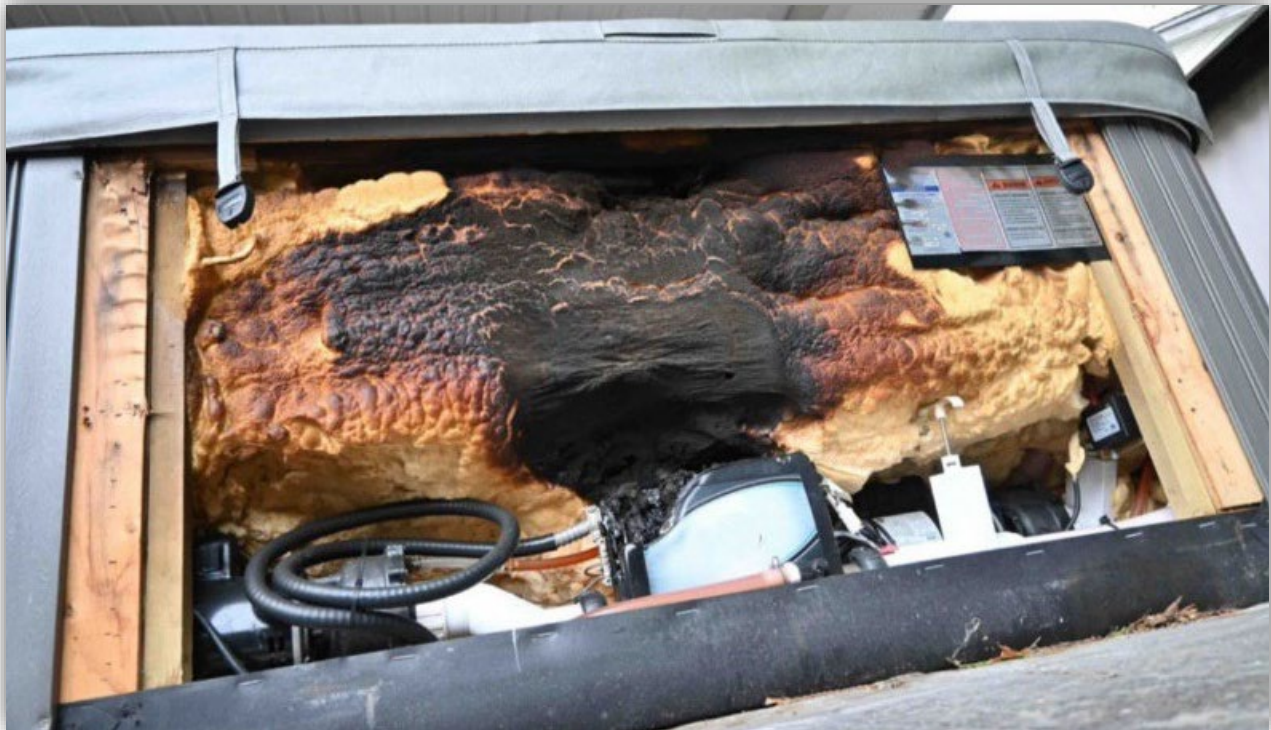
Image 3 – Close up of damaged hot tub.

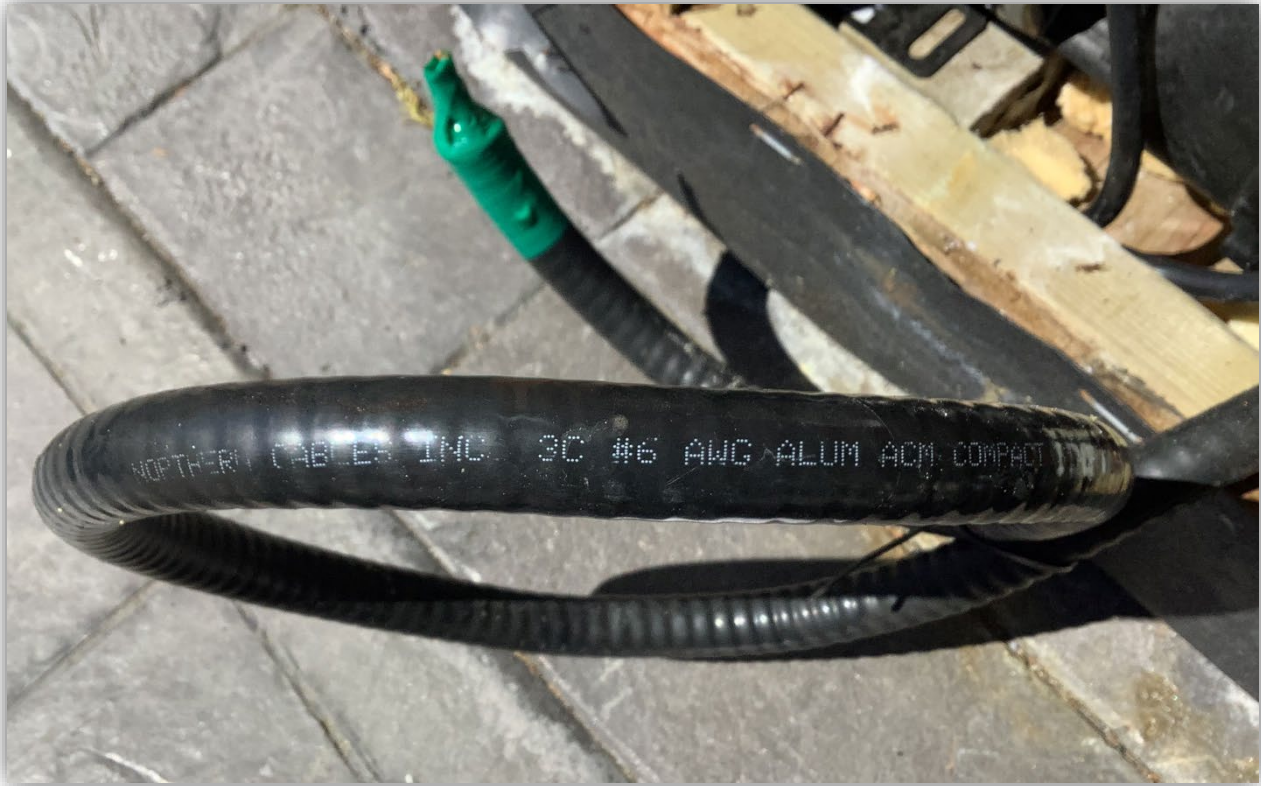
Image 4 – Aluminum conductor used to connect to the hot tub.
