Incident Summary #II-1347792-2022 (#26731) (FINAL)

SUPPORTING INFORMATION	Incident Date	March 22, 2022	
	Location	Port Coquitlam, BC	
	Regulated industry sector	Boilers, PV & refrigeration - Refrigeration system	
	Impact	Qty injuries	0
		Injury description	N/A
	Damage	Injury rating	None
		Damage description	Failure of shaft seal of oil transfer pump released ammonia vapour from the refrigeration system into machinery room
		Damage rating	Insignificant
	Incident rating	Insignificant	
Incident overview	There was a minor ammonia vapour leak from shaft seal, isolated to idle oil transfer pump.		
INVESTIGATION CONCLUSIONS	Site, system and components	<p>This relatively new ammonia refrigeration plant is equipped with a new oil transfer pump which transfers fresh refrigeration oil from a barrel to fill up the compressor oil separators to the operating oil level. However, the oil pump has been idle for a prolong period with the electrical power connection incomplete.</p> <p>Conversely, the associated piping system seems completed. One end of the oil distribution header is connected to the oil transfer pump discharge port while the other end is connected to an oil recovery vessel which is

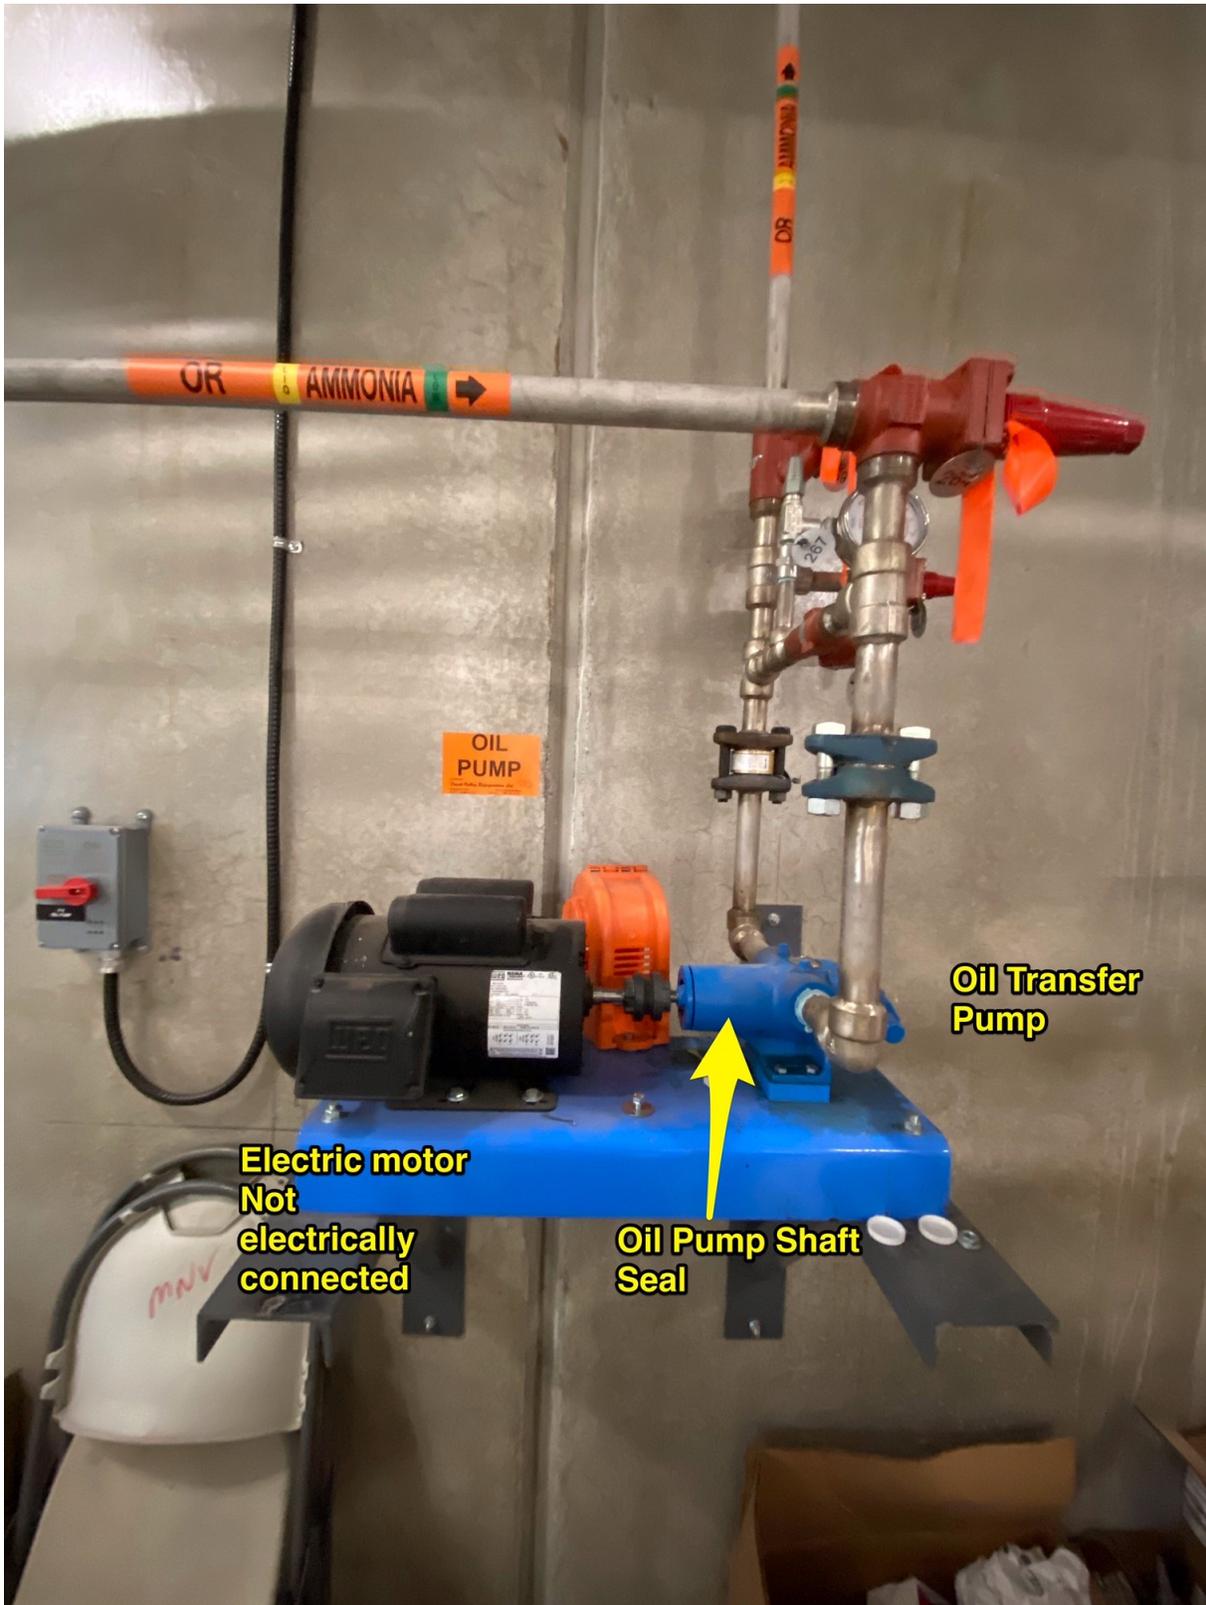
<p>4) Around 2:00pm, licensed refrigeration contractor showed up. The ammonia leak from the shaft seal of the oil transfer pump was identified.</p> <p>5) The pump was isolated by shutting off the suction valve (#264) and discharge valve (#269). The pump remained mechanically depressurized.</p>
<p>Facts and evidence</p>	<ul style="list-style-type: none"> • Customer service report recommended to replace the shaft seal for the oil pump. • The oil pump was not isolated. It was idle for prolong period with the associated piping system under ammonia vapour suction pressure. • No Safe Operating Procedures for oil pump start-up and shut down were found. • No written training manual for the oil pump was provided to client's operating engineers.
<p>Causes and contributing factors</p>	<p>The new oil transfer pump with the associated piping system might have been left pressurized with ammonia vapour at suction pressure.</p> <p>It was likely that the new oil pump was never isolated from the pressurized piping system.</p> <p>It is possible that with Safe Operating Procedures for oil pump start-up and shut down, the leak from the shaft seal could have been prevented.</p>

Image 1 - Oil Transfer Pump

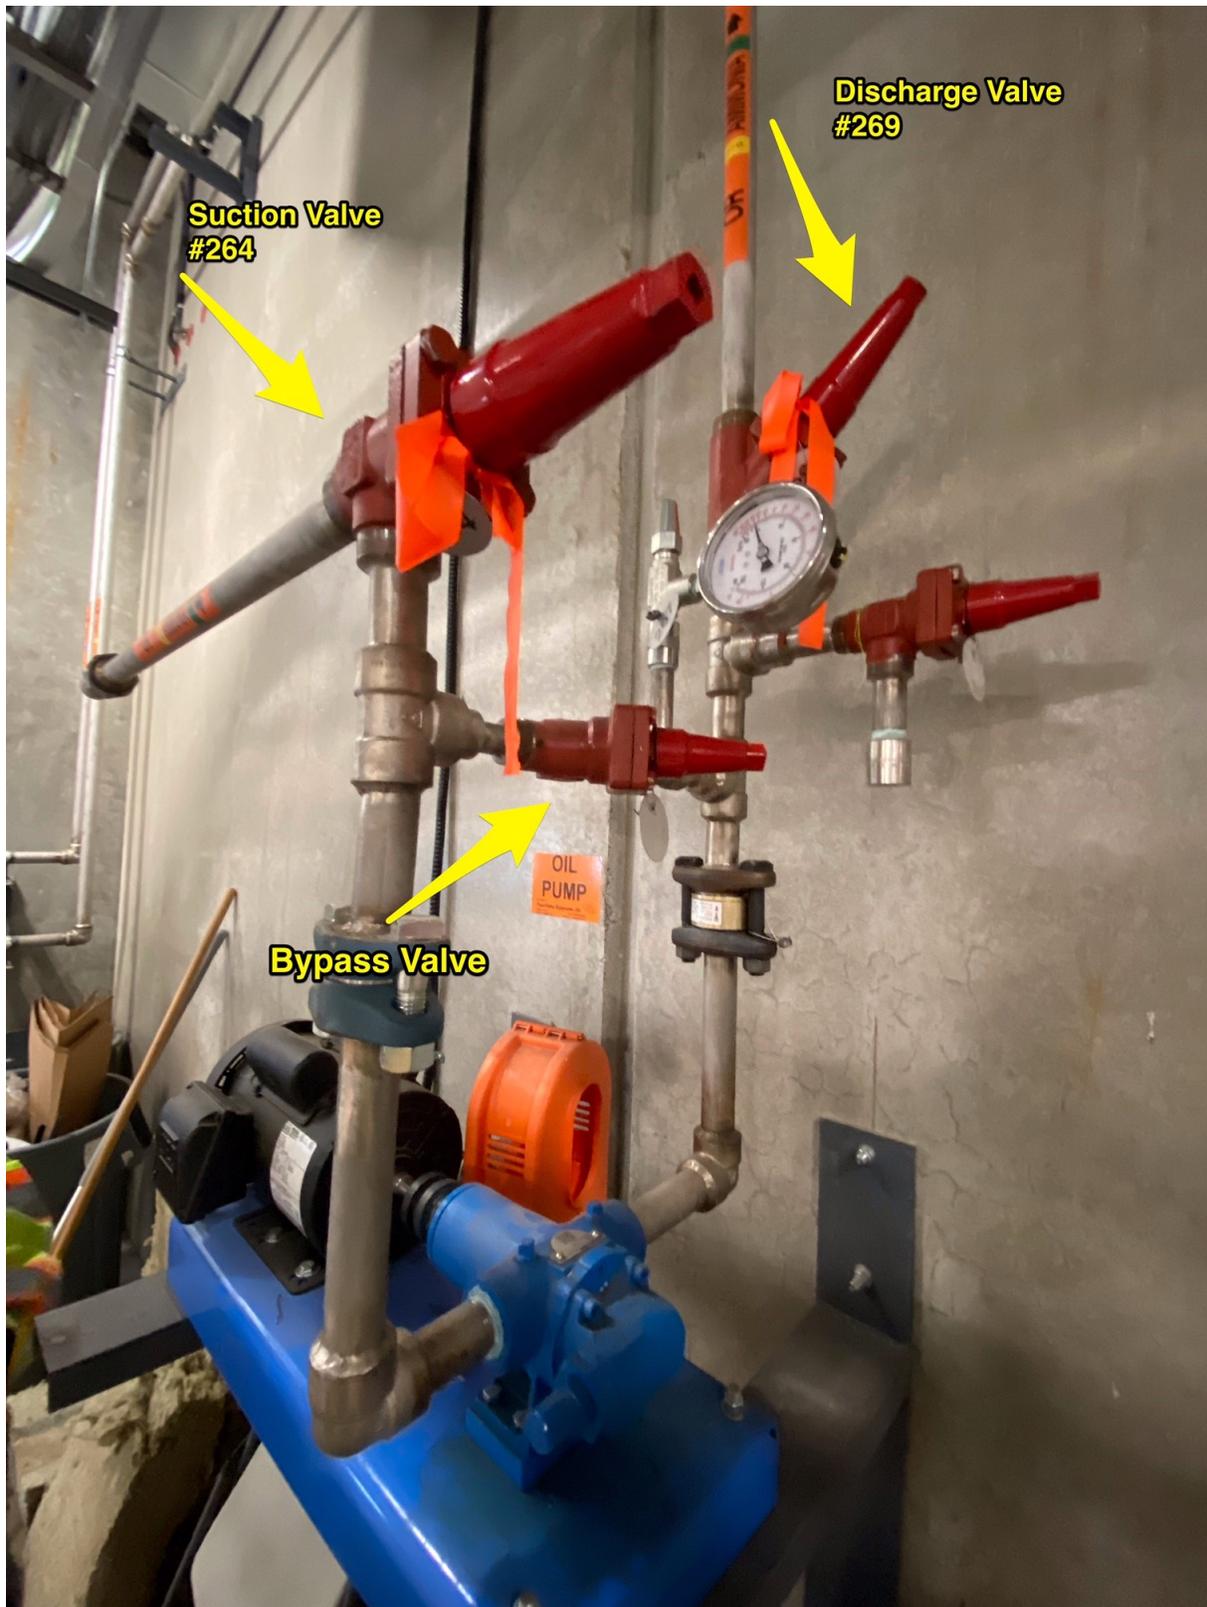
Image 2 - Oil Pump Valves Configuration

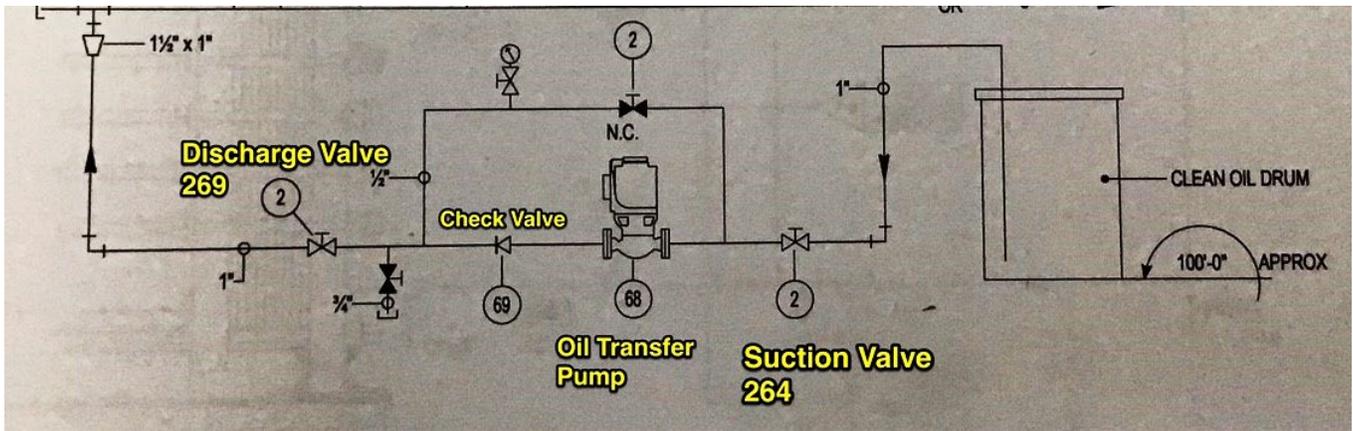
Image 3 - Oil Pump Piping and Instrumentation Diagram
