Incident Summary Report II-705921-2018 (7470) Final

SUPPORTING INFORMATION	Incident Date	May 31,2018	
	Location	Vancouver	
	Regulated industry sector	Elevating Devices - Escalator	
	Impact	Qty injuries	None
		Injury description	None
		Injury rating	None
	Damage	Damage description	It was observed that the escalator steps, step treads, comb plates, step chain pins, bottom of skirt panels all showed signs of damage. Most of these were bent metal and 5 step chain pins were sheared completely
		Damage rating	Major
	Incident rating	Major	
Incident overview	The escalator piled up into the upper landing. This is a malfunction that occurs when the moving components come into contact with the stationary components		
INVESTIGATION CONCLUSIONS	Site, system and components	<p>Escalators core parts are hidden beneath the steps, called a truss. At the top of the unit is an electric motor that runs the four primary gears, two drive gears on either side at the top, and two return gears on either side at the bottom. Chains loop around the gears and run down each side. The chains are connected to each step and help make their way up or down at a speed set by the motor, via electronic panel.</p> <p>Th

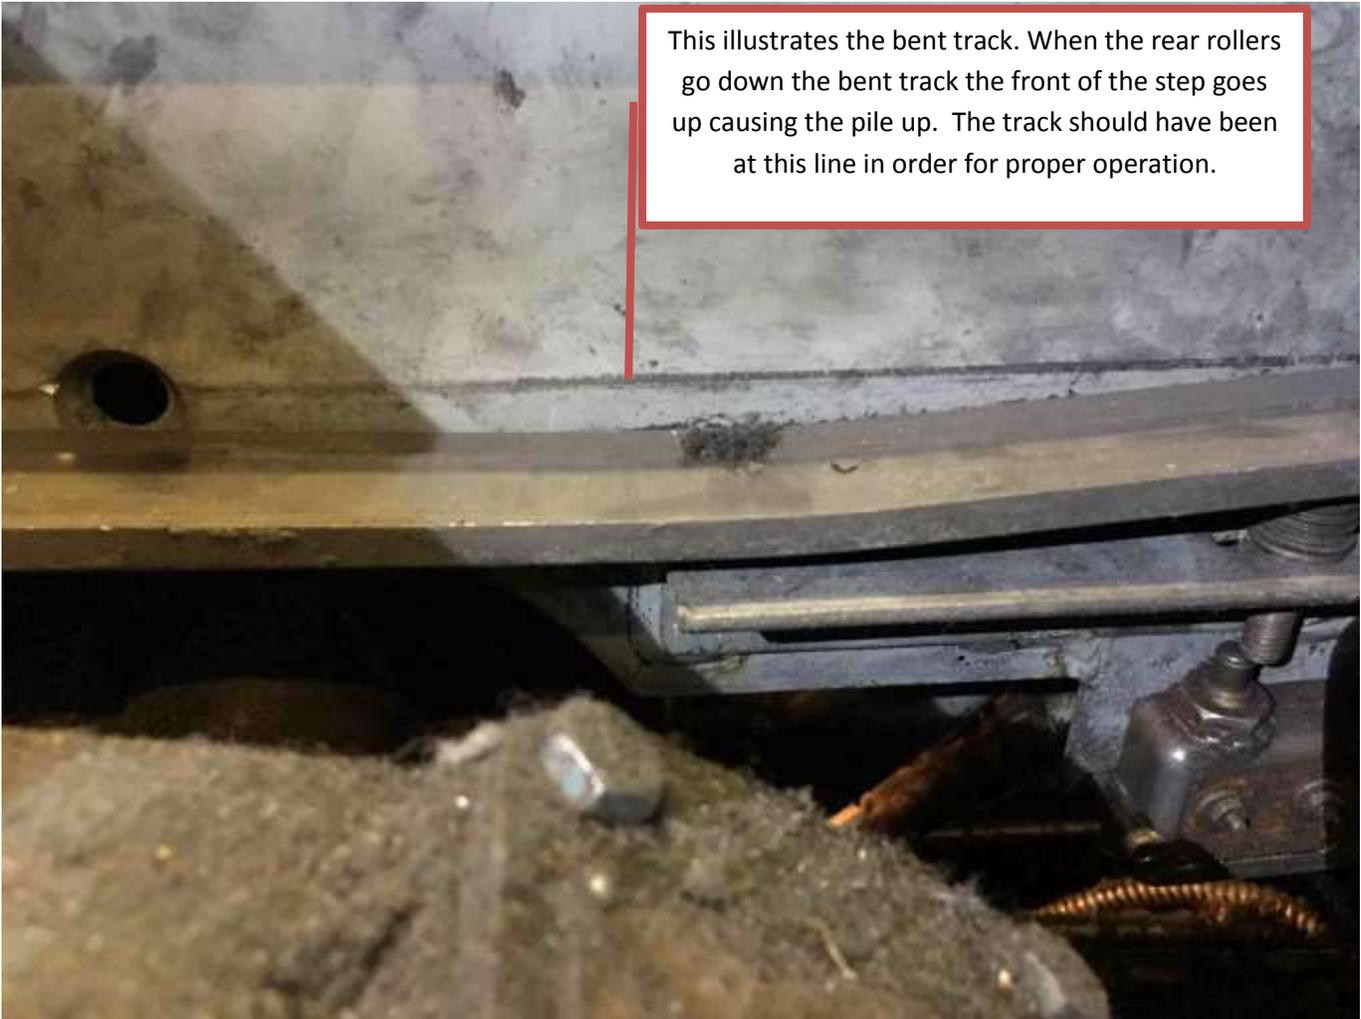
Failure scenario(s)	<p>The escalator usage, constant weight & the amount of people, contributed to wear on components, leading to the tolerances (measurements) for the steps, which are very critical, becoming misaligned and resulting in a bend in the track.</p> <p>This misalignment, which was not captured during a regular maintenance inspection lead to steps striking stationary components of the escalator causing the pile up.</p>	
	Facts and evidence	<p>On Site investigations:</p> <ul style="list-style-type: none"> Escalator located at a high foot traffic area, and subject to weather conditions (rain, snow, salt). Escalator operates at extended usage hours Escalator shut down and barricaded upon arrival

This illustrates the bent track. When the rear rollers go down the bent track the front of the step goes up causing the pile up. The track should have been at this line in order for proper operation.

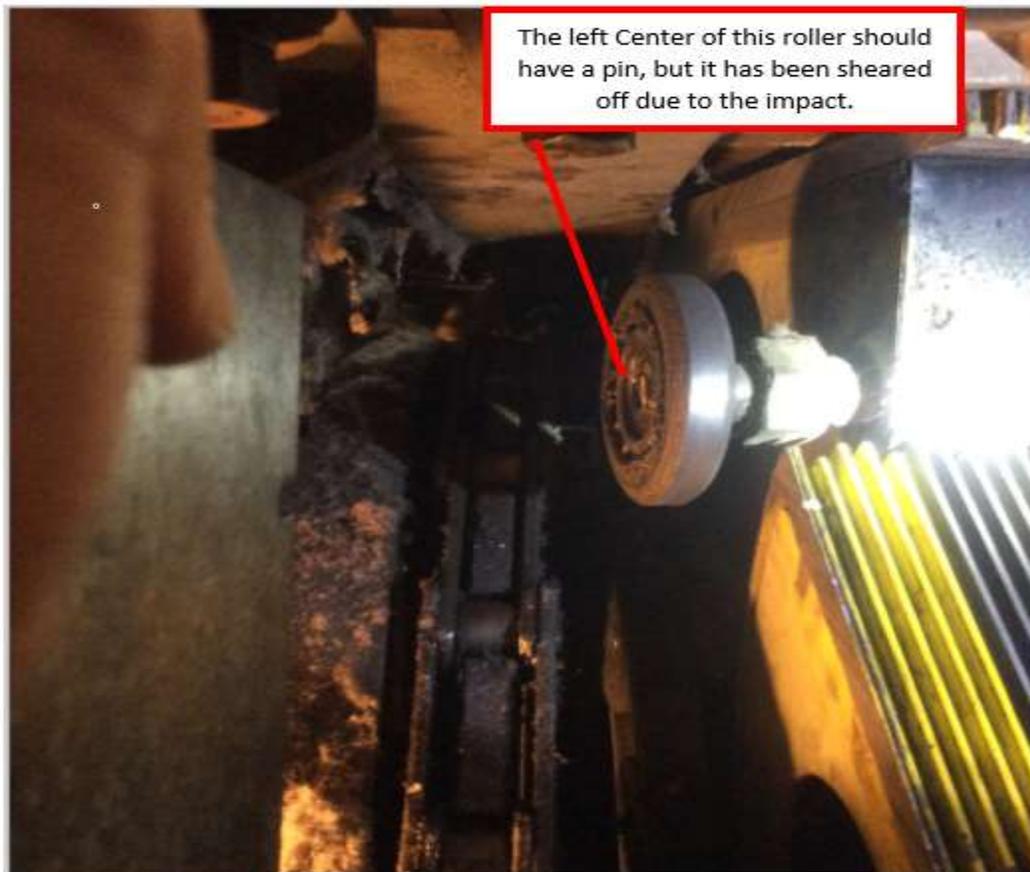
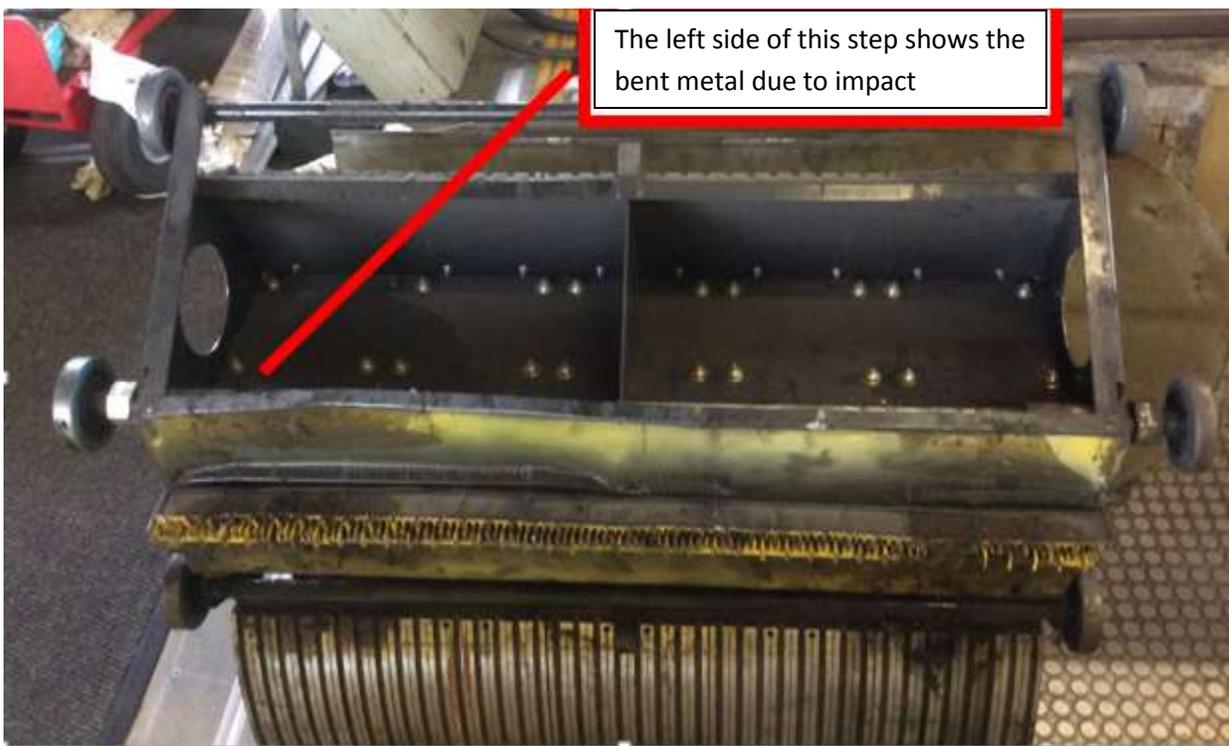
<ul style="list-style-type: none"> • Escalator service personnel on-site • Log books were not available for reviewing at the time of visit. • The escalator was partially disassembled by removing the damaged steps and opening the access floor plates. • Damaged escalator step observed (see attached photos) • During observation of the damage, a bent track was discovered. It was identified that the original position of the track, and the position of the track after the pile up, indicated a difference in the measurements and tolerances. (see bent track picture below) • Differences in tolerances were verified on site during the investigation of the pile up, after unit was opened up. It was visibly noticeable that the tolerances were out. See picture below.
<p>Causes and contributing factors</p>	<p>On opening the unit it was found that the tolerances(measurements) were out. It is probable that the proper measurements of the steps were not maintained due to the infrequency of the maintenance visits. A contributing factor could possibly be the lack of proper examination of the tracks and their tolerances on a more frequent maintenance schedule.</p> <p>However, the frequent usage of the escalator is a contributing factor to this type of degradation of equipment (slight measurement changes and bent track) and it wasn't detected by normal maintenance. The amount of track bend and gap would indicate that frequency, environmental contributors and location of unit were contributing factors to the misalignment.</p>
