Incident Summary #II-1715960-2024 (#46877) (Final)

SUPPORTING INFORMATION	Incident Date	May 29, 2024		
	Location	Salmon Arm		
	Regulated industry sector	Electrical - Low voltage electrical system (30V to 1000V)		
	Impact	Injury	Qty injuries	0
			Injury description	N/A
			Injury rating	None
	Damage	Damage description	Damage description	Interior branch wiring fire damage occurred for exterior neon signage within a commercial establishment damaging minor exterior wall structural, vapour barrier, and insulation.
			Damage rating	Minor
Incident rating	Minor			
Incident overview	<p>At approximately 2:30AM the fire department was called to the location with reports of exterior signage had caught fire. The location had a power outage at this time and is believed to have been related.</p> <p>At the time of the incident the electrical utility provider was dealing with a power outage in the general area that involved a utility pole fire.</p>			
INVESTIGATION CONCLUSIONS	Site, system, and components	The illuminated signage provides a visible means to the business, is typically installed on the store fronts and powered from the electrical panel within the business space. The signage is illumin

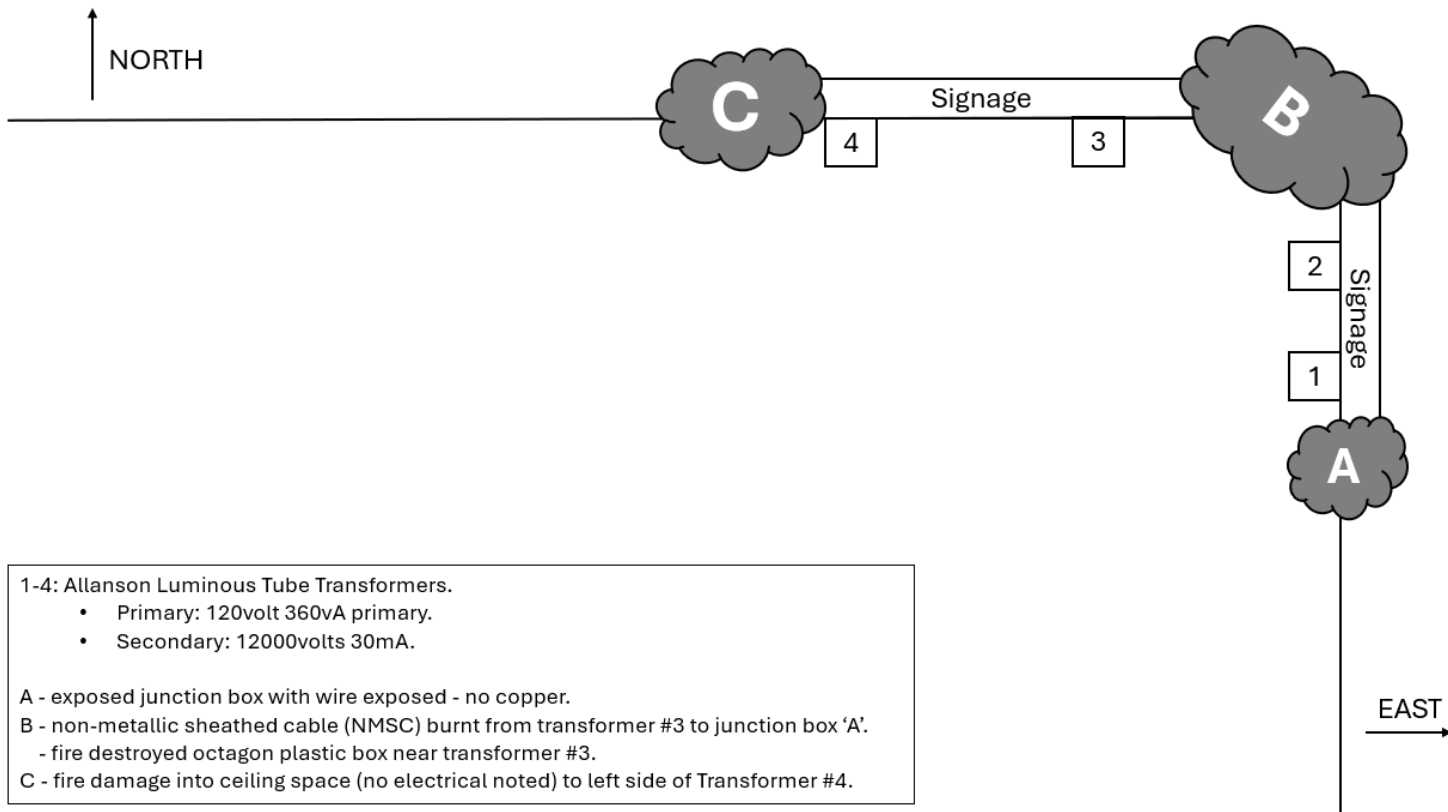
- The fire spread to approx. 16 roof trusses above T-bar ceiling space along the north side of the store where the vapour barrier then caught fire, melted and discoloured/ burnt the ends of trusses.
- There were 3 main areas being noted having additional fire damage to structural wood: first most damage area is located at and above transformer ballast #4, the second at the corner wall between ballasts #2 and #3 and at last junction box #2 beside ballast #1 (as per drawing below).

- It was noted a 3 conductor #12awg non-metallic sheath cable was burnt with all exterior sheathing and conductor insulation consumed for approx. 6 to 8'+ in length from junction box #1 beside ballast #4 over a round corner towards transformer ballast #2 (as per drawing below).

Image 1 – Identification of incident damage.

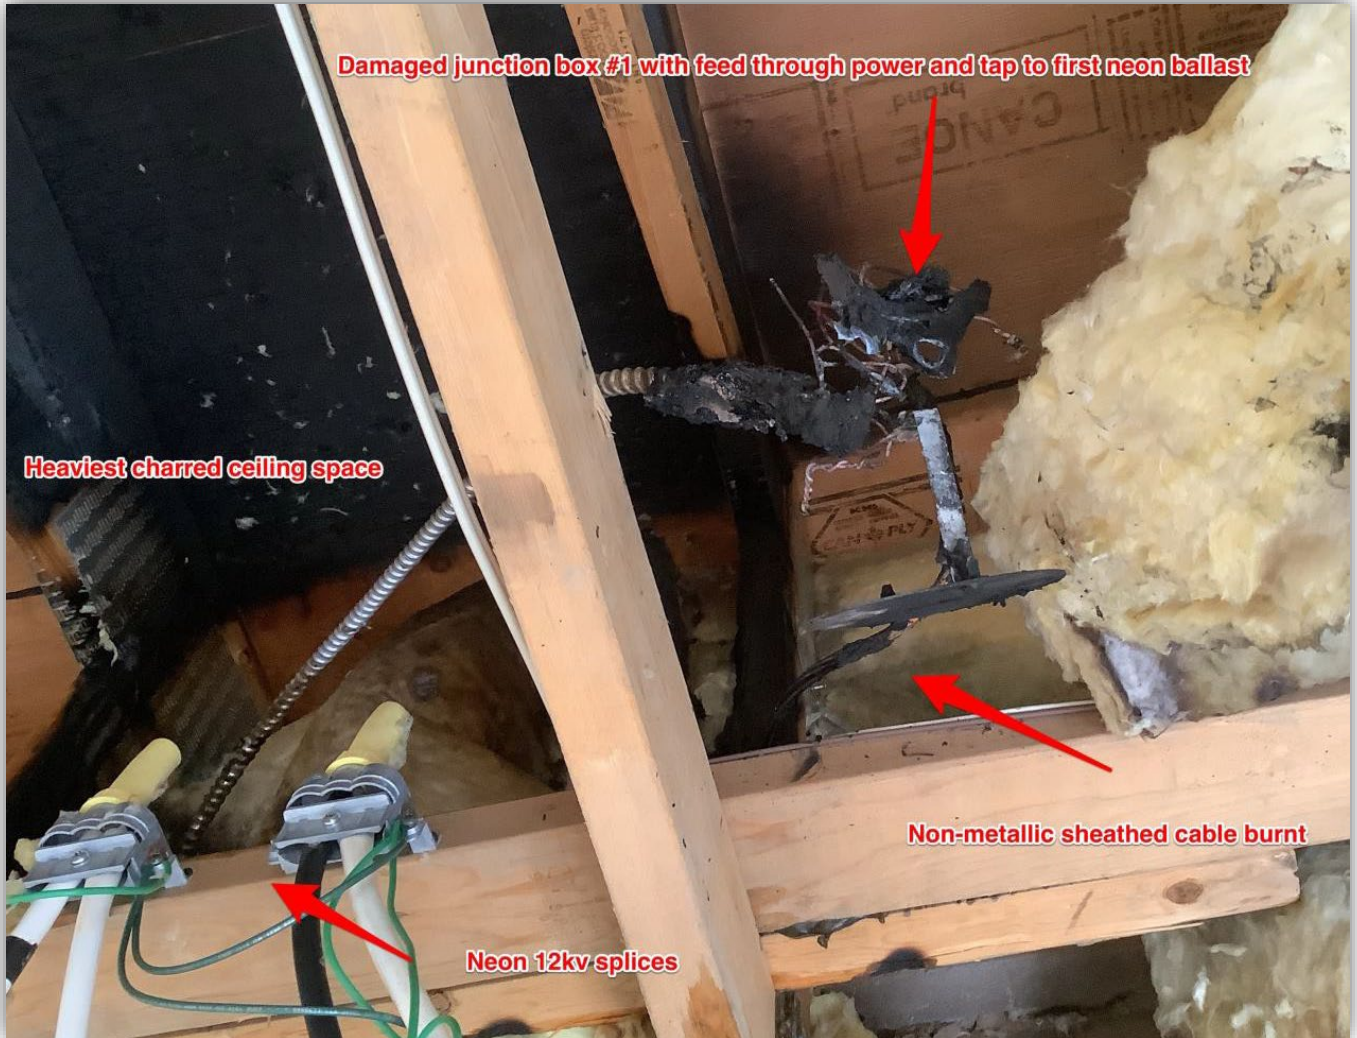
Image 2 - Damaged area.

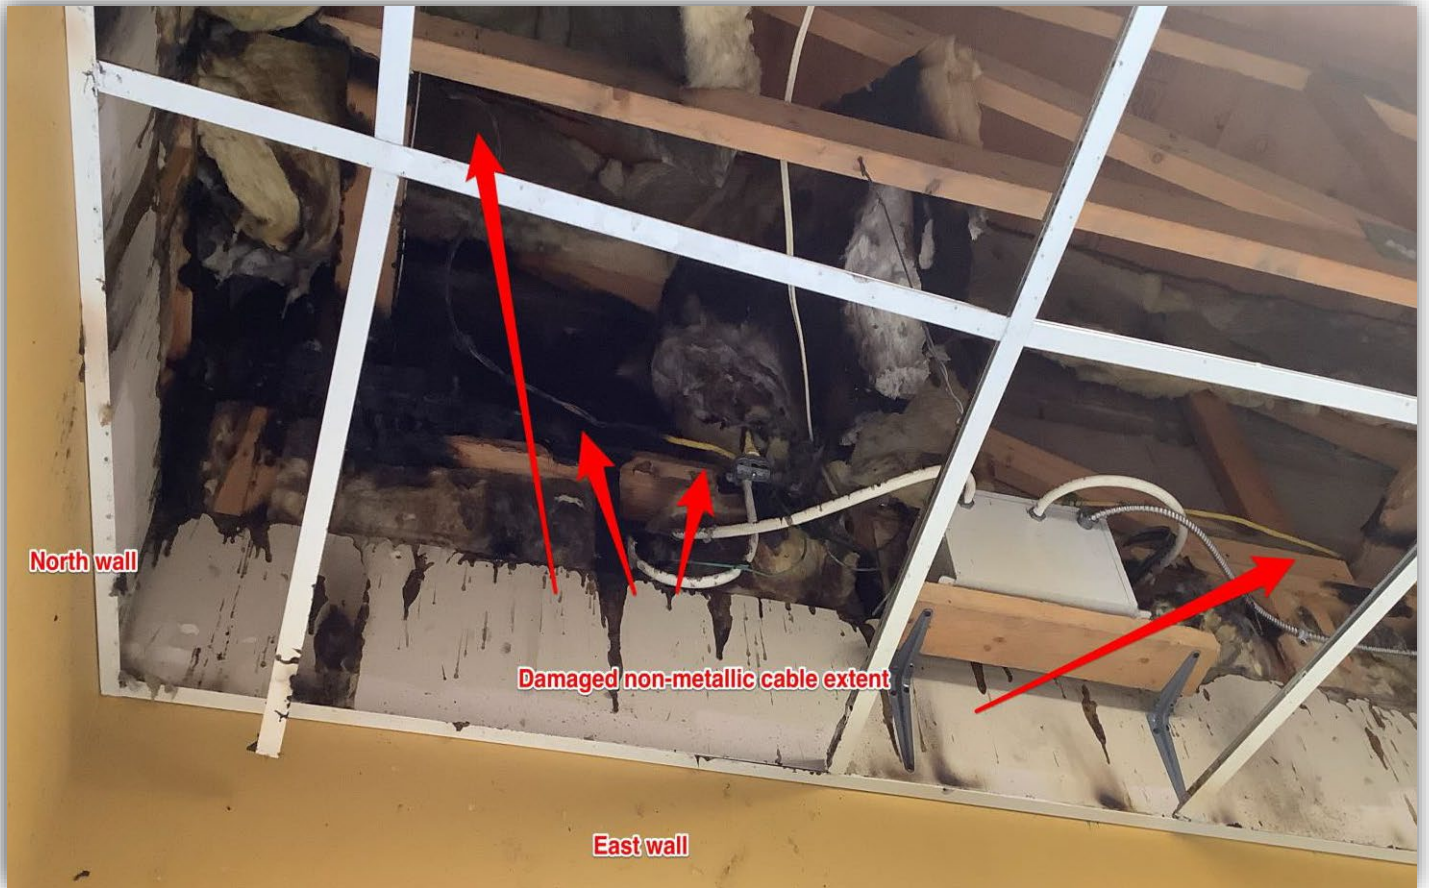
- Additionally, junction box located beside ballast #1 on east wall that shows signs of burning and a missing junction box cover as wires/ wire connectors were noted sticking out of box in free air with heat damage.

Image 3 - East wall.

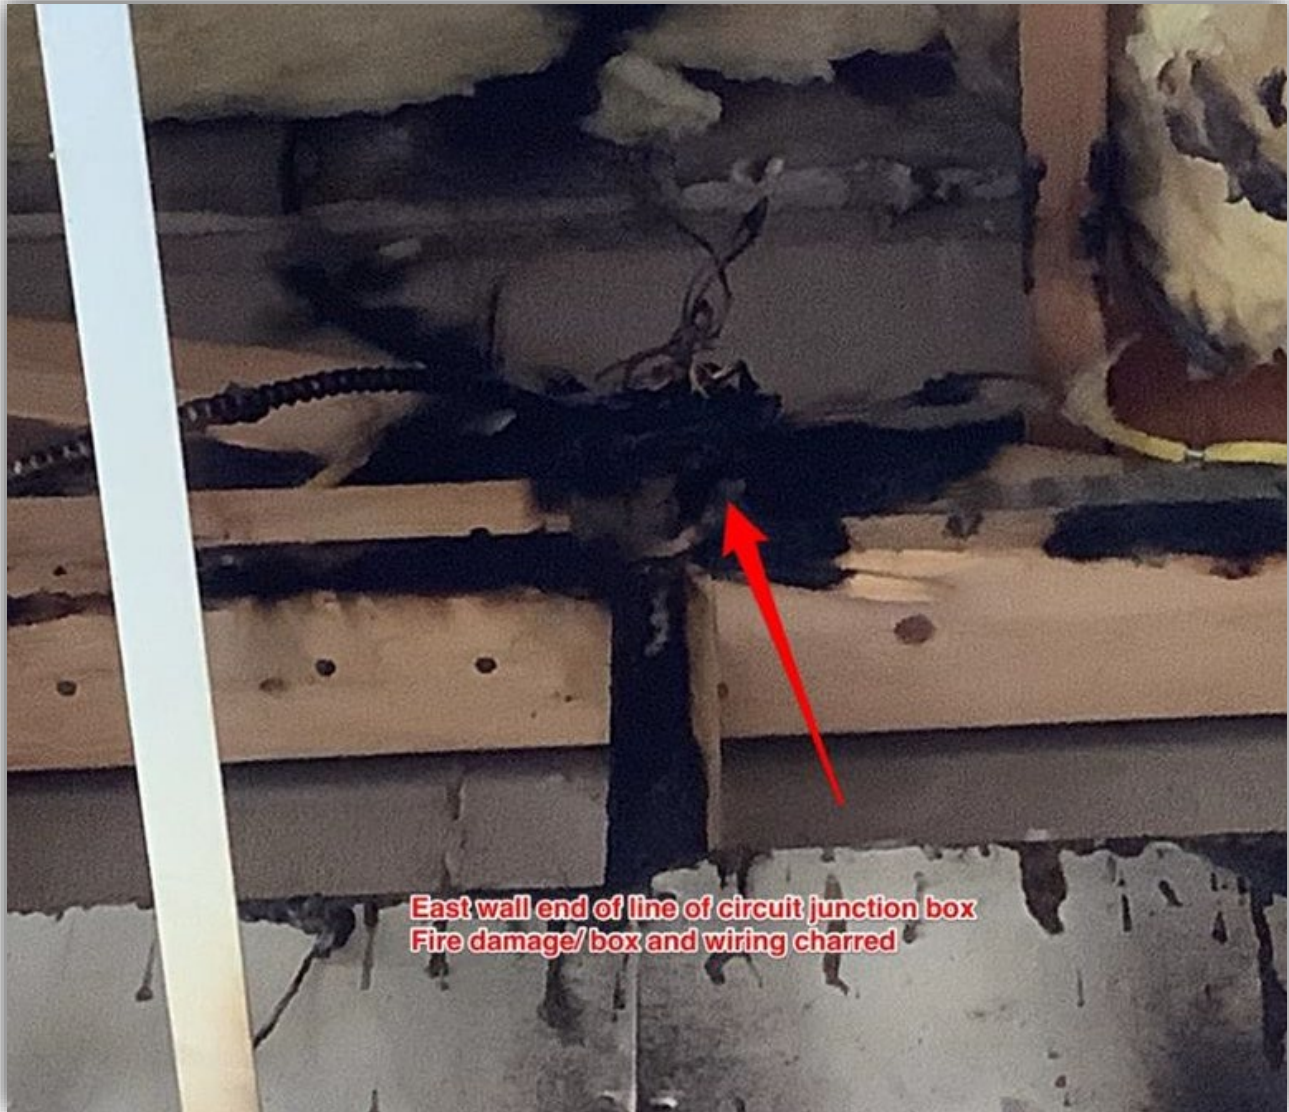
- Junction box beside transformer ballast #4 was completely destroyed/ burnt with no evidence of the box or cover plate remaining and all conductors burnt away from the box.

It is possible the voltage surge from the utility may have created a fault condition at both junction boxes where the splicing was located above the ceiling space during operation causing arcing and shorting. The junction box beside ballast #4 is the first in the circuit in the area with most fire damage and ignited the wall with flames rising into the truss space and plywood roofing.

Image 4 – Damaged junction box.
