## Incident Summary #II-1382708-2022 (#28074) (FINAL)

SUPPORTING INFORMATION	Incident Date	May 26, 2022	
	Location	Kamloops, BC	
	Regulated industry sector	Electrical - High voltage electrical system (greater than 750V)	
	Impact	Qty injuries	1
		Injury description	A worker sustained 1st/2nd degree burns to their hand, arm, and hip.
		Injury rating	Moderate
	Damage	Damage description	N/A
		Damage rating	None
	Incident rating	Moderate	
	Incident overview	<p>Electricians were performing routine, annual maintenance on a High Voltage transformer.</p> <p>Upon completion of transformer maintenance and prior to closing all the equipment and re-energizing the system, the crew foreman (worker) wanted evidence of good operating condition of the load break switch knives.</p> <p>The top section of the live end of the load break switch was removed and the worker reached into the equipment with a camera. While reaching in, the live system arced over to the worker and entered the workers left hand.</p>

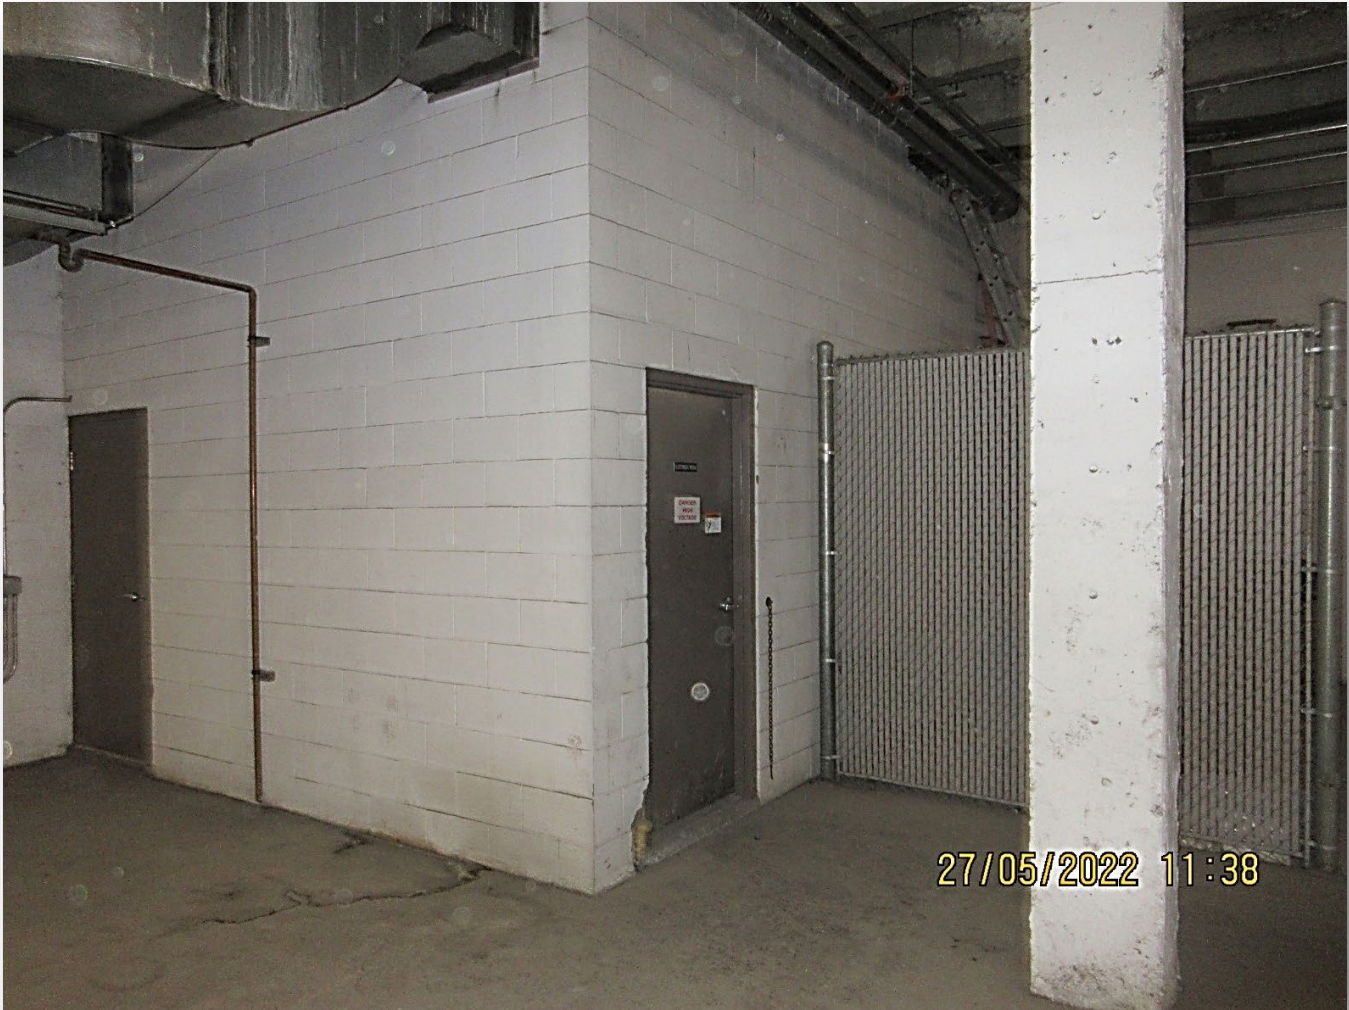
INVESTIGATION CONCLUSIONS	Site, system and components	<p>Electrical room housing the Electrical Vault unit found within the building parkade - (<a href="#">Photo 1</a>).</p> <p>Electrical Vault unit - (<a href="#">Photo 2</a>)</p> <ul style="list-style-type: none"> <li>- 12.5Kv Load break switch.</li> <li>- 1000Kva Dry type Transformer.</li> <li>- 600Volt Main Distribution center.</li> </ul> <p>12.5Kv Load break switch - (<a href="#">Photo 3</a>).</p> <p>The switch has 2 sections (<a href="#">Photo 3</a>). The lower section is the switch service compartment. The upper section is the “live” supply where the knives of switch reside when main switch is in the opened position.</p> <p>The utility supplies 12,500volts (12.5kv) underground from the utility supply distribution system. This enters the vault (<a href="#">Photo 2</a>) from the underground rear side of the enclosure and terminates to the supply side of the load break switch (<a href="#">Photo 3</a>) at the top.</p> <p>The electricity flows from the switch to the 1000kva transformer where the power transforms from 12.5kv down to 600volts for distribution to dedicated consumer retail units.</p>

**Photo 1** – Electrical room as seen from the parkade area.

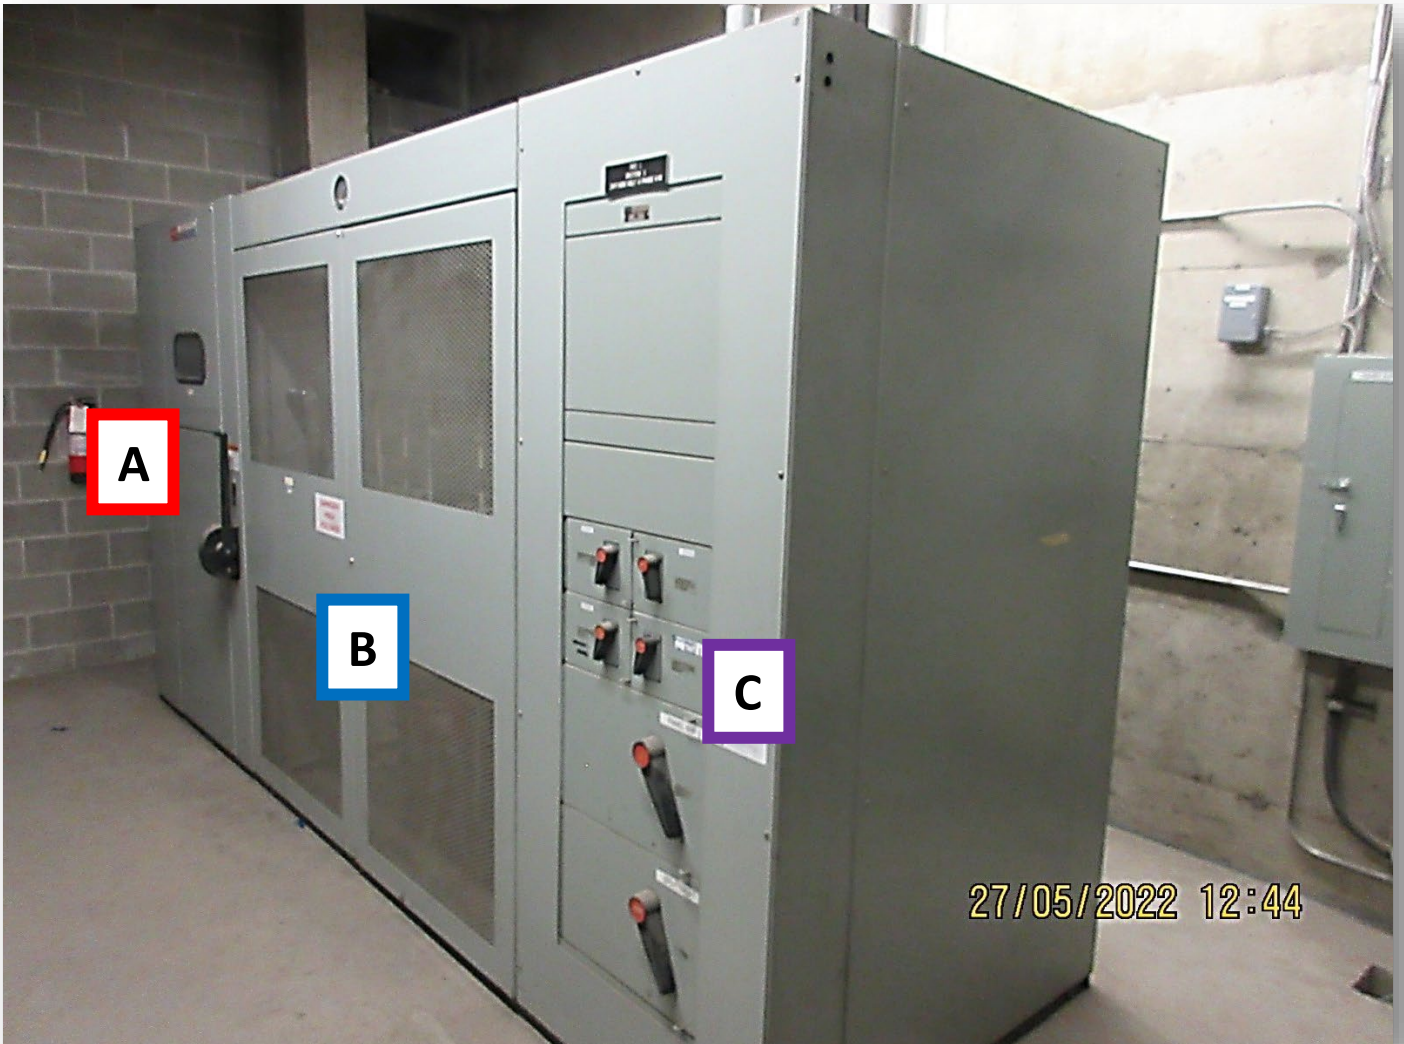
<p>This 600volt main distribution center is also viewed in <a href="#">(Photo 2)</a>.</p>
<p>Failure scenario(s)</p>	<p>Three on-site electricians set up for a night shift power shut down and servicing / cleaning protocol. (1x Foreman = Worker 1 and 2x electricians = Workers 2,3).</p> <p>The crew was set up and equipped with all required PPE and safe-work procedures in place.</p> <p>Once the scope of work was completed, (removal of the temporary grounding from the transformer, bolting the transformer back together and then removing of the kirk key and returning the key to its load break switch location). Worker 1 removed their PPE.</p> <p>Worker 1 then decided to view the knives on the load break switch where they noticed discoloration in the energized portion of the switch and decided to open the cabinet door to investigate.</p> <p>Worker 1 stated confidence (very comfortable in the surroundings) and was aware that the switch section was in the de- energized position.</p> <p>Worker 1 then proceeded to reach in front of the knives on the load break switch with a smart phone in hand to take photos of the decolorization that was present on the knives. The worker's left hand came in proximity to the exposed and energized buss bar, where the system then arced over to their left hand, travelled up their forearm then down the left side to their hip. Due to the left hip resting on the grounded door through the worker's left hip acted more as a flash over then electrocution.</p> <p>This resulted in 1<sup>st</sup> and 2<sup>nd</sup> degree burns.</p>

**Photo 2** – Inside the electrical room/vault.

- A. 12KV Load-break switch.
- B. 1000KVA transformer.
- C. 600volt Main Distribution Center.

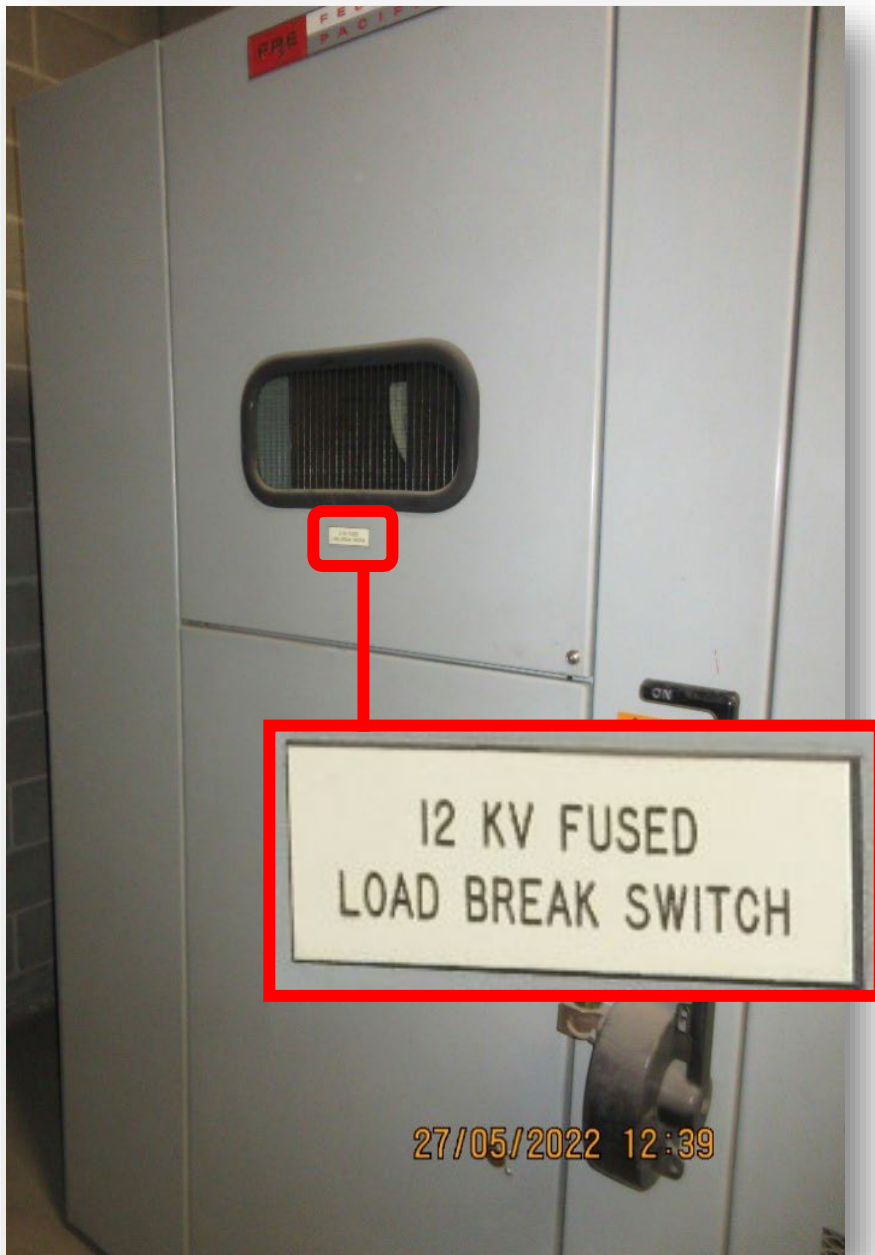
**Photo 3** – 12KV Load-break switch compartment.
