Incident Summary #II-1288074-2021 (#25071) (FINAL)

SUPPORTING INFORMATION	Incident Date		November 18, 2021
	Location		Comox
	Regulated industry sector		Gas - Natural gas system
	Impact Injury	Qty injuries	28
		Injury description	One moderate injury requiring hospitalization and up to 27 additional injuries all ranging from minor to moderate resulting from a natural gas explosion.
		Injury rating	Moderate
	Damage	Damage description	Explosion damage to a military barracks building, including blown out walls, roof, windows and a partially collapsed second story floor.
		Damage rating	Severe
	Incident rating		Severe
Incident overview		An exposed underground gas line was struck by an excavator while installing new perimeter drain around an occupied military barracks building under exterior renovation. The escaping gas from the damaged gas line migrated into the building through building openings and contacted a source of ignition resulting in a large explosion.

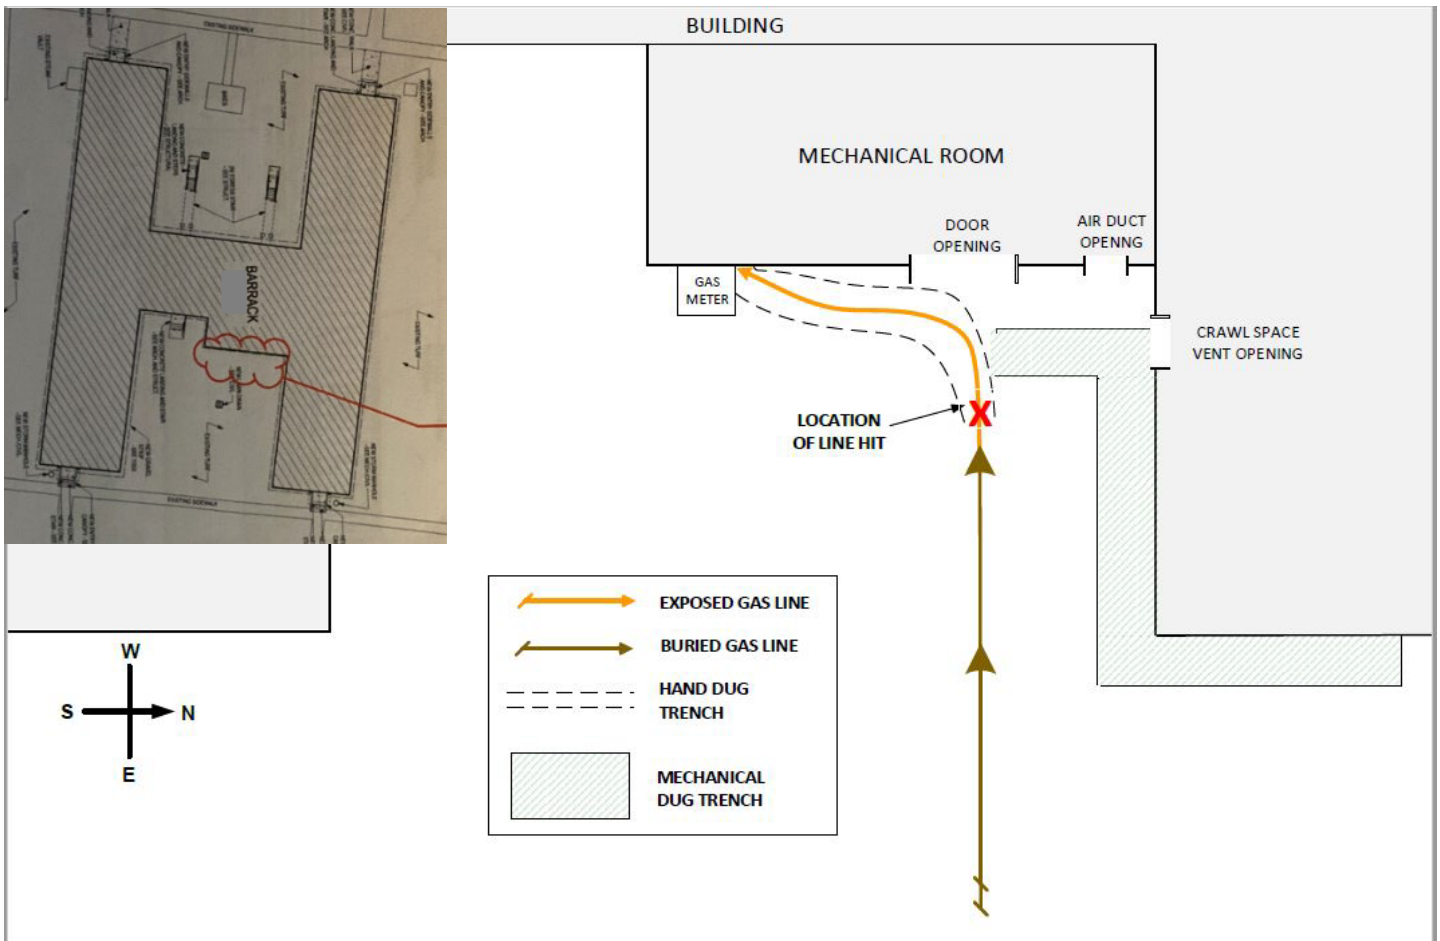
INVESTIGATION CONCLUSIONS	Site, system and components		<p>The building is a two-level multi-unit residence used for housing personnel. The building is structured in the shape of an “H” with individual rooms along the ends and common areas in the connecting middle section (Diagram 1). The design creates areas on the East and West sides surrounded by three two story walls and open on one end. The structure is built on a 4-foot-deep crawl space with passive ventilation openings into the crawl space located around the entire structure. The East side of the building has an attached mechanical room with a double access door facing the outside. The mechanical room houses equipment including a gas fired water heater, hallway pressurization and ventilation air handling unit and air compressors along with electrically operated components such as pumps, switches, and controls.</p> <p>Contractors working at the site are required to review and sign a construction contract that stipulates they and their subcontractors must comply to all provincial and municipal regulations.</p> <p>The building had a natural gas supply from the gas utility. A ¾ inch diameter polyethylene gas line was run underground approximately 40 feet away from a main distribution line to a gas meter located on the East side of the building outside the mechanical room. The supply pressure in the line up to the meter was 80 pounds per square inch (PSI).</p> <p>Medium density polyethylene underground gas line is manufactured yellow which provides increased visibility while exposed and identifies it as containing combustible gas.</p>

Diagram 1 - Location of gas pipe hit in relation to the building and building openings.

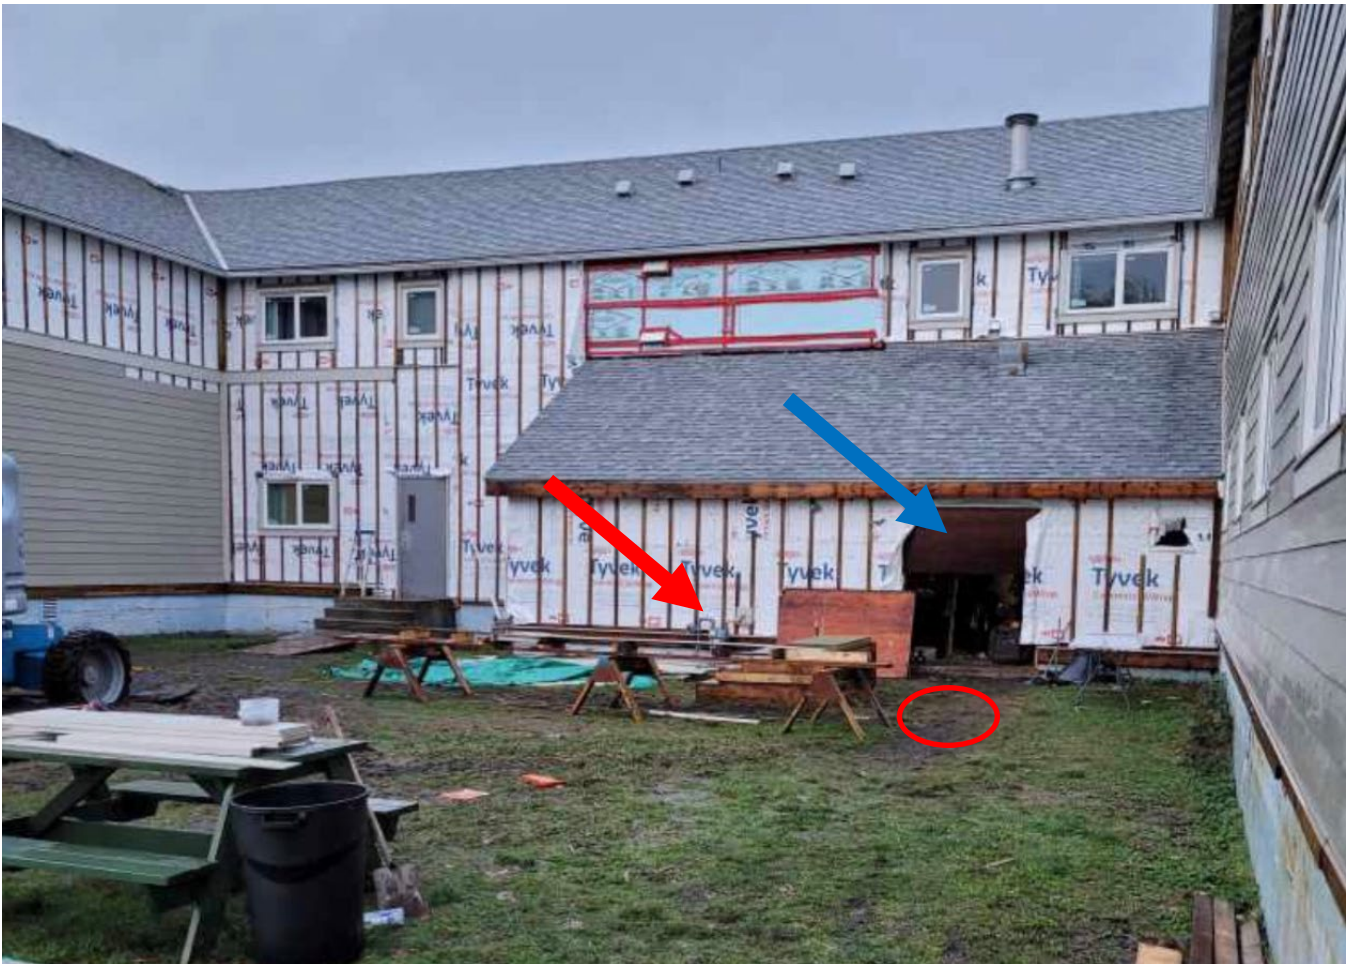
Image 1 – East side of building prior to incident. Red arrow indicates location of gas meter. Blue arrow indicates the mechanical room door opening with door removed. Red oval indicates location of gas pipe strike.

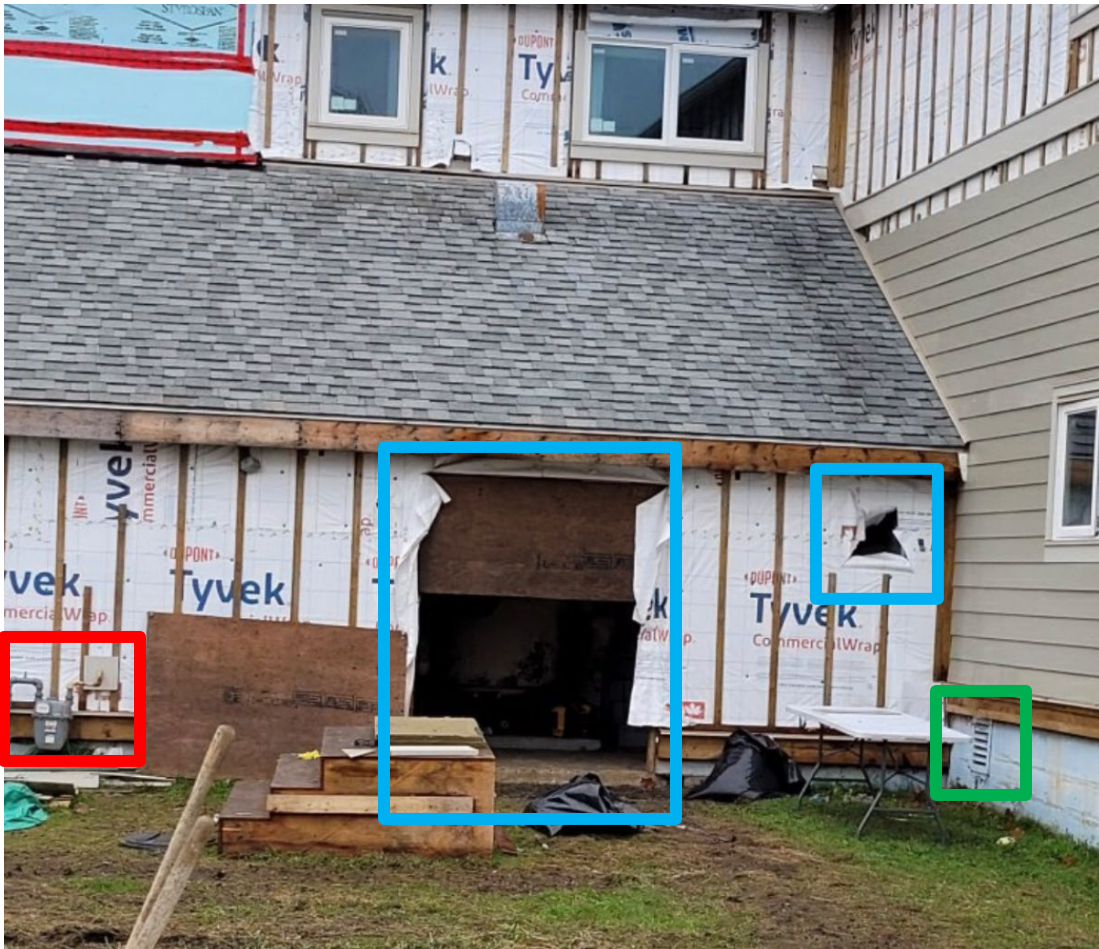
Image 2 – Mechanical room entrance prior to excavation and explosion. Redbox shows location of gas meter, blue boxes show the mechanical room doorway with door removed and an opening for the combustion air duct for the water heater, green box shows passive ventilation into the building crawlspace.

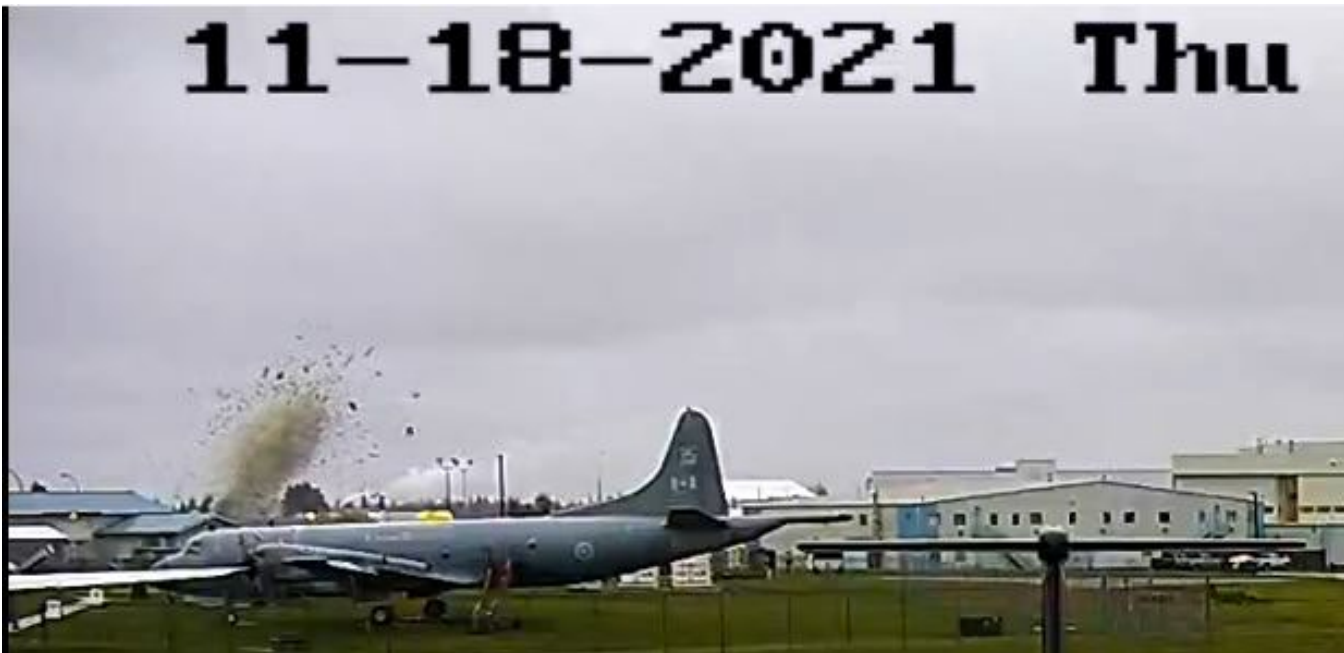
Image 3 – Still shot taken from airport surveillance video showing blast and debris.

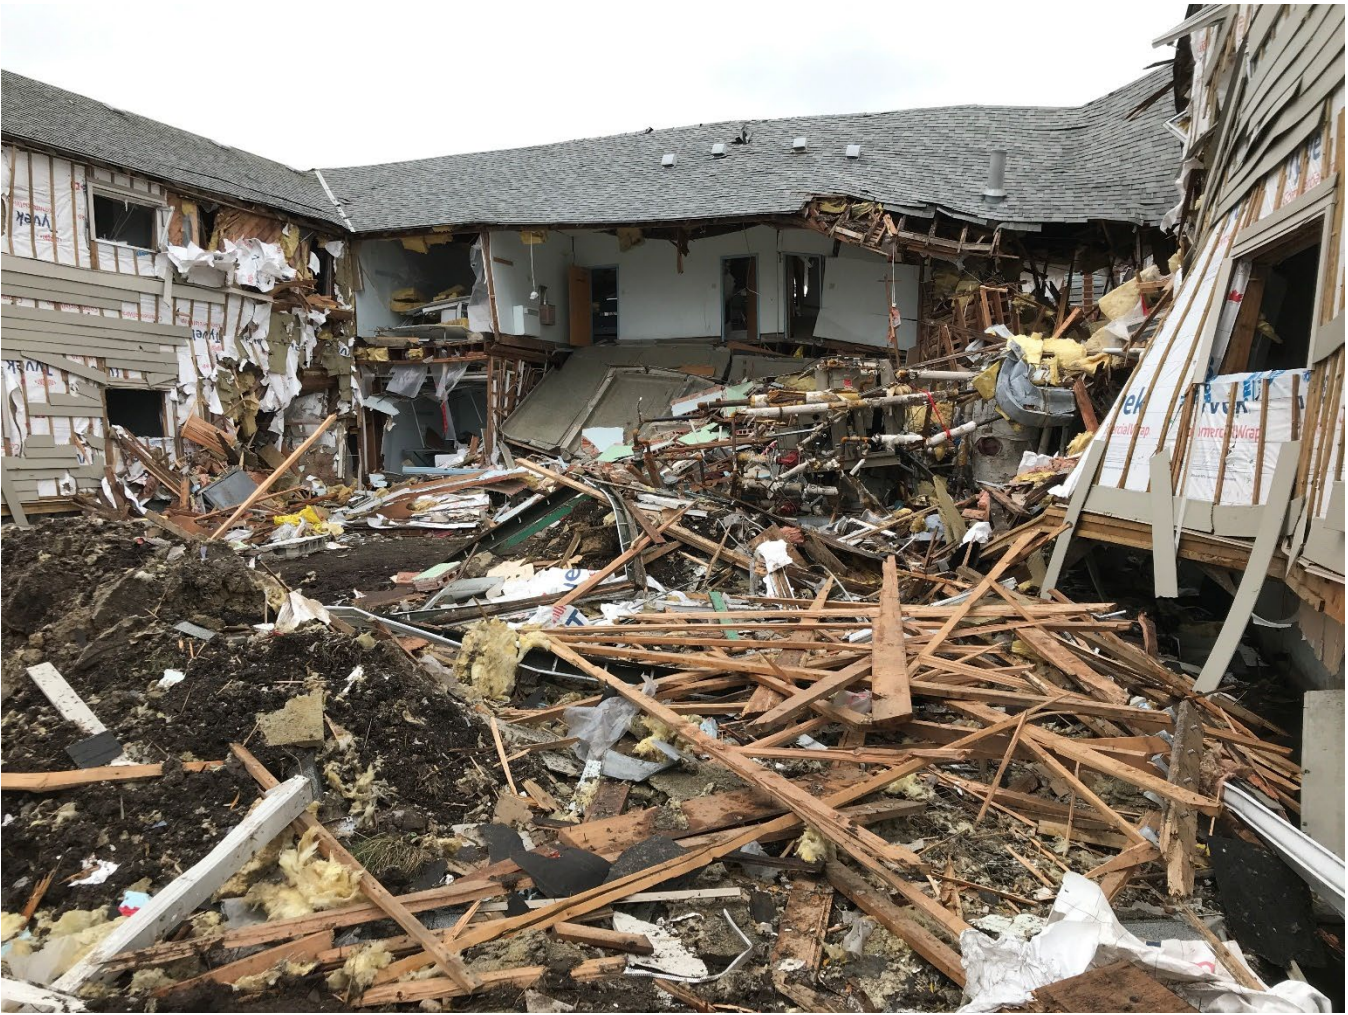
Image 4 – East side of building after the incident.

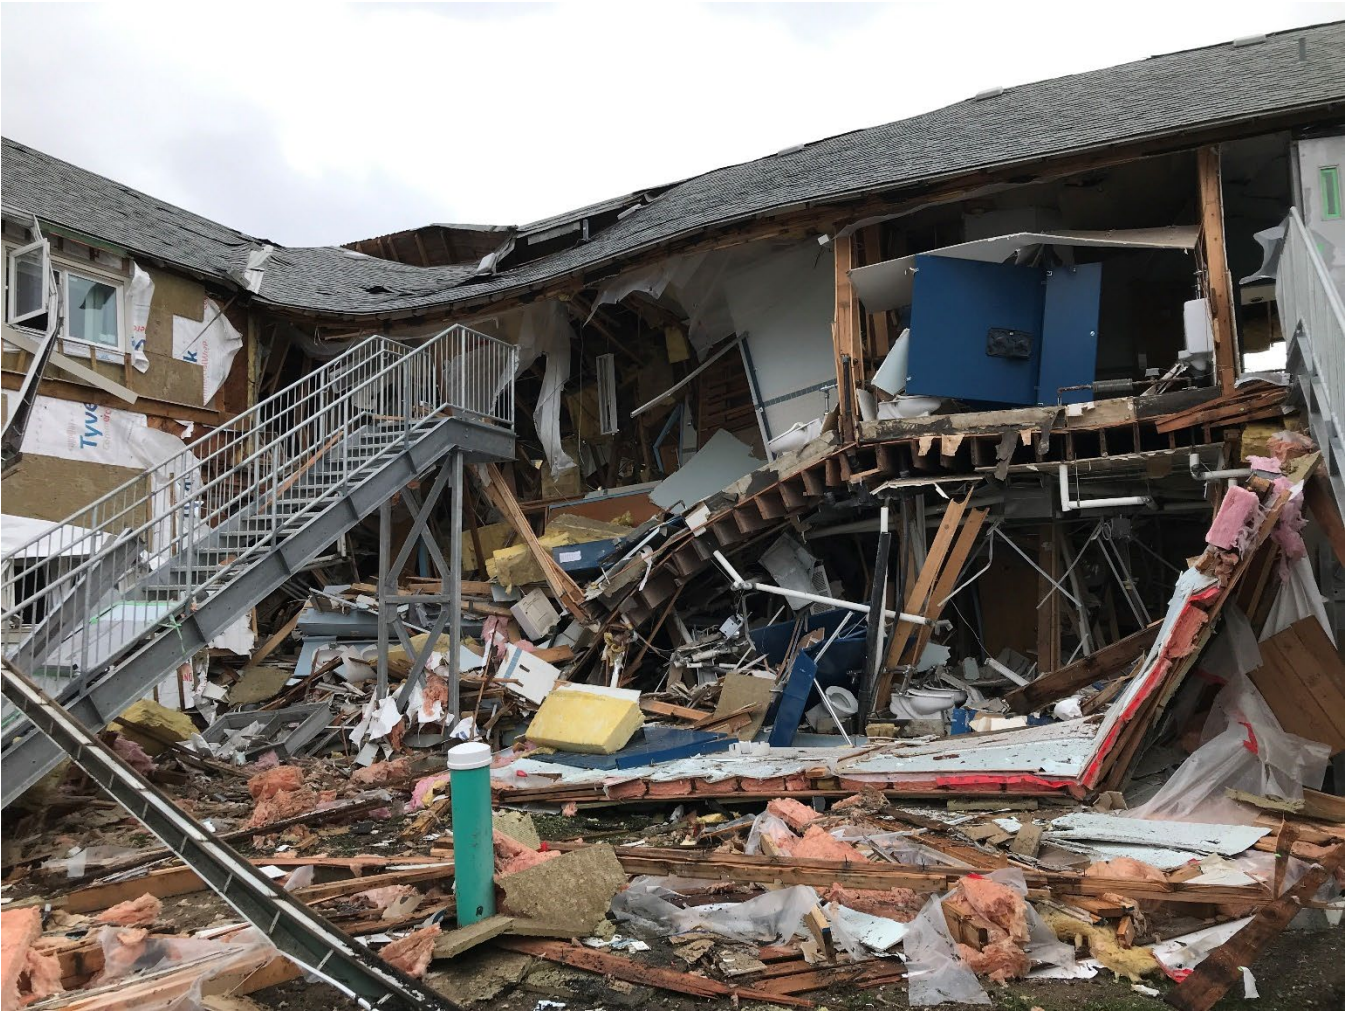
Image 5 – West side of building after the incident.

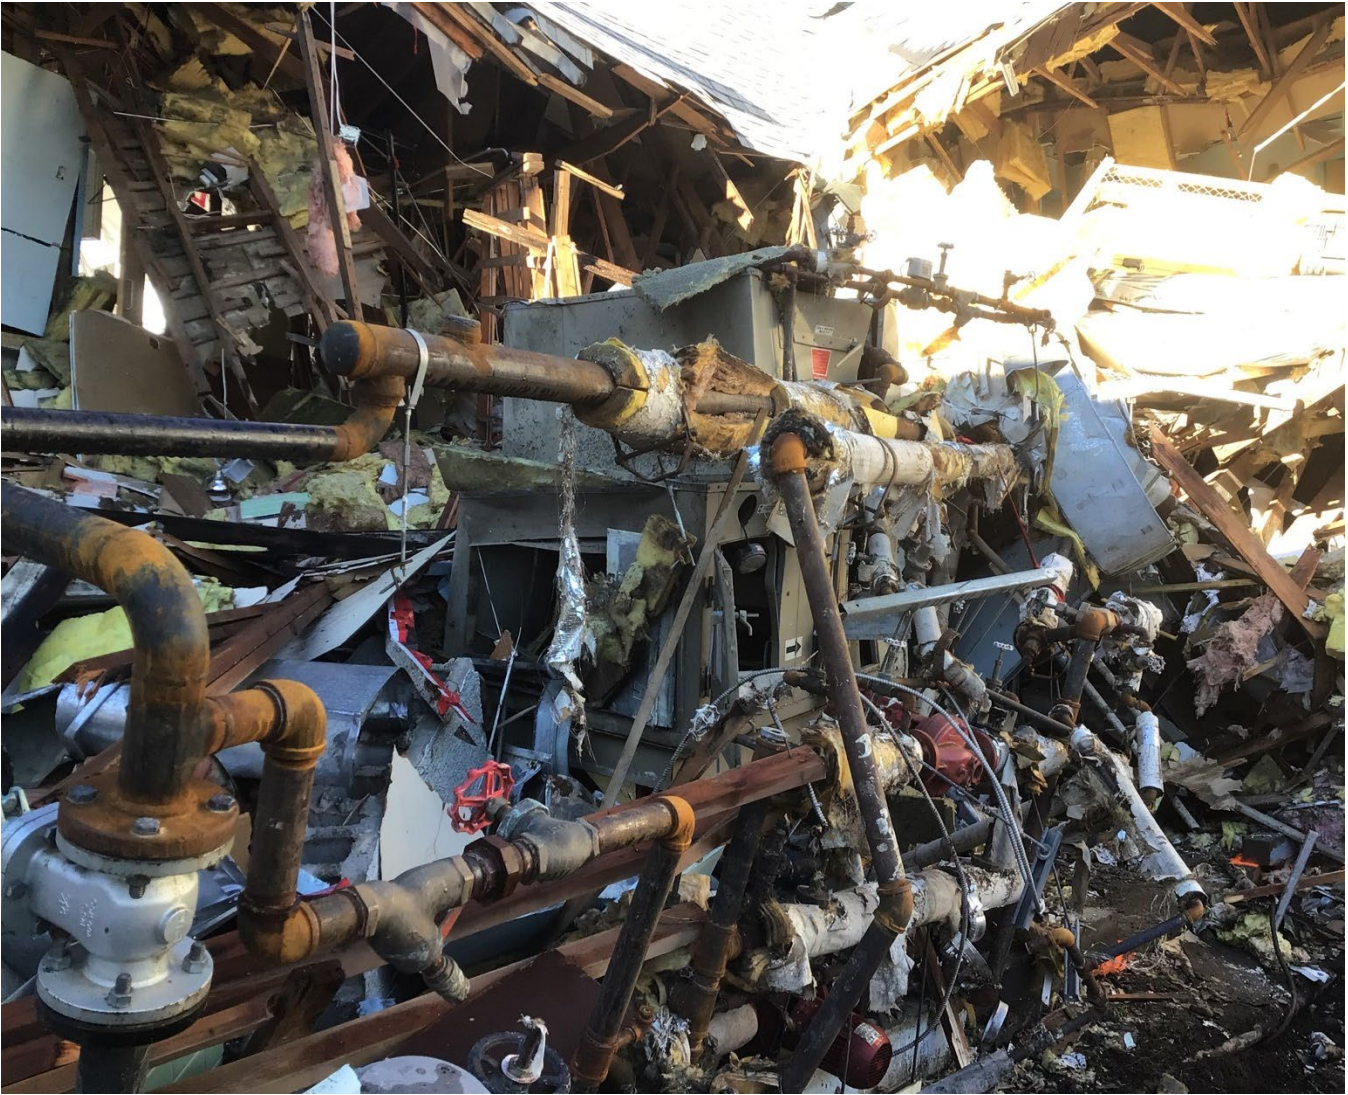
Image 6 – Mechanical room piping and equipment after the incident.

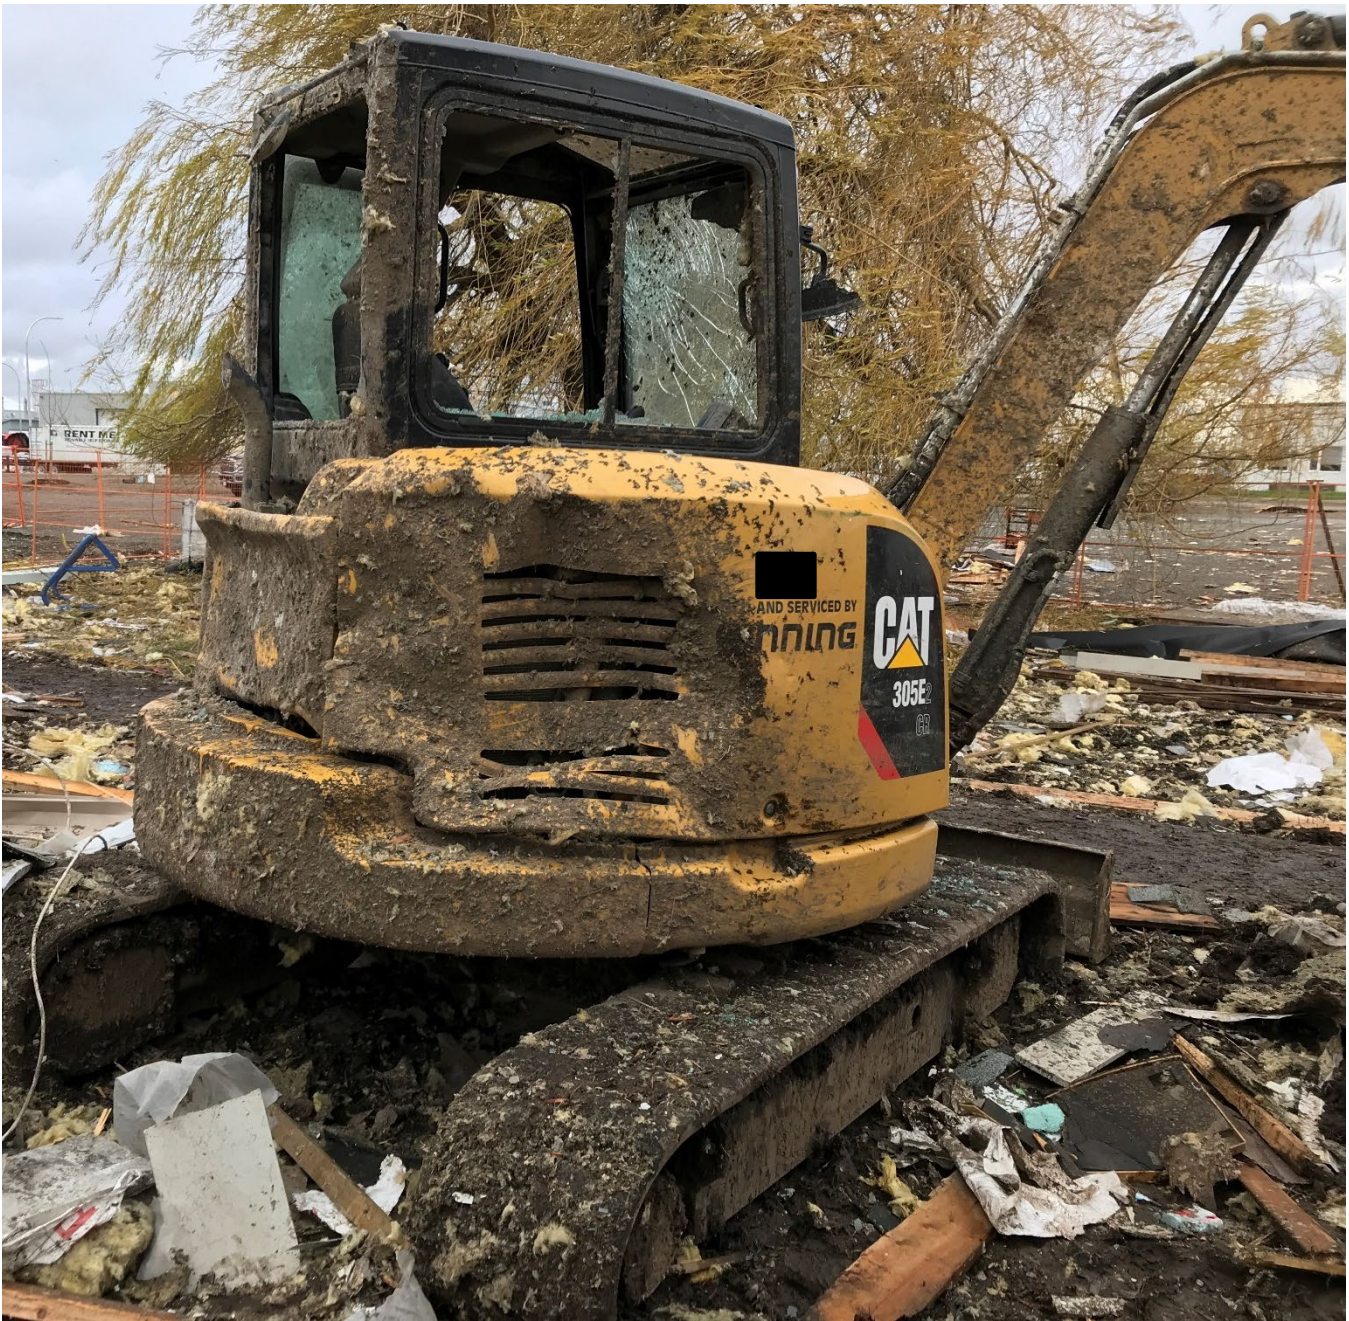
Image 7 – Excavator damage from the blast and flying debris from the explosion.

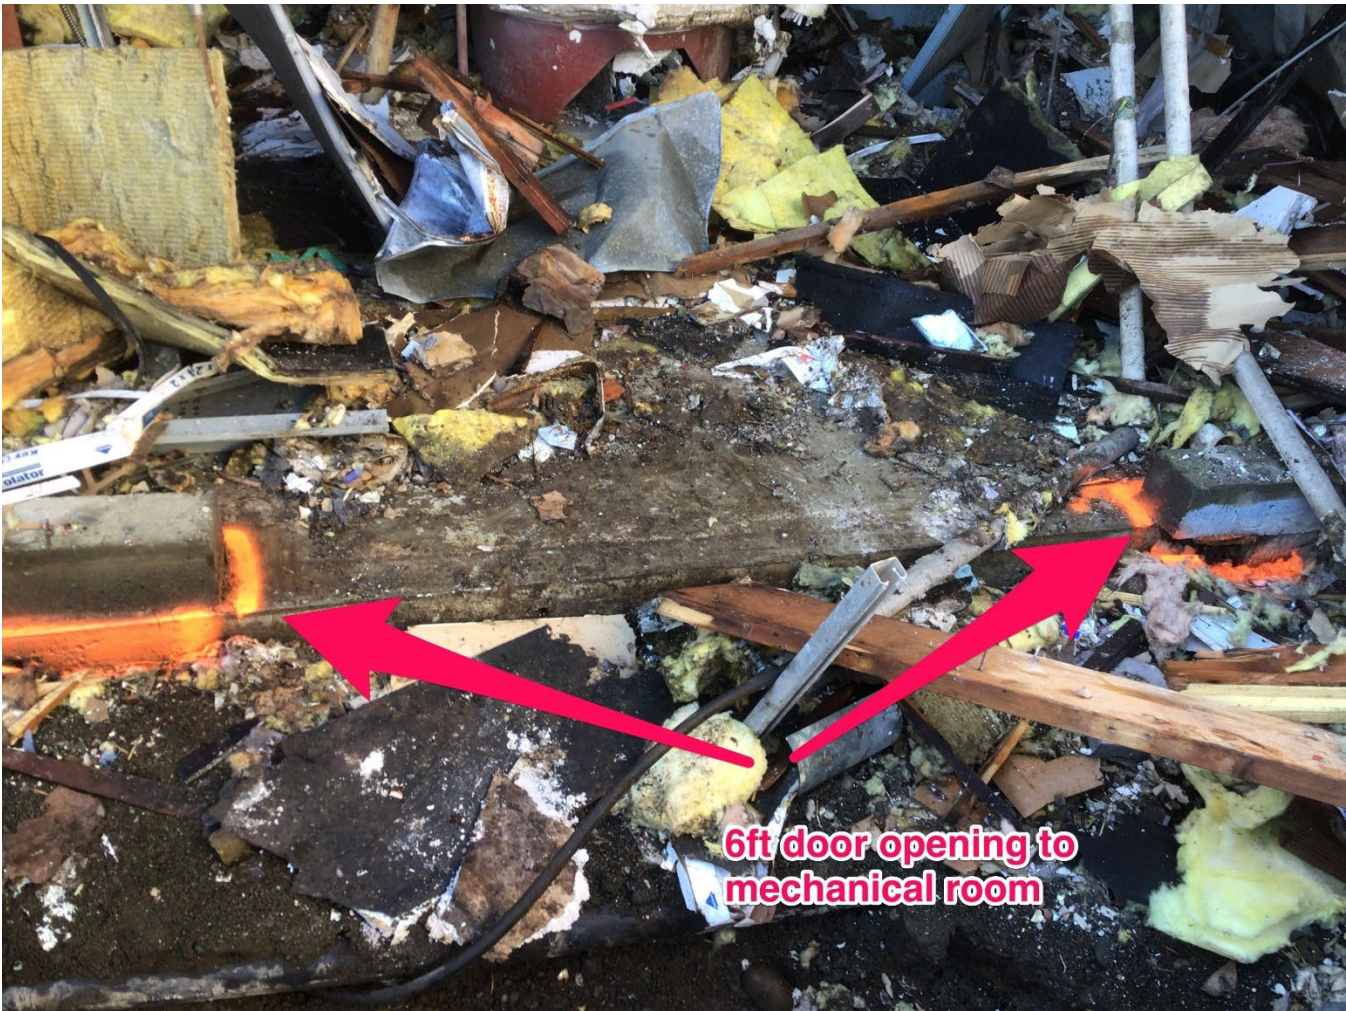
Image 8 -Opening to mechanical room with orange paint marking the edges of the doorway that was not installed at the time of the explosion.

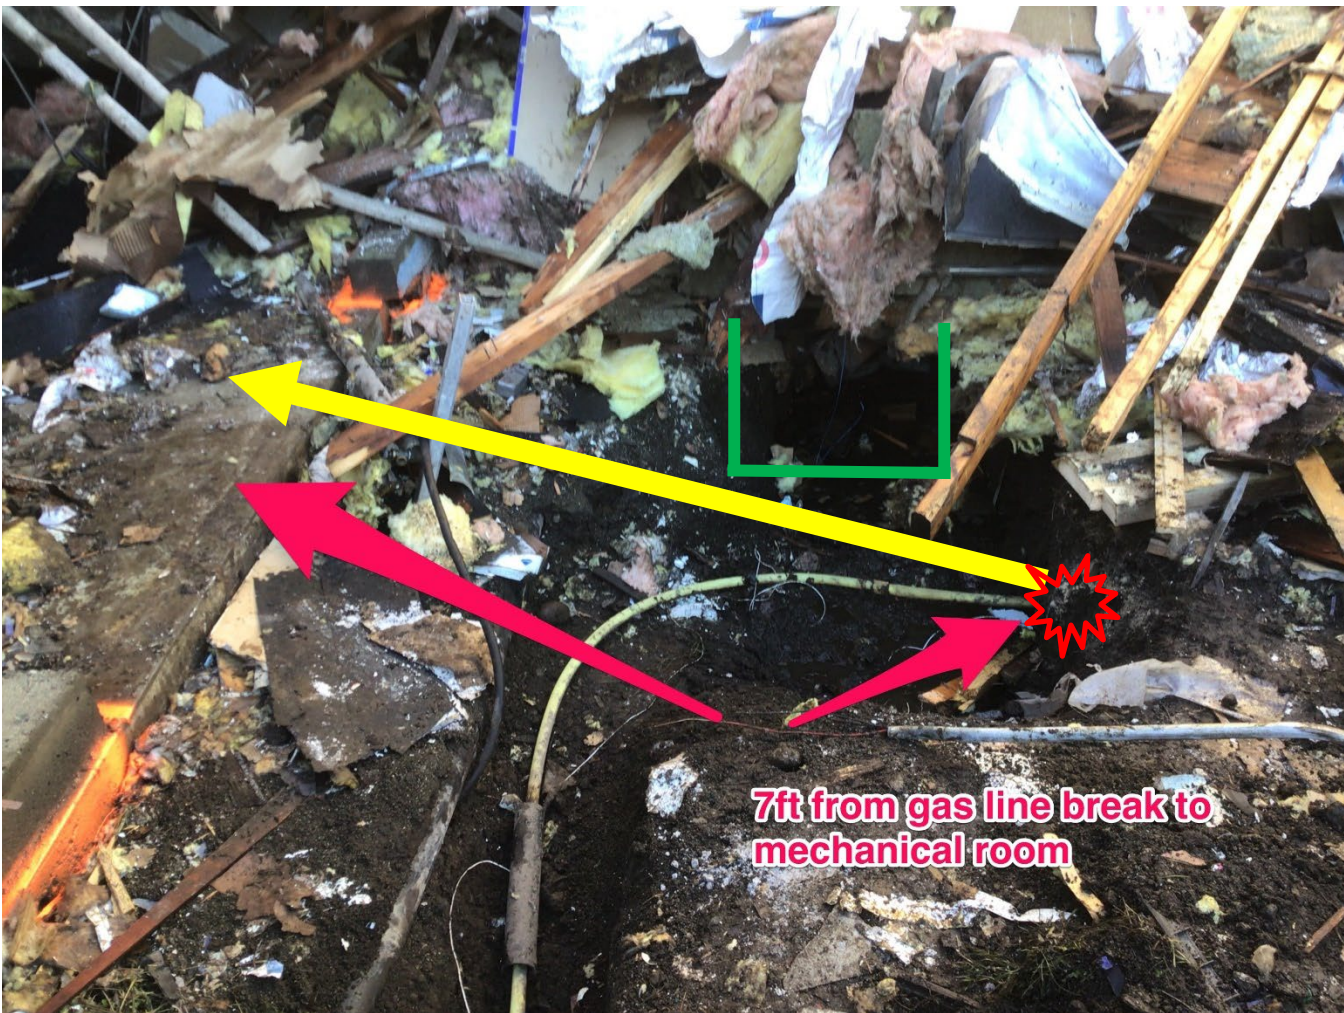
<p>Causes and contributing factors</p>	<p>The explosion was caused by the excavator hitting the exposed gas line.</p> <p>The gas line in the vicinity of the excavation work had been located, identified, and exposed by hand. The hazard of hitting the line with the excavator had been identified by the contractor who developed a plan and communicated to employees to keep mechanical excavation over one meter away from the line.</p> <p>Contributing factors that could be considered dangerous manners of excavation work include:</p> <ul style="list-style-type: none"> • Working in close proximity to an exposed and unprotected gas line with a mechanical excavator. • Working in close proximity to an unprotected gas line without a spotter. • Misunderstanding of explosion risks when working near live gas lines. • Not moderating excavation practices when increased risk of explosion hazards are present such as occupied buildings, building openings and ignition sources.

Image 9 – The gas pipe laid back in the hand dug trench after the incident. The red arrows indicate the pipe break 7 feet away and centered to the mechanical room doorway opening. The green lines indicate the location of the mechanically dug trench. The yellow arrow indicates the direction of gas flow from the broken pipe towards the mechanical room door opening. The red symbol indicates the location of the gas pipe strike.

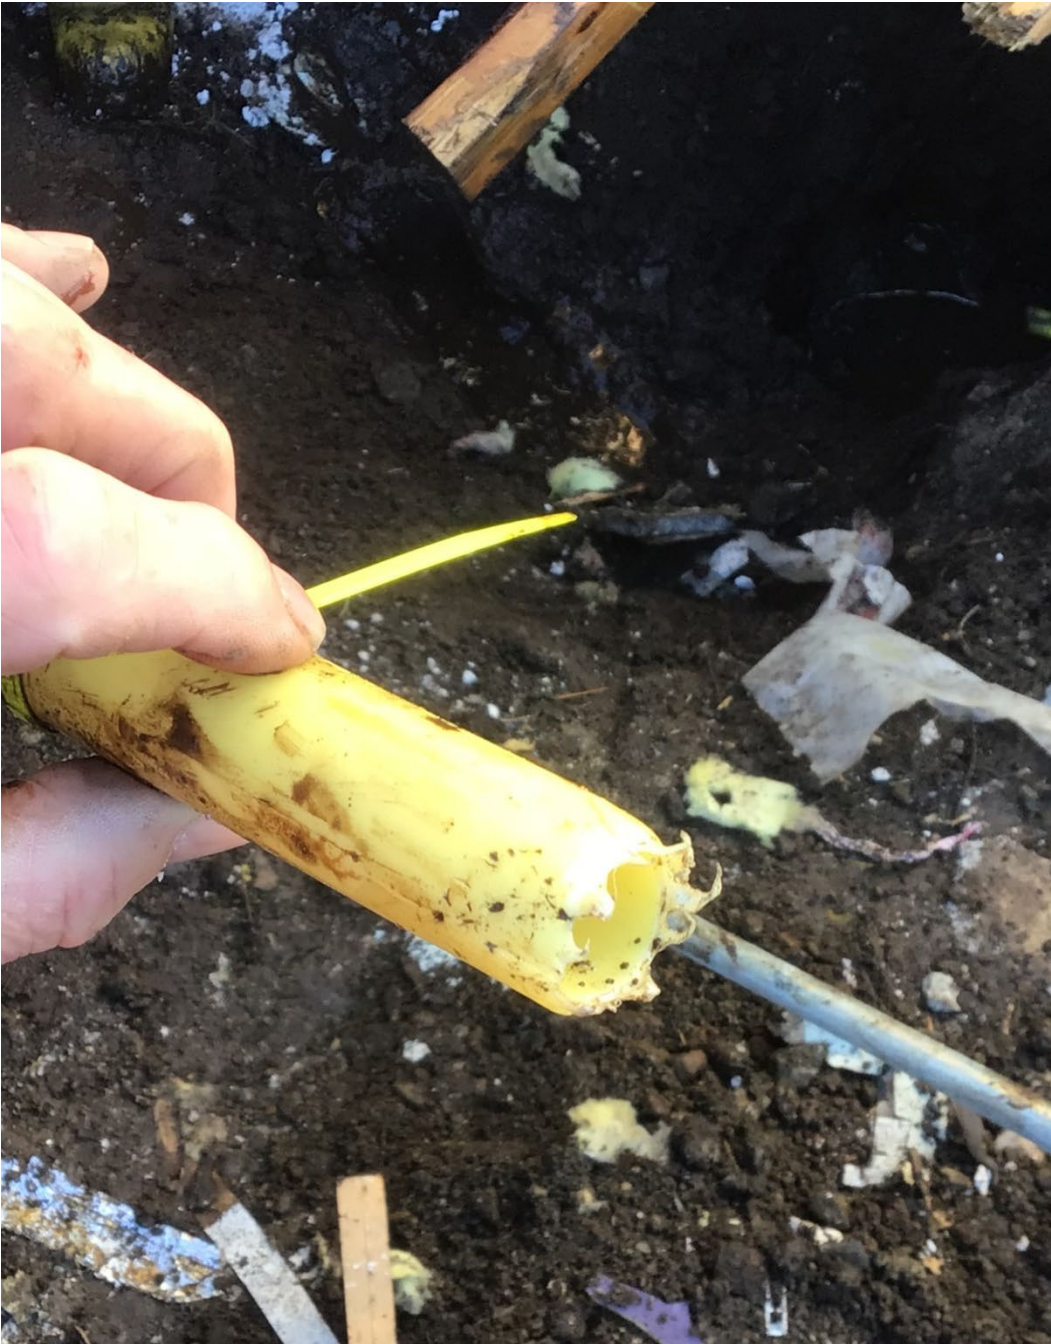
Image 10 – Close image of the severed end of gas pipe.

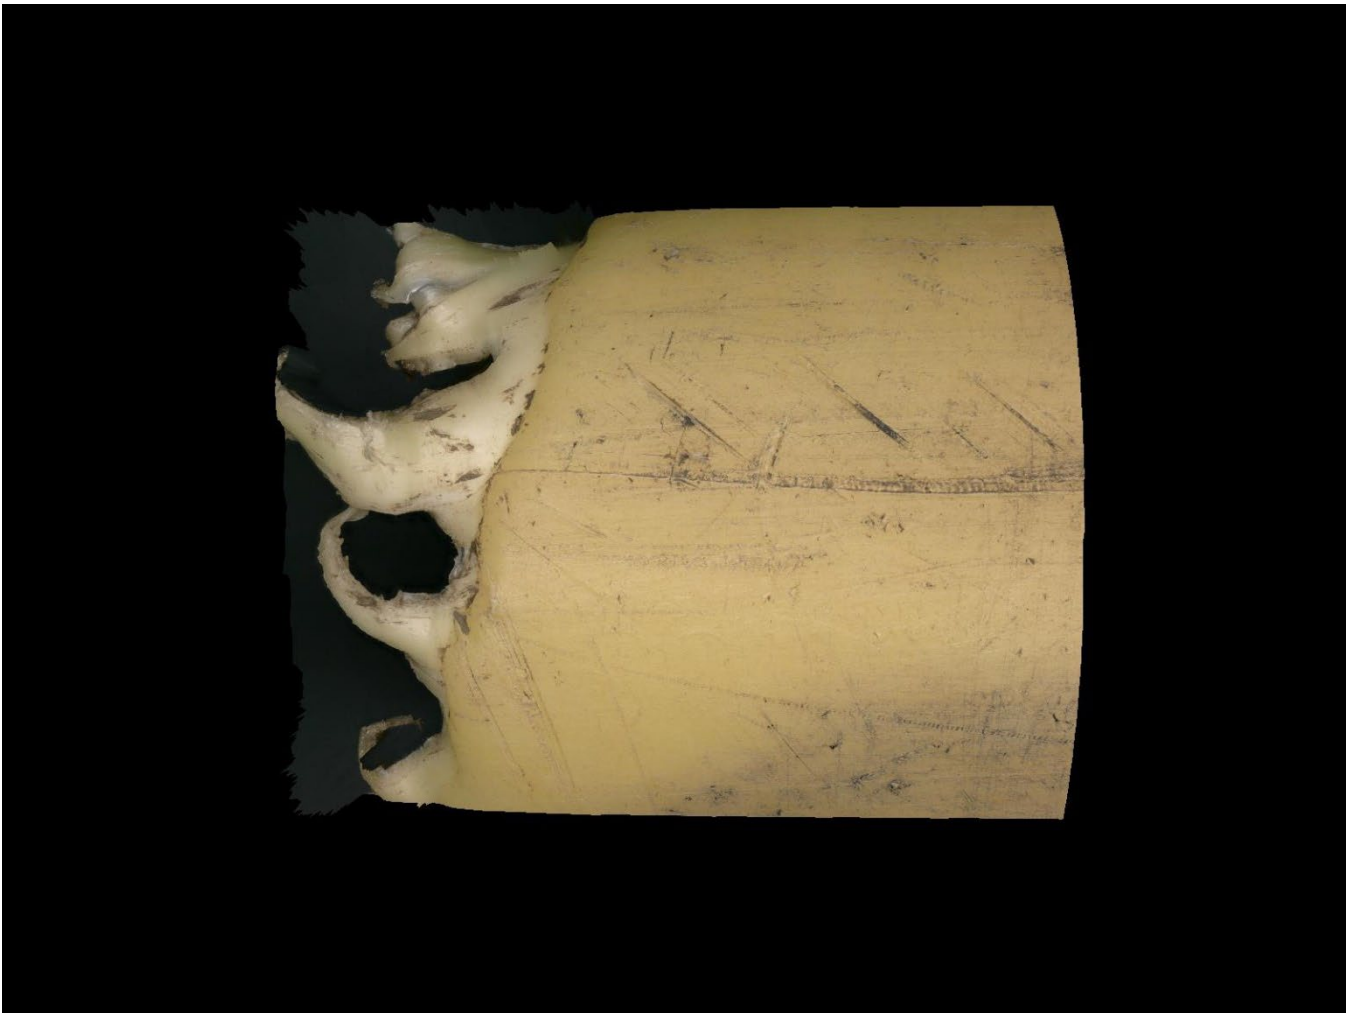
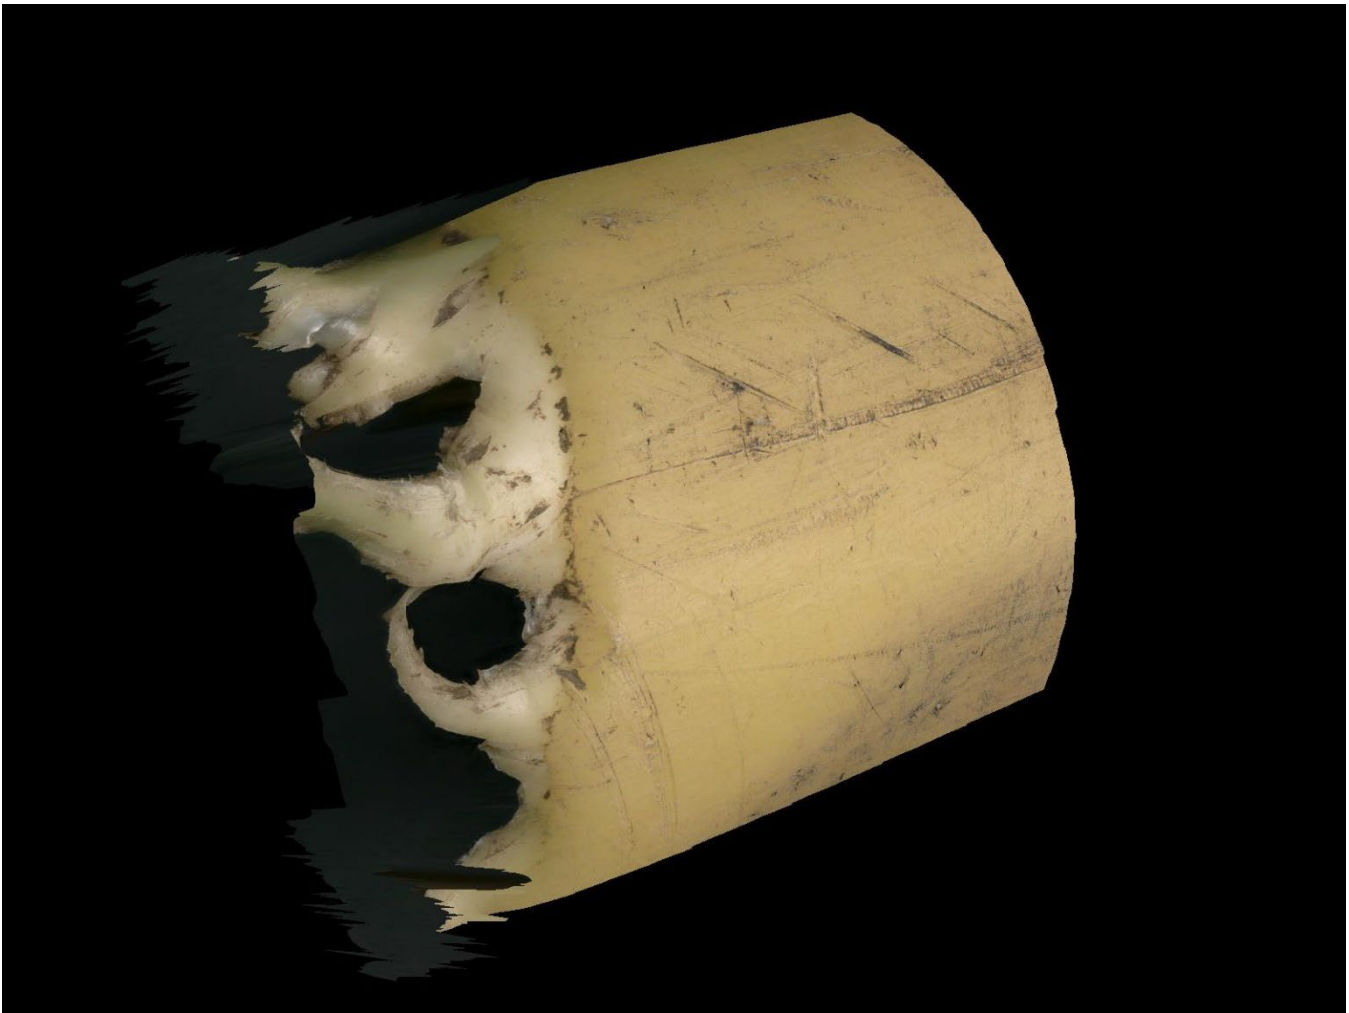
Image 11 – Macro image of gas pipe break from an independent testing laboratory

Image 12 – Macro image of gas pipe break from an independent testing laboratory
