Incident Summary #II-1230899-2021 (#22950) (FINAL)

SUPPORTING INFORMATION	Incident Date		July 29, 2021
	Location		Surrey B.C.
	Regulated industry sector		Gas - Natural gas system
	Impact	Qty injuries	0
		Injury description	N/A
		Injury rating	None
		Damage description	A 3" (88MM) polypropylene gas line @ 60 PSI was punctured causing a major uncontrolled gas release and fire which resulted in the total loss of an excavator that was consumed by the flames. A second excavator received minor damaged due to the flames.
		Damage rating	Major
	Incident rating		Major
Incident overview		During excavation for the installation of a new sanitary service on a public road in a commercial area, an underground gas service line was punctured. The uncontrolled release of gas ignited resulting in a large fire. Due to difficulty of isolating the main gas line that was pressurized from both directions by the utility company, 6 hours was taken to isolate the release. Two homes were isolated from natural gas during the incident. One excavator owned by the excavating contractor was a total loss and a second excavator was damaged from the fire.

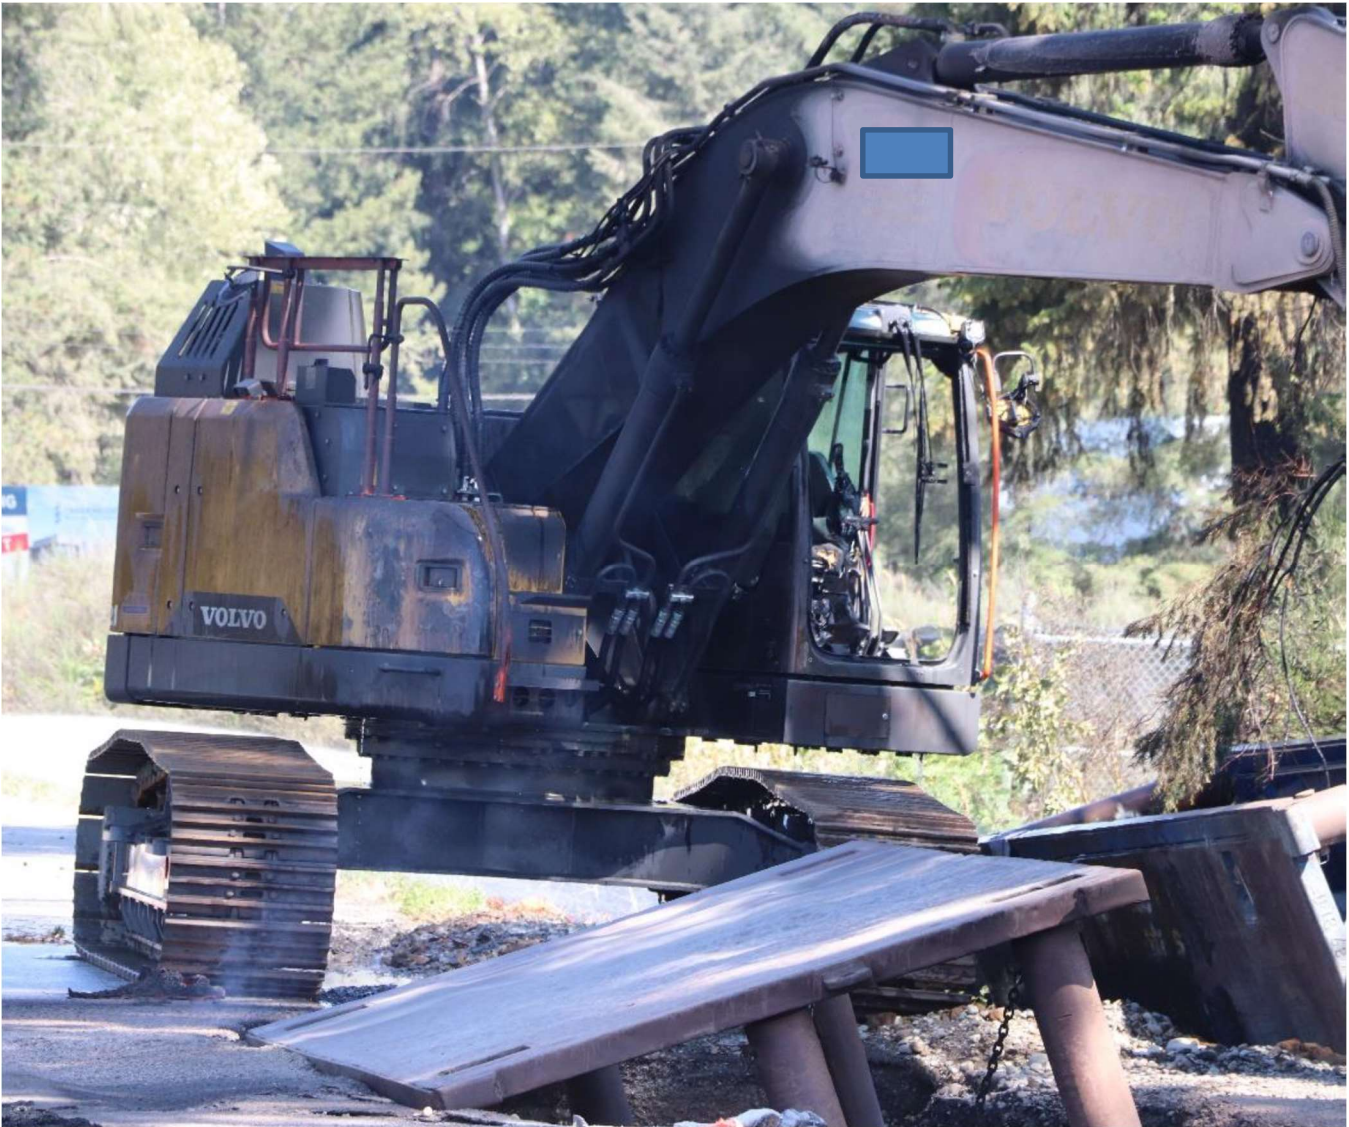
Image 1 - Photo supplied by the utility company showing the first excavator damage caused by the fire resulting in a total loss.

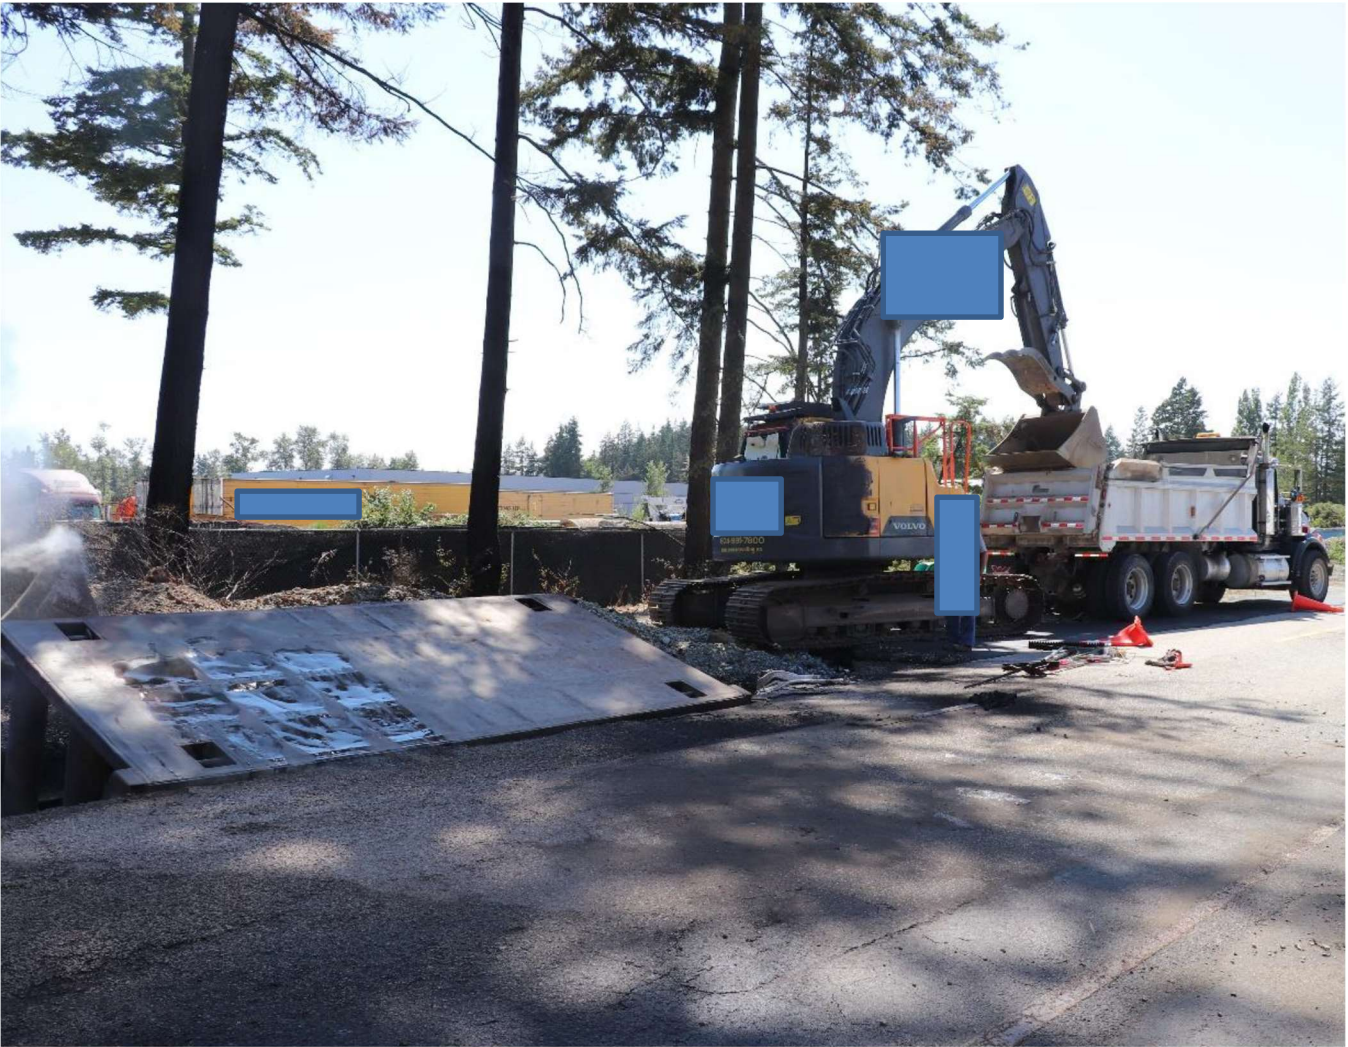
Image 2 - Photo supplied by the utility company showing the second excavator damage caused by the fire resulting in minor damage.

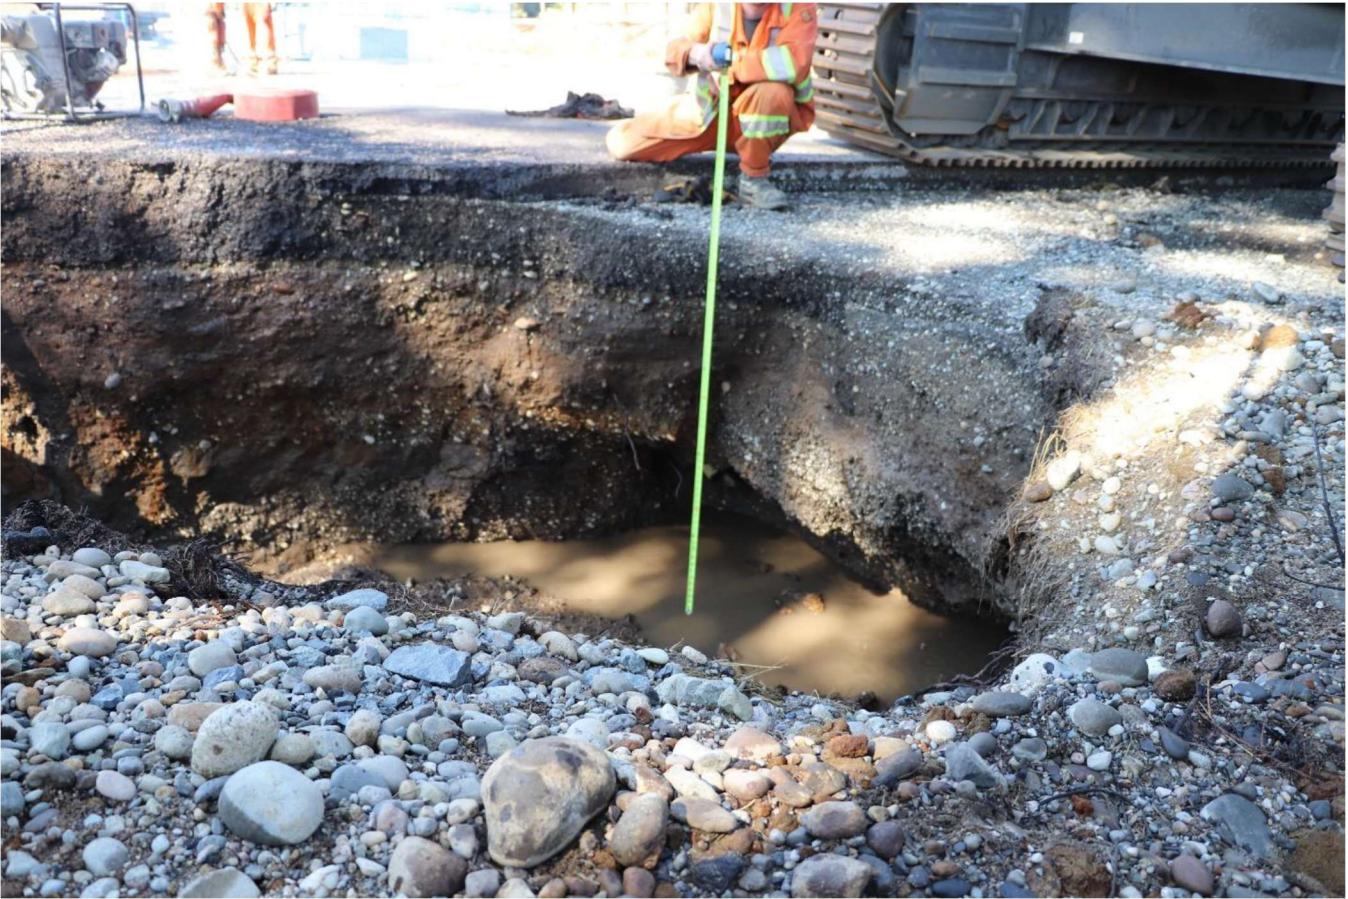
Image 3 – Photo supplied by the utility company showing the actual depth of the gas line at 54”.

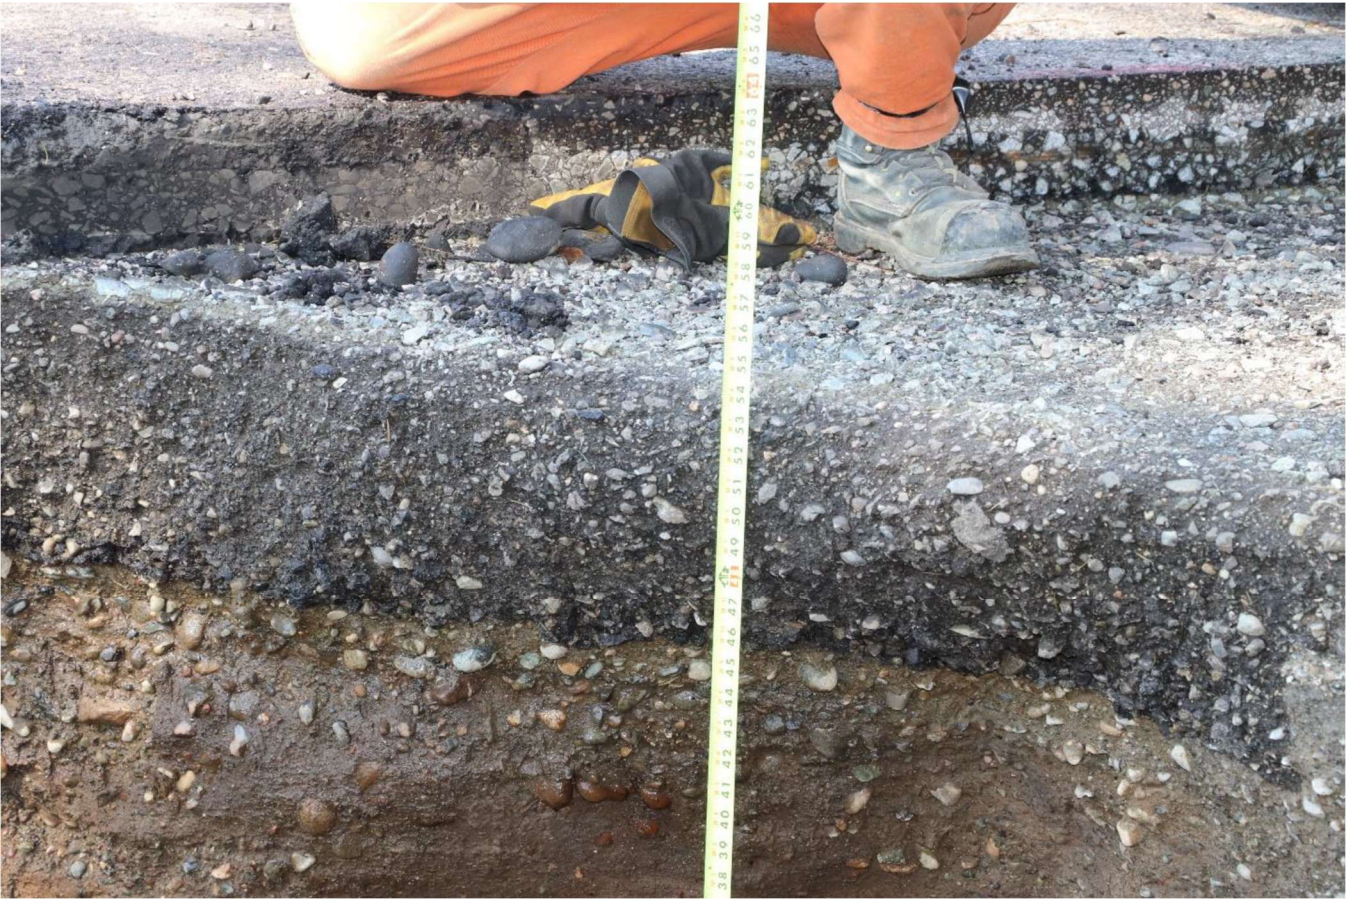
Image 4 - Photo supplied by the utility company showing the actual depth of the gas line at 54".

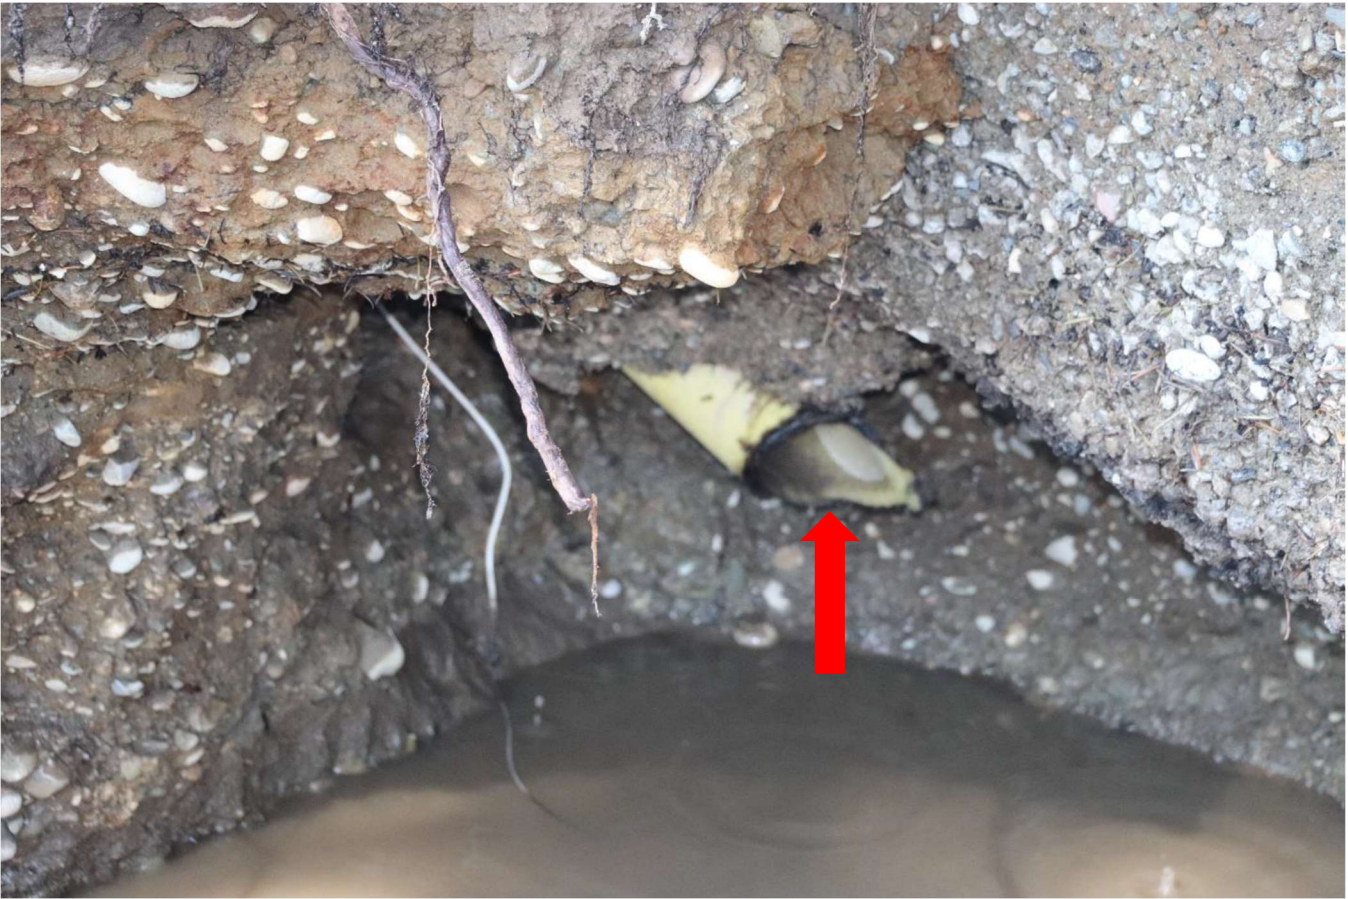
Image 5 - Photo supplied by the utility company showing the punctured gas line after the fire and the removal of the downstream section of piping. Photo shows the burnt end of the piping because of the fire.

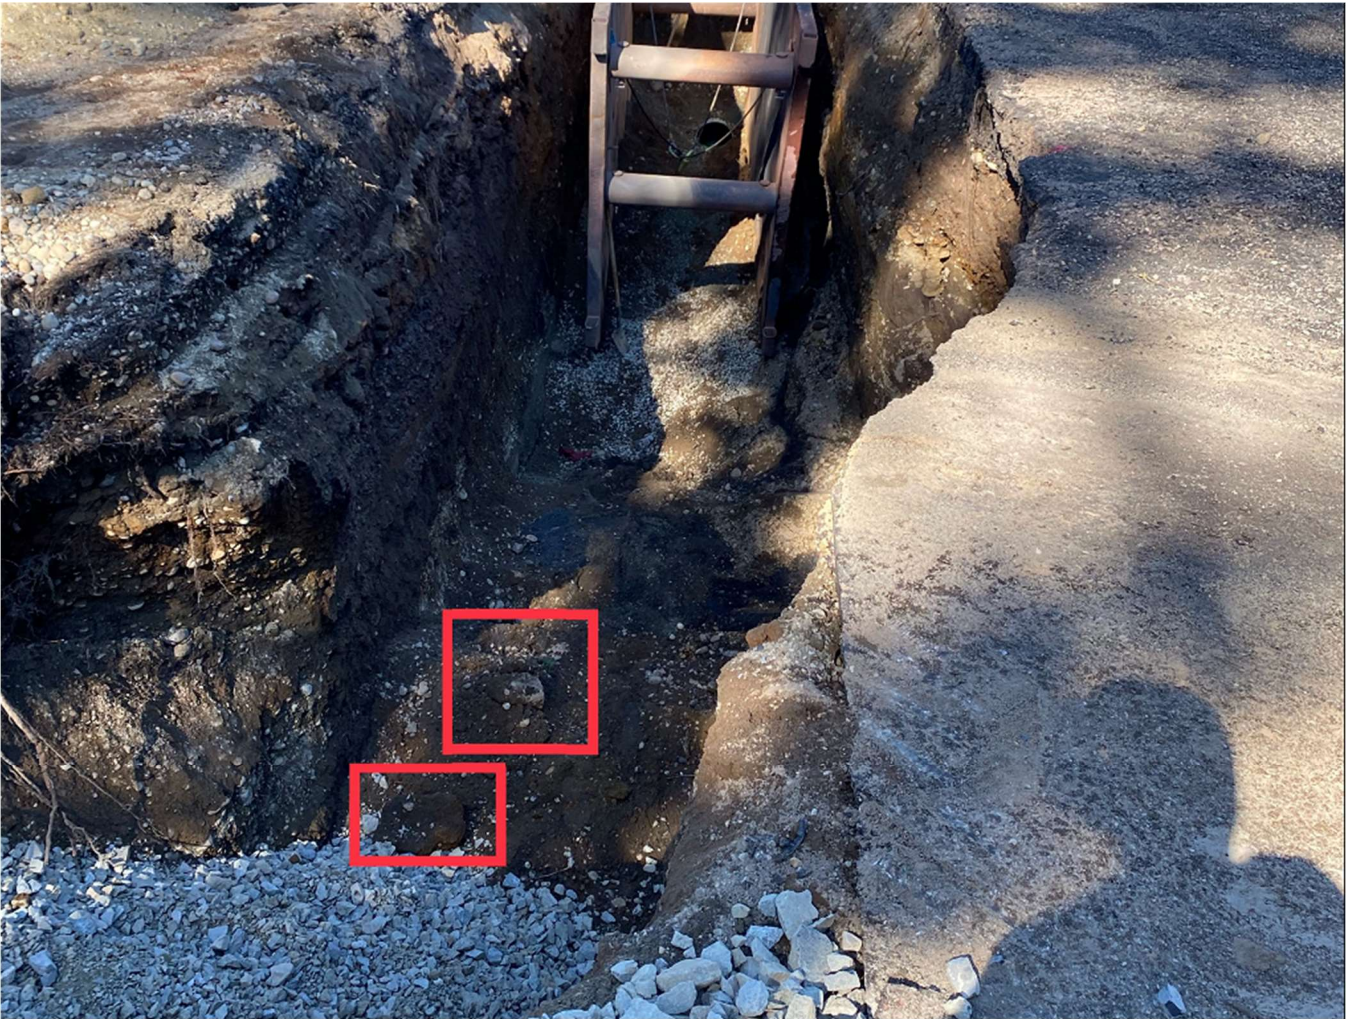
<p>the machines and evacuated the area. The excavation foreman explained that it was assumed due to the heavy bucket and the weight of the machine pushing on the earth and ground below, pieces of concrete left in the hole from the crews in the past must have shifted and struck the gas line causing the puncture (Image 6).</p> <ul style="list-style-type: none"> - 5-10 minutes after the gas leak started, the gas ignited, and a fire was created. - Service drawings were only obtained showing GPS locations of gas lines without depths. - Issues with determining depths with the tracing tool took place while tracing lines on adjacent properties. - Depth was determined by "potholing" the 4" (100MM) main across the road. - Depth of the punctured line was assumed at 6-7 feet deep. - The site foreman was not aware of the <i>Safety Standards Act</i> and requirements for excavating around gas lines in the act. - The site foreman did not attempt to trace out the punctured line from the meter set due to a gate around the meter set. <p>Investigator - Gas utility company</p> <ul style="list-style-type: none"> - No secondary call was made to the gas utility company for verification of the gas lines and depths or to request assistance in accessing the locked meter set that the punctured line serviced. - The tracing wire that was attempted to be traced out by the excavating company was broken and untraceable. - As built drawings for the neighbour property showing depths at 42" deep were available. - The actual gas line location from the top of the asphalt was 56" deep (Images 3 & 4). - Investigator with the gas utility assumed the cause of ignition was static electricity caused by high-pressure and volume gas rushing through the plastic line. <p>Emails</p> <ul style="list-style-type: none"> - The excavating company obtained service lists from the survey company of the gas lines. - No secondary call was made to the utility company for verification of location of the gas lines.

Image 6 – On site photo taken by the safety officer showing some concrete debris in the trench.
