## Incident Summary #II-1268495-2021 (#24429) (FINAL)

SUPPORTING INFORMATION	Incident Date	October 13, 2021	
	Location	Chilliwack	
	Regulated industry sector	Electrical - Low voltage electrical system (30V to 750V)	
	Injury	Qty injuries	1
		Injury description	Damage to the individual's safety glasses and work gloves. No burns or injury to the body.
		Injury rating	Insignificant
	Impact Damage	Damage description	<ul style="list-style-type: none"> <li>• Damage to the Bay 2 power connection boxes in the interior and exterior of test bay.</li> <li>• Damage to the heavy-duty cable connectors that are used to connect test power from the test bay power connection boxes to the natural gas compressor.</li> <li>• Damage to the vent fan contactor on the inside of the motor control centre (MCC).</li> <li>• Damage to the individuals work gloves and safety glasses.</li> </ul>
		Damage rating	Minor
		Incident rating	Minor
	Incident overview	Heavy-duty cable connector connected under electrical load resulted in an arc flash that caused damage to electrical equipment and personal protective equipment. The incident occurred in a facility that manufactures compressed natural gas (CNG) and compressor

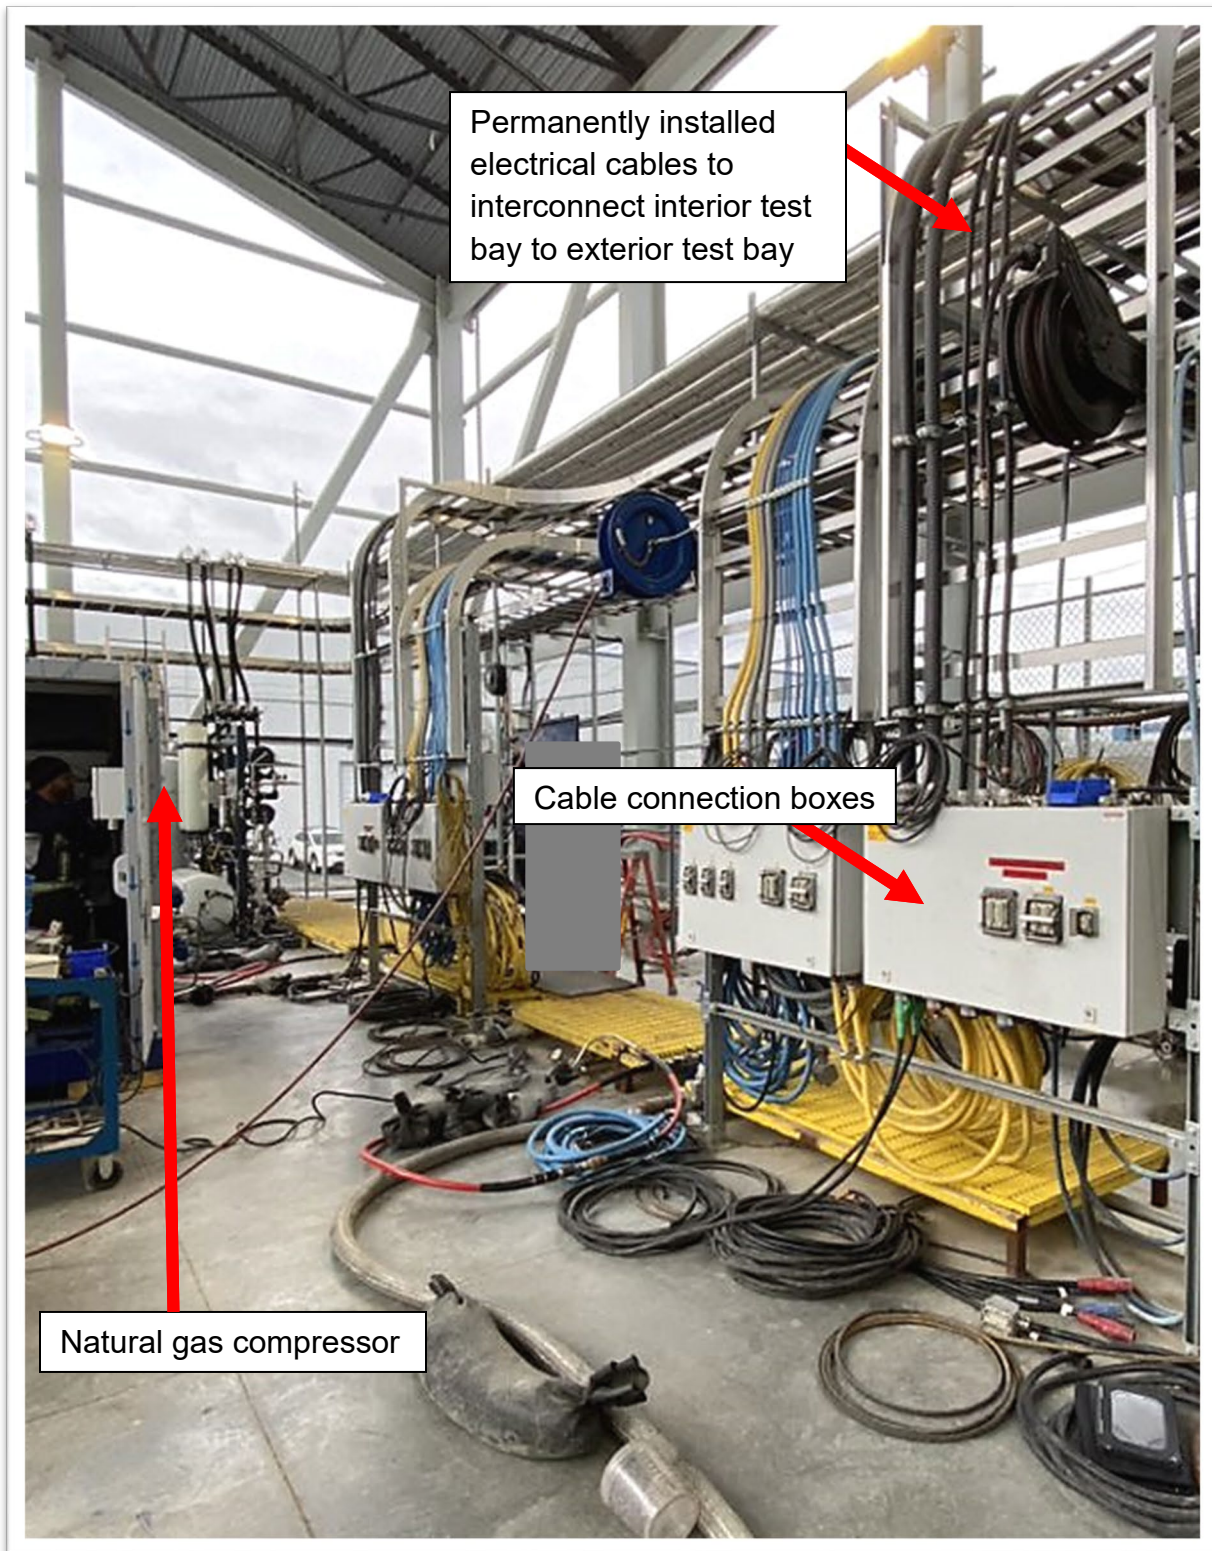
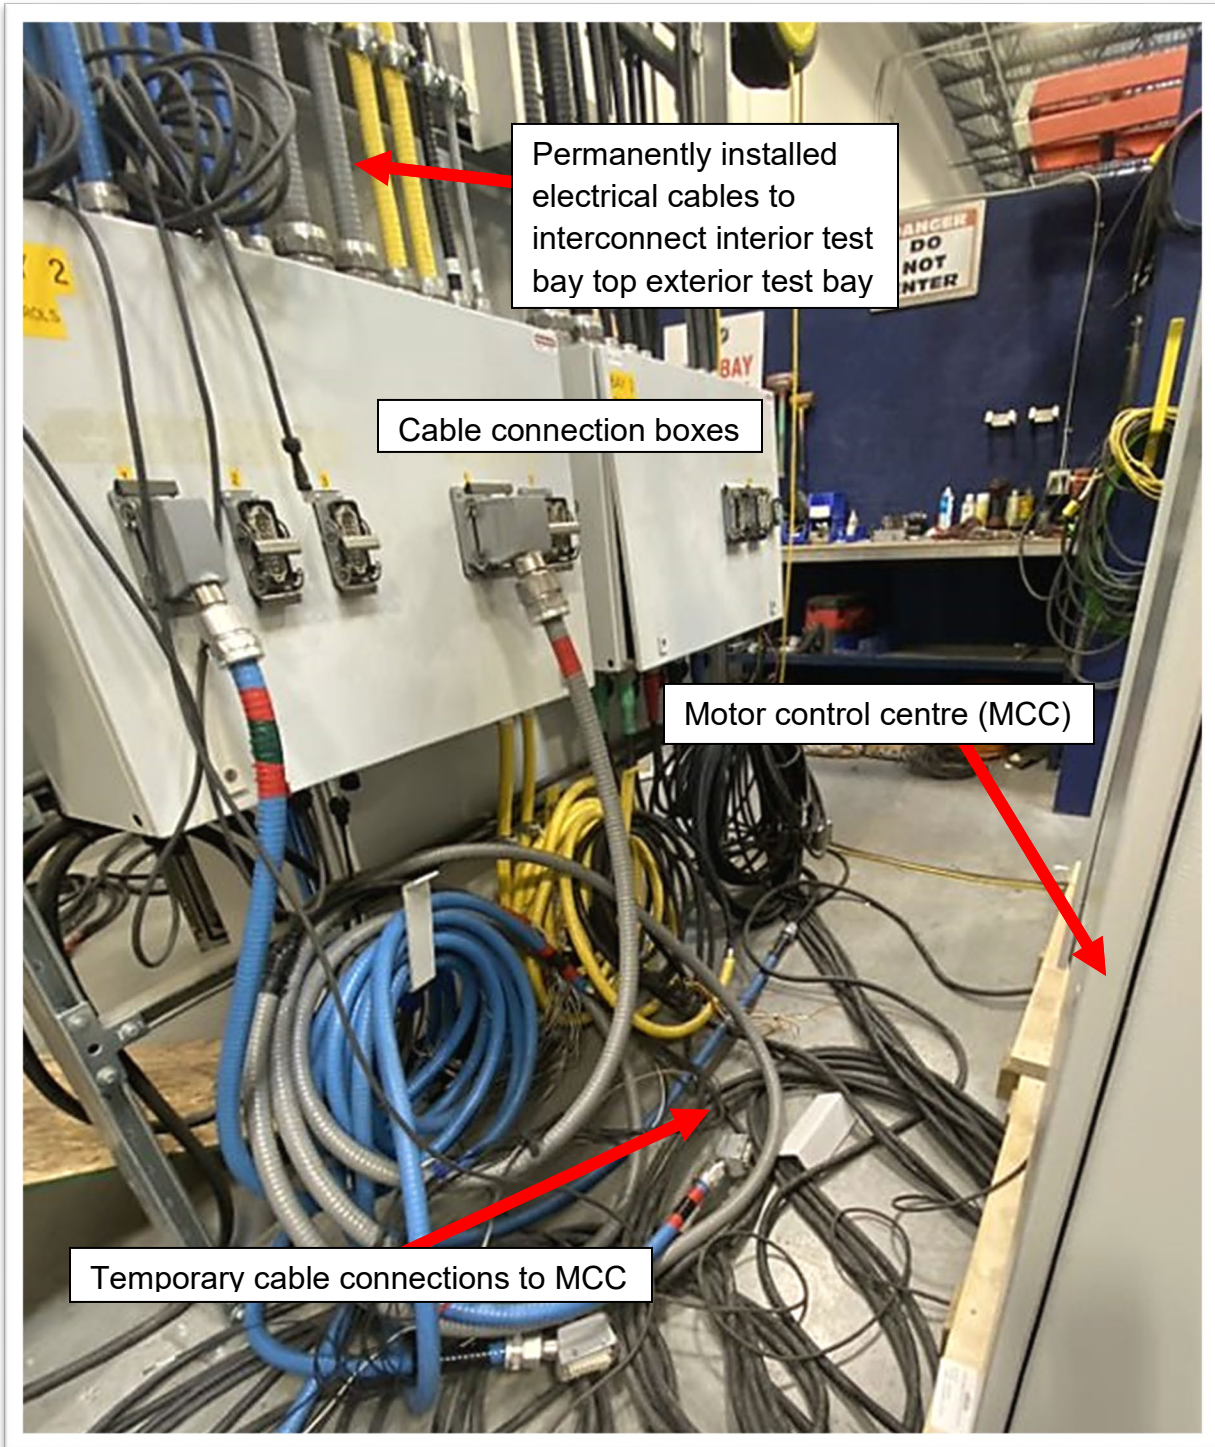
## Photos 1 – Locations

INVESTIGATION CONCLUSIONS	Site, system and components	<p>Before each compressor is shipped to the customer, it is tested to ensure that all the components are functioning properly. The electrical system for testing consists of a distribution system that is designed to test the compressors at either 600-volts or 480-volts depending on the customers requirements.</p> <p>Test Bay:</p> <ul style="list-style-type: none"> <li>• A typical test bay has a section on the exterior of the building where the compressor is located, and a section on the interior of the building where a motor control centre (MCC) that controls all the electrical components of the compressor, is located.</li> <li>• The interior section and the exterior section are interconnected with permanently installed electrical cables that terminate into power connection boxes at either end. This is essentially a large jumper to transfer all the power and controls between the two sections of the test bay.</li> <li>• The power connection boxes as well as each piece of electrical equipment used for testing are equipped with either cam lock style cable connectors, or large heavy-duty cable connectors that allow the power and control wiring, required to run the compressor for testing, to be easily connected or disconnected in a timely manner (See <a href="#">Photo 1</a>).</li> </ul>

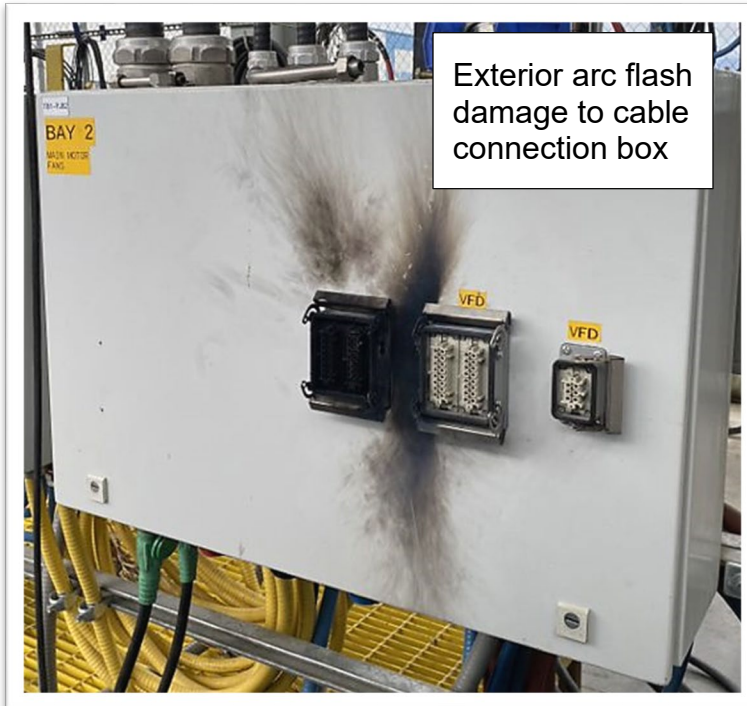
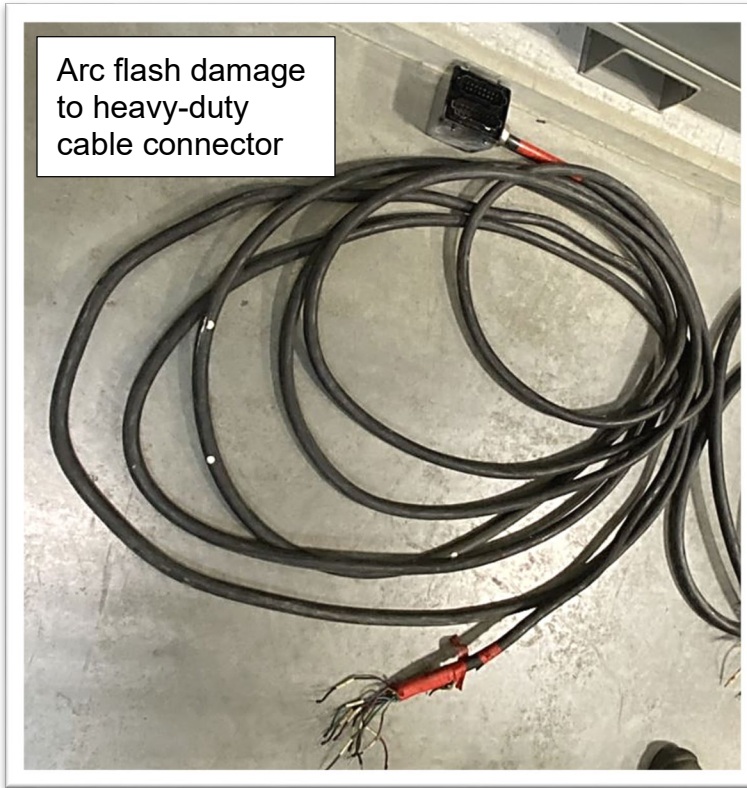
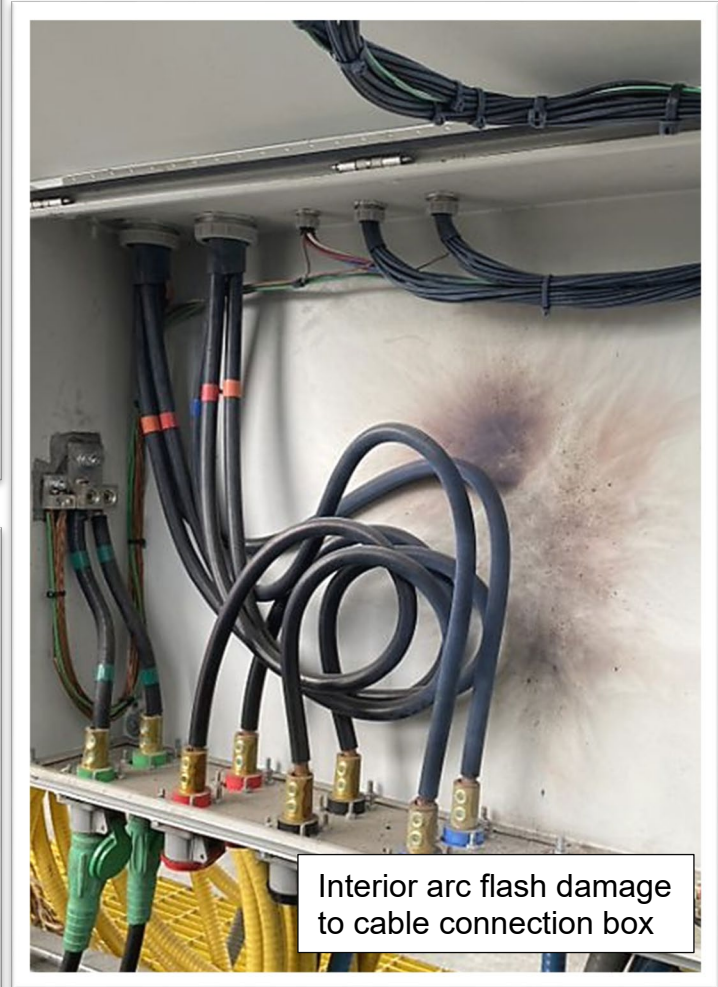
## Photos 3 – After arc flash

<p>Failure scenario(s)</p>	<p>An individual was connecting test cables from the power connection box to the natural gas compressor in the exterior section of test bay 2. The individual was not aware that the power was turned on to the MCC on the inside section of the test bay.</p> <p>There is a detector on the inside of the compressor that senses a natural gas build up and will automatically turn ventilation fans on through the MCC control wiring.</p> <p>At the time the individual was connecting the test cable for the ventilation fan power, the detector had sent a signal to the MCC for the ventilation fans to turn on. When the individual tried to connect the test cable for the compressor ventilation fans, there was an arc flash due to connecting the test cable under an electrical load.</p>
<p>Facts and evidence</p>	<p>Onsite interview and tour with head electrician for the facility and test bay foreman:</p> <ul style="list-style-type: none"> <li>• Voltage selected for the compressor test was 480-volts and confirmed the power to the MCC was on.</li> <li>• The individual was not aware that the MCC was powered on.</li> <li>• The control test cables were already connected from the MCC to the compressor.</li> <li>• The gas detector inside the compressor was reading a gas level of 17% lower explosive limit (LEL) which is a percentage of natural gas in the atmosphere where it is ignitable. The gas detector would be sending a signal to turn the compressor ventilation fans on.</li> <li>• The heavy-duty connector that arc flashed has 32 pins inside of it that are approximately one centimetre apart from one another. The connector is not designed to be connected under load (See <a href="#">Photo 2</a>).</li> <li>• Arc flash evidence was present on the individual's safety glasses and work gloves (See <a href="#">Photo 4</a>).</li> <li>• Arc flash damaged electrical components were observed (See <a href="#">Photo 3</a>).</li> </ul>

<p>Causes and contributing factors</p>	<p>It is almost certain that the cause of the arc flash was due to the attempted connection of the heavy-duty cable connector that is not designed to be connected under an electrical load.</p> <p>The contributing factors are that the individual was not aware that the main power to the MCC was turned on, and that the gas detector was signalling the ventilation fans to turn on creating an energized power connection box.</p>

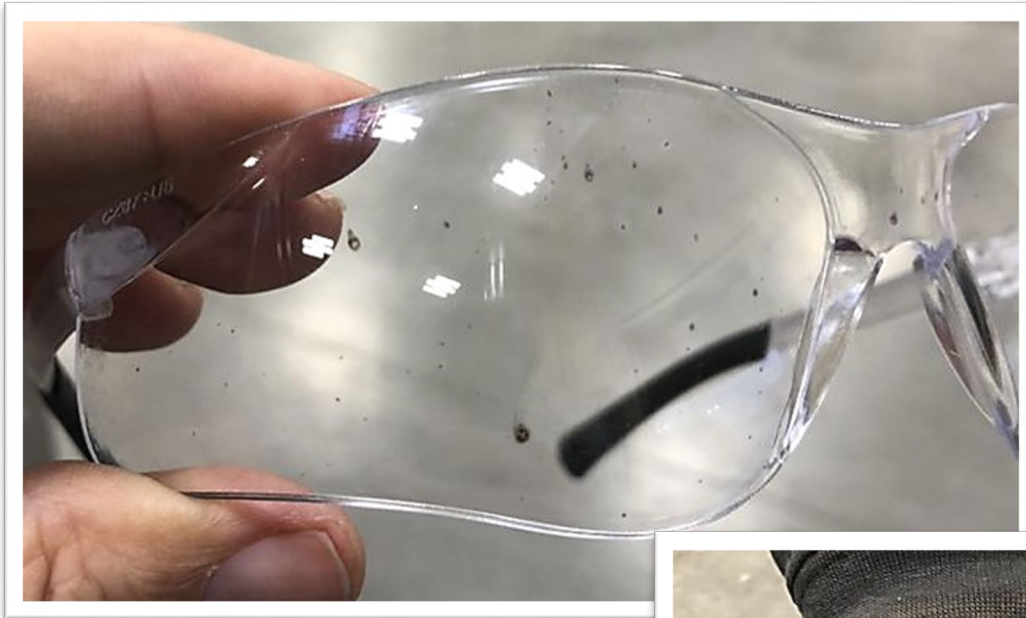
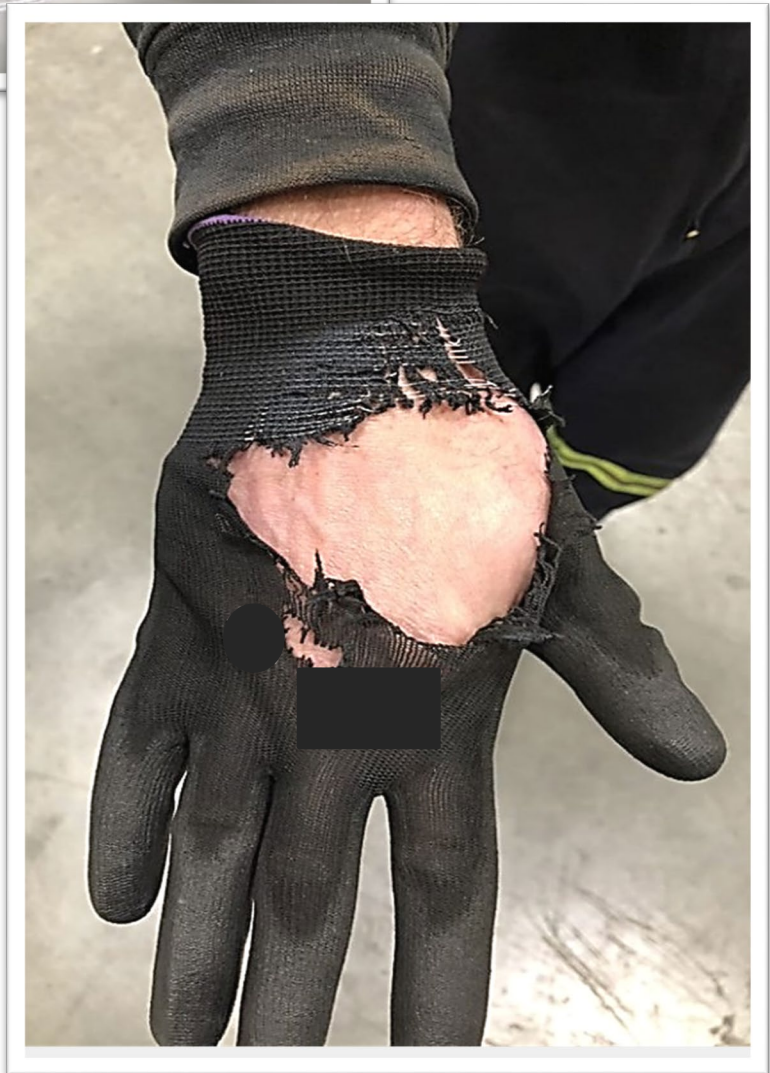
## Photos 4 – Personal Protective Equipment

Arc flash damage to individual's personal protective equipment
