## Incident Summary (II-699373-2018) (Final)

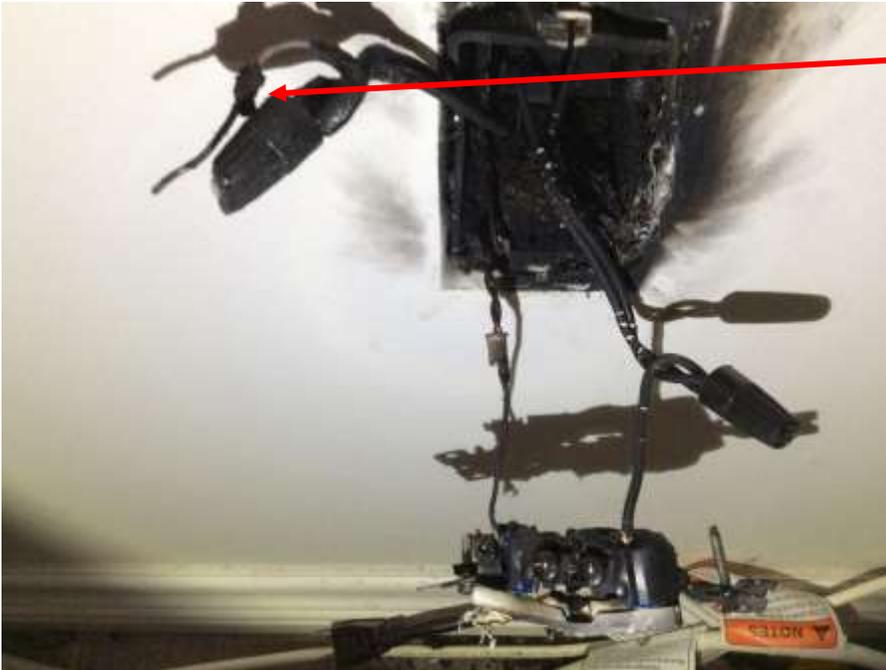
- The 15A / 125V receptacle was charred and burnt and a portion of the receptacle was missing on the ungrounded (hot) side of the receptacle. The identified (neutral) conductor and bond conductor were still connected to the receptacle but the ungrounded conductor appeared to have burnt off. The neutral conductor connected to the receptacle through the back-wired connection on the receptacle. The conductors were charred and burnt and insulation was missing from the line conductor.

Ungrounded (hot) conductor is burnt off of receptacle. Wire connector is also melted.

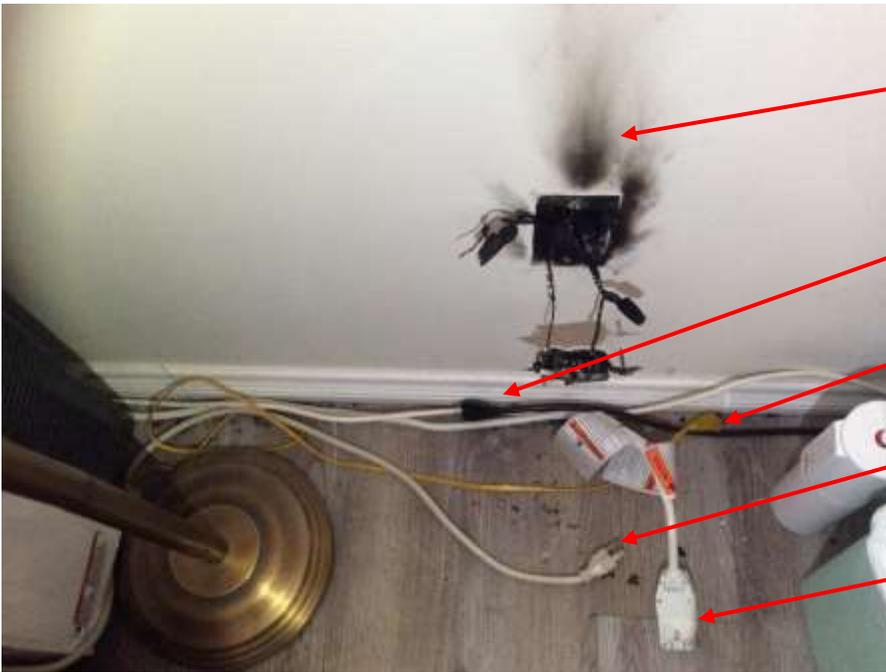
- Cord ends for the 1500W portable oil filled heater, 1040W portable AC unit, floor lamp and cord connected power bar were below the outlet.
- The junction box the receptacle was mounted on was burnt on the inside and the bottom, left side of the box (as looking from the wall) was melted and distorted. The wall above the junction box had minor fire and smoke damage.

Fire / smoke damage on wall

Heater Cord

Lamp Cord

Power bar cord

AC unit cord

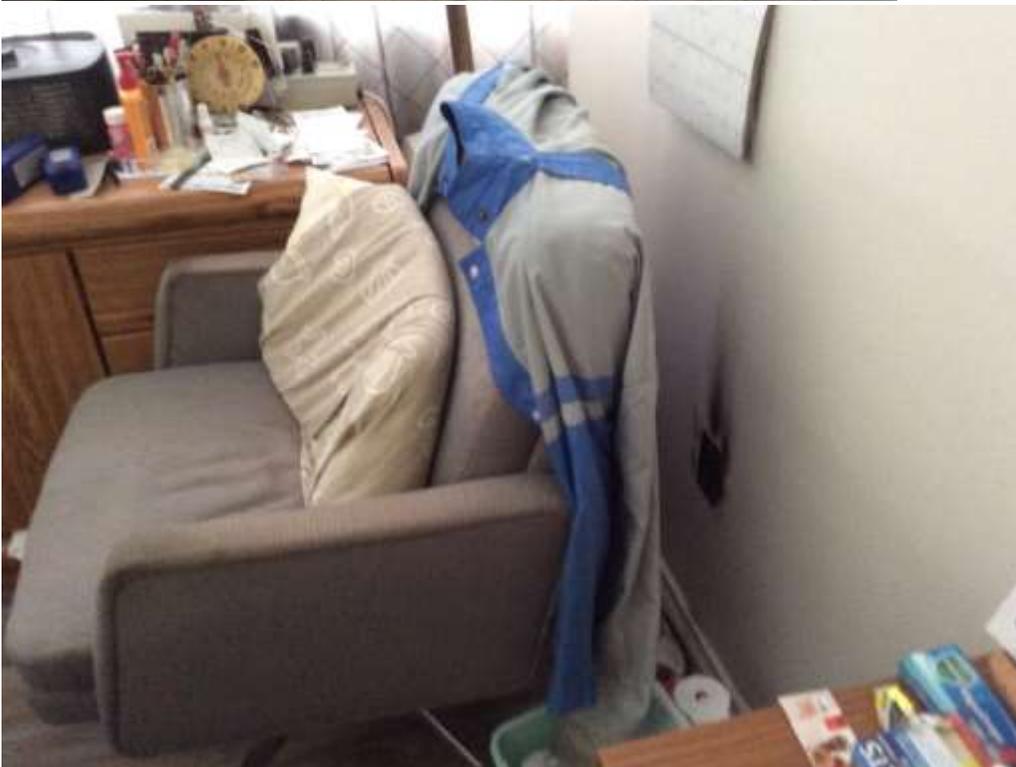
A contributing factor may have been the chair that was stored in front of the receptacle. When the chair was moved, it may have bumped the surge protected power strip and the power strip may not have been fully seated into the receptacle. If the plug was not fully seated, less metal would have been in contact and it would have compounded the overheating at the connection.

Location of chair when not in use at computer.

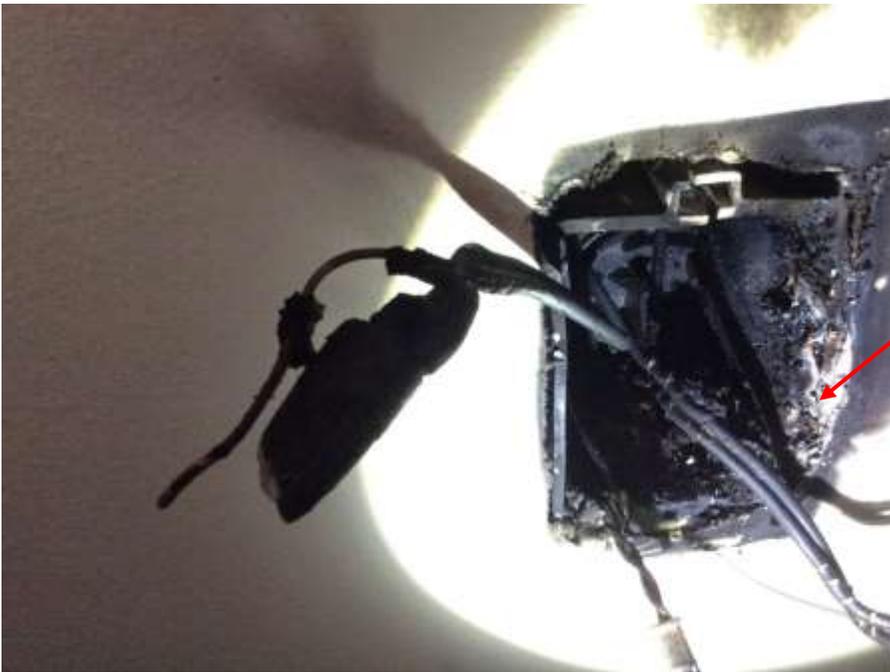
Inside of box is burnt.  
Bottom corner is melted

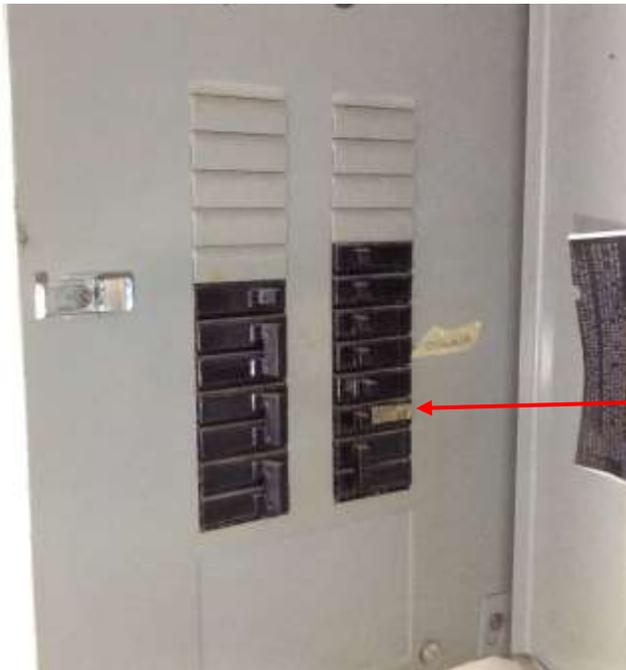
- The 15A, 1 pole breaker in the electrical panel for circuit 18 was in the tripped position.

Tripped breaker in panel.

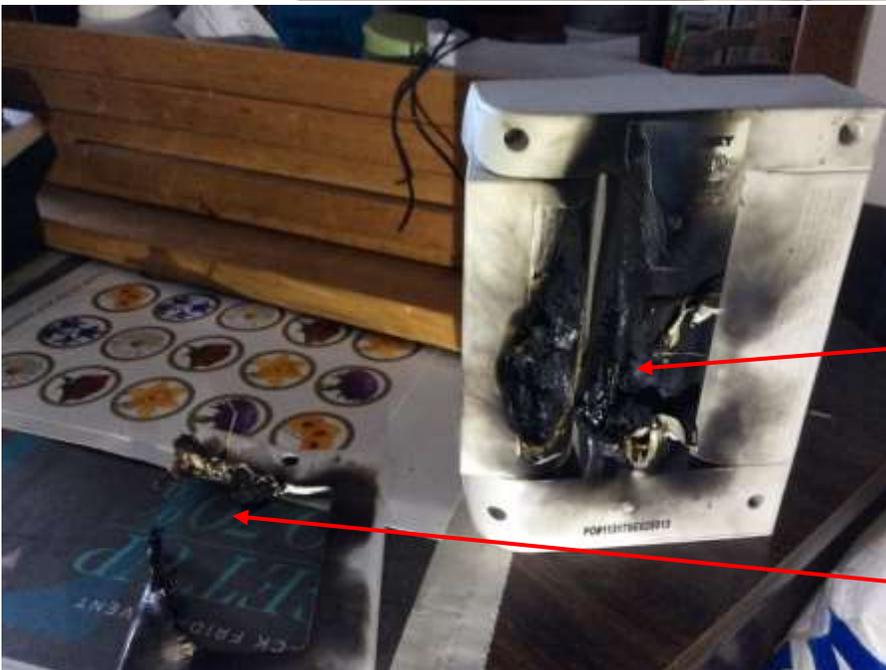
- The receptacle plate was scorched on the inside and a burn mark in the bottom, left side of the plate corresponded with the missing portion of the receptacle and burn marks on the back of the surge protected power strip.

Back of surge protected power strip

Bottom of cover plate is melted

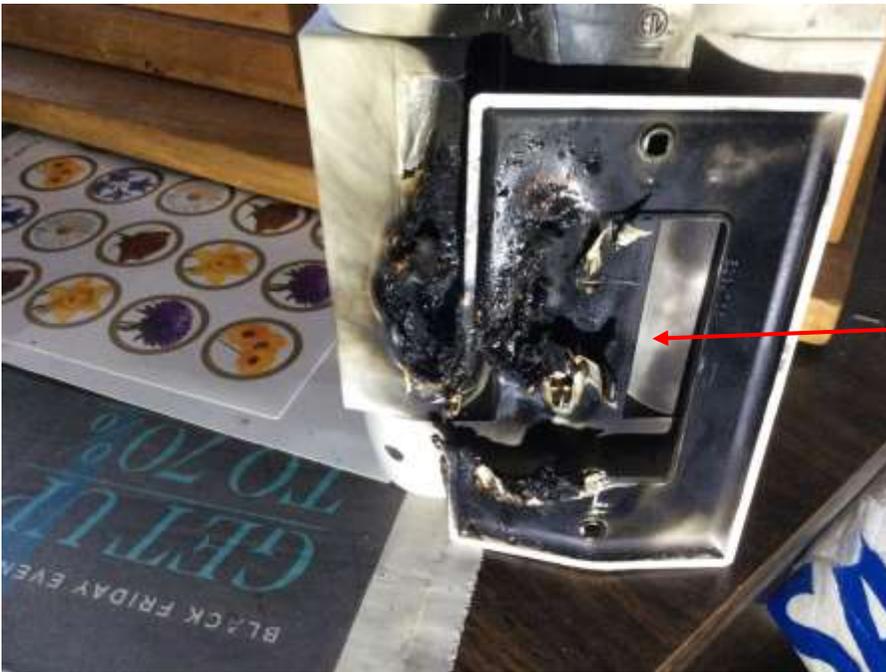
Cover plate and back of surge protected power strip aligned.

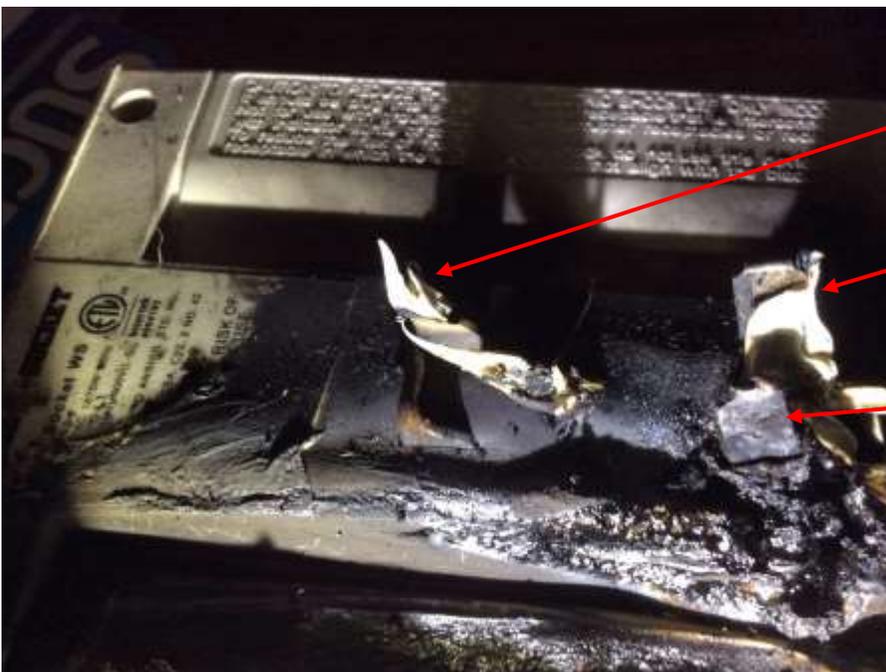
- The 1875W surge protected power strip had six outlets and had a certification mark for use in BC. The power strip had burn marks on the back of the outlet. The plastic tabs that fit in the upper portion of the outlet to provide support for the power strip had melted off the device. The neutral blade of the plug had marks that would indicate high heat. The ungrounded (hot) blade of the plug was melted and a portion of the blade was missing which indicated an arc fault.

Plastic tabs have melted off of the top of the power strip.

Identified (neutral) blade has been exposed to high heat.

A portion of the ungrounded (hot) blade has melted from the arc

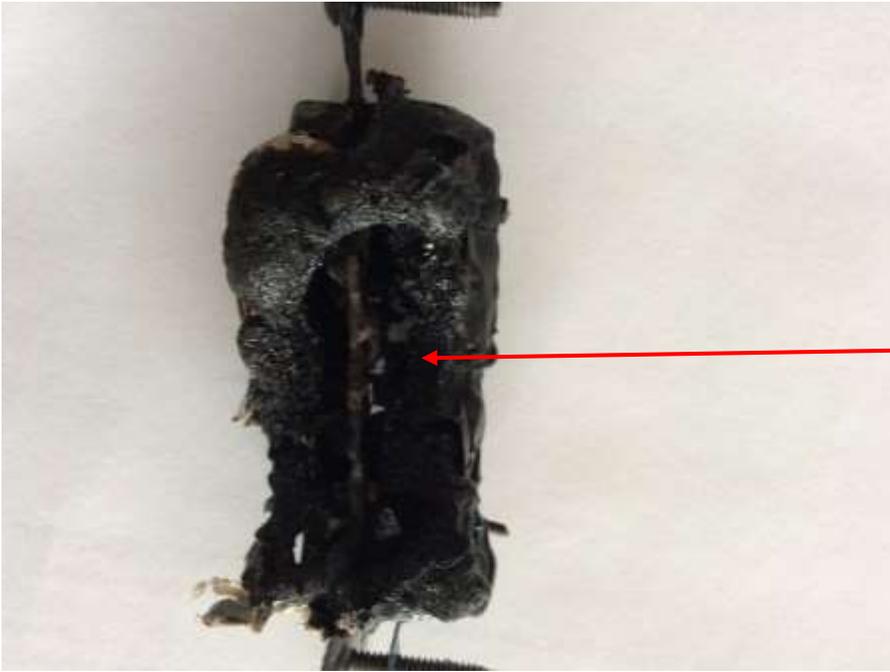
The ungrounded (hot) terminals are missing off the side of the receptacle and the high heat from the arc has disintegrated the side and back of the receptacle body.

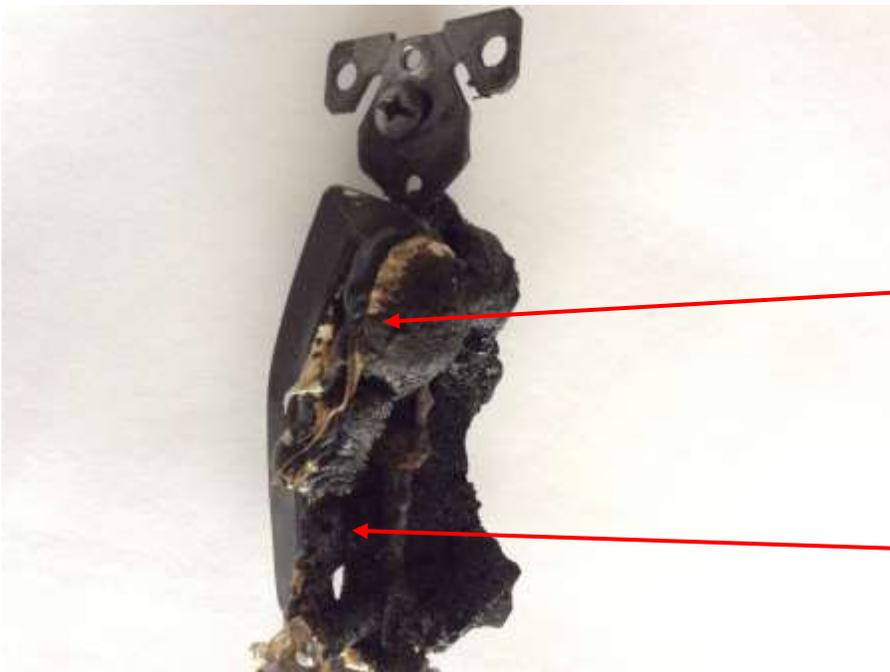
Melted plastic tabs off of the top of the power strip in the receptacle.

Location of the power strip blades in the receptacle.
