## Incident Summary #II-935026-2019 (#15793) (FINAL)

SUPPORTING INFORMATION	Incident Date	November 1, 2019	
	Location	Port Coquitlam	
	Regulated industry sector	Boilers, PV & refrigeration - Refrigeration system	
	Impact	Qty injuries	1
		Injury description	One person sustained ammonia burn in his right hand.
		Injury rating	Moderate
	Damage	Damage description	An apprentice refrigeration mechanic was injured by contact with liquid ammonia while replacing a leaking discharge valve for an ammonia compressor.
		Damage rating	None
	Incident rating	Minor	
	Incident overview	<p>A licensed refrigeration contractor's refrigeration mechanic was called in by a chicken processing plant's maintenance manager to provide service to compressor CU1 which had an error message of 'Oil Temperature Sensor' indicating a refrigerant flood back. The mechanic suspected the 2" check valve between the oil separator and the pipe discharge valve was leaking. He initiated pumping down the compressor by shutting off the power, closing the pipe discharge valve and having the compressor's suction open. This allowed the condensed ammonia in the compressor, oil separator and associated pipes to gradually evaporate

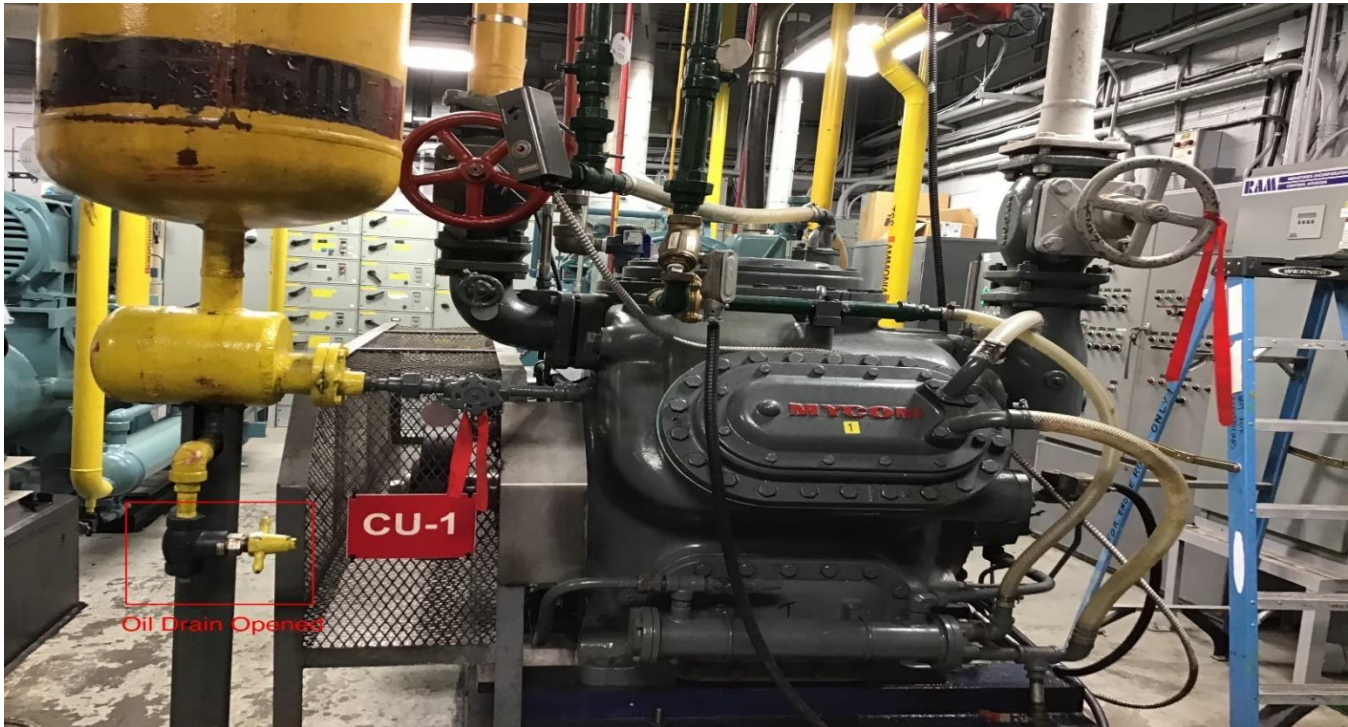
<p>Failure scenario(s)</p>	<ul style="list-style-type: none"> <li>• The apprentice who was assigned to replace the leaky check valve was not qualified to perform regulated work on regulated equipment.</li> <li>• The apprentice failed to report to the plant maintenance manager for plant orientation as required prior to entering the machinery room.</li> <li>• The apprentice was able to enter the machinery room through the building exterior door which was supposed locked at all times to prohibit any unauthorized personnel from entering.</li> <li>• It was likely that the refrigeration mechanic did not perform valve tag-out / lock out. He tied a piece of red tape to the valve handle of the pipe discharge valve to indicate that the valve was closed.</li> <li>• The apprentice might have taken the initiative to work by himself in the machinery room without arranging for mechanic's supervisions.</li> <li>• The apprentice failed to check that the compressor's suction valve was open. This meant the compressor, oil separator and the associated pipes were still in the process of pump down.</li> <li>• The apprentice's opening the oil drain valve resulted in ammonia release to the atmosphere in the machinery room.</li> </ul>

Image 1 - Oil drain valve opened

It is possible that ammonia leak could have been prevented provided a licensed refrigeration mechanic had supervised the apprentice while working together to conduct the check valve repair.

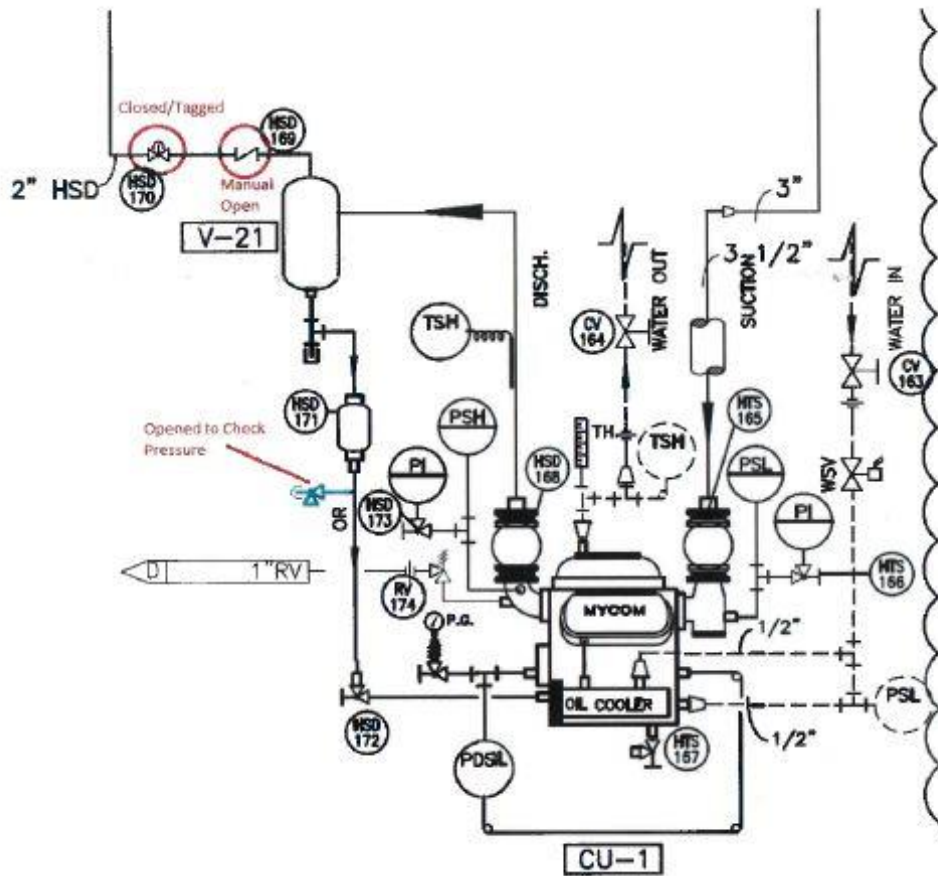
Note: Valve opened to access was not shown on P&ID. It is an oil drain valve on the bottom of the float valve. Approximately where the blue valve is shown above. Float is an old, phillips style float valve with 3 connections, not the 11-LD with 2 connections as shown above.

Image 2 - Compressor CU1 piping diagram

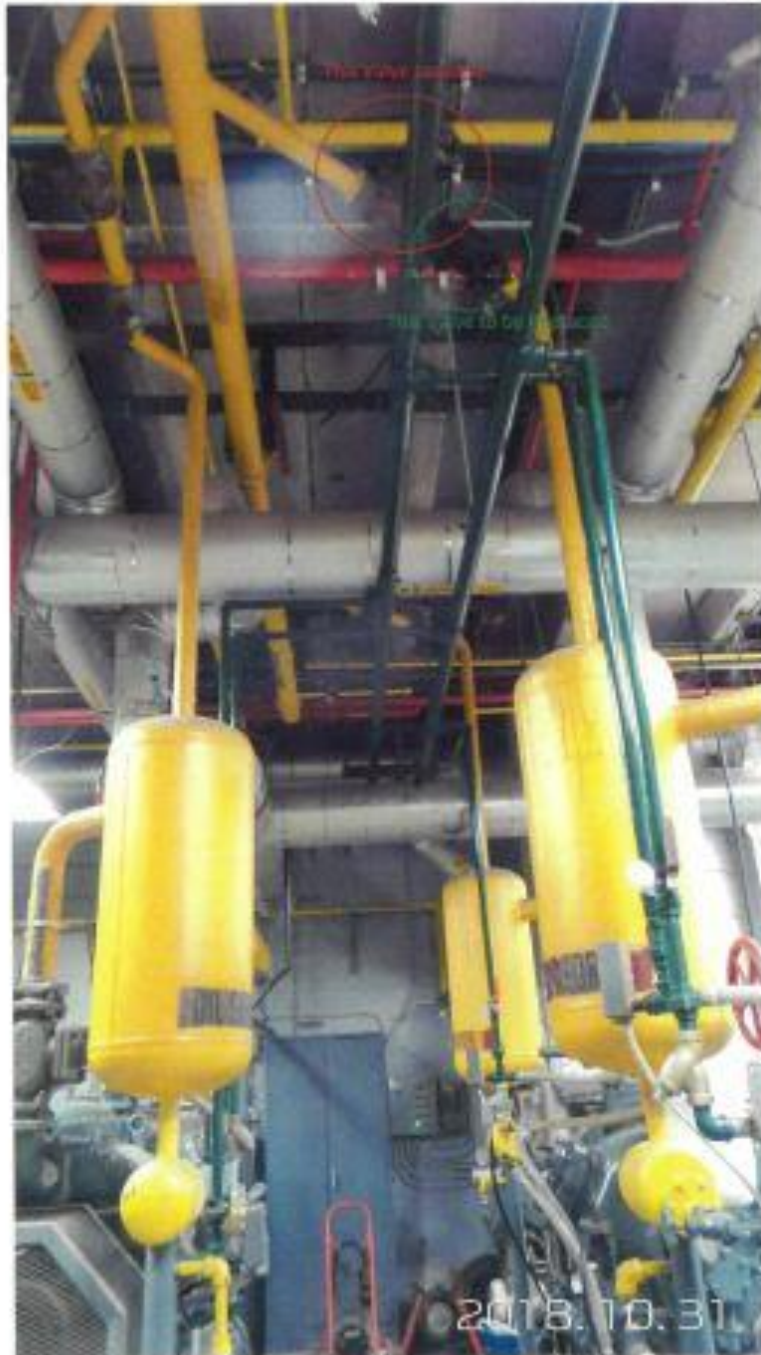
Image 3 - Discharge valve (Closed) and check valve (to be replaced)
