Incident Summary #II-795000-2019 (#10451) (FINAL)

SUPPORTING INFORMATION	Incident Date	November 7, 2018	
	Location	Whistler	
	Regulated industry sector	Passenger ropeways - Above surface ropeway	
	Impact	Qty injuries	1
		Injury description	The worker noticed discomfort grow over the next 48 hours and went to first aid. The worker suffered a rotator cuff injury.
		Injury rating	Moderate
	Damage	Damage description	NA
		Damage rating	None
Incident rating	Moderate		
Incident overview	Employee was installing a communication line and was in the process of tensioning the line, when the cable grip slipped along the line. This caused the cable tension to release. The tower dramatically swayed several feet and threw the worker off balance. The worker caught himself by grabbing the rail with his left arm during the movement of the tower. The worker felt slightly sore in the left shoulder at the time of incident and reported it to his supervisor.		
INVESTIGATION CONCLUSIONS	Site, system and components	<p>Incident occurred on the top of a ropeway tower of an under construction detachable grip gondola.</p> <ul style="list-style-type: none"> Based on the profile drawings, the communication cable

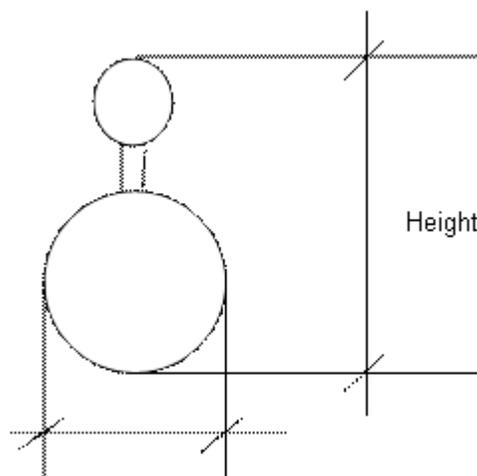
Figure 1, Cross Section of Communication Cable

- Telecom Cable
- ALFOUR-83, 50PR X 19AWG 3/8" PE-38
- Figure 8 configuration, height 46 mm, width 30.4 mm, -Jacketed messenger 3/8", steel cable. Jacket material is LLDPE (Linear Low-Density Polyethylene).
- Diameter of jacketed messenger 12.5 mm.
- 1518 kg per 1000 m.

The smaller upper diameter circle represents the messenger cable 12.5 mm

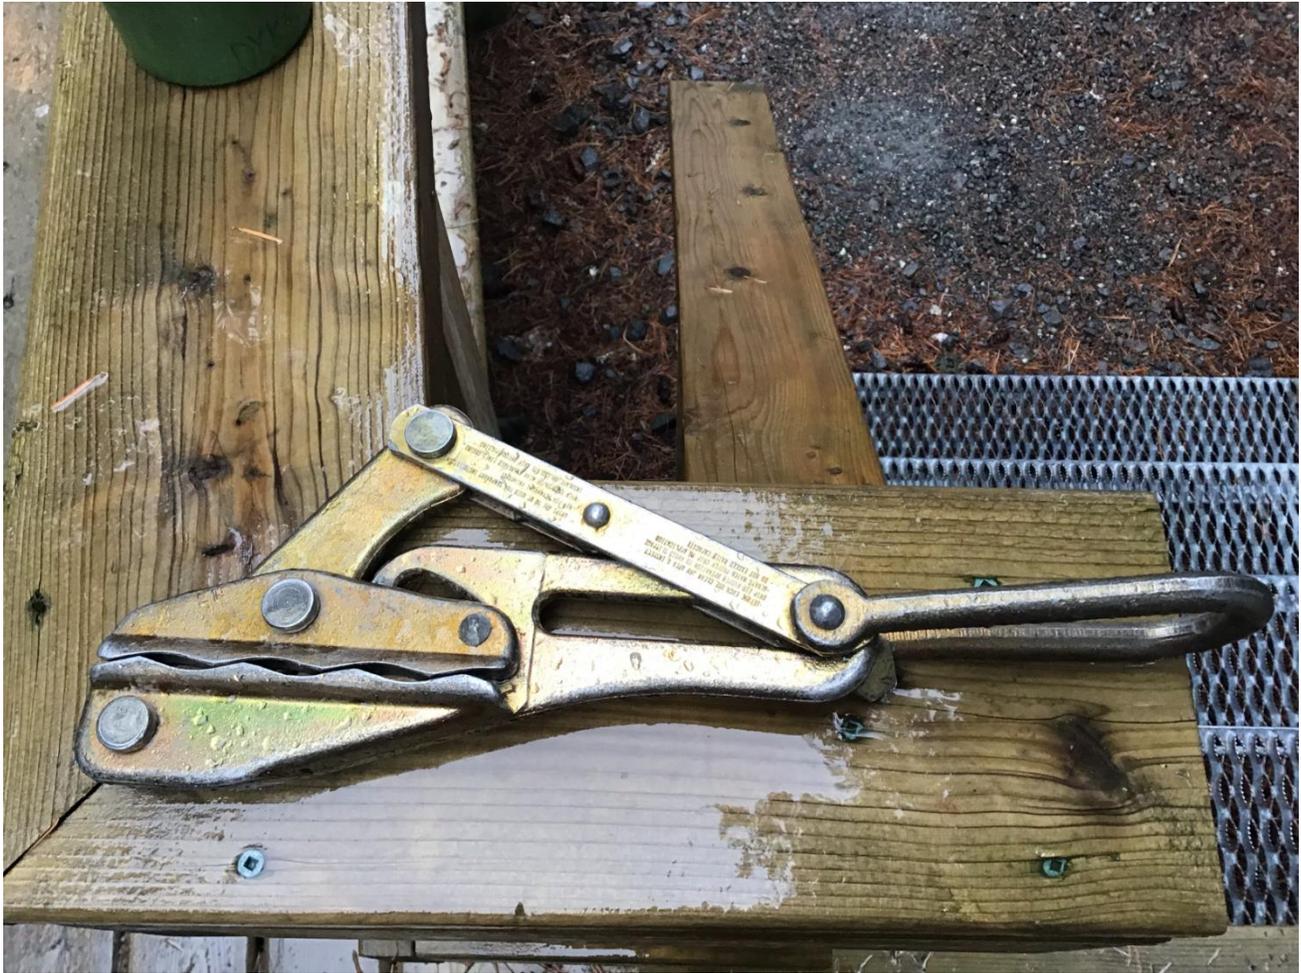
Cable Grip

- Chicago Grip for PVC Covered Conductors 0.5-Inch, 1659-30, manufactured by Klein Tools.
- Specified for copper cable, specified for cable diameters of 7.87-12.70 mm, SWL 2041 kg force.

would have been to tension the cable to a sag of .84 m. This would have resulted in a tension force of approximately 3284 kg. This value significantly exceeds the 2041 SWL rating of the cable grip (note: this also exceeds the SWL rating of the 3 ton Cumalong).

-Specification for the cable grip indicate the cable type as copper. The cable that was being pulled was a jacketed steel messenger. It is therefore not certain that this cable grip was suitable for a steel cable.

-The manufacturer's specifications indicate cable grip is intended for use on PVC covered conductors. The cable that was being tensioned is LLDPE covered conductor/messenger. It is therefore not certain that this cable grip was suitable for the cable.

-The cable specification indicated that the jacketed messenger has a diameter of 12.5 mm. The working range of the cable grip is specified as 7.87 mm - 12.70 mm. It is likely that the cable diameter was within the working range to the cable grip (the cable grip was correctly sized for the cable diameter).
