Incident Summary #II-1318573-2022 (#25892) (FINAL)

SUPPORTING INFORMATION	Incident Date	January 20, 2022		
	Location	Peace River Region		
	Regulated industry sector	Boilers, PV & refrigeration - Boiler and pressure vessel system		
	Impact	Qty injuries	0	
		Injury	Injury description	N/A
			Injury rating	None
	Damage	Damage description	An electric sweet gas heater overheated rupturing the heater shell wall resulting in loss of containment of sweet sales gas into the building.	
		Damage rating	Major	
Incident rating	Major			
Incident overview	An electric heater for sweet gas ruptured from overheating and released sweet gas into the building as the high temperature shutdown was not in operation.			
INVESTIGATION CONCLUSIONS	Site, system and components	<p>This electric seal gas heater is used to heat sweet gas which then is piped downstream to provide positive pressure on seals for a turbo expander as a part of a compressor. Therefore, the heater is called a “seal gas heater”.</p> <p>In normal operation, sales-gas (gas where the hydrogen sulfide is removed, also called “sweet-gas”) normally flows continuously through the heater which uses an electric heating element within the heater’s

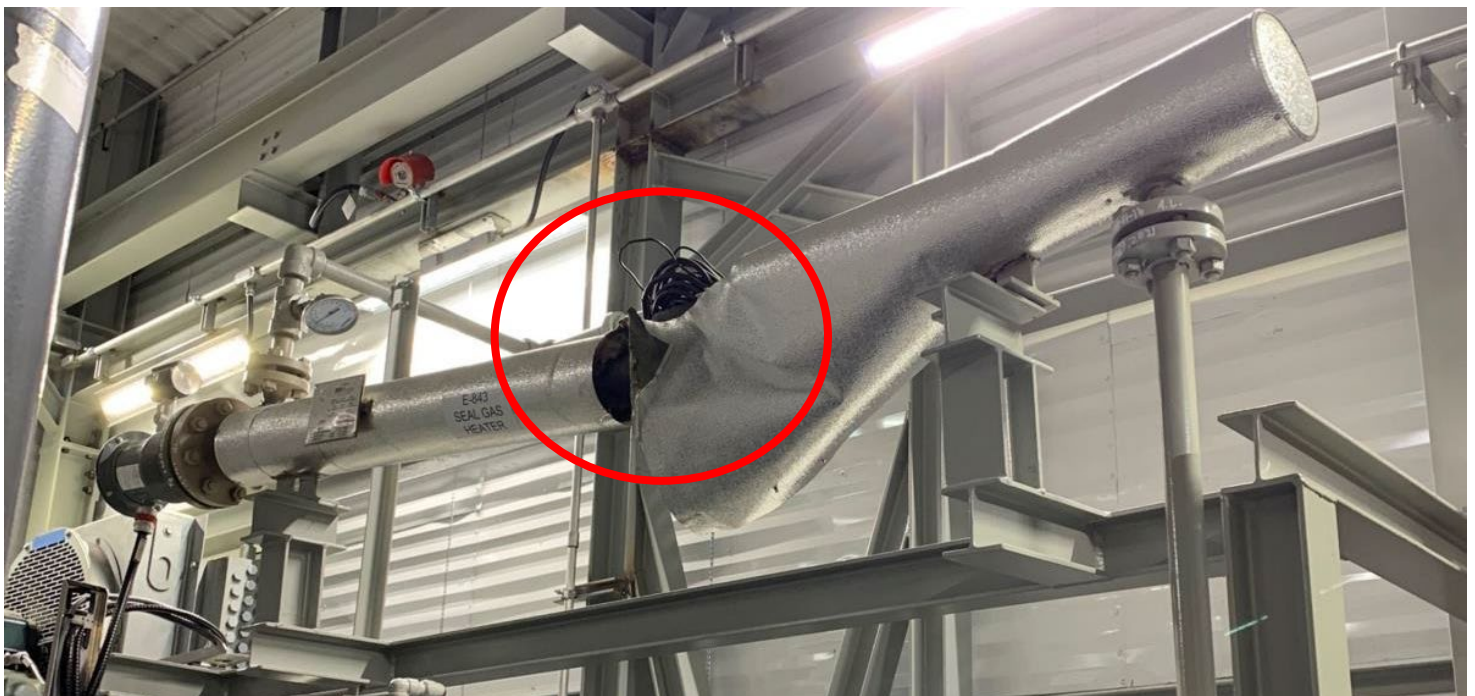
Photo 1: Overview of Heater

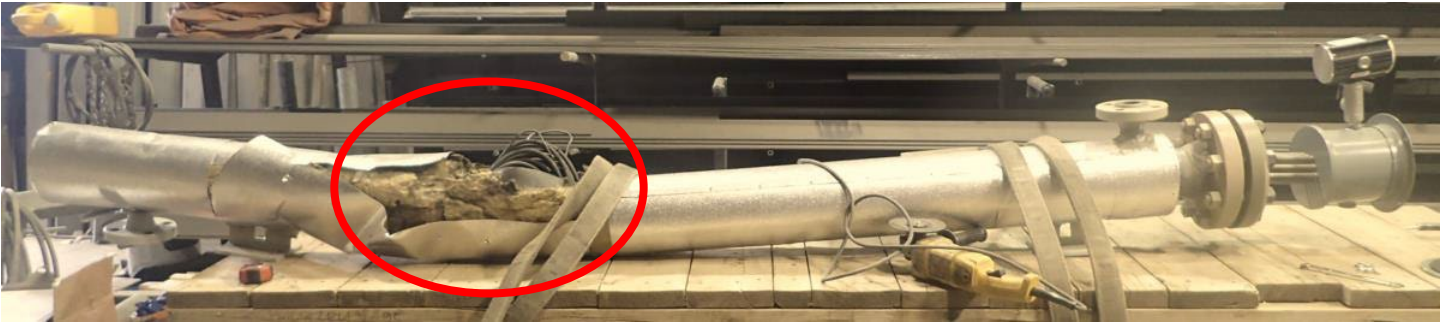
Photo 2: Heater removed from pipe rack

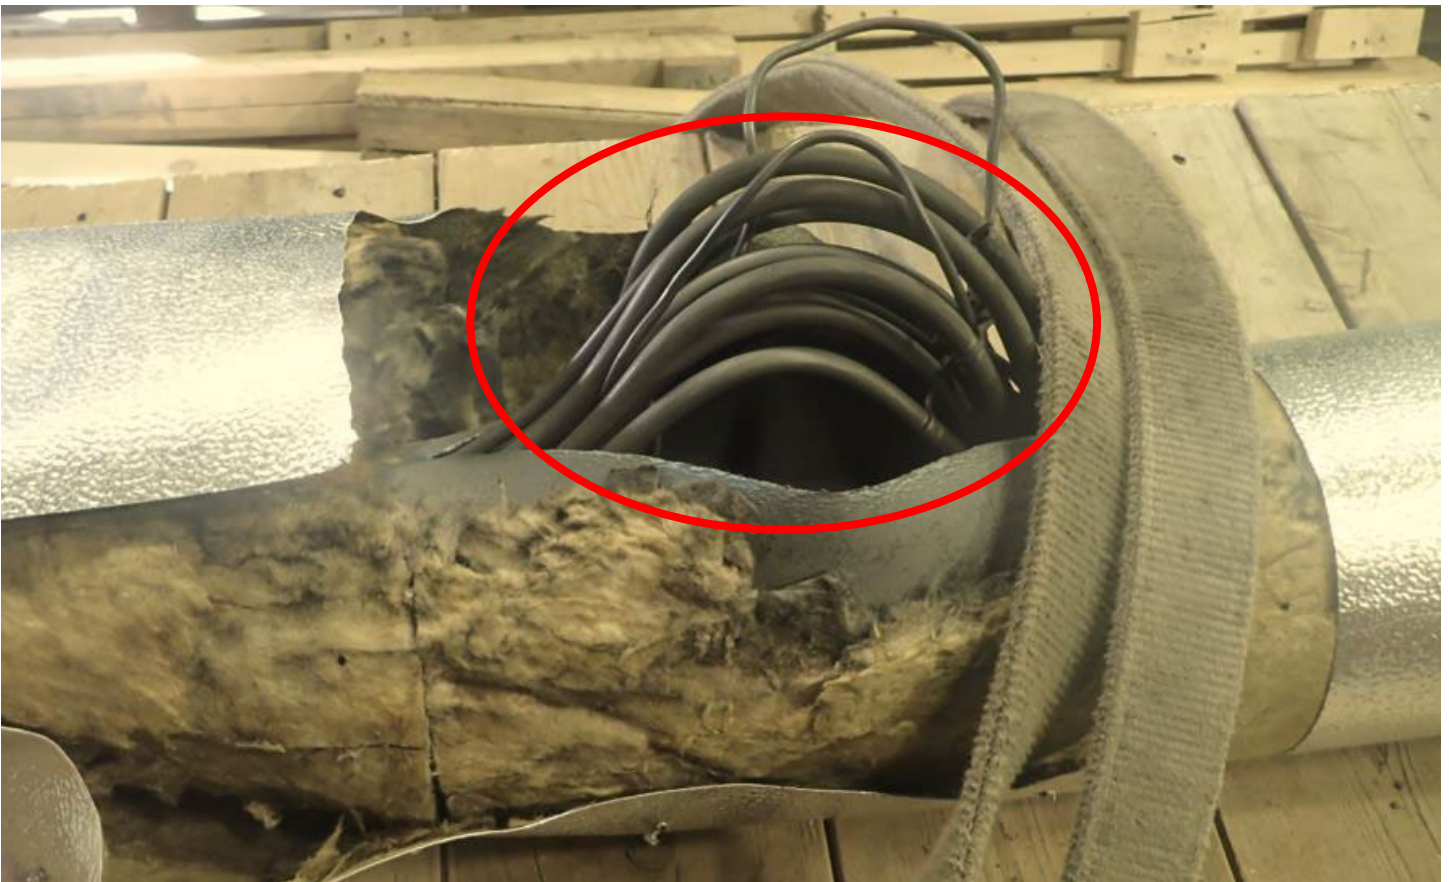
It is very likely that the uninstalled temperature controls was the cause of this incident.

Photo 3: Heating coils displaced through rupture opening
