Incident Summary #II-746278-2018 (#8544) (FINAL)

SUPPORTING INFORMATION	Incident Date	September 11, 2018	
	Location	Richmond	
	Regulated industry sector	Elevating devices - Elevator	
	Impact	Qty injuries	1
		Injury description	Elevator passenger hit head on the wall opposite the elevator.
		Injury rating	Minor
	Damage	Damage description	No damage to the elevator
		Damage rating	None
	Incident rating	Minor	
Incident overview	Elevator passenger was exiting the elevator, as the elevator door was opening with the elevator cab not fully stopped and levelled to the floor. The passenger tripped and hit their head on the wall opposite the elevator.		
INVESTIGATION CONCLUSIONS	Site, system and components	An elevator should be adjusted so that the elevator door will not begin opening until the sill of the elevator cab is within 300 mm (12") of being level to the sill of a building landing. The elevator should be stopped or substantially level with the sill of the building landing before the elevator door is fully opened.

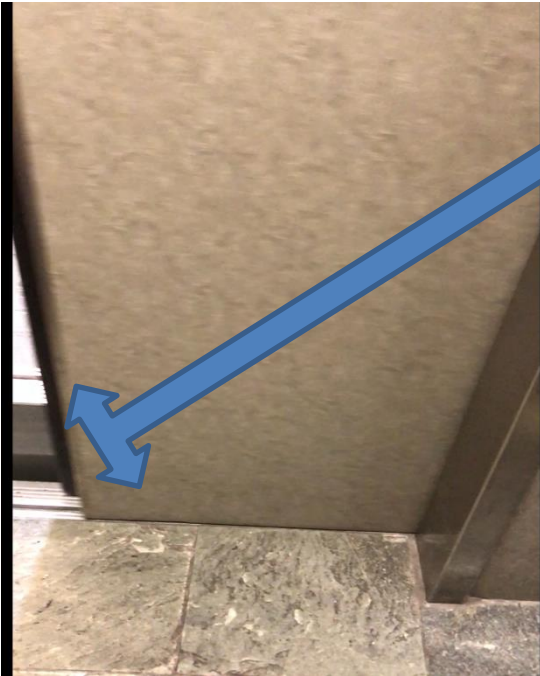
It is most likely that the elevator controller was poorly adjusted as observed and that the elevator was still levelling into the landing even after the door was fully opened. A contributing factor to the mishap could be that the passenger did not observe the elevator cab and landing sills were not level prior to exiting the elevator causing the trip and fall.

Picture 1 - showing the elevator door opening with the sills substantially out of level.

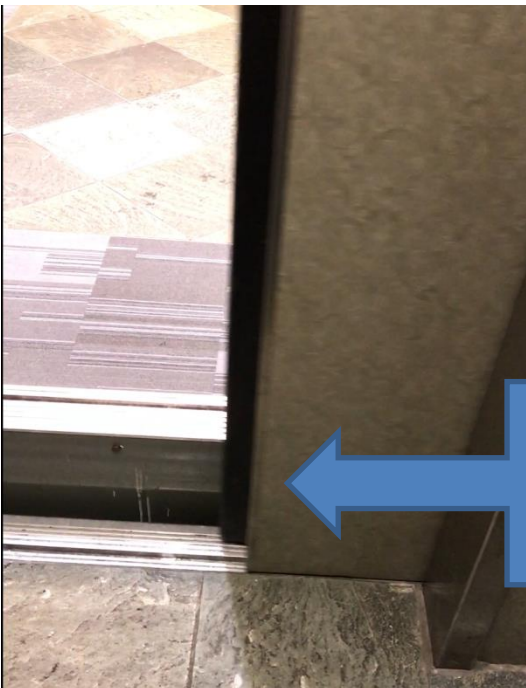
Picture 2 - showing the door opening wider and the elevator cab is still levelling into the landing,

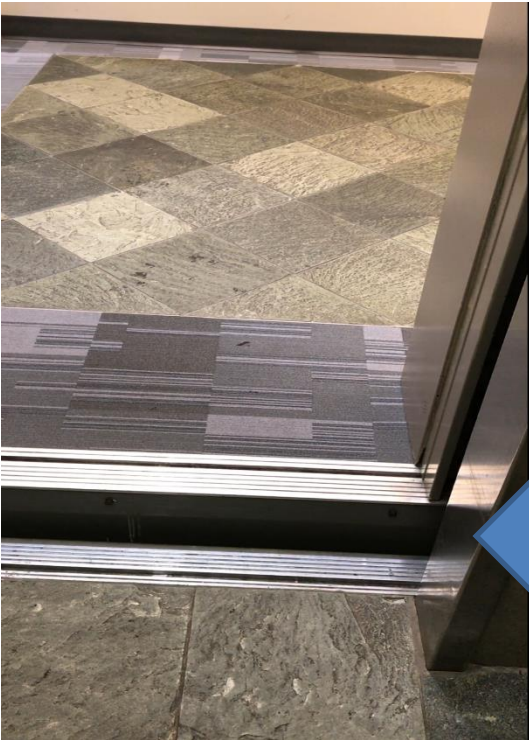
Picture 3 - showing the elevator door fully open and the elevator cab was still levelling into the landing.

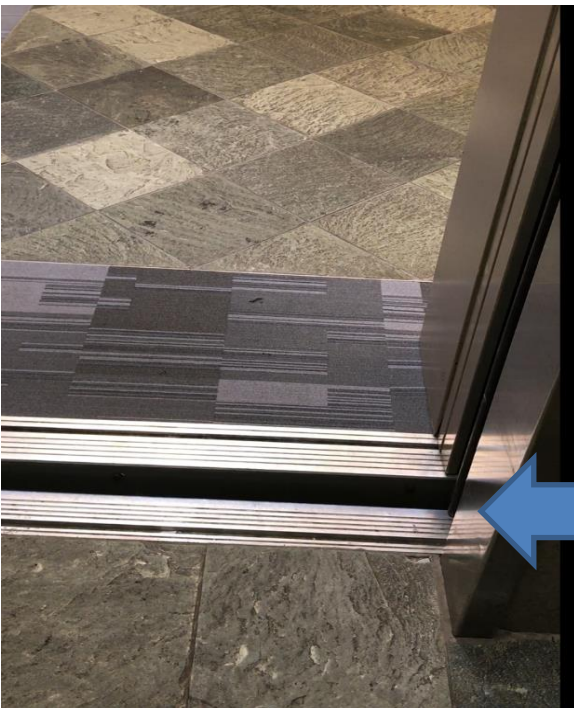
Picture 4 - showing the elevator cab levelling further into the landing.

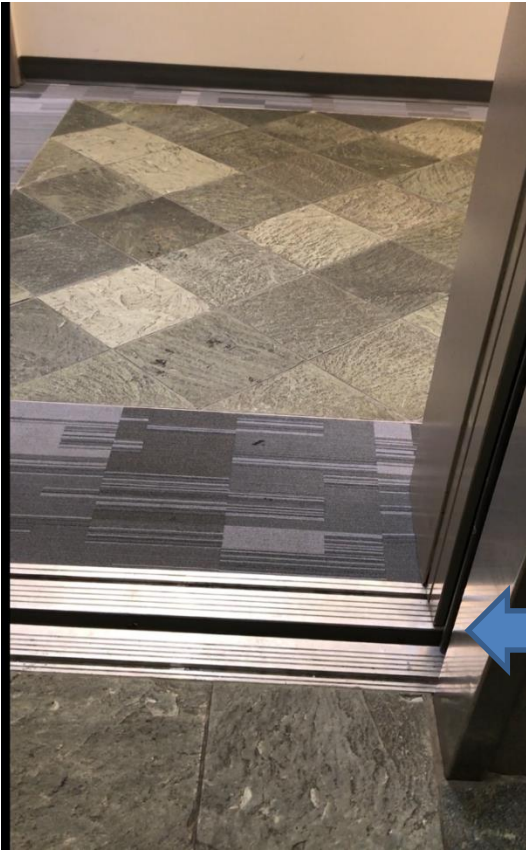
Picture 5 - showing the elevator cab fully level with the landing.
