Incident Summary #II-797439-2019 (#10506) (FINAL)

SUPPORTING INFORMATION	Incident Date	January 7, 2019	
	Location	Coldstream, BC	
	Regulated industry sector	Boilers, PV & refrigeration - Refrigeration system	
	Impact	Qty injuries	0
		Injury description	No Injuries
		Injury rating	None
	Damage	Damage description	Part of a gasket was blown out from a flange on the plate heat exchanger releasing (NH3) ammonia into the machinery room.
		Damage rating	Moderate
	Incident rating	Moderate	
Incident overview	On the plate heat exchanger a machined nut had backed off on the flange bolt that holds the gasket in place causing part of the gasket to be blown out resulting in (NH3) ammonia to leak out.		
INVESTIGATION CONCLUSIONS	Site, system and components	The plate heat exchanger has many grooved plates with gaskets that allows heat from fluid, liquid or gas to pass to a second fluid, liquid or gas without the two fluids having to mix together. The fluid passes through pressure piping that is connected to the plate heat exchanger by a four bolt flange. The essential principle is that it transfers the heat without transferring the fluid that carries the heat. It usually is working to reclaim los

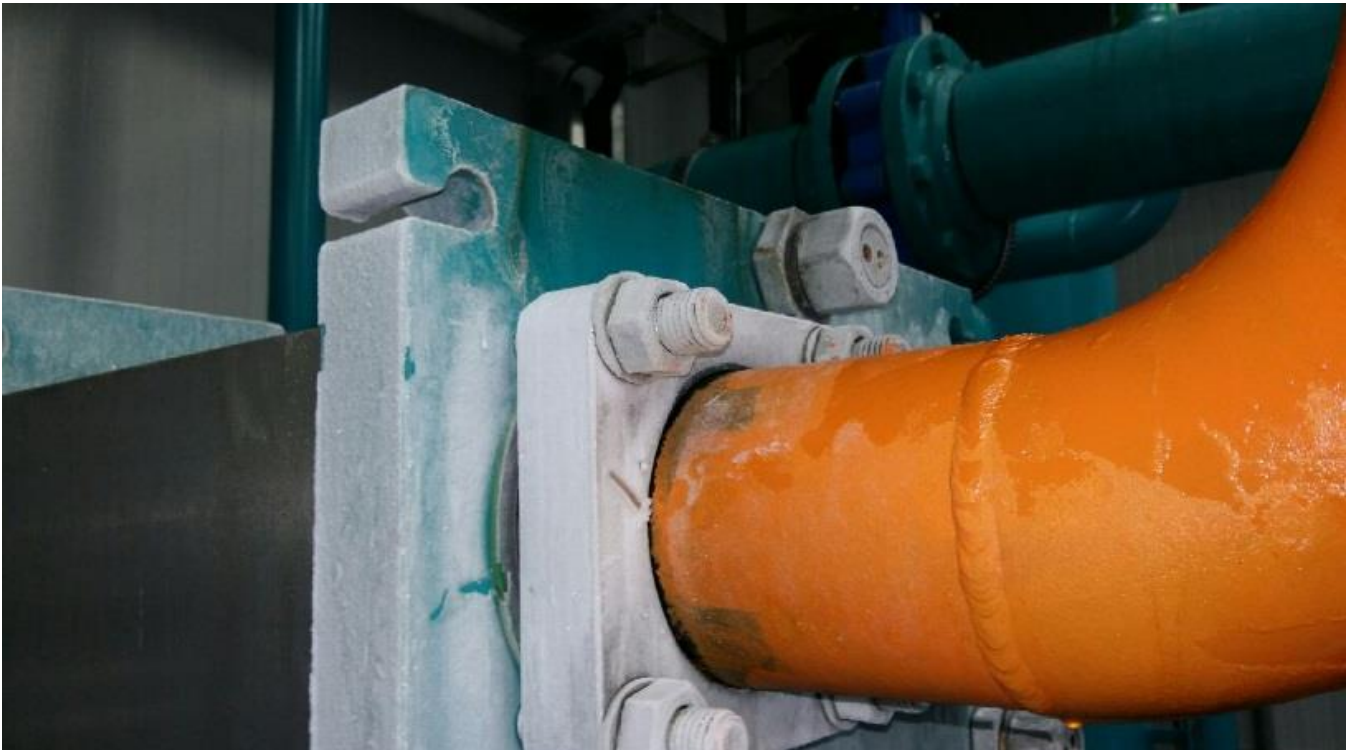
It is highly likely that the missing lock washers did not create a tightening back pressure on the nut after installation which would not maintain the torque specified by the manufacture. The lock washer prevents nuts and bolts from turning, slipping and coming loose because of vibration. The loose nuts on the flange caused the gasket to blow out and created a (NH3) ammonia leak.

Image 1 NH3 Leak – no lock washer on bolts

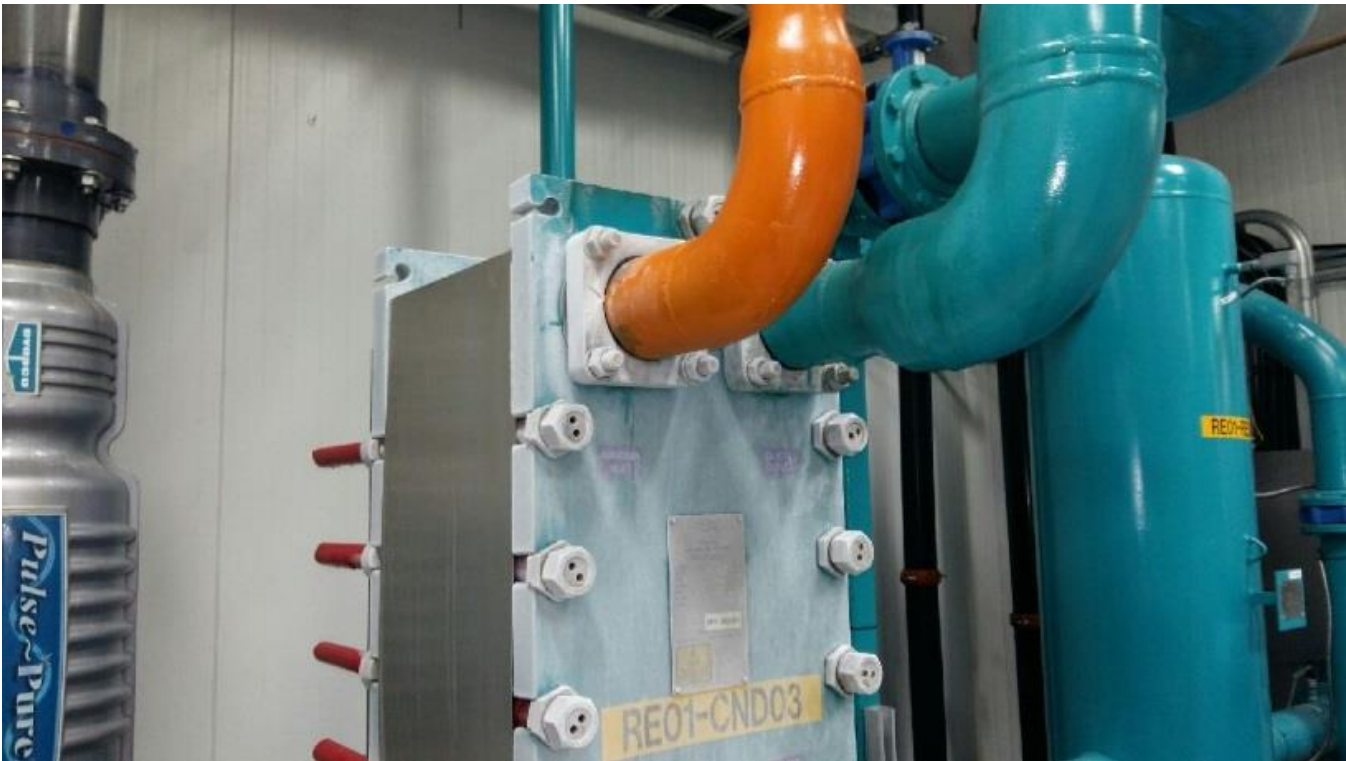
Image 2 Plate Heat Exchanger & NH3 Orange Pipe

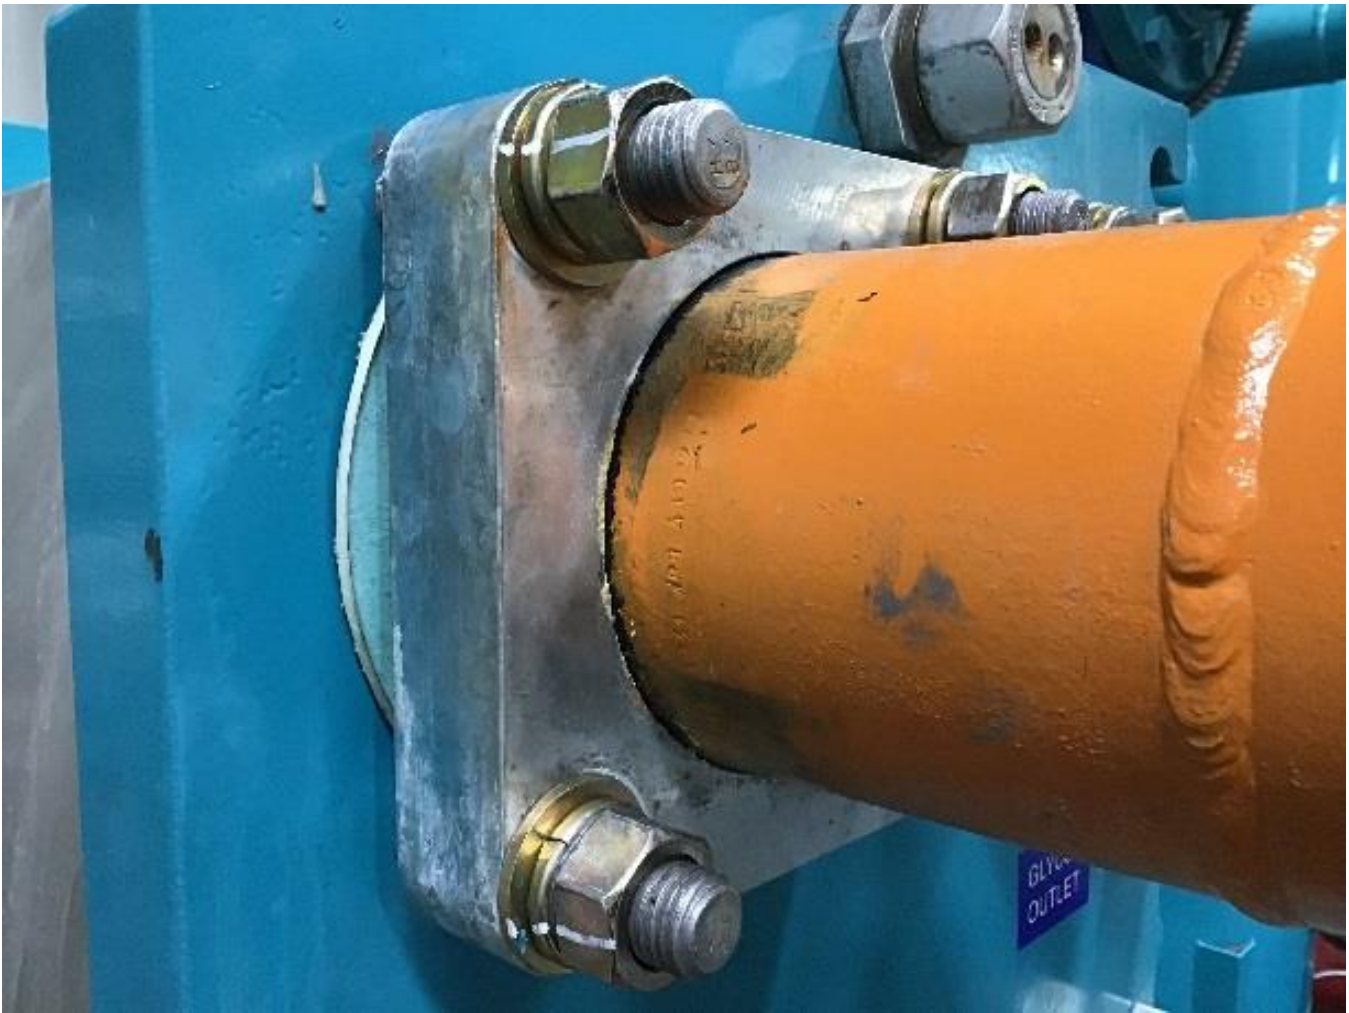
Image 3 New nuts and lock washers

Failure scenario(s)	The plate heat exchanger has (NH3) ammonia flowing through an orange painted pipe that has a flange bolted on the outside of the plate heat exchanger. The bolted flange holds the orange (NH3) ammonia pipe in place by 4 bolts, washers and machined nuts. The nuts loosened from the flange bolts and that created a gap between the gasket and the flange. That then created an area for (NH3) ammonia to escape. The pressure from the (NH3) ammonia gas blew out part of the gasket.	
	Facts and evidence	<p>The (NH3) ammonia was released into the machinery room and the alarm was activated.</p> <ul style="list-style-type: none"> • Upon inspection the nuts on the bolts where very loose and only a flat washer was in place with no locking washer on the bolt. • The manufactured nuts did not fit on to the bolts tightly and lock washers where missing on the bolts. The nuts may have been manufactured with a different pitch than the bolts. • Part of the gasket from the flange that holds the orange (NH3) ammonia pipe was on the floor from being blown out. • The nuts on the bolts showed a gap that indicated they had loosened off from the time of installation and were no longer at the manufactures torqued specifications of 277ft-lbs. • All the nuts where then taken off the bolts and replaced with new nuts and locking washers.

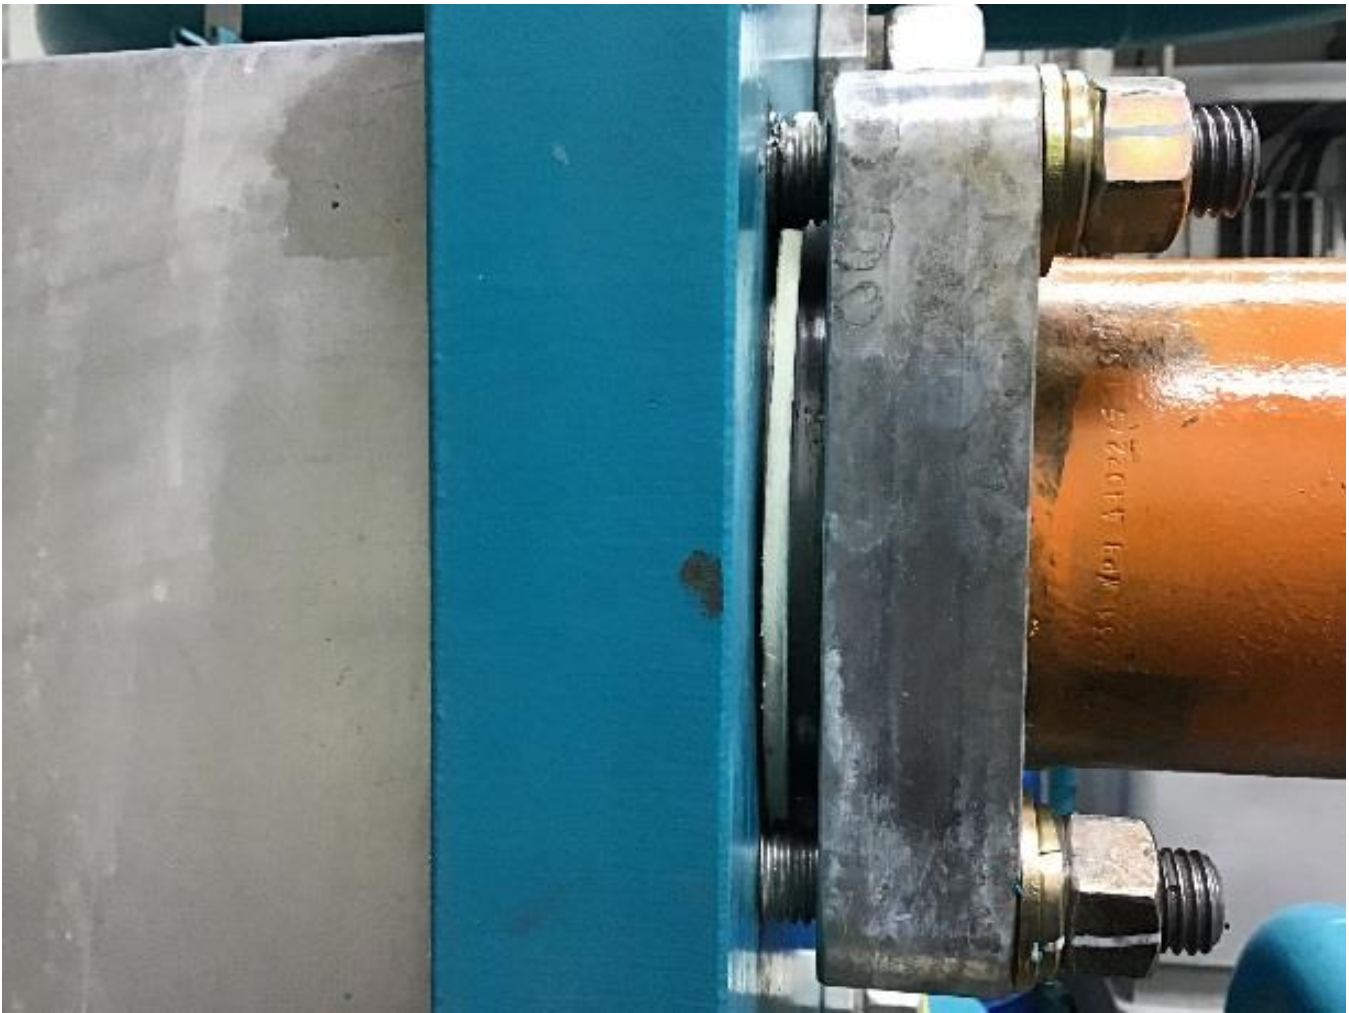
Image 4 NH3 Pipe - new flange gasket

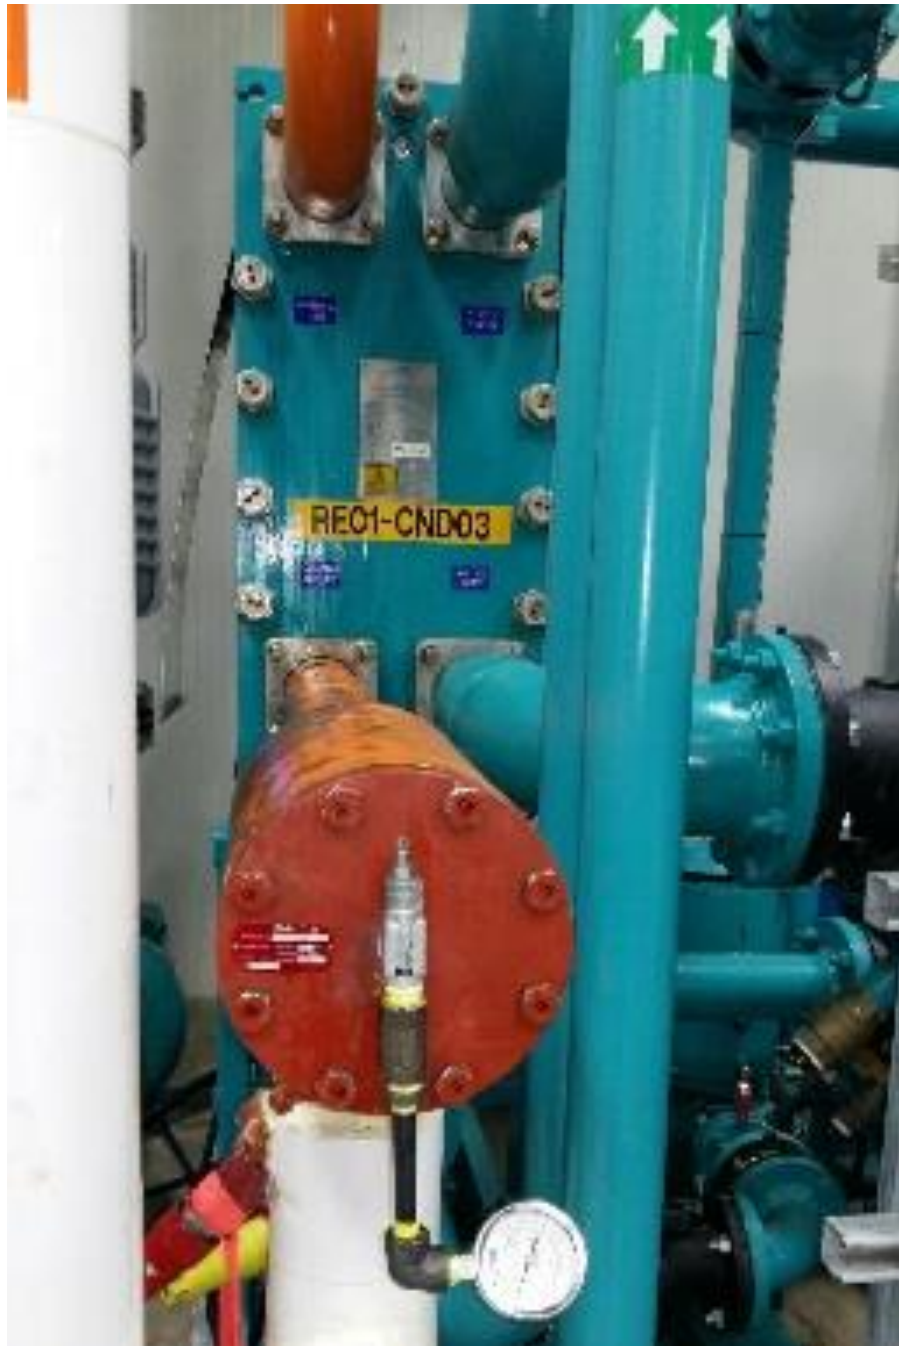
Image 5 Plate Heat Exchanger – NH3 & glycol
