Incident Summary #II-768291-2018 (#9315) (FINAL)

SUPPORTING INFORMATION	Incident Date	October 22, 2018
	Location	Whistler
	Regulated industry sector	Passenger ropeways - Above surface ropeway
	Injury	Qty injuries 1
		Injury description Collapsed lung, multiple rib fractures
	Impact	Injury rating Major
		Damage description NA
	Damage	Damage rating None
		Incident rating Major
	Incident overview	During the construction of an above surface ropeway a worker was assisting in the install of a communication cable onto the ropeway towers. During the process of pulling the communication cable over the towers the cable became jammed on some guide equipment. A subsequent release of the jammed cable and the resulting equalization in tension of the cable caused a line reaction in which the cable was whipped upward nearby the worker. The worker became entangled with the cable causing them to be lifted approximately 3m-4m and the dropped onto hard ground.
INVESTIGATION CONCLUSIONS	Site, system and components	<p>Incident occurred during the construction process of an above surface ropeway. At the time the incident occurred the installation of ropeway tower structures had been completed. The task

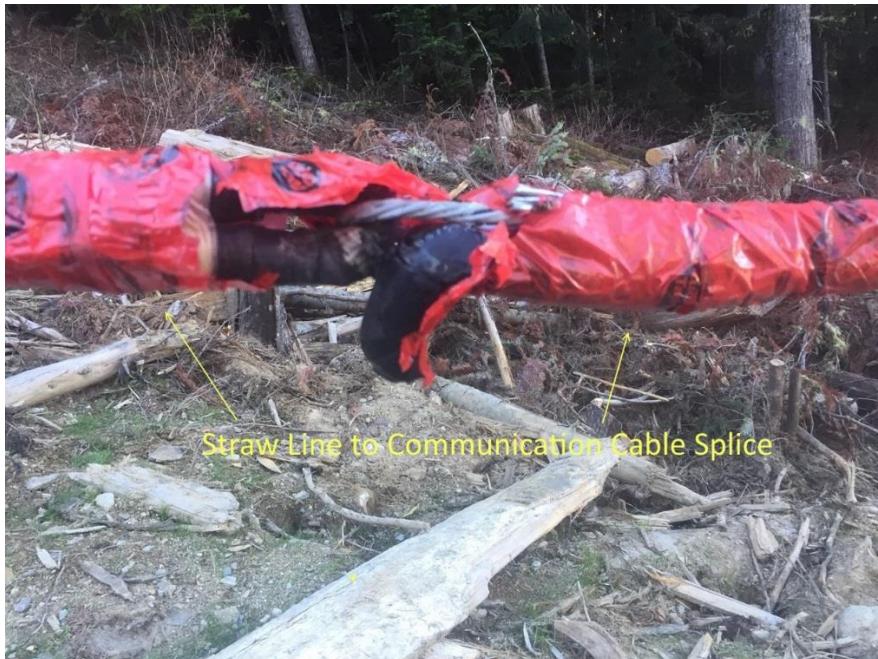
<p>the supervisor of the communication cable install did not have a clear view of all workers in the area.</p> <ul style="list-style-type: none"> The worker that spliced the communication cable to the straw line did not ensure it would run smoothly through the roller stringing blocks.
Causes and contributing factors	<p>It is very likely that the splice connecting the communication cable to the straw line was constructed in a method that allowed it to become jammed or bound up with guide equipment. The splice jammed in the roller stringing block, the sudden release and re-tensioning is what very likely caused the line reaction with which the worker became entangled with.</p> <p>It is certain that the worker was within the reaction zone (bight) of the communication cable that was being installed. As the worker was not provided with clear instructions of hazards and how to avoid them for task of monitoring the cable position. It is plausible the worker was not aware of the bight hazard around the moving/tensioned cable.</p> <p>The person at the bottom station responsible for the supervision of the cable install did not have a clear view of all the workers in the area. It is plausible, that the worker being within the bight hazard zone, was not realized by the supervisor. Further distraction to the workers and supervisors may have also been a contributing factor due to that multiple tasks were being completed in the same area</p>

Figure 2: Straw Line to Communication Cable Splice

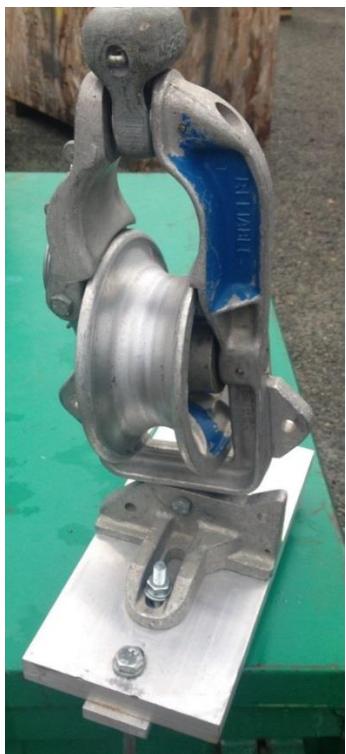
<ul style="list-style-type: none"> Guidance to the cable and straw line is provided by a series of roller stringing blocks temporally mounted along the ropeway lift line. (FigureS 3 and 4)
Failure scenario(s)	<p>The straw line splice to the communication cable became bound up on one of the intermittent roller stringing blocks during the install (while pulling cable uphill). Slack in the communication line developed downhill from the roller string block as tension uphill continued to be applied by the engine powered winch. The subsequent release of the bound-up splice caused a sudden equalization in the communication cable/straw line tension. The reaction due to the equalization in tension caused the communication cable to whip upward and entangle a worker.</p>
Facts and evidence	<p>The factual information regarding this incident is based on discussions had with contractors representatives and reports provided by the contractor:</p> <ul style="list-style-type: none"> The worker was on loan to a ropeway install contractor from the operating contractor. The worker was assisting in the installation of communication cable along lift towers. The worker was initially assigned to the task of assisting in pulling the straw line downhill. A task deemed by the contractor, that the worker was experienced enough to conduct. Upon completion, the worker was re-tasked with a job to monitor the communication cable as it unraveled from the spool and moved past the bottom operator station. Report indicates that the worker was instructed to "watch the cable" with no clear instructions of the hazards and how to avoid them. As tension was being pulled on the communication cable/straw line the splice traveling through a roller stringing block mounted on tower #3 became jammed inside the block. An all stop was called by radio and both winch operator (top of ropeway) and brake operator (at bottom of ropeway) stopped the cable spools. Some of the cable spooled off the reel and ended up gathering on the ground near the bottom station lift hut during the stop. During the stop period the worker stepped near the cable to adjust it. The cable splice became dislodged from inside the roller stringing block and the cable that had gathered on the ground near the bottom station hut became under tension. As the cable tensioned it sprung up catching the worker standing near it. The worker was lifted 3m-4m and then fell landing on their side. <p>Further reports provided by the contractor relating to instructions, site and equipment indicated that:</p> <ul style="list-style-type: none"> At the bottom station multiple tasks were being completed in the same area; crane lifting roof station panels into place, IT personnel working in and around the lift hut installing a cable (not related to communication cable being installed on the towers). The person responsible for the supervision of the communication cable install at the bottom station did not communicate an operational plan to all the workers in the area. While the installation process was occurring, the person responsible for

Figure 3: Roller Stringing Block
