## Incident Summary #II-1484979-2022 (#30753) (FINAL)

| | Regulated industry sector | Boilers, PV & refrigeration - Boiler and pressure vessel system | |
| Incident overview | A Kraft pulp mill recovery boiler had been firing on natural gas only for an extended period. An operator opened one of the 4 plugged spouts and a sudden release of accumulated molten smelt resulted in heavy runoff into the dissolving tank. Water and smelt came into contact and smelt-water explosions occurred resulting in damage to surrounding equipment and structures. | | |

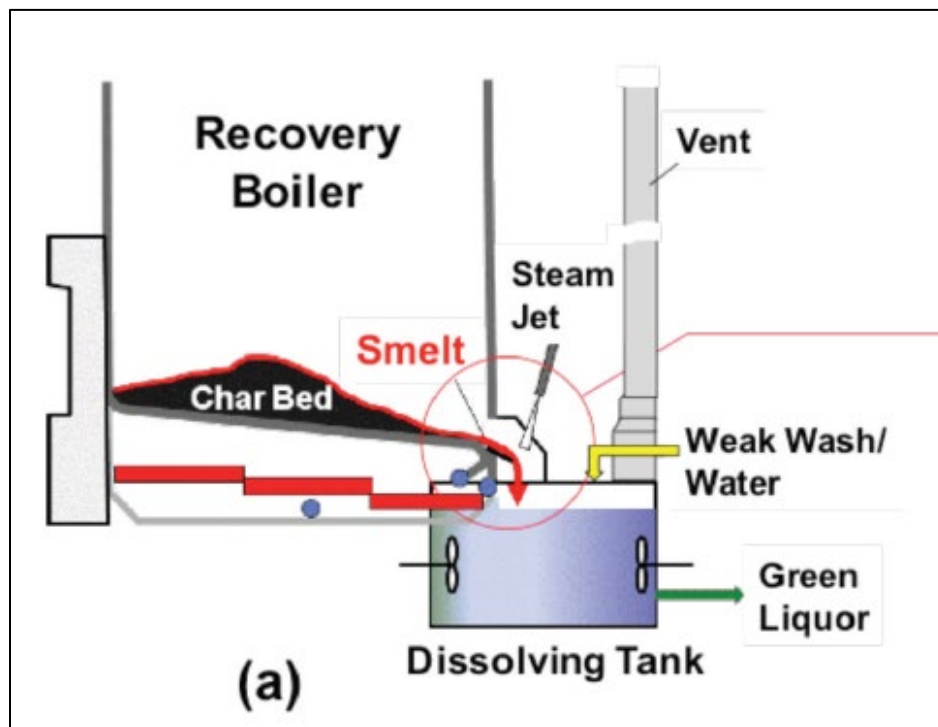
**Figure 1** - Explanatory diagram of system.

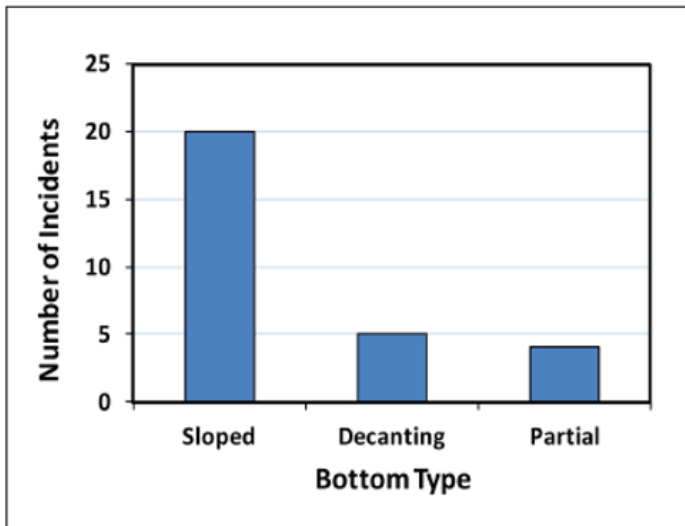
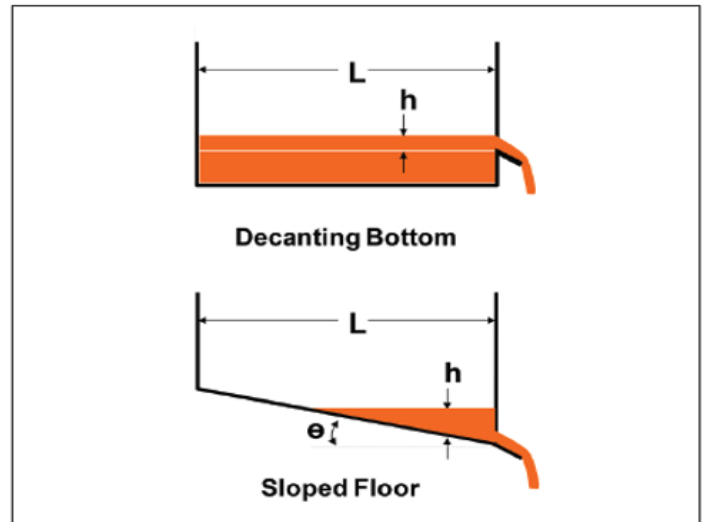
| <p>Facts and evidence</p> | <p>This recovery boiler has a sloped hearth with spouts on the front wall (bottom of slope). A review of industry incident reporting finds that the boiler geometry of the lower furnace plays a significant role in runoff events. Sloped floor units are more vulnerable to smelt buildup and heavy runoff incidents because the spouts may plug more easily and they rapidly develop hydrostatic head, which is the driving force for smelt flow. The location of this boiler's spouts relative to the nose arch can affect the likelihood of spouts plugging when material sheds from the upper furnace. The geometry of the "bullnose" or "nose arch" being on the back wall does not provide protection from material shedding from the upper furnace superheaters.</p> <p>Mill operational cycling resulted in fluctuation in black liquor chemistry. The liquor chemistry was stated as being conducive to forming "jelly roll" smelt, which is more prone to plugging of spouts. The 4 boiler spouts were reported to have been plugging up periodically and spouts were opened several times.</p> <p>Prior to the incident, deposits were stated to have been noticed on the superheaters and a char bed on the floor was observed. After the event, it was observed that the hearth was very clean, this suggests that any char bed buildup had been since been consumed.</p> |

| <p>Causes and contributing factors</p> | <p>The primary contributing factor to the incident was the boilers sloped hearth design and operational fluctuations contributing to likelihood of smelt build up and heavy runoff.</p> <p>Additional contributing factors include:</p> <ul style="list-style-type: none"> <li>- A lack of effective procedures in place to address extended periods off liquor and on auxiliary fuel firing.</li> <li>- The abnormal situation of extended natural gas firing without black liquor likely contributed to a degree of complacency and incorrect understanding of the presence of molten smelt in the boiler.</li> </ul> |

2. Summary of heavy runoff incidents in recovery boilers with different bottom types.

10. Smelt pools in sloped and decanting bottom units.

**Figure 2** - Boiler geometry affects likelihood of dissolving tank explosions.

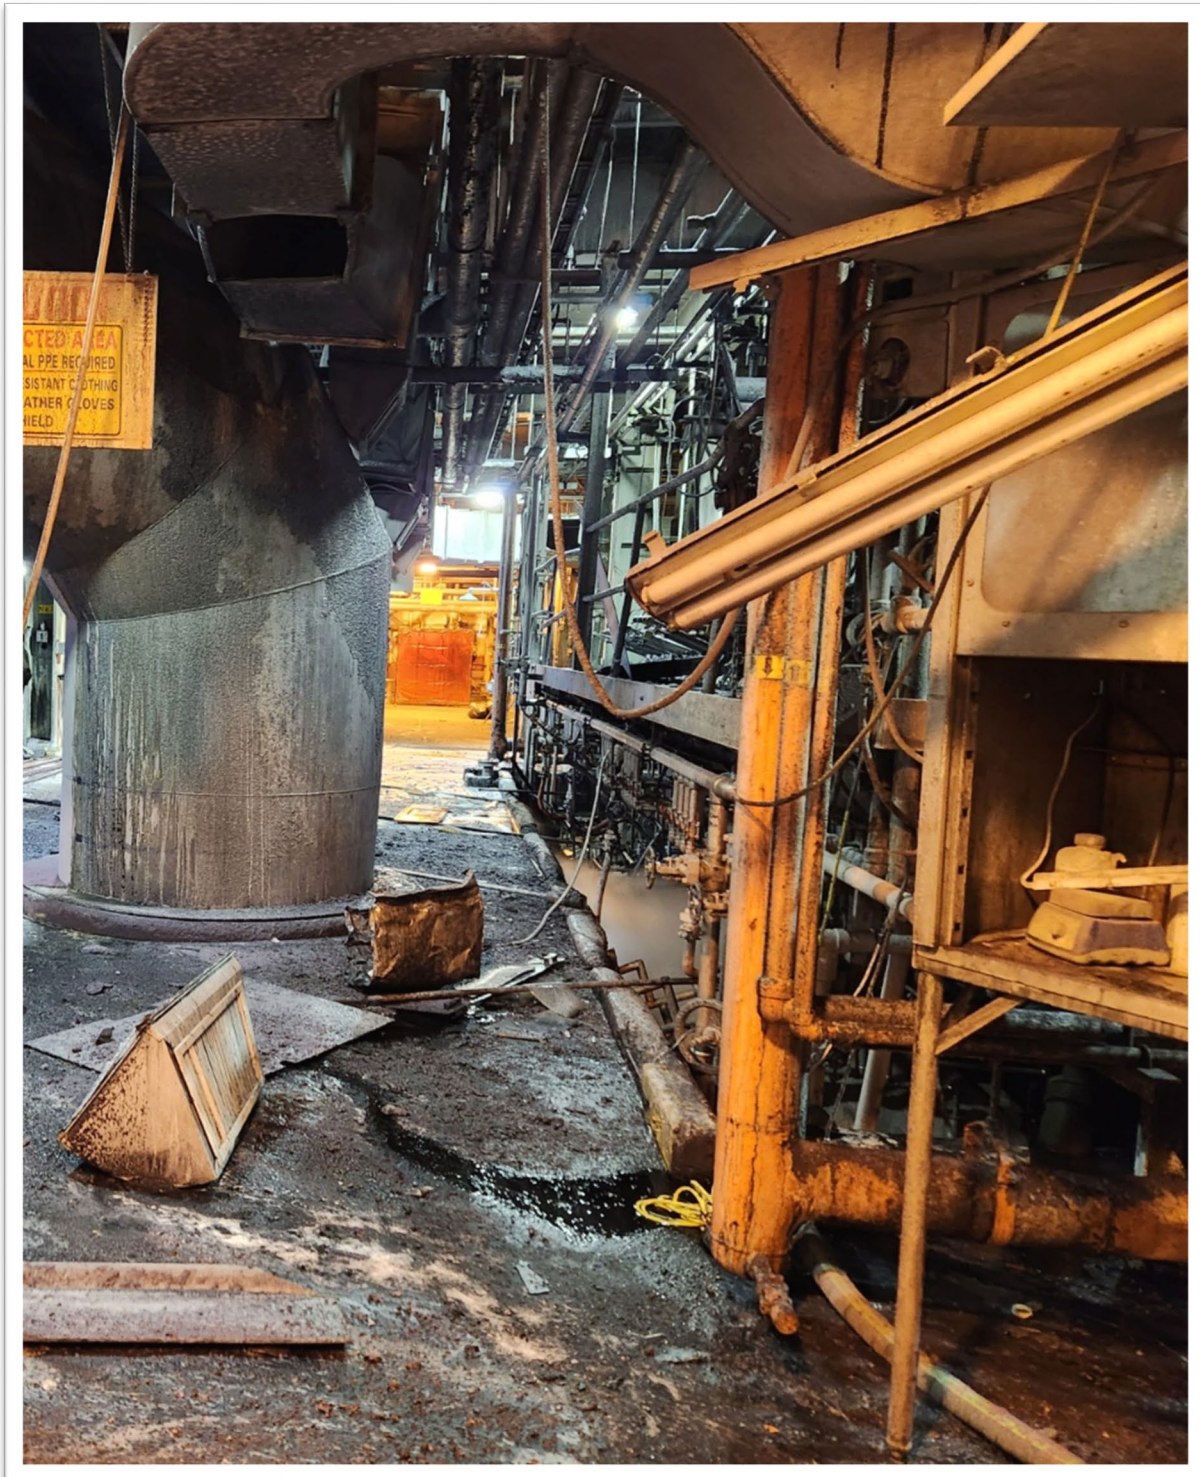
**Photo 1** – Location of recovery boiler smelt spouts and dissolving tank.

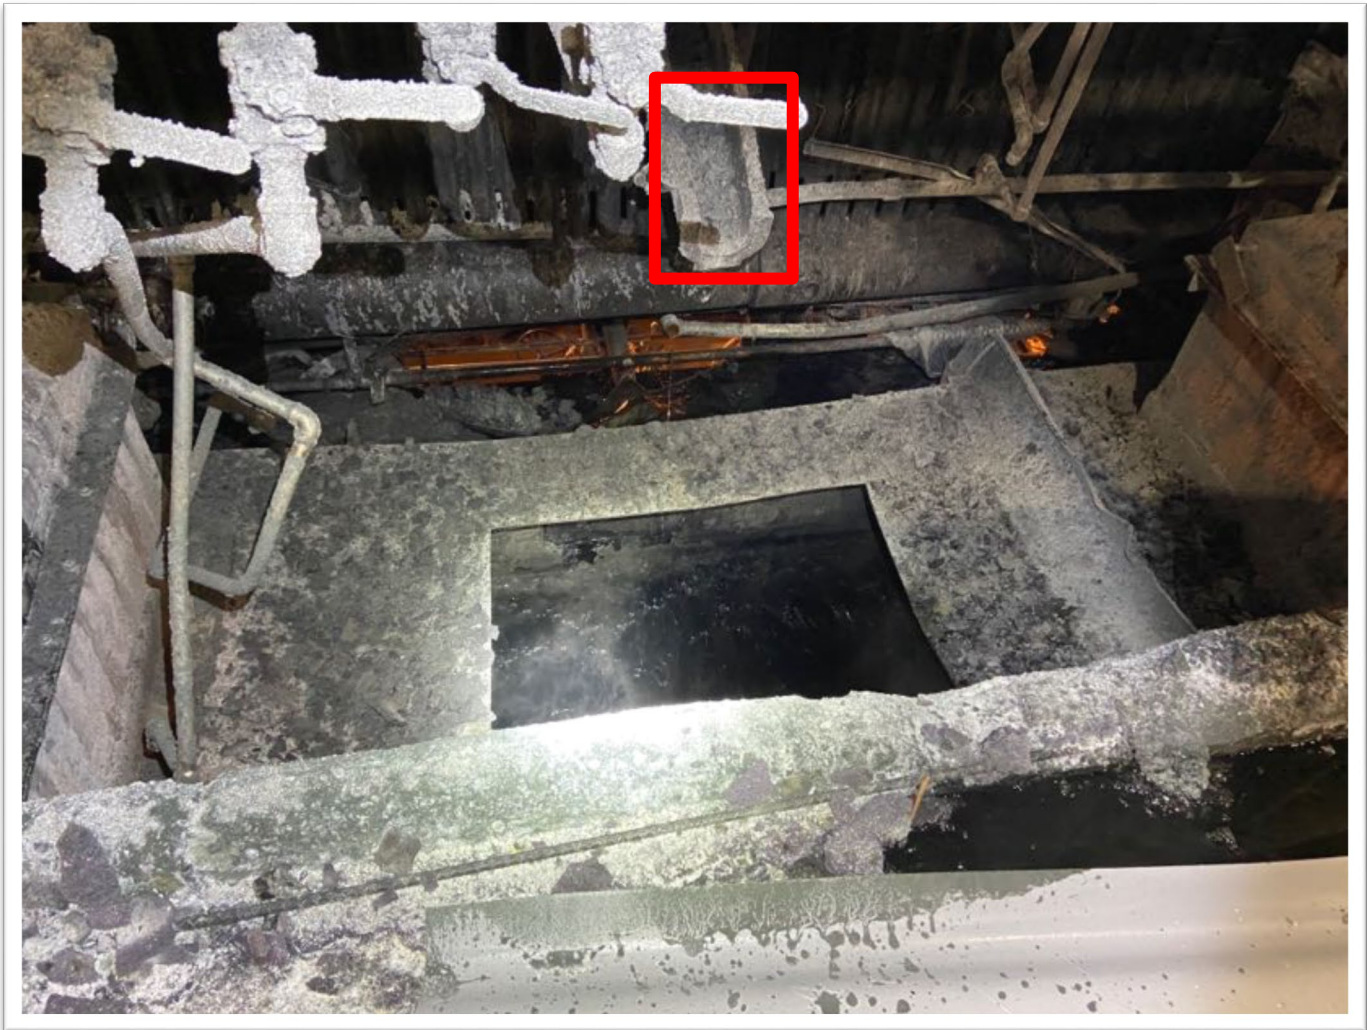
| | Impact<br>Damage | Damage description | Boiler, building, and elevator cladding broke free. There was extensive damage to the dissolving tank roof and support beam. A smelt spout and nearby small-bore piping were damaged. The spout hood disconnected and dropped into dissolving tank. |

**Photo 2 – RED:** Smelt spout and opening to dissolving tank. Note that the shatter spray cover is missing and was later found inside the tank.
