Incident Summary 1005087

SUPPORTING INFORMATION	Incident Date	<i>December 27, 2017</i>	
	Location	<i>Comox</i>	
	Regulated industry sector	<i>Refrigeration System</i>	
	Impact	Qty injuries	<i>0</i>
		Injury description	<i>None</i>
		Injury rating	<i>None</i>
	Damage	Damage description	<i>Bonnet gasket leaking from chiller isolation valve to oil pot</i>
		Damage rating	<i>Minor</i>
Incident rating	<i>Minor</i>		
Incident overview	<i>The bonnet gasket on the isolation valve between the brine chiller and the oil pot leaked approximately 10 lbs ammonia into the mechanical room. Two refrigeration technicians were completed draining oil from the oil pot and when isolation valve was closed the bonnet gasket leaked ammonia into the brine chiller insulation. The ammonia detection alarm did not activate and the arena was closed to the public.</i>		
INVESTIGATION CONCLUSIONS	Site, system and components	<i>The refrigerant plant is an indirect closed surface system, critically charged, risk assessed public assembly arena using R717 ammonia as refrigerant. There are two compressors totalling 119kw. Oil draining of the brine chiller through the oil pot is part of the regular maintenance occurrin

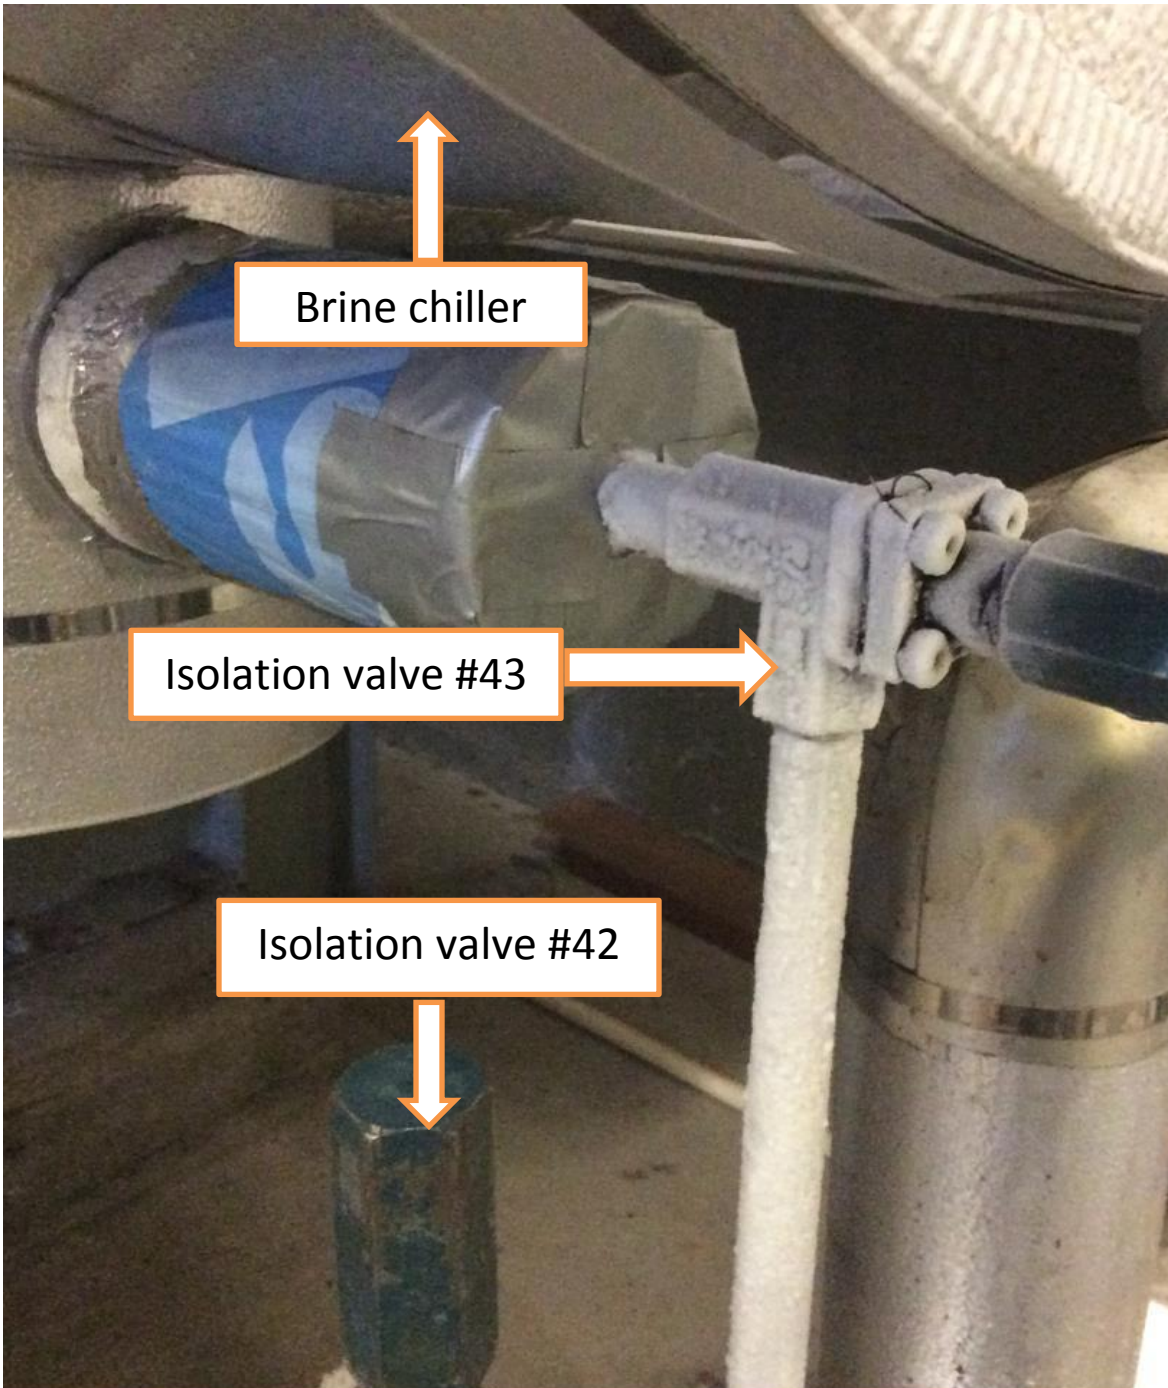
Isolation valve 43

Failure scenario(s)	<i>The bonnet gasket on isolation valve #43 between the brine chiller and the oil pot leaked ammonia due to the loose bonnet bolts which caused the bonnet gasket to leak liquid ammonia. Isolation valve #43 is usually coated with built-up ice which requires additional force to operate.</i>	
	Facts and evidence	<p><i>At approximately 12:30pm, two refrigeration technicians completed draining oil from the oil pot from the brine chiller. When isolation valve #43 was closed liquid ammonia leaked from the bonnet gasket. Ammonia also gathered into the surrounding insulation which became saturated with ammonia gas. When the employees smelled a strong presence of ammonia the plant was shut down, the ventilation fans were turned on to high, the mechanical room was evacuated, and the fire department and refrigeration contractor were called. The plant was closed to the public at the time of the incident. The ammonia detector did not activate as it was turned off prior to the employees draining oil.</i></p> <p><i>The refrigeration contractor determined that the ammonia leaked from the bonnet gasket. The four bolts that tighten the gasket between the bonnet and the body were loose and required tightening to correct the leak. No leak was determined on the valve stem. The valve is usually coated with built-up ice and the refrigeration technicians stated that the valve is difficult to operate due to the ice conditions. Additional force is usually required to operate the valve which can result in loosening of the bonnet bolts. The valve tag had turned green which indicated previous leakage and the refrigeration technicians confirmed that they had detected ammonia previously. There was no record of maintenance for the isolation valve.</i></p> <p><i>The ammonia detector was turned off prior to draining the oil from the oil pot to avoid nuisance alarms which is not part of the written oil draining procedure. With the detector off the ammonia concentration could not be determined.</i></p>

It is probable that the contributing factors of isolation valve #43 bonnet gasket leaking was the continuous use of additional force in opening the valve when the valve had ice build-up, the employees not noticing the leak getting worse over a period of time, and with the ammonia detector turned off during the oil draining procedure the ammonia levels could not be determined if the ammonia concentration was increasing.
