## Incident Summary 5616104

SUPPORTING INFORMATION	Incident Date		May 16, 2017	
	Location		Delta B.C.	
	Regulated industry sector		High voltage electrical system greater than 750 volts	
	Impact	Injury	Qty injuries	one
			Injury description	One person sustained loss of consciousness after receiving an electrical shock. The person sustained an entry burn to their right elbow and exit wounds to their right hand, top of head and left shoulder.
			Injury rating	Major
	Damage	Damage	Damage description	No damage occurred to the system
			Damage rating	None
	Incident rating		Major	
	Incident overview		<p>Workers were replacing the existing 4160 volt high voltage switch gear in a substation.</p> <p>While working on the inside of the equipment that was thought to be de-energized an electrician received a shock. Medical personnel responded and the electrician was transported to a medical facility.</p>	
INVESTIGATION CONCLUSIONS	Site, system and components		<p>The site is a bulk loading facility that consists of a series of conveyers, offloading and loading equipment from rail cars to ships.</p> <p>Existing 4160 volt high voltage switchgear was in the process of being replaced with new modern

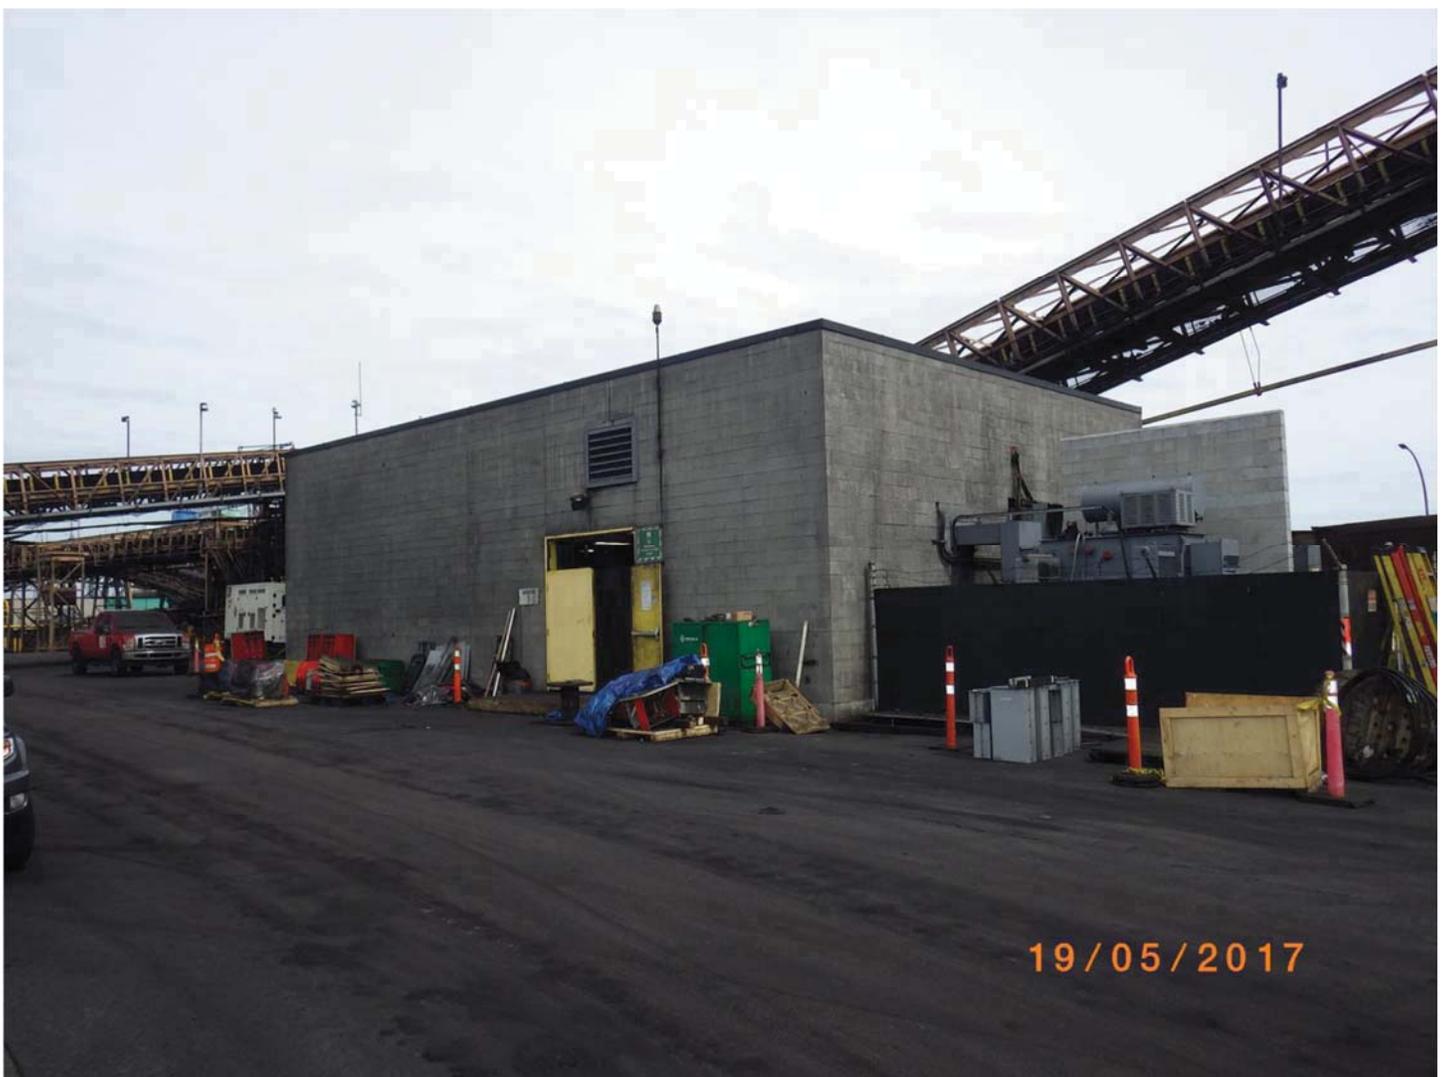
Photo 1,  
Photo indicates the exterior view of substation number 5 where the electrical switch gear inside the building was being replaced. The photo also shows one of the two 13,800/4160 volt, 5 megawatt step down transformers that feeds the electrical distribution equipment inside the building.

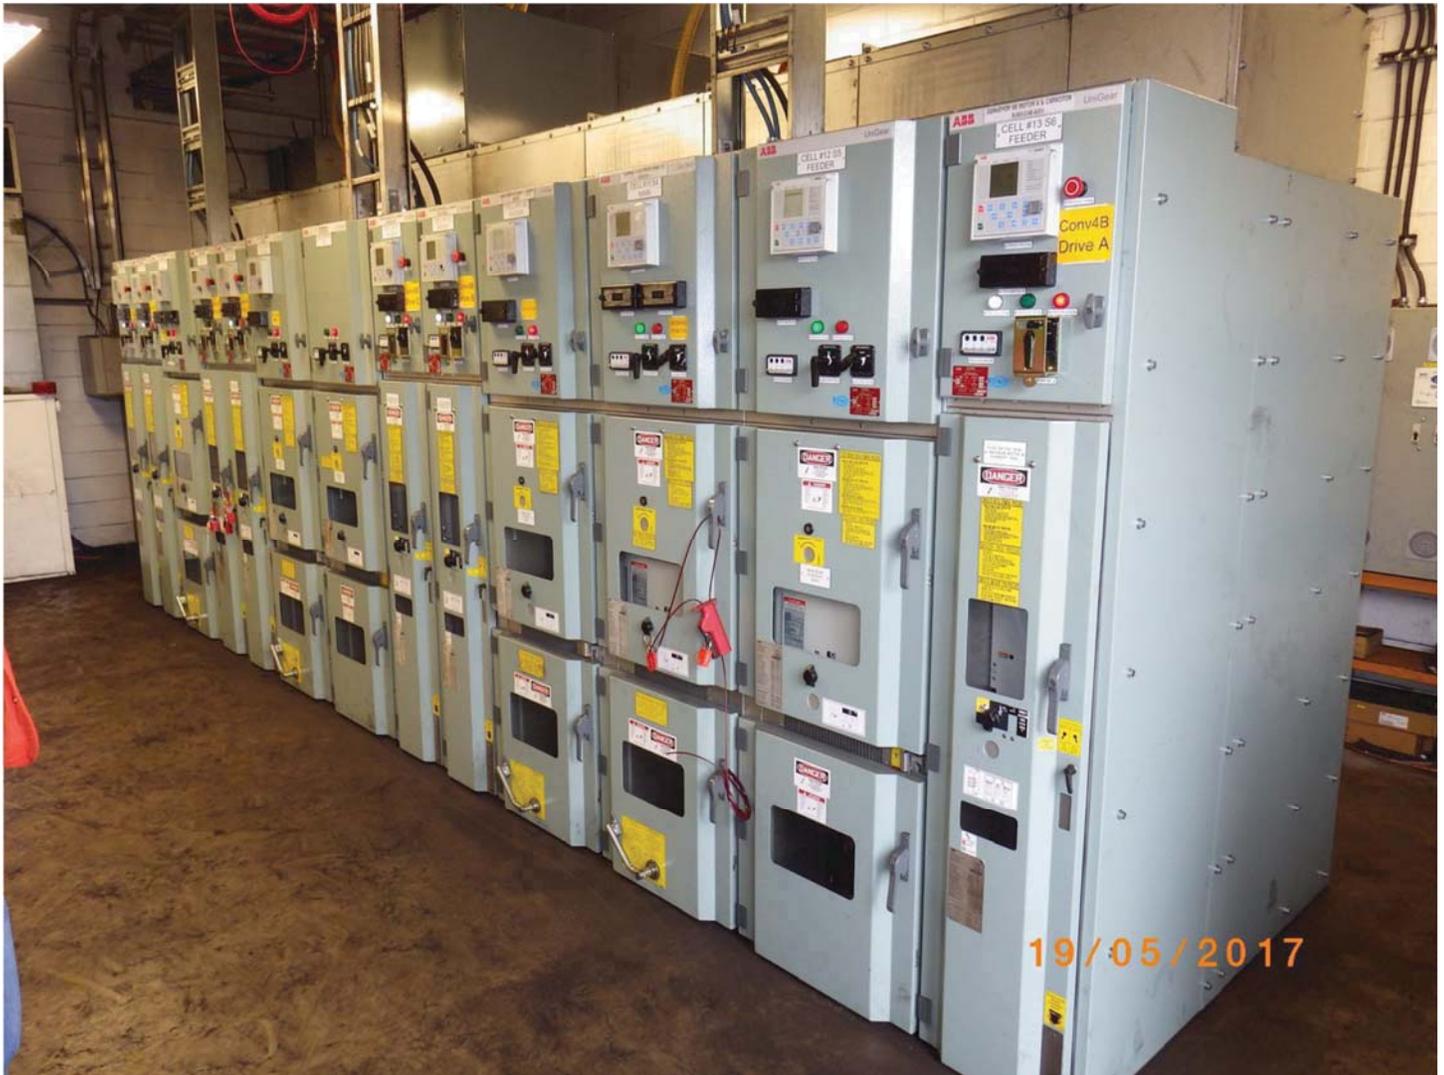
Photo 2:  
Overview of the newly installed 4160 volt electrical switch gear.

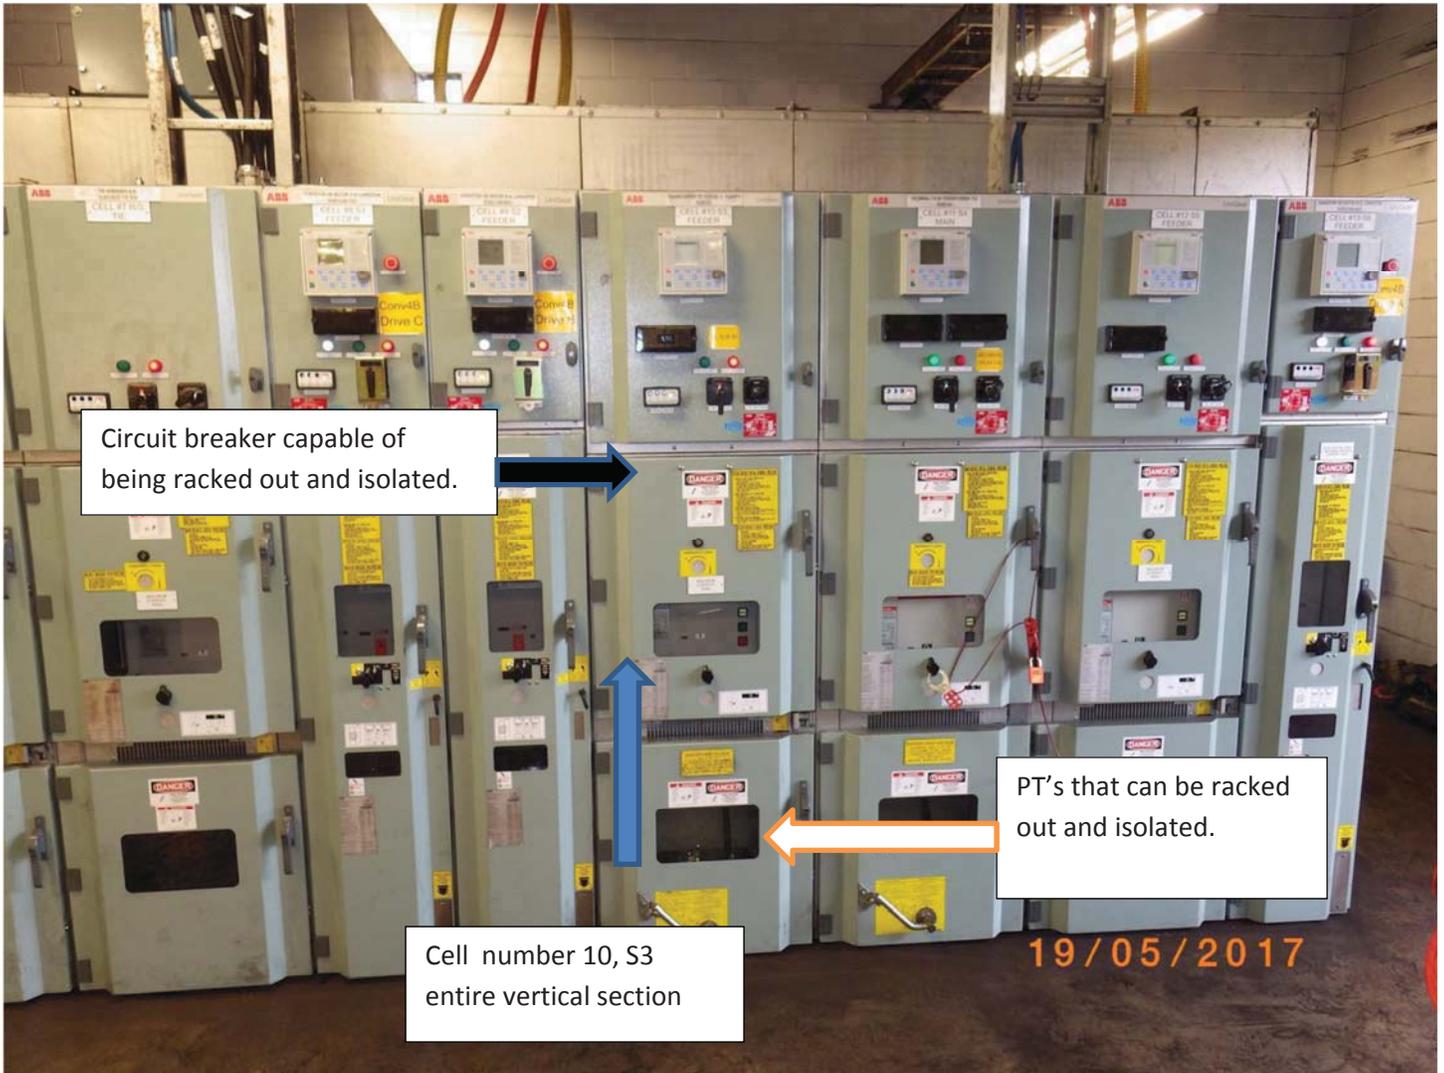
Photo 3:

Frontal view and location of “cell number 10, S3 Feeder” identified with the blue arrow. Lower enclosure contains the Potential Transformers used for control circuitry (Tan arrow), The middle enclosure (black arrow) contains the 4160 volt, high voltage circuit breaker which can be racked out so that electrical work can be safely performed on the equipment downstream from this point.

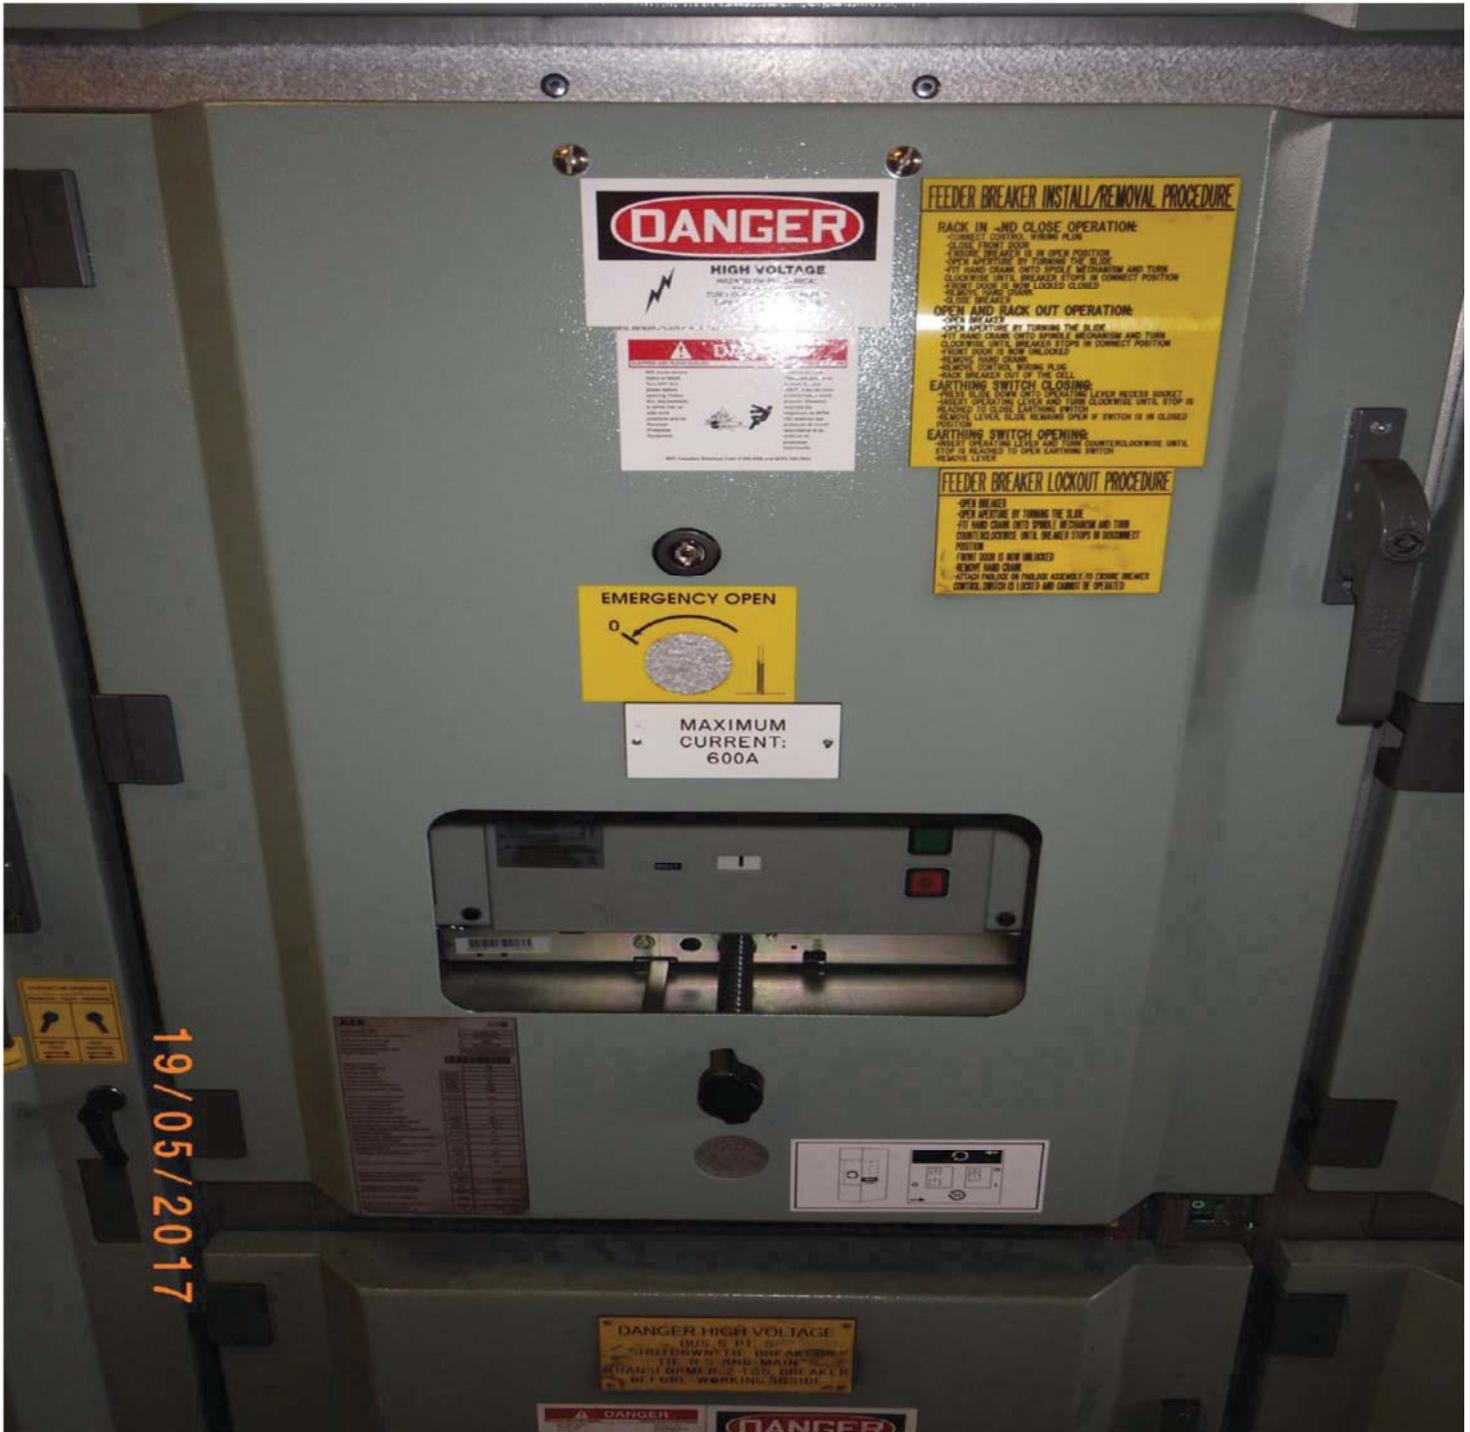
Photo 4:  
Front view of the circuit breaker for cell 10, S3 Feeder,

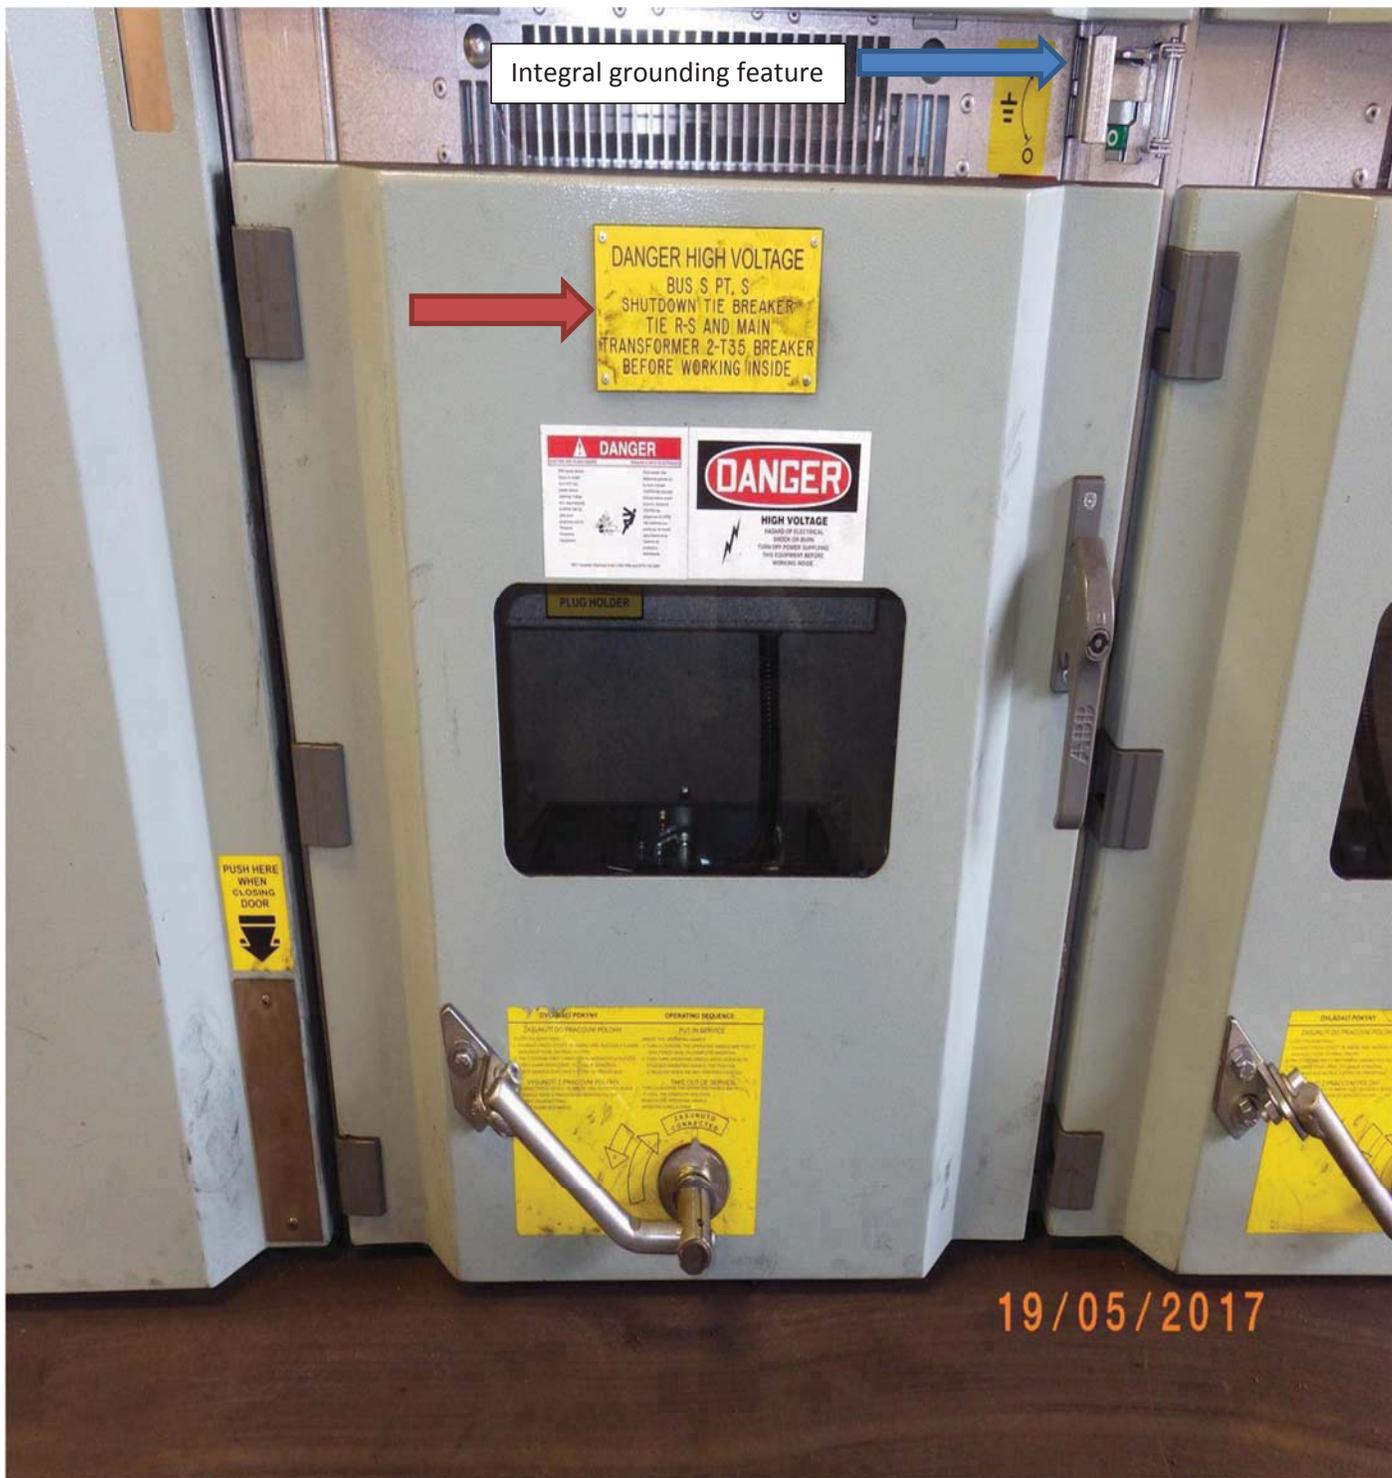
- The existing neutral grounding resistor was open and that it had been replaced,
- Employee of electrical sub-contractor tested for potential voltage at the cable termination bus using a modiewark high voltage tester,
- Confirmed modiewark high voltage testing on the 4200 volt scale, but did not test within the entire cable termination enclosure,
- Could not install the grounding cables due to the lack of room within the cable termination enclosure,
- System integral grounding device had been applied. (System Integral grounding is an internal grounding system built within the equipment thereby eliminating the requirements to manually apply grounding conductors to the phase conductors. See photo 5)
- Had we known that other voltages were present we would not have conducted work in this manor

Photo 5: Frontal view, PT enclosure of cell 10 indicating the procedure to follow before working inside the enclosure (red arrow). Blue arrow indicates an integral grounding device that will ground the load side of the equipment without having to use the grounding cables.

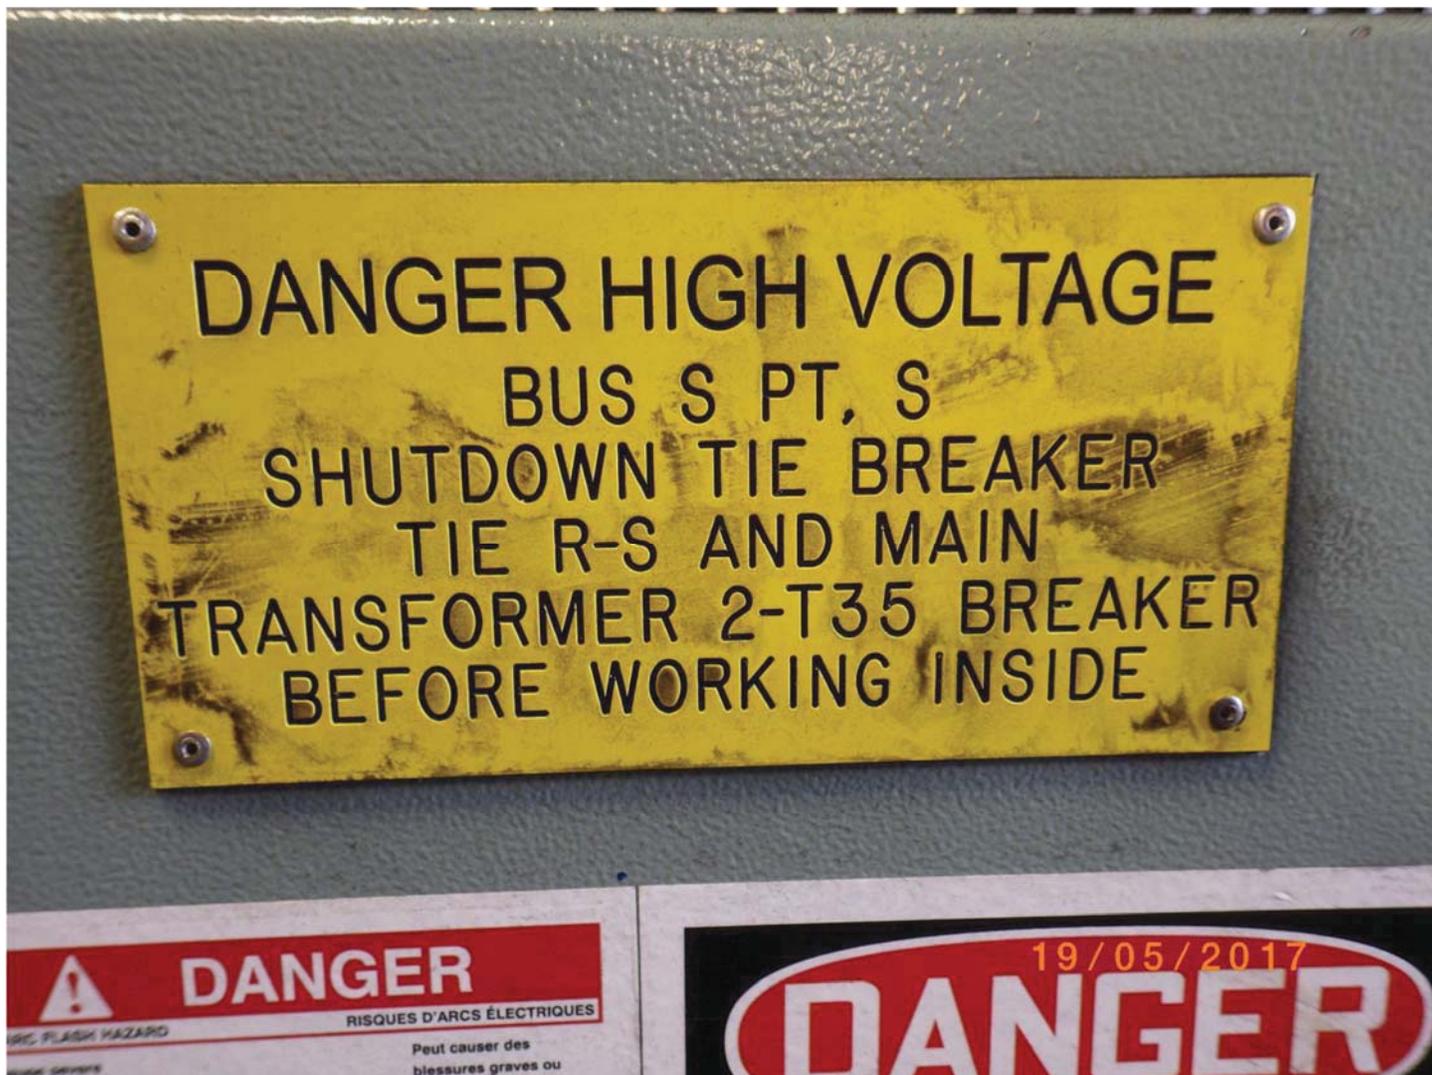
Photo 6:

- Their job was to provide labor only and all voltage testing was the responsibility of the equipment owner,
- Journeyman electrician was working within the cable termination compartment when accidental contact was made between an energized potential transformer connection and ground. (see photo 8)
- Even though the circuit breaker to the cable compartment had been racked out, everyone working onsite were either unaware or failed to identify that a voltage was still present within the cable termination compartment,
- Inadequate warning notices had been provided, a warning notice had been applied to the front of the PT enclosure, but not on the back of the cable termination cabinet, (See photos 5, 6 and 7)

Close up view of the PT 's warning notice which identifies how to proceed prior to working inside the enclosure

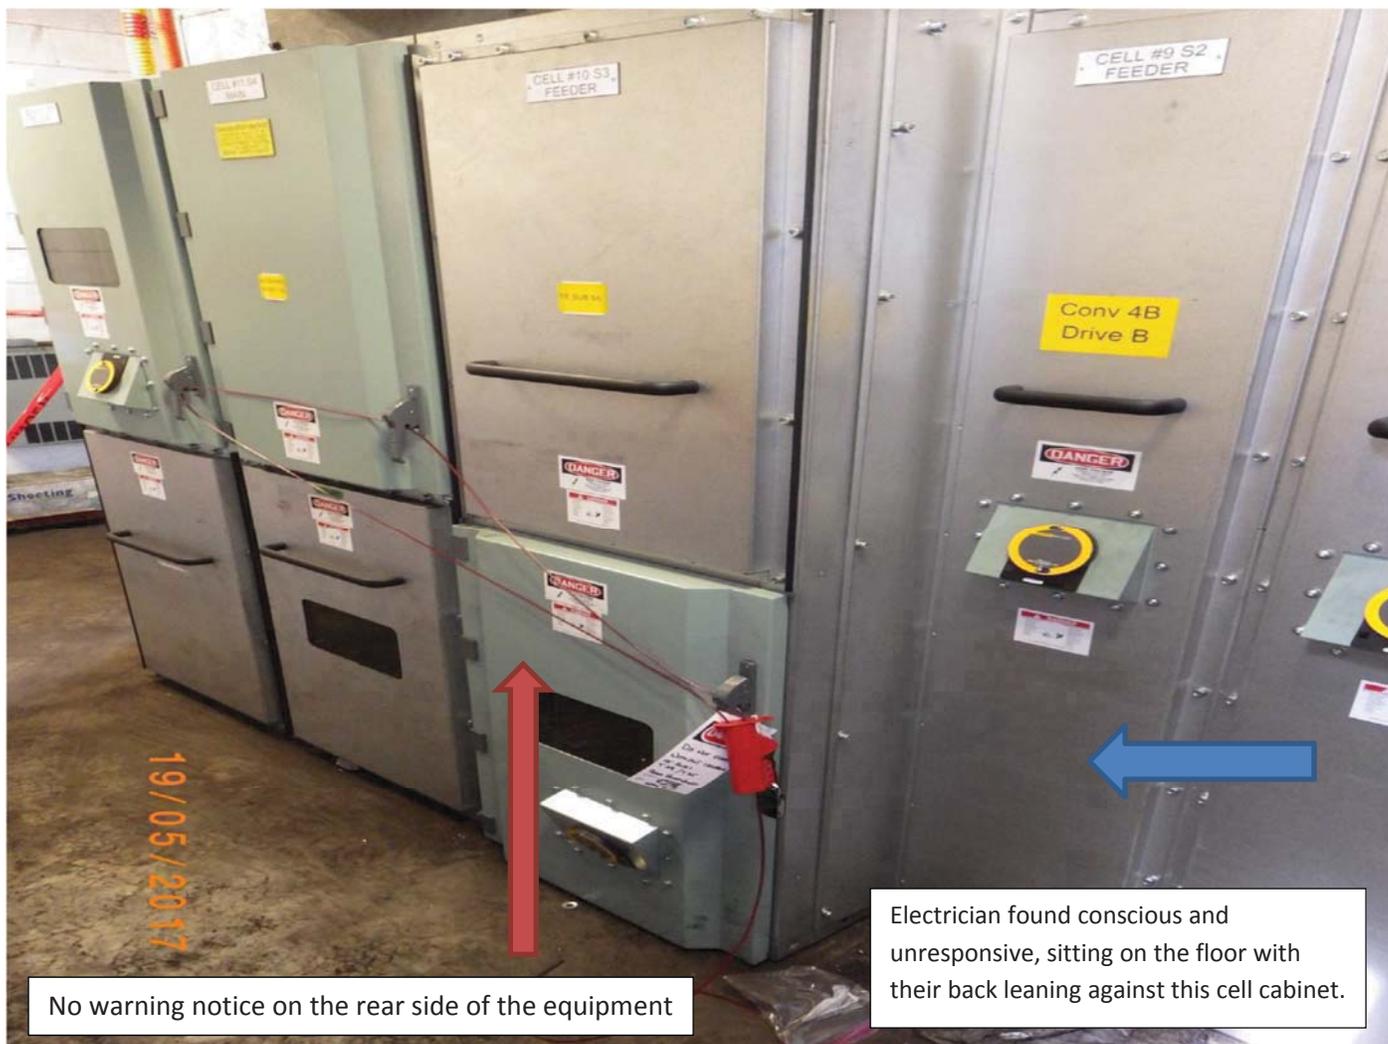
Photo 7:

Rear view of cell number 10, cable termination enclosure which measures approximately 25 inches wide by 25 inches high. No warning notice indicating that an additional power source may be available if the cover has been opened or removed.

The rear side of the cabinet is where the feeder cable to the electrical equipment is terminated.

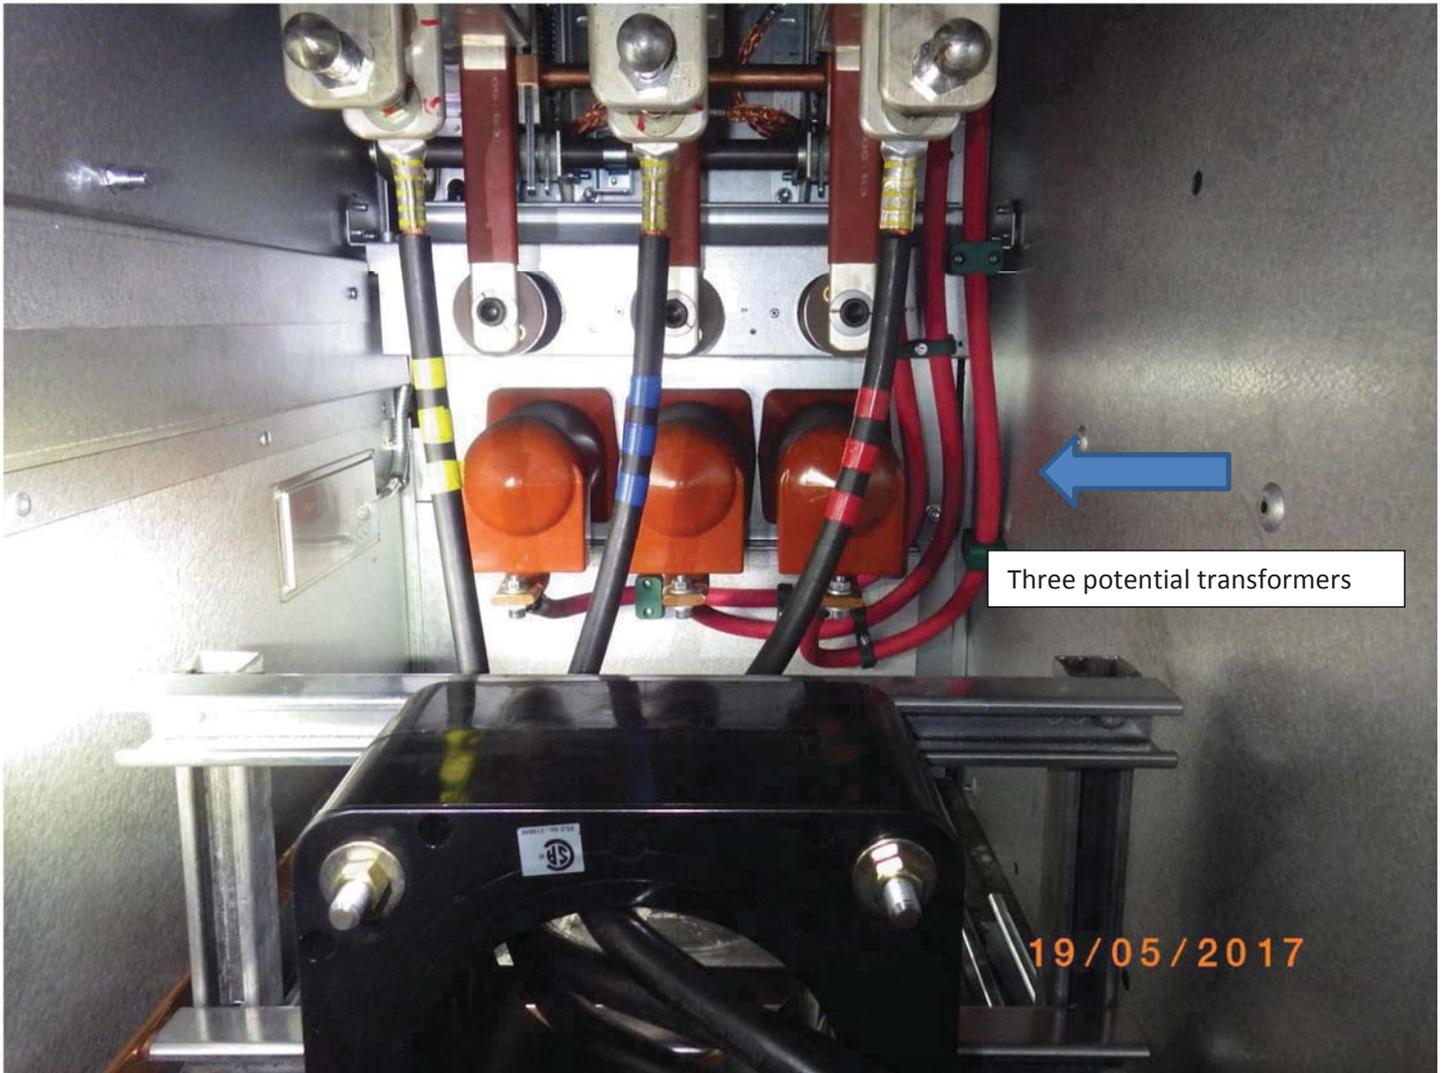
Photo 8:  
Photo taken through the viewing window from the back of the electrical switch gear.

Photo identifies three potential transformers (brown items and at the back of the enclosure) that are fed from the line side of the busbars. Unless the PT's are disconnected as indicated by the warning notice on the front of the enclosure, they are continuously energized.

The 3 black conductors identified yellow, blue and red are from the load side of the circuit breaker and feed electrical energy to equipment located within the facility.

Unless you are familiar with the switch gear assemble, it is possible to work on the de energized feeder conductors, and still work in an energized cable termination enclosure.

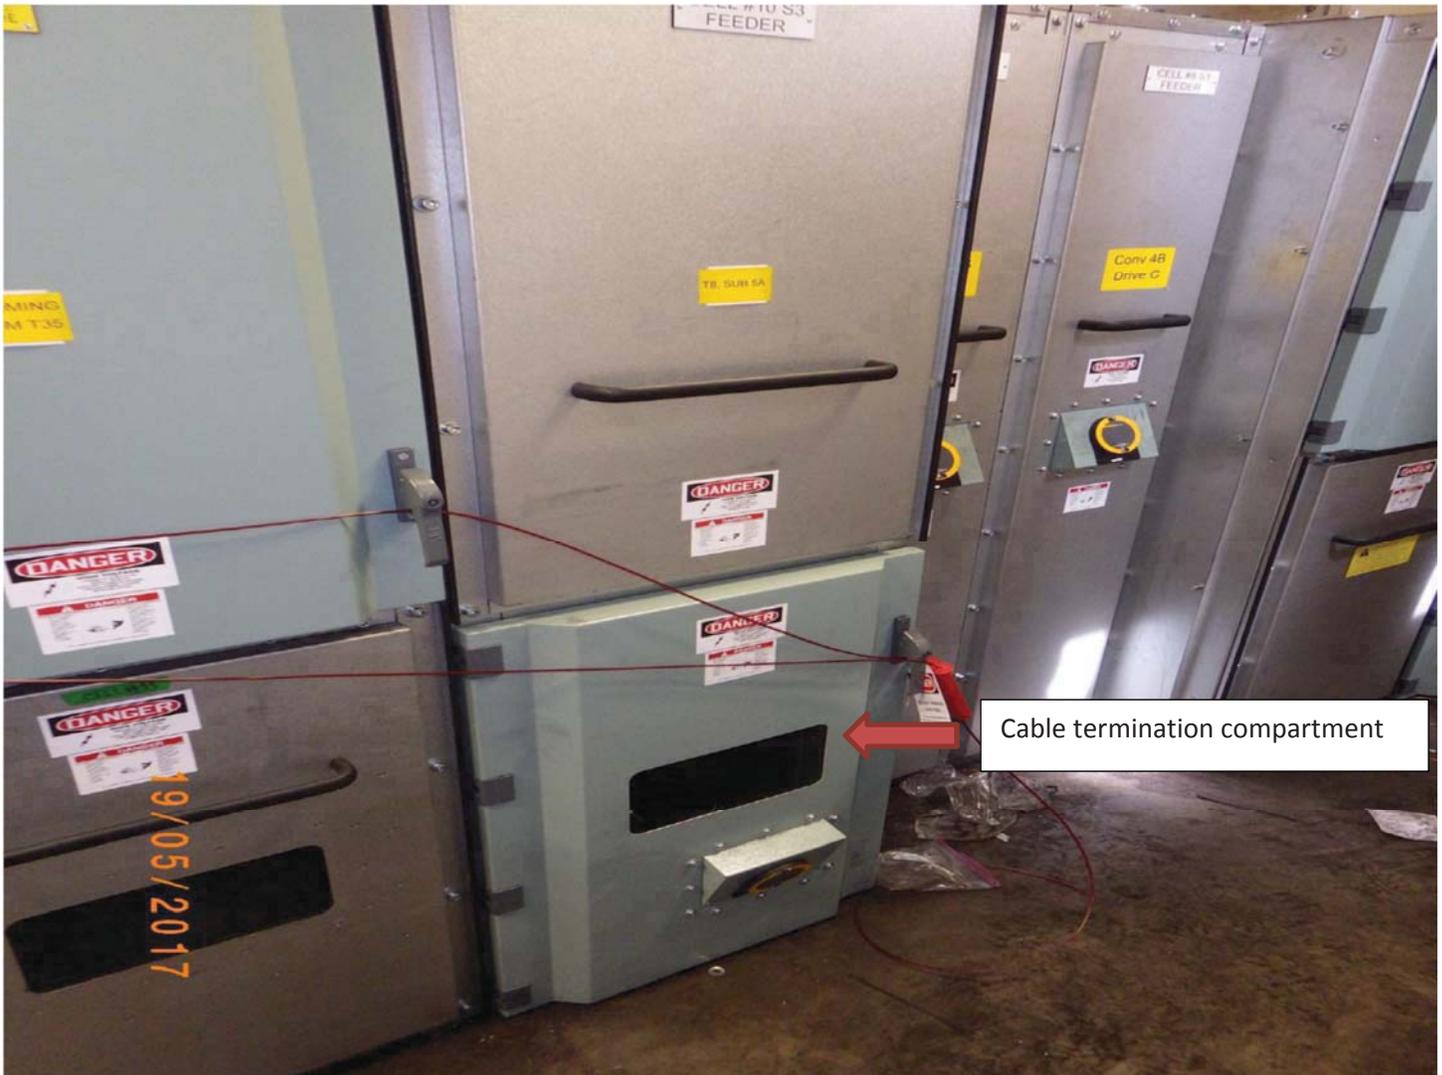
Photo 9:

Photo taken from the backside of the equipment.

No warning notice indicating that electrical energy is available even though the circuit breaker has been turned off and isolated.
