Appendix E

Lab Analysis Report

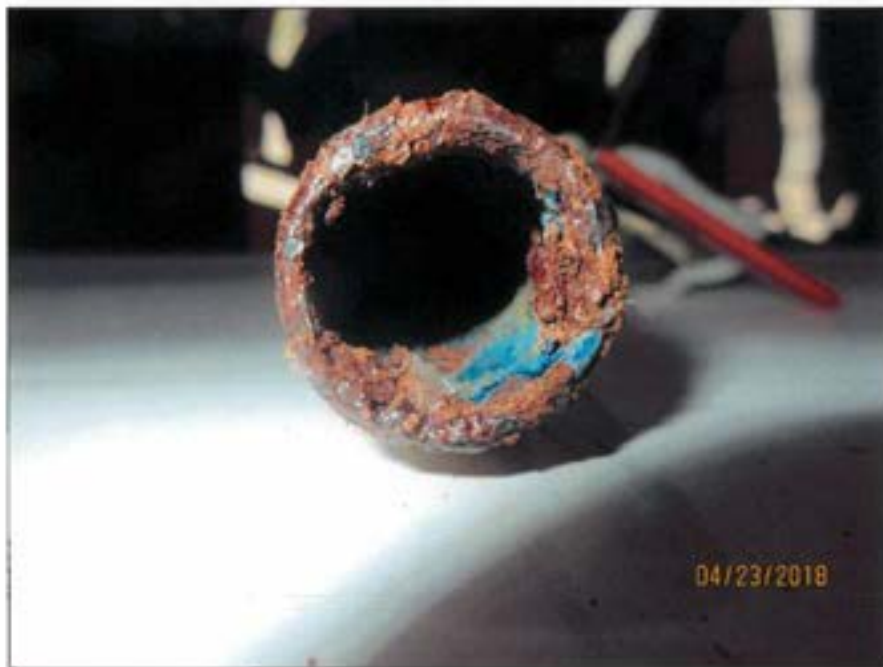
Figure 7 Corrosion products on nipple end of Valve A-3.

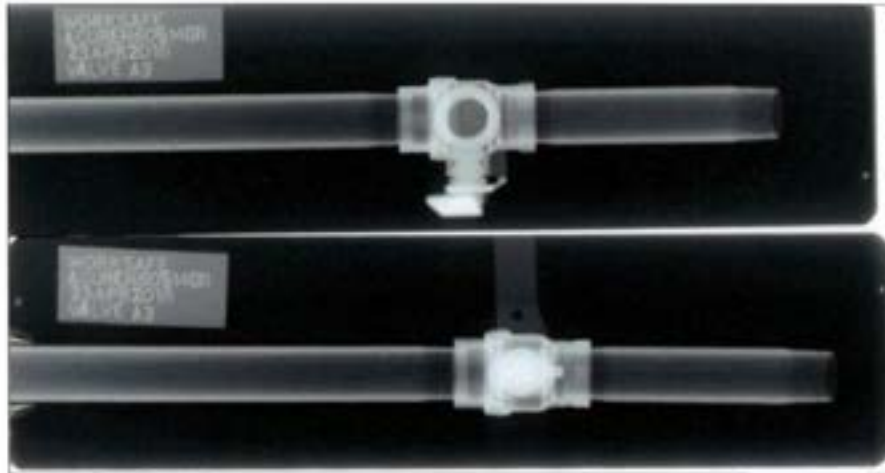
Figure 8 Radiographic images of Valve A-3 in views 90° apart. Ball is fully closed.

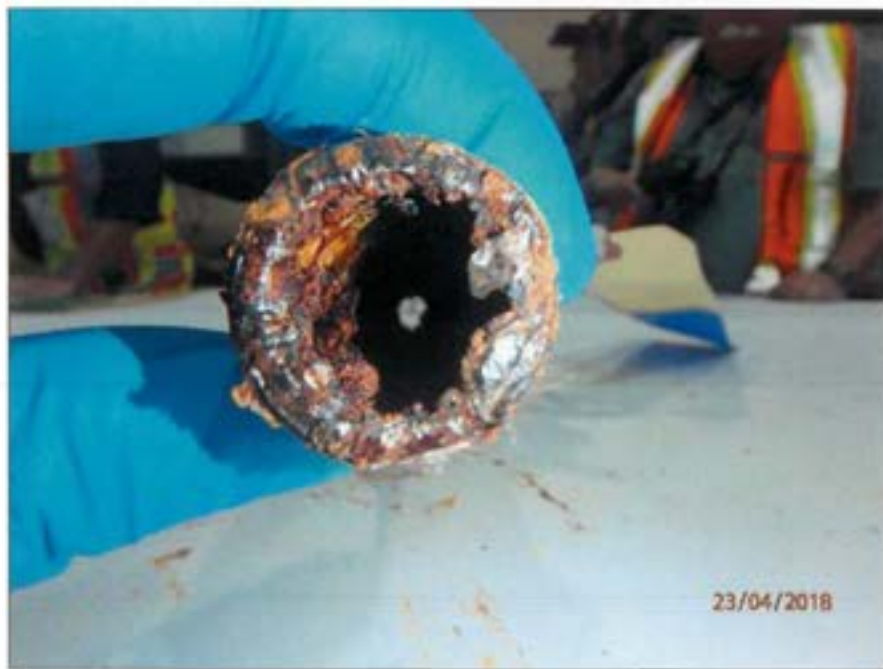
Figure 13 Corrosion damage and partial plugging of nipple end of A-2.

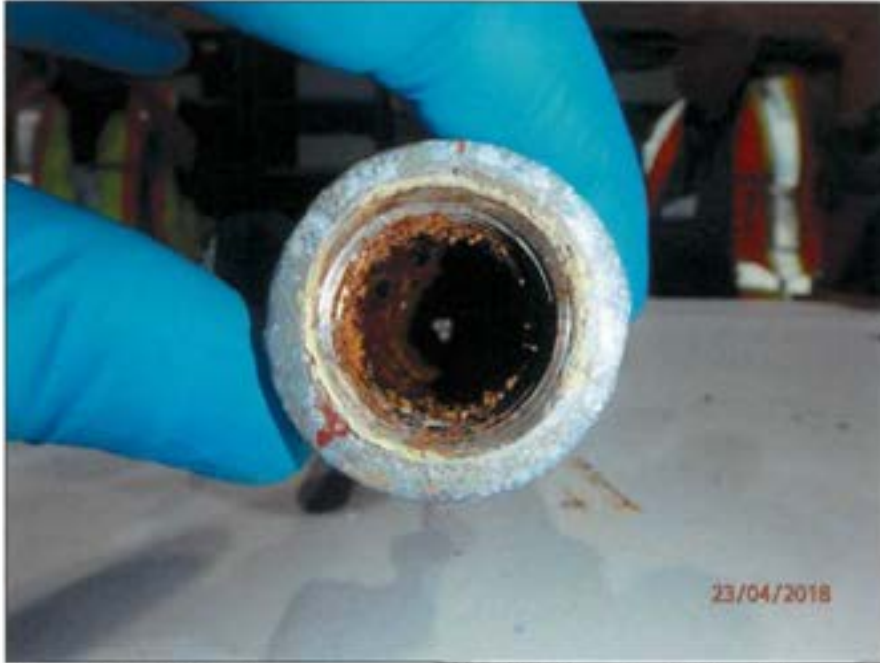
Figure 14 Relatively minor corrosion debris in Tee end of Valve A-2.

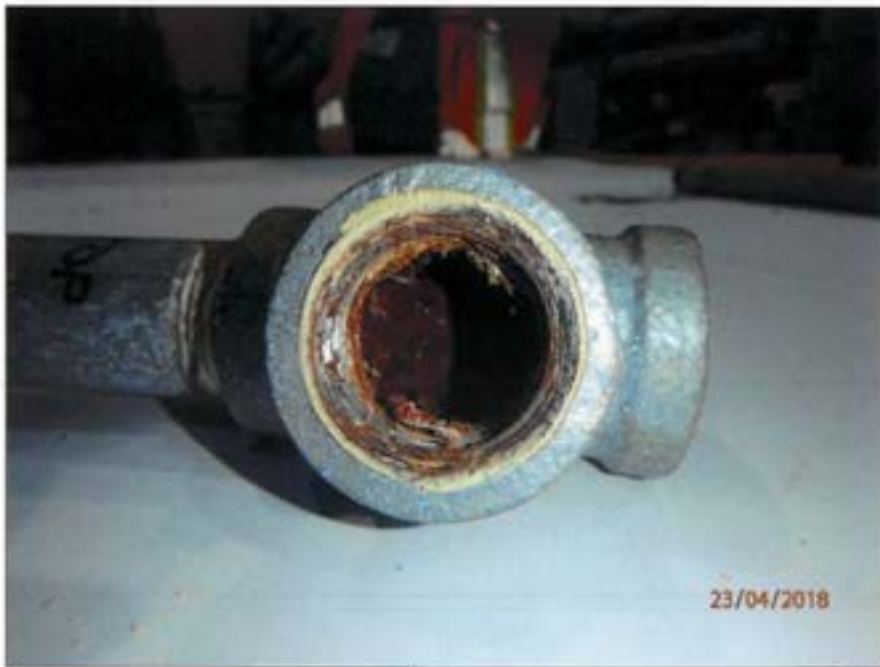
Figure 15 Relatively minor corrosion debris in second Tee end of Valve A-2.

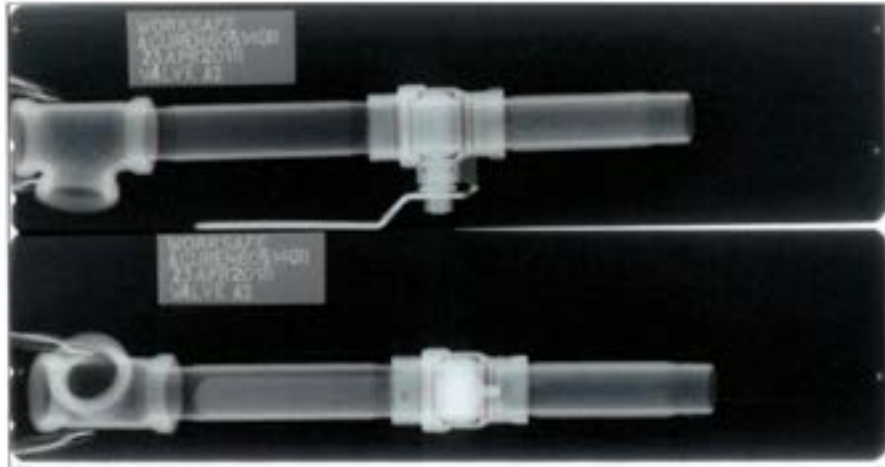
Figure 16 Radiographic image of Valve A-2 in open position.

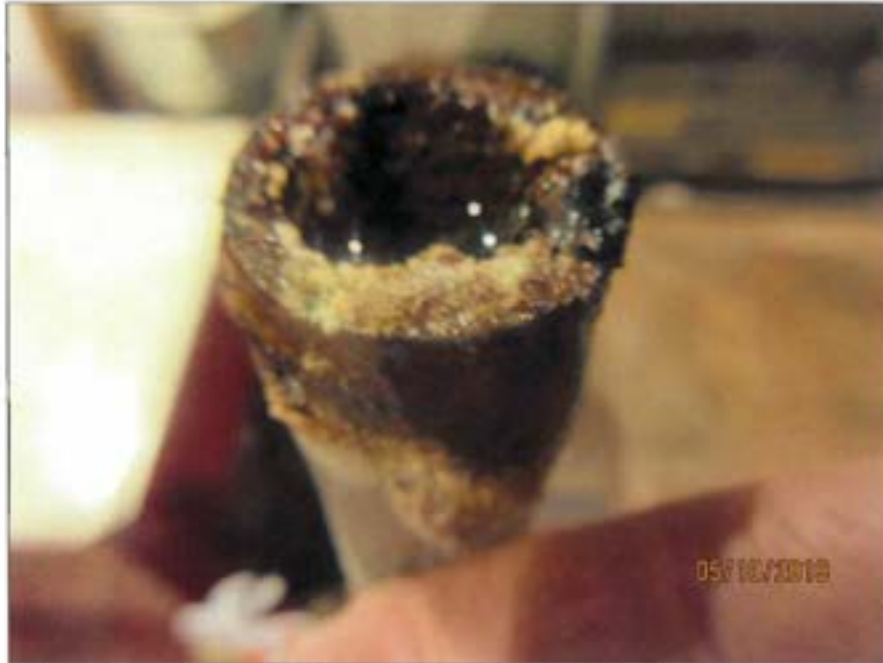
Figure 22 Water remaining at steady level in valve Z leak test.

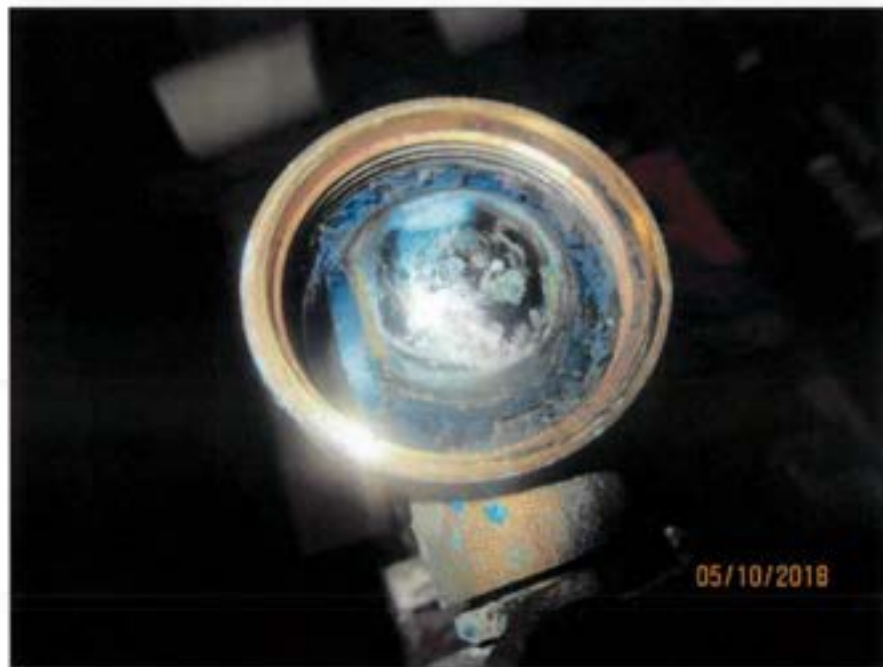
Figure 23 Corrosion debris surrounding ball in partially cocked valve Z.

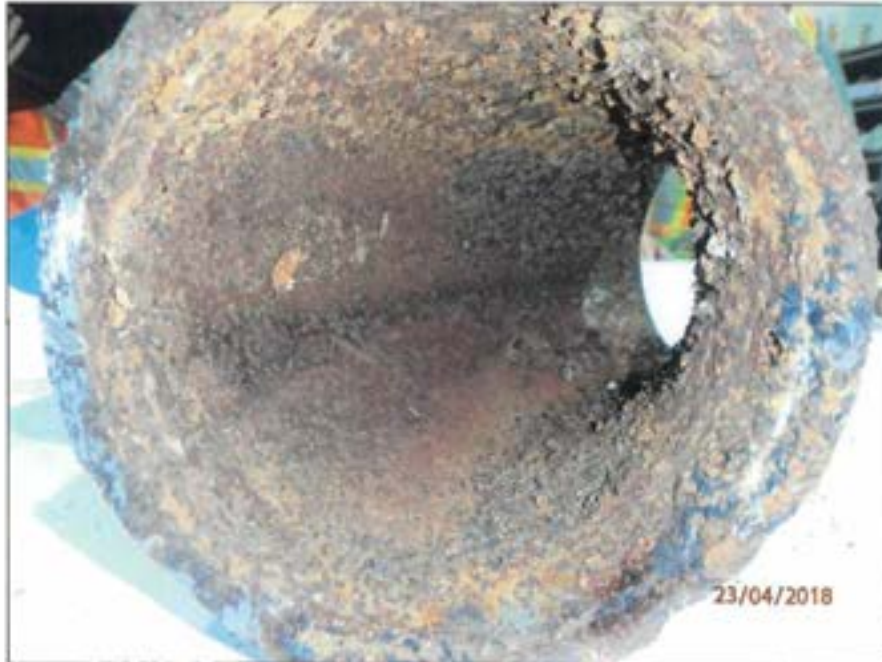
Figure 24 Inside of Elbow A-10 showing severe corrosion damage.

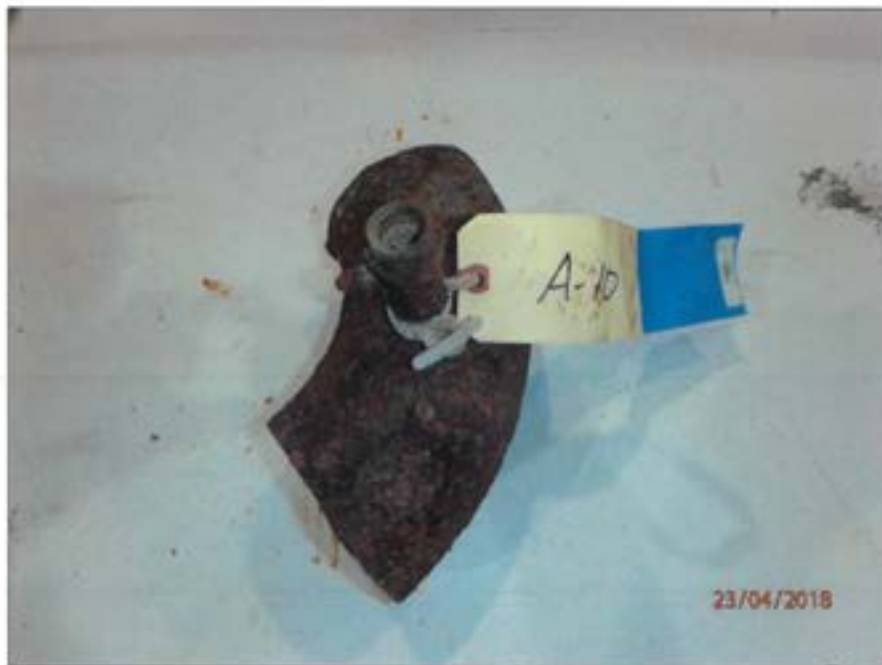
Figure 25 Valve A-10 on rusty elbow. Ball appears corroded and slightly worn.

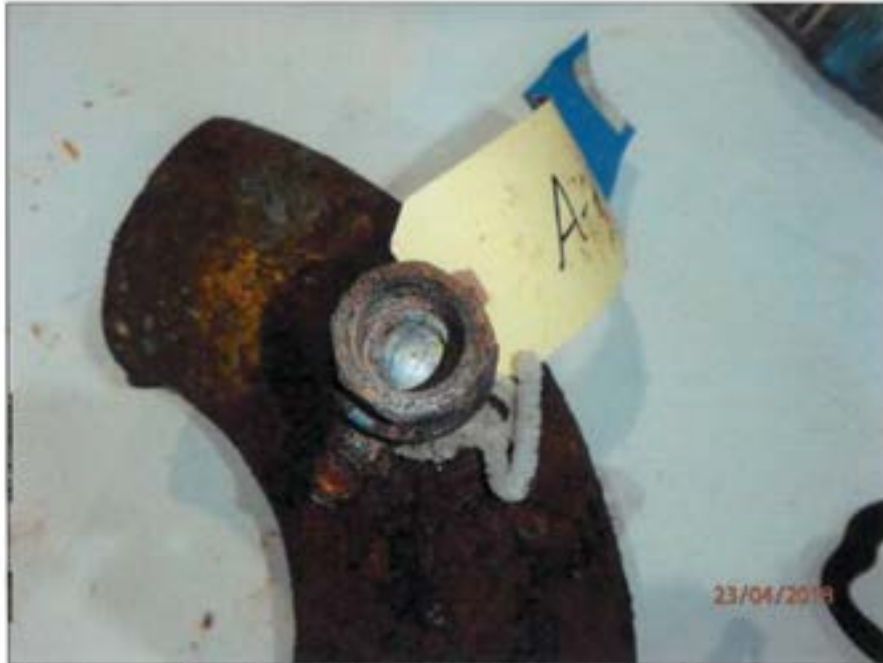
Figure 26 Closer view of ball on Valve A-10 showing light corrosion.

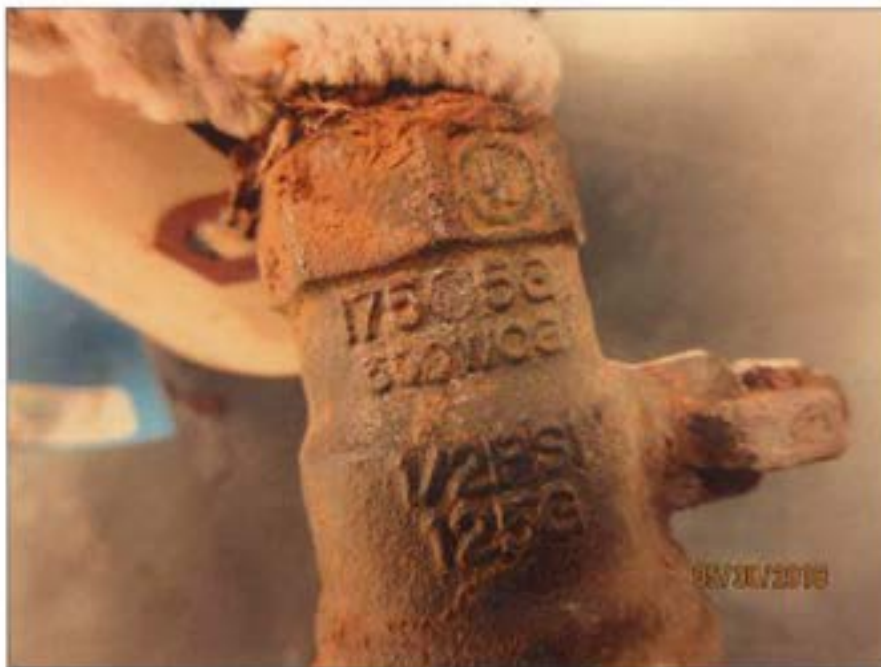
Figure 27 Markings on Valve A-10.

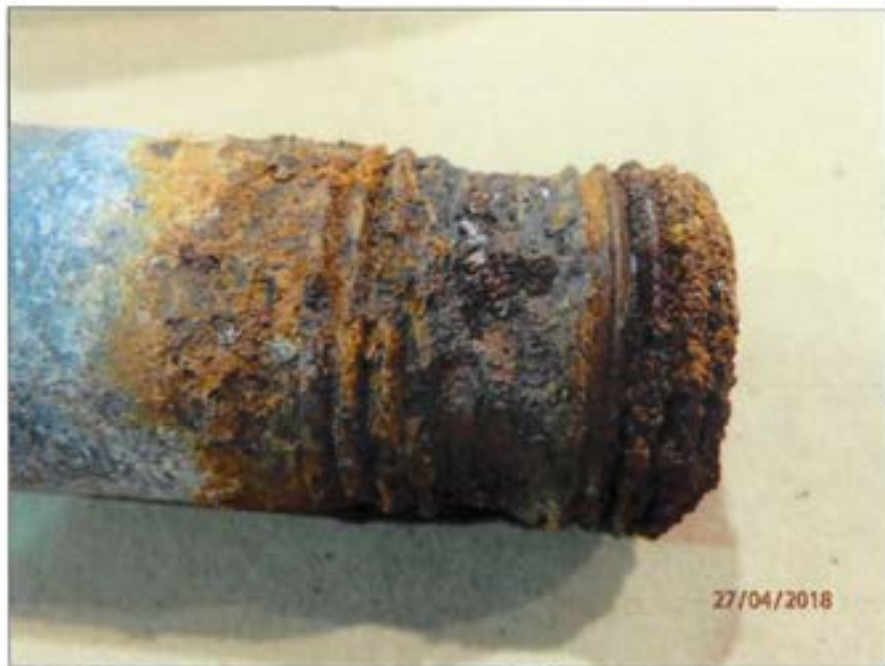
Figure 31 Corroded nipple threads on Valve Y nipple.

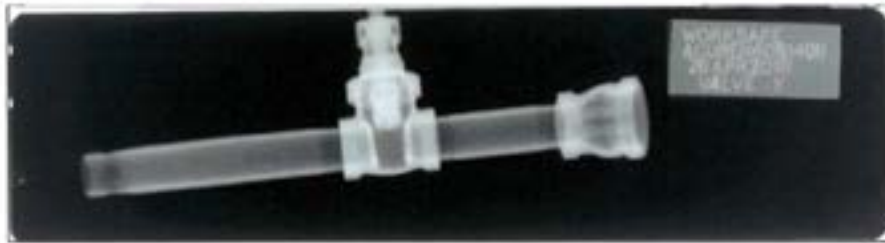
Figure 32 Radiographic view of Valve Y. Gate is fully open.

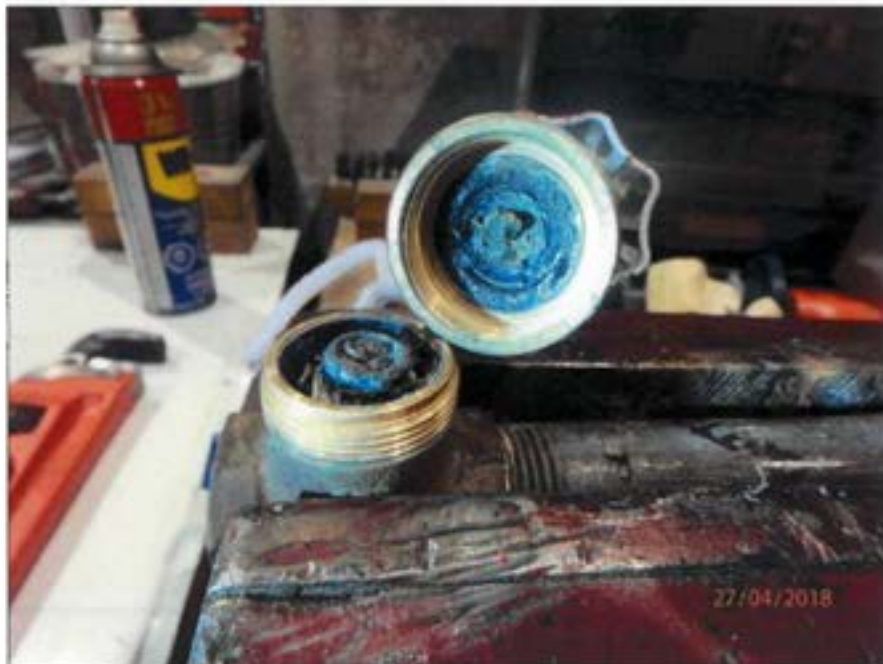
Figure 33 Gate Valve Y internal components. Stem would not engage and appeared fractured.

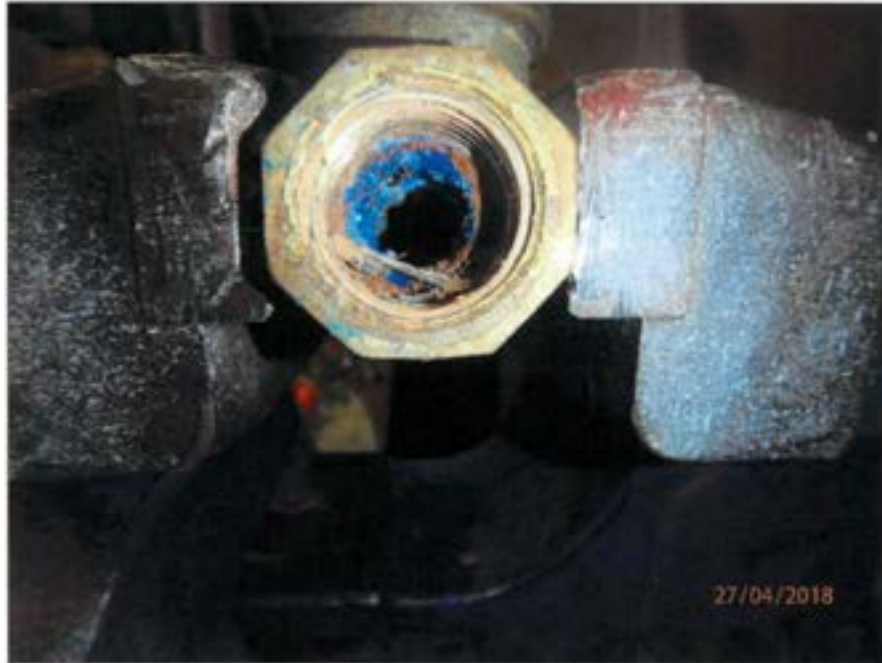
Figure 34 Blue corrosion product in Valve Y body. Body is partially plugged.

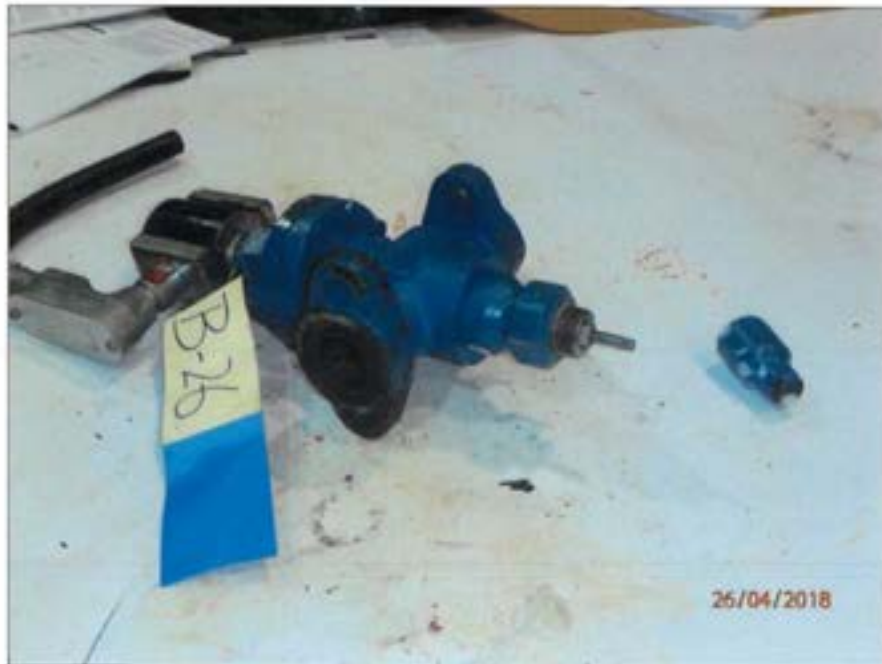
Figure 35 Overall view of solenoid valve B26.

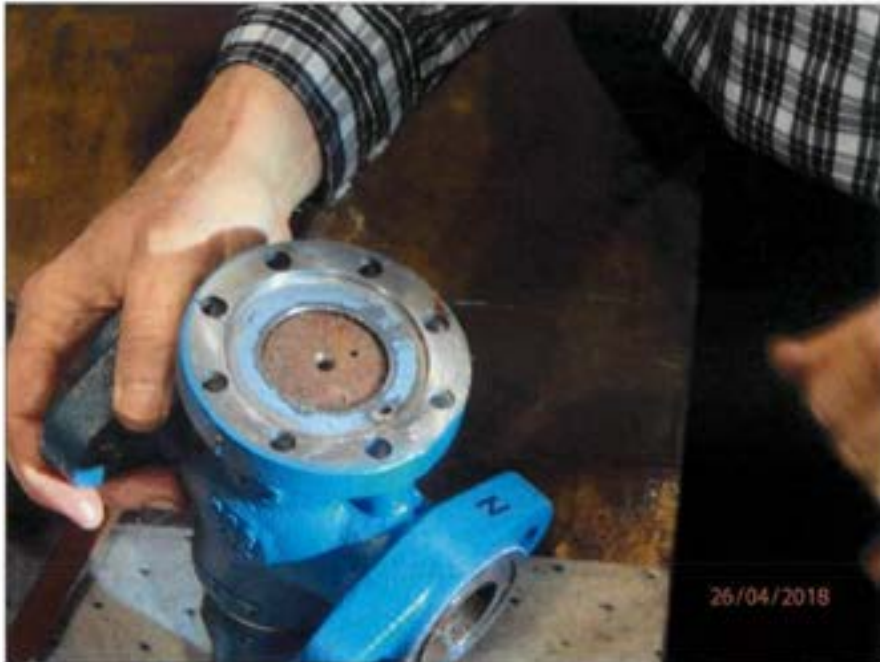
Figure 39 Valve B-26 dismantled showing corrosion and seized piston.

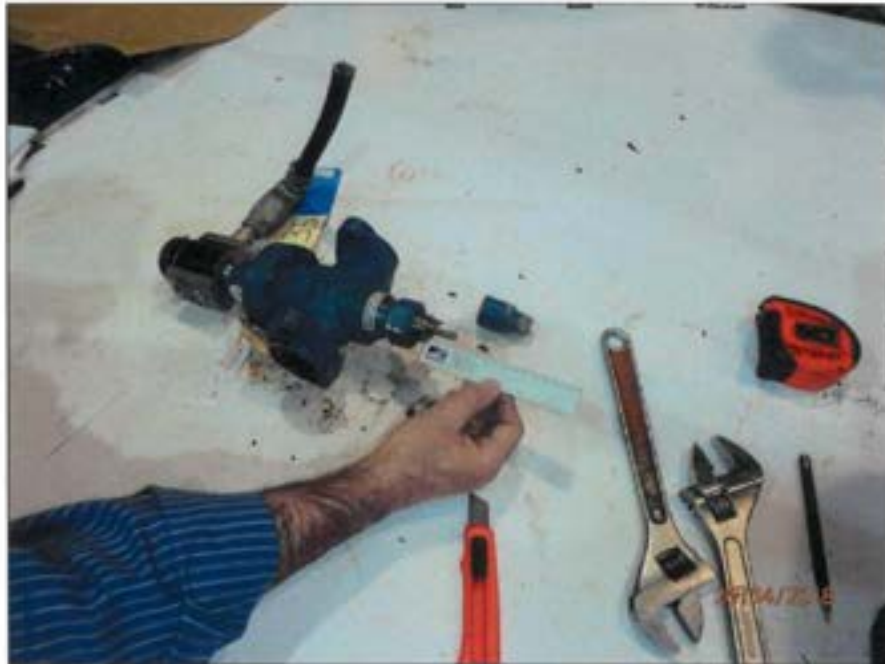
Figure 40 Overall view of solenoid valve B-35.

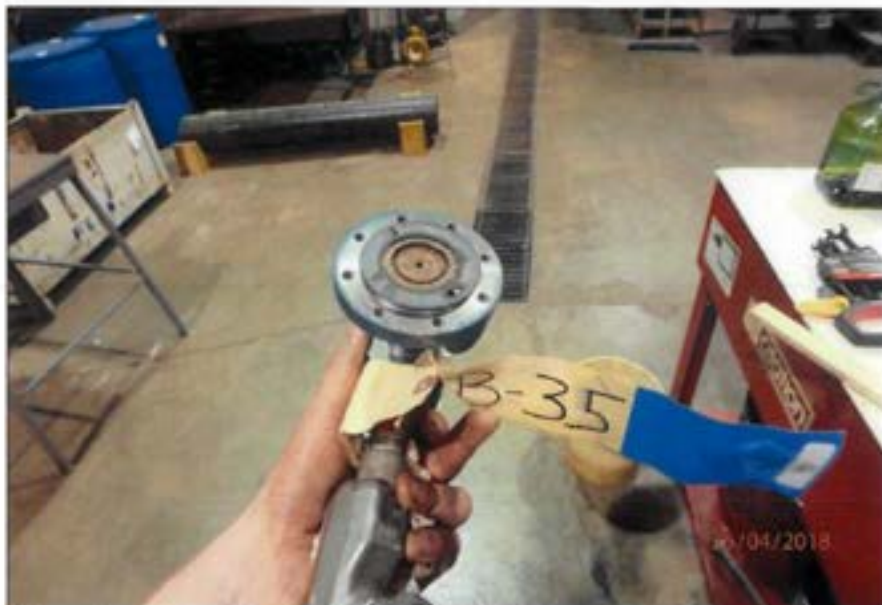
Figure 43 Severe corrosion on B-35 piston. Piston could not be freed.

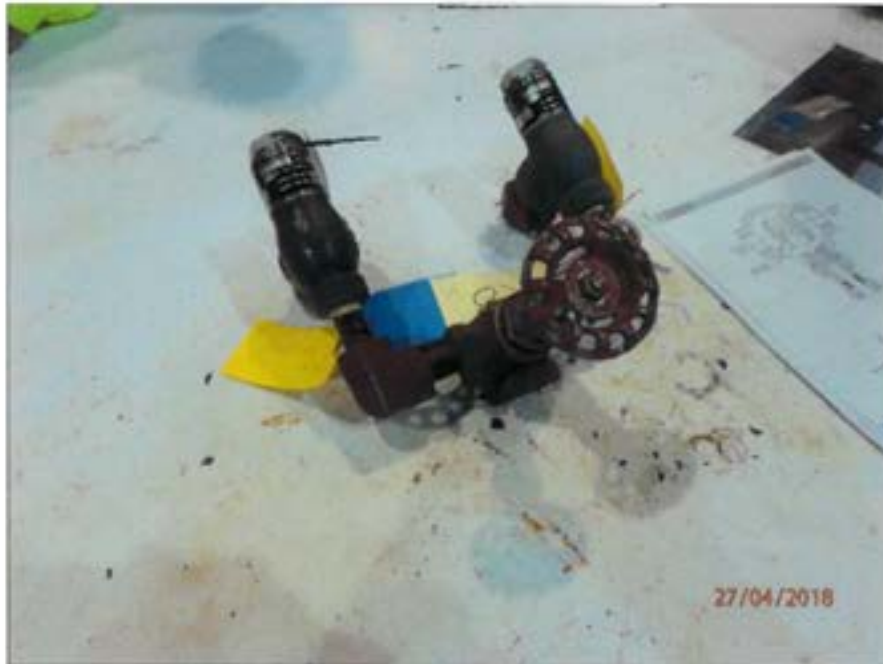
Figure 44 Overall view of pressure relief valve "Y" connection labelled R8.

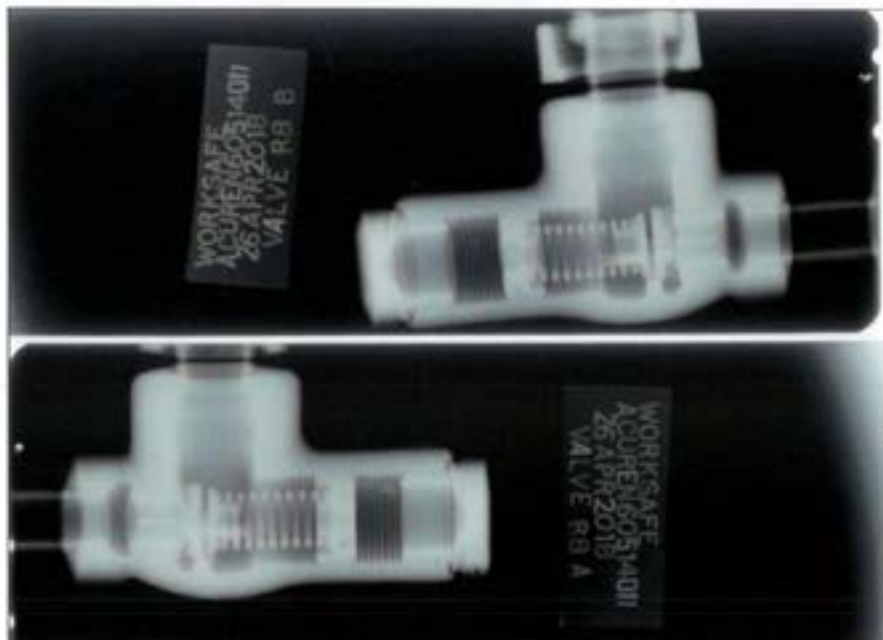
Figure 45 Radiographic images of pressure relief valves "1" (A) and "2" (B). The "1" valve was in service at the time of the event. Both units appear to be in good condition with no blockages.

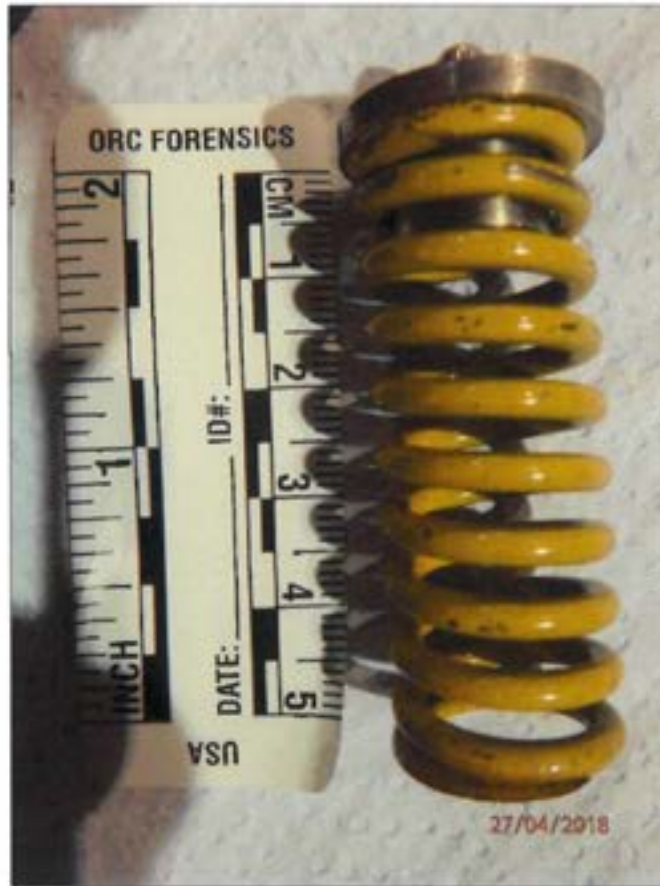
Figure 46 PRV "1" spring. No evidence of calcium chloride is present.

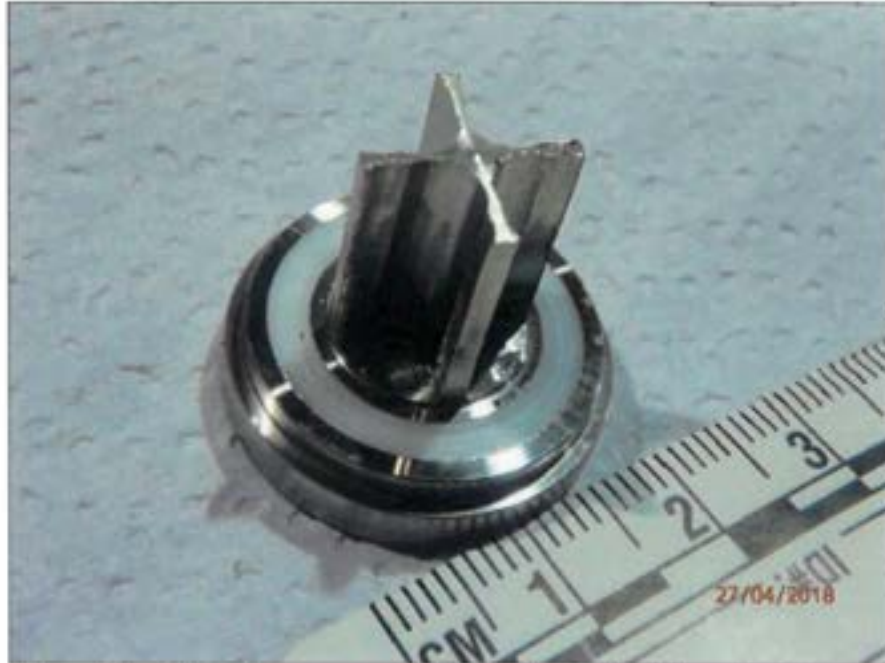
Figure 47 Valve "1" pressure seal. No evidence of calcium chloride was found. The seat contains minor amounts of debris.

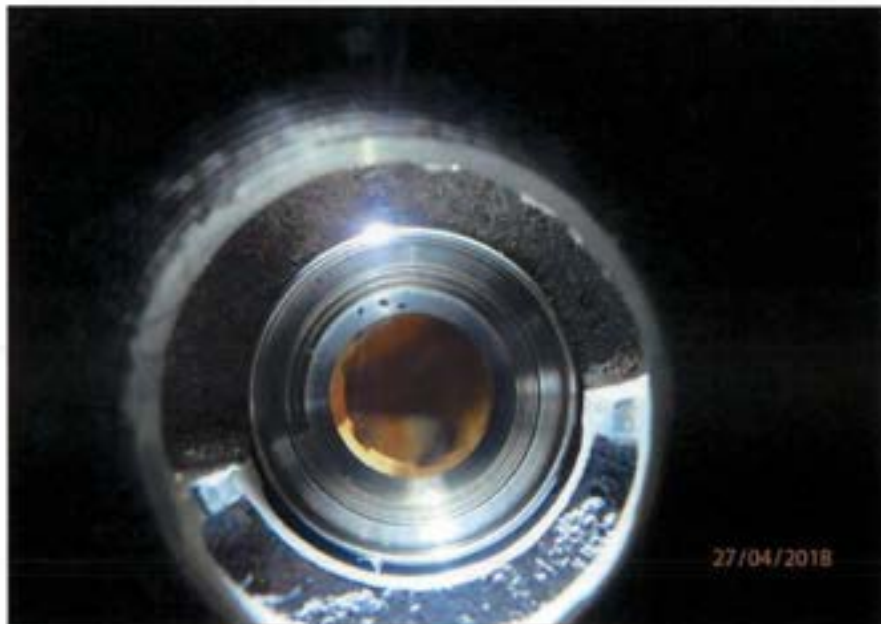
Figure 48 PRV Valve "1" internal bore. No evidence of calcium chloride is present.

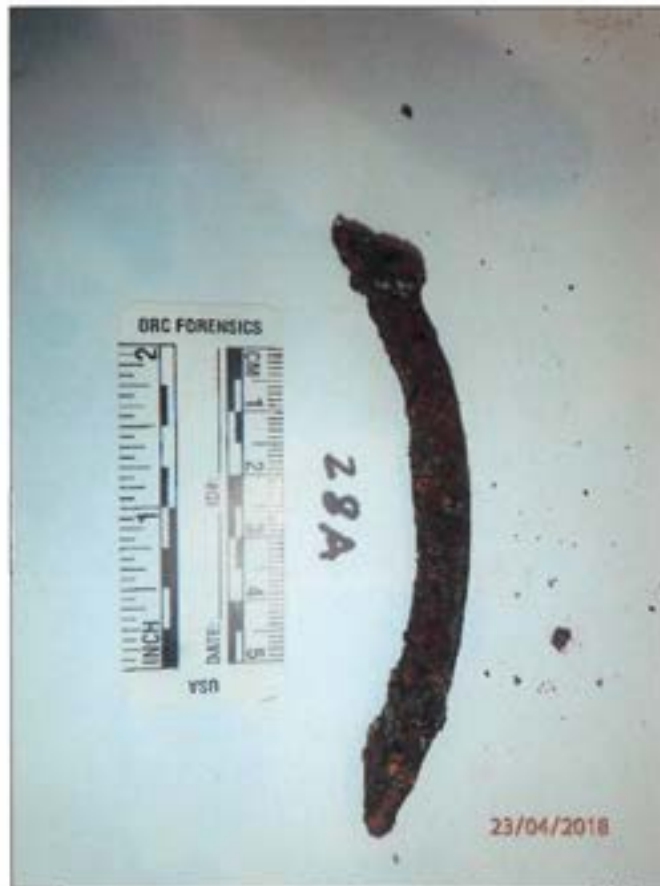
Figure 55 Piece of metal debris 28A found between head and tubesheet on inlet/outlet side of chiller.

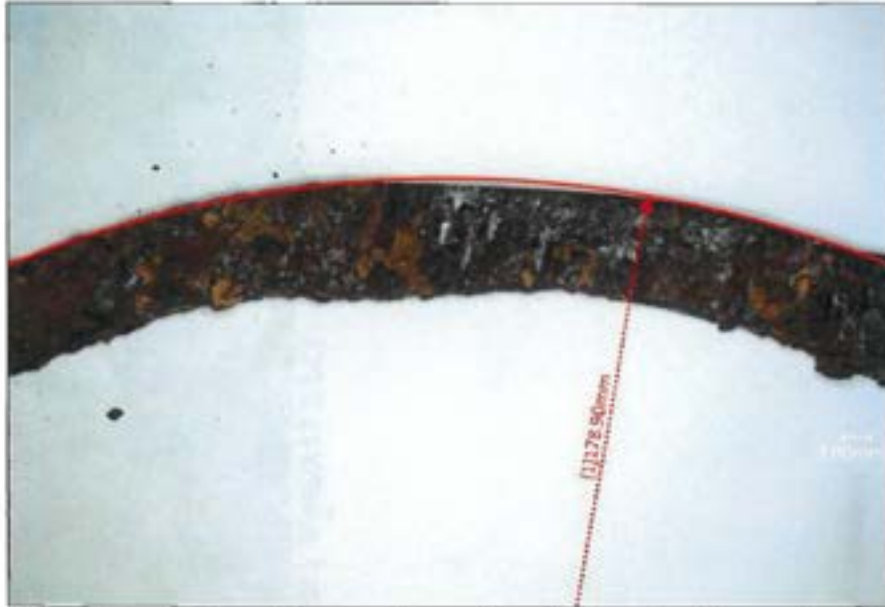
Figure 56 Estimated diameter of curved metal piece found between head and tubesheet on inlet/outlet side of chiller (179 mm or 7 inches).

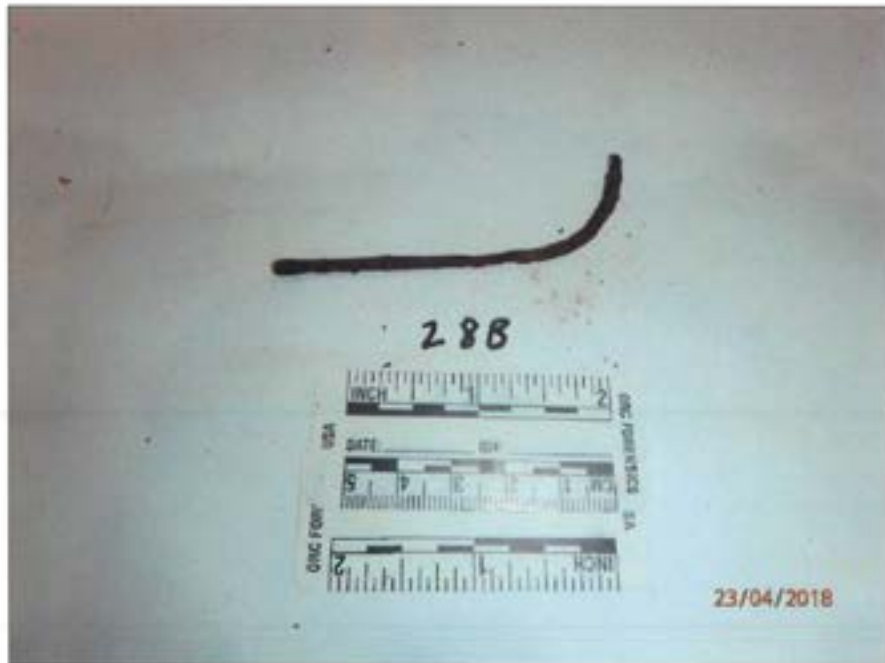
Figure 57 Wire piece found between head and tubesheet on inlet/outlet side of chiller.

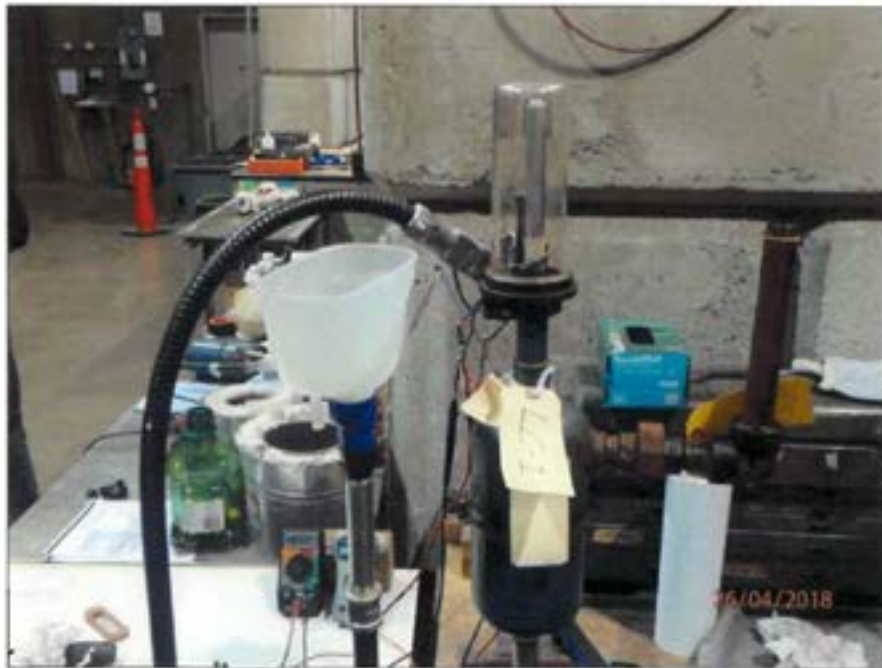
Figure 58 Test set-up for actuation of LC1. Olive oil was used to simulate ammonia.

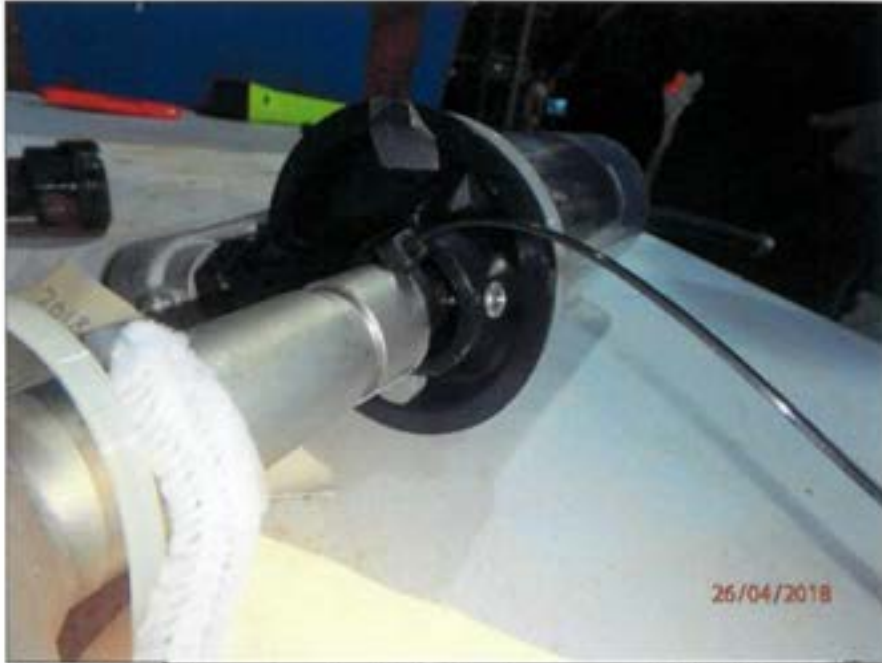
Figure 62 Zap strap found on LC2. Operation was restricted by this strap.

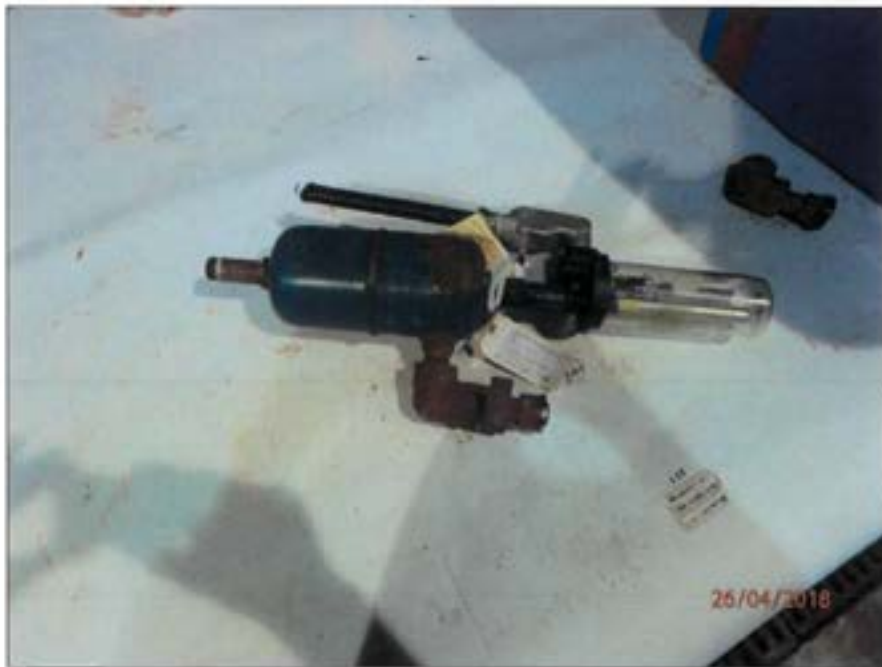
Figure 63 Overall view of LC3 prior to test.

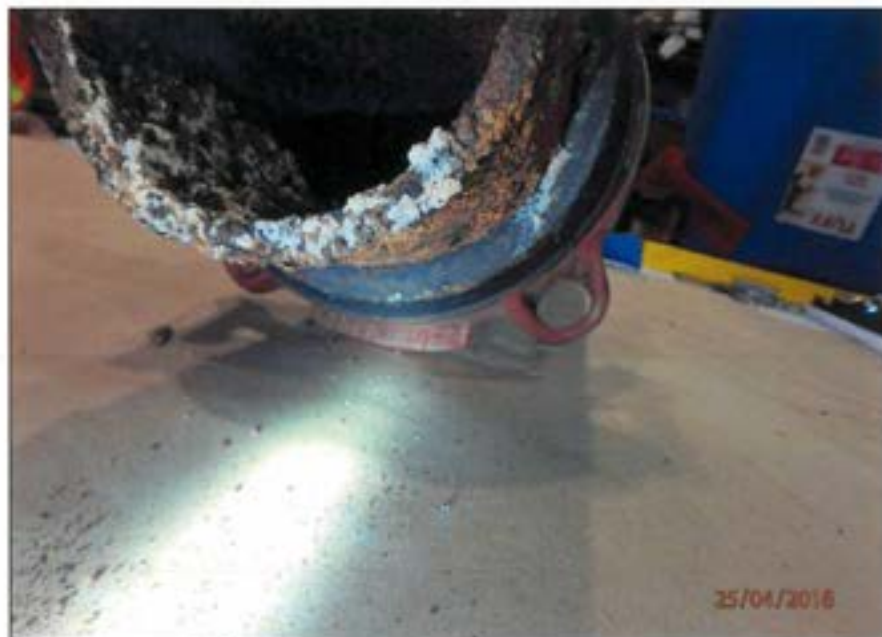
Figure 74 Typical white salts found within the pipe attached to horizontal [redacted] coupling.

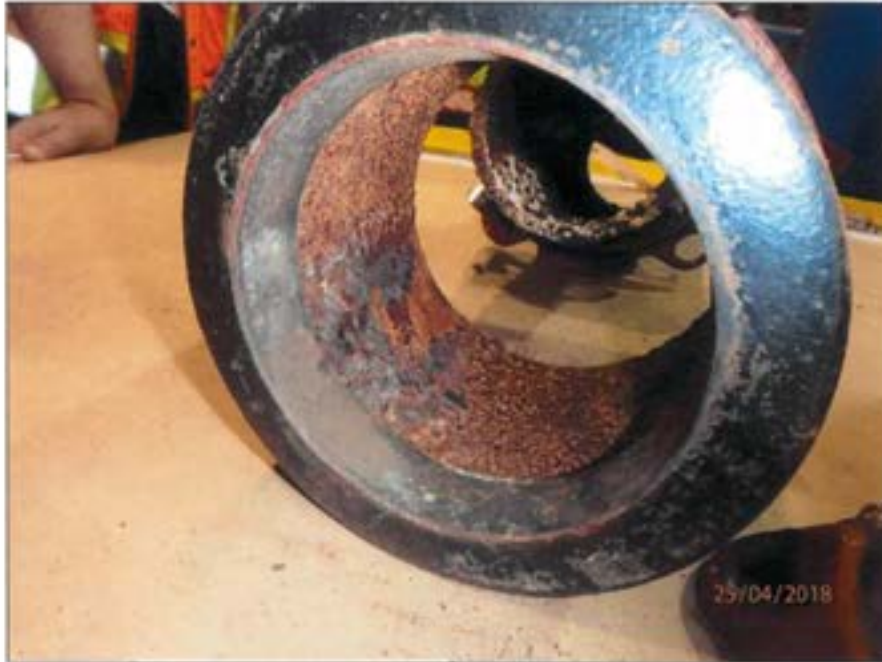
Figure 75 Rubber gasket on sleeve end of horizontal coupler showing imprint of end plate casting surface. Hardness was Shore A52.

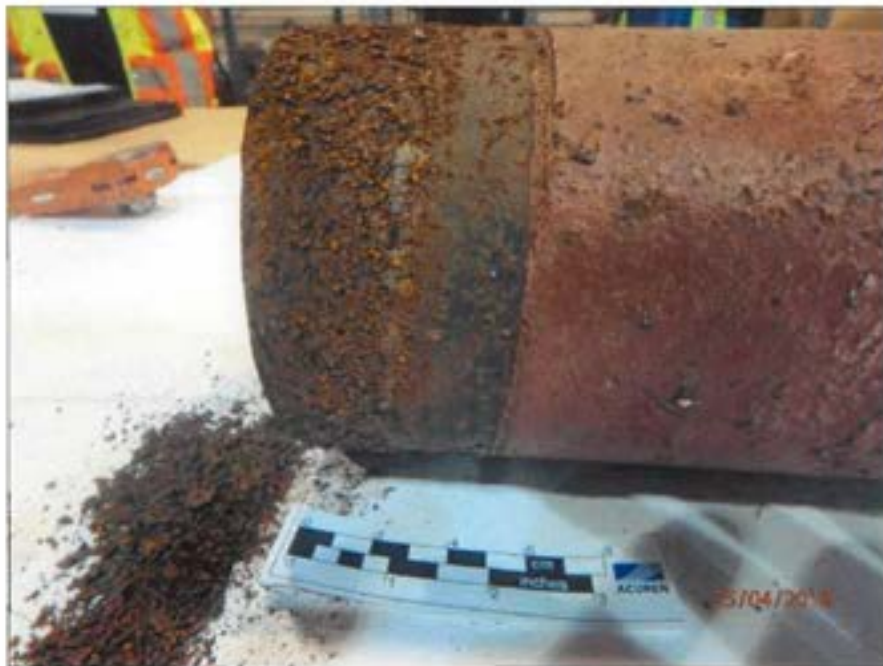
Figure 78 Corrosion found in unpainted area of separated pipe mounted within horizontal coupling.

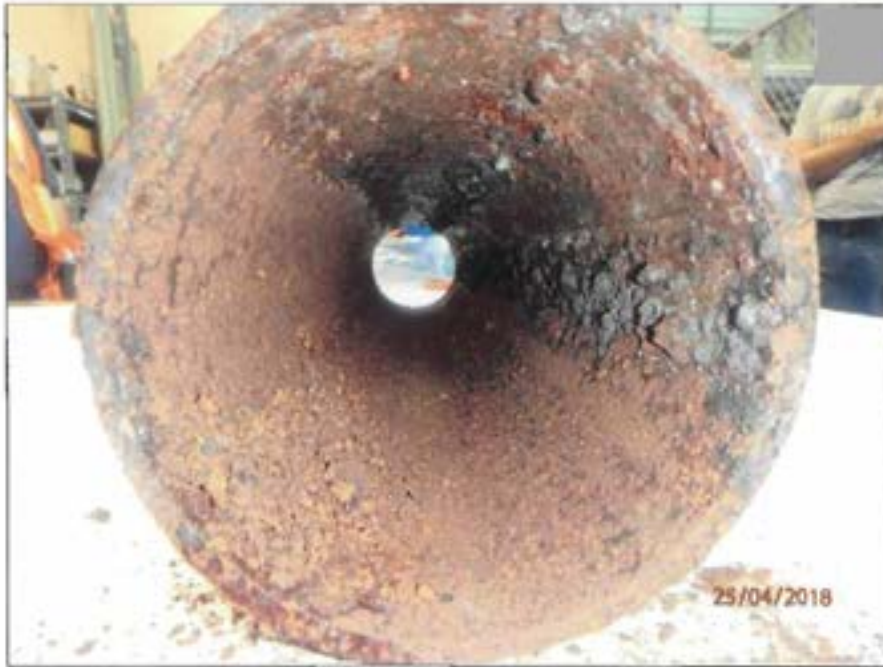
Figure 79 Severe corrosion in horizontal brine pipe that detached from coupling.

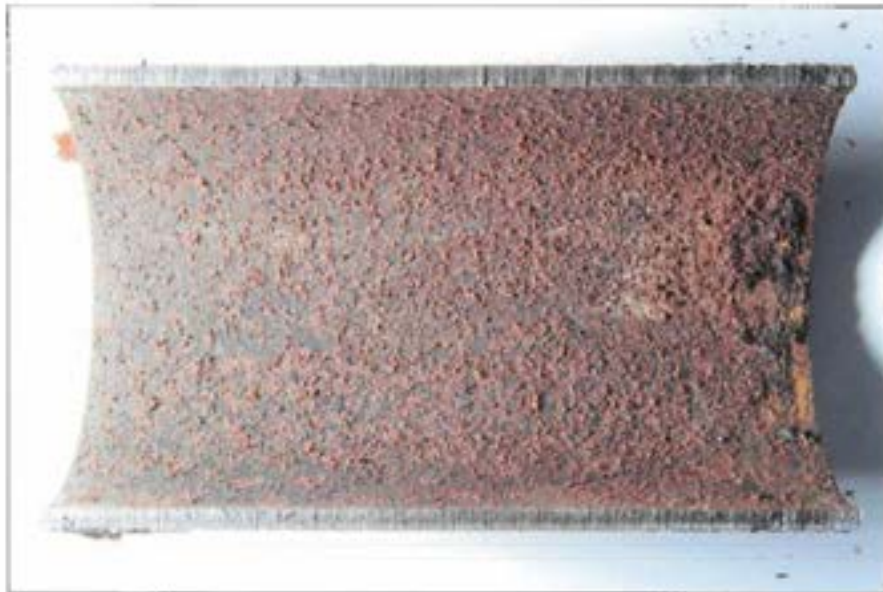
Figure 80 Corrosion found in horizontal brine pipe separated from coupling.

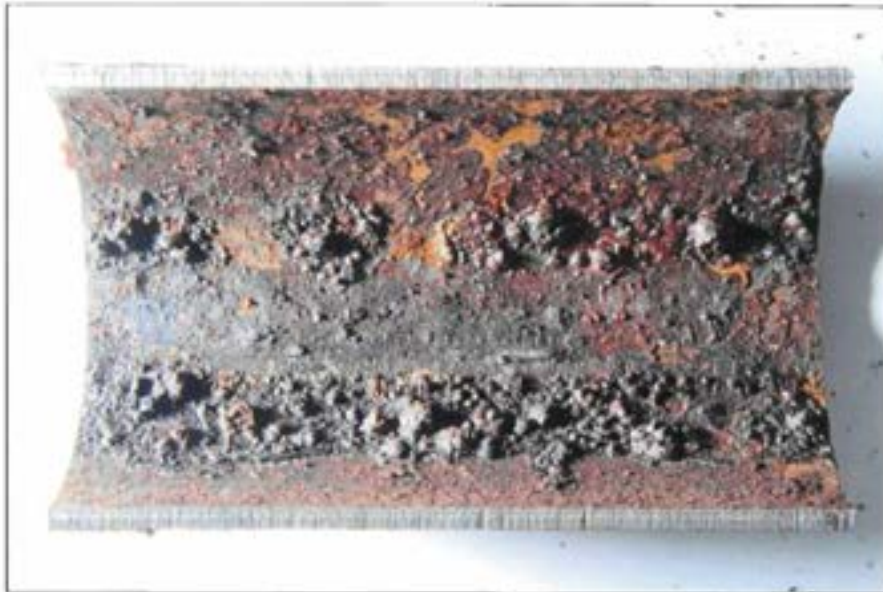
Figure 81 Corrosion found in horizontal brine pipe separated from coupling (opposite side of Figure 80 piece).

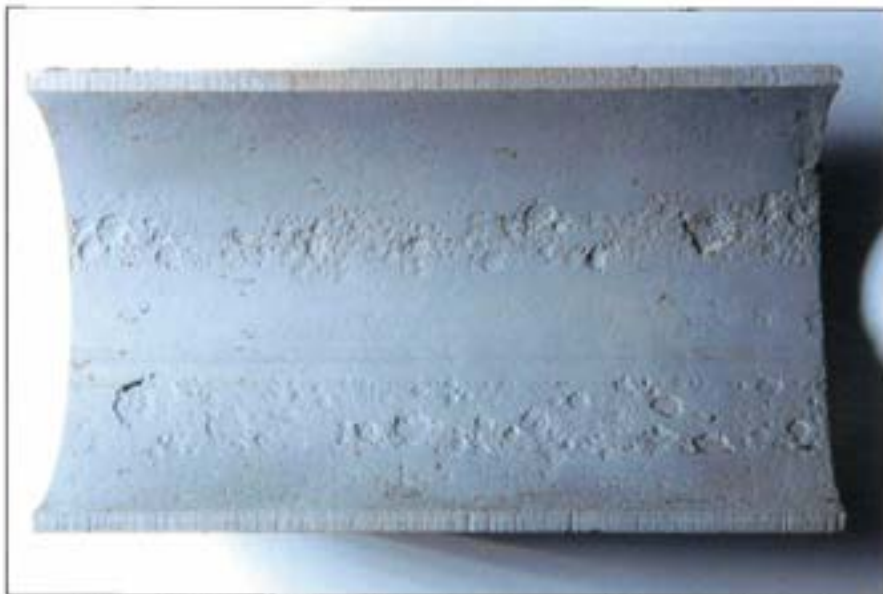
Figure 82 Sand blasted internal surface of separated horizontal brine pipe showing pitting around weld seam.

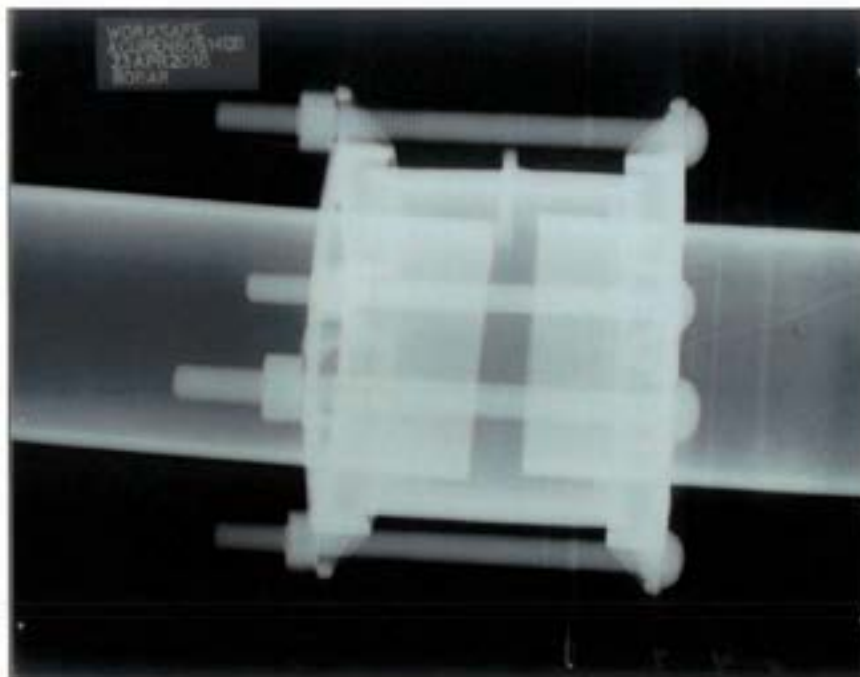
Figure 84 Radiographic image of vertical coupling showing proper installation and misalignment caused by event forces.

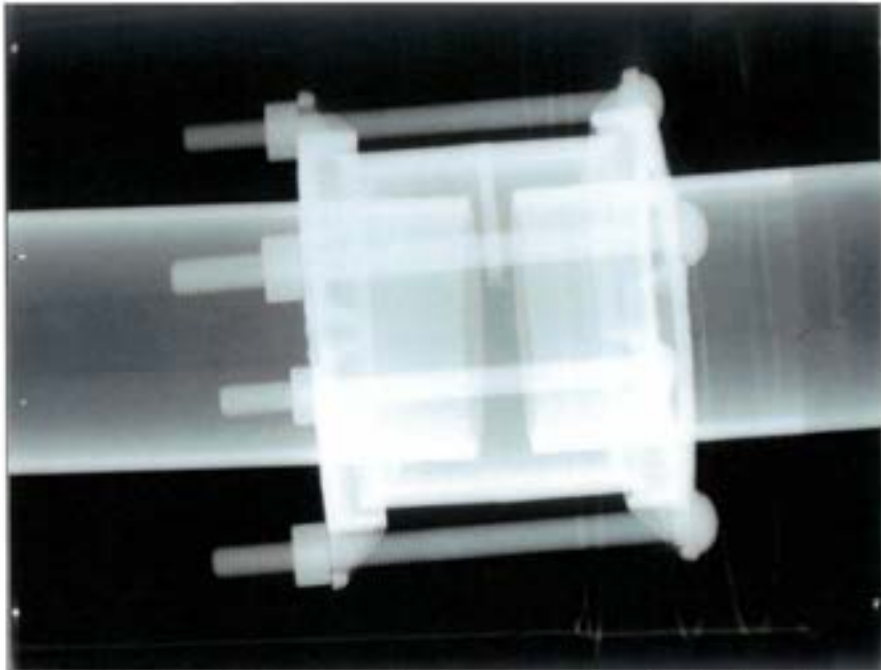
Figure 85 Second view of vertical coupling showing installation location and misalignment caused by event forces.
