Appendix E

Lab Analysis Report

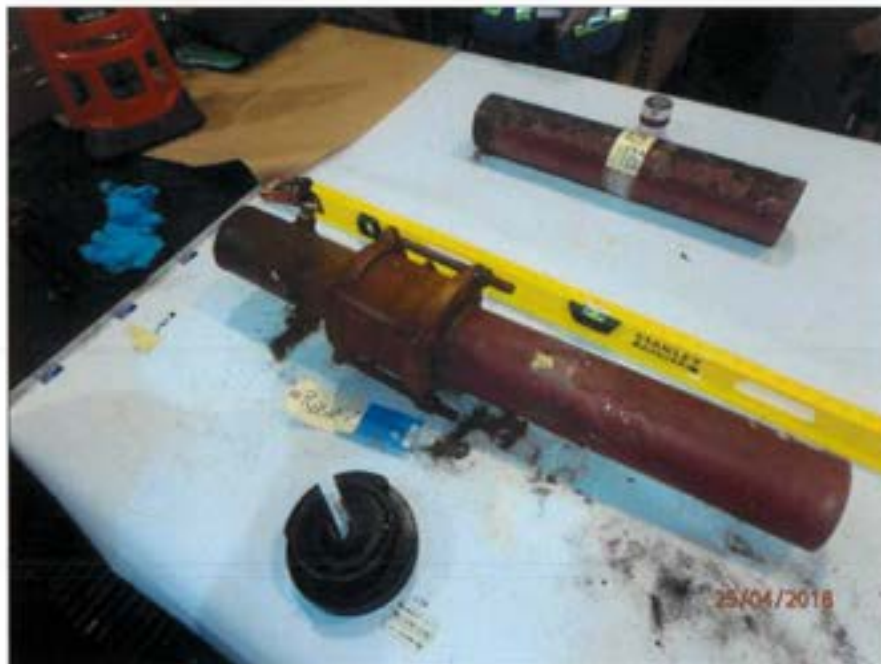
Figure 86 Vertical coupling after removal from foam.

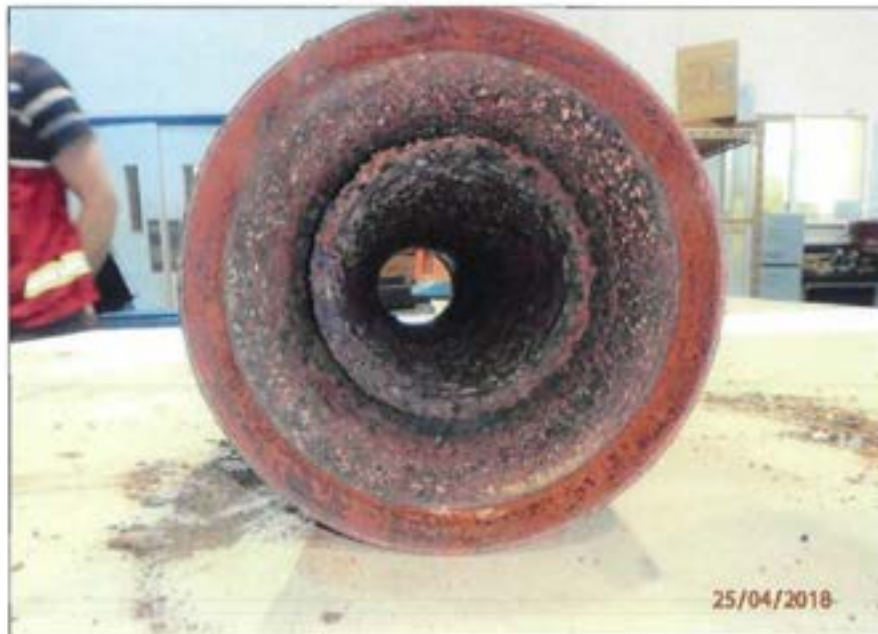
Figure 88 Severe corrosion damage on interior surface of vertical coupling.

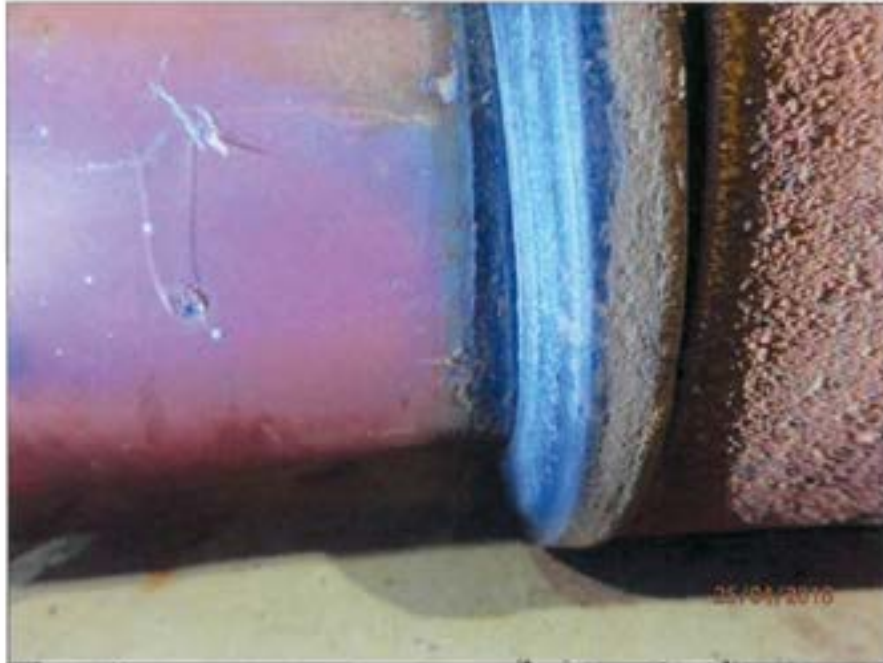
Figure 89 Corrosion damage beneath rubber gasket on vertical coupling.

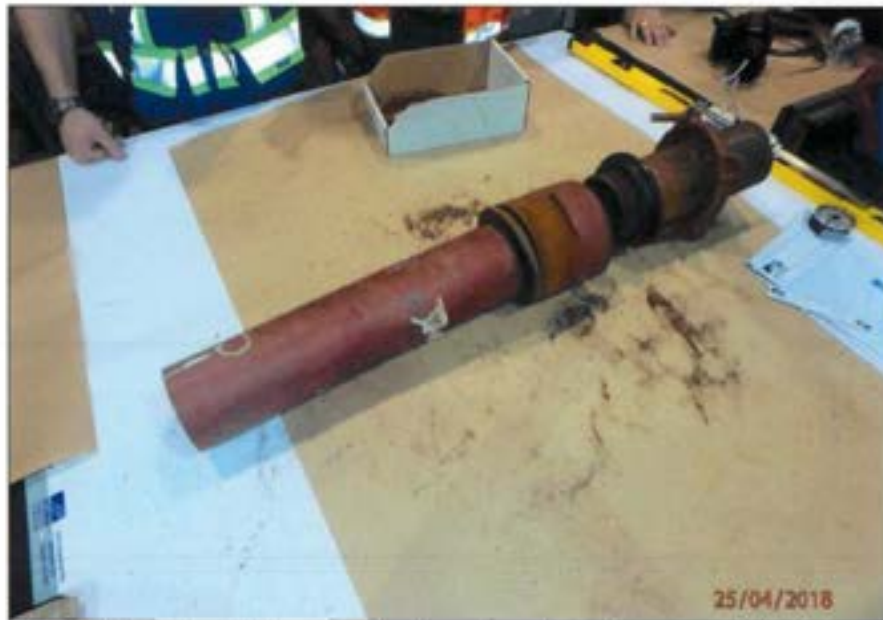
Figure 90 Overall view of vertical coupling after removal from foam constraints.

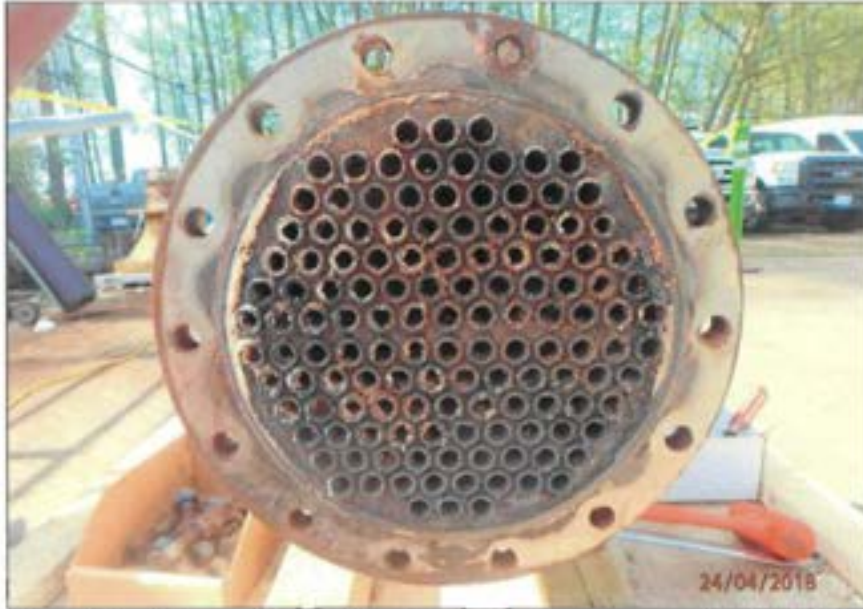
Figure 97 Return tubesheet side of chiller. Tubes are corroded and partially filled with debris.

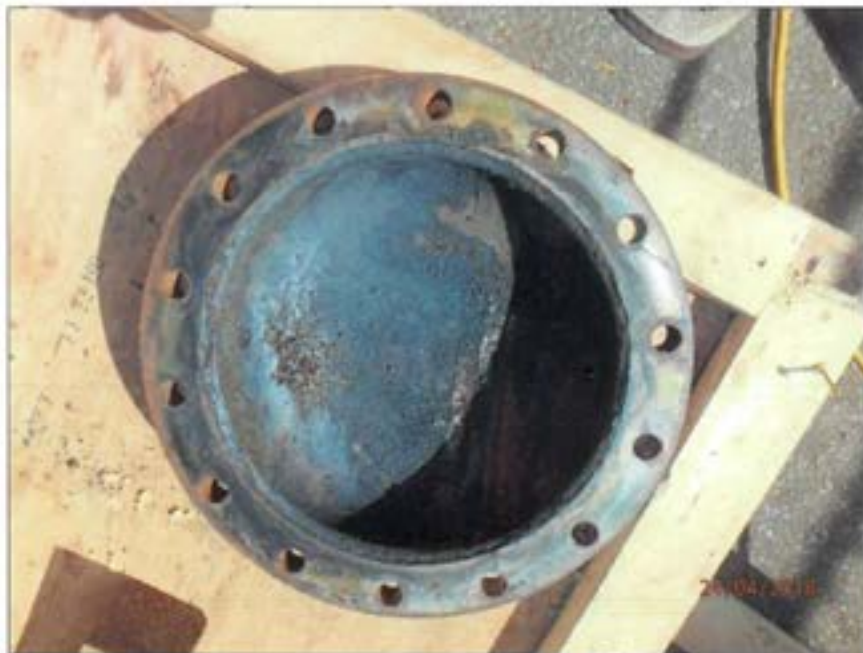
Figure 98 Return side head showing a blue-black scale and very little corrosion damage.

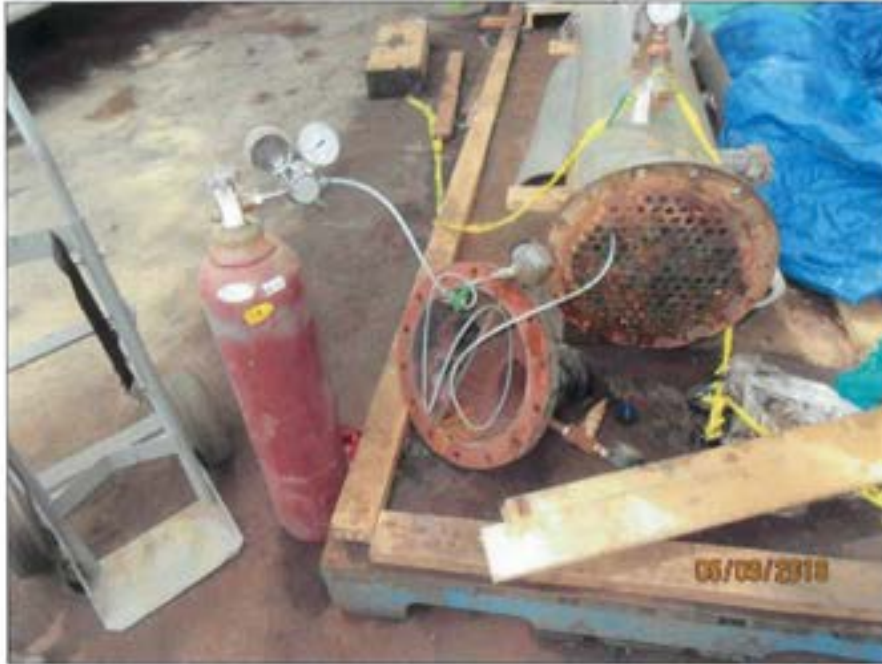
Figure 99 Pressure-test set up for steel chiller tubes.

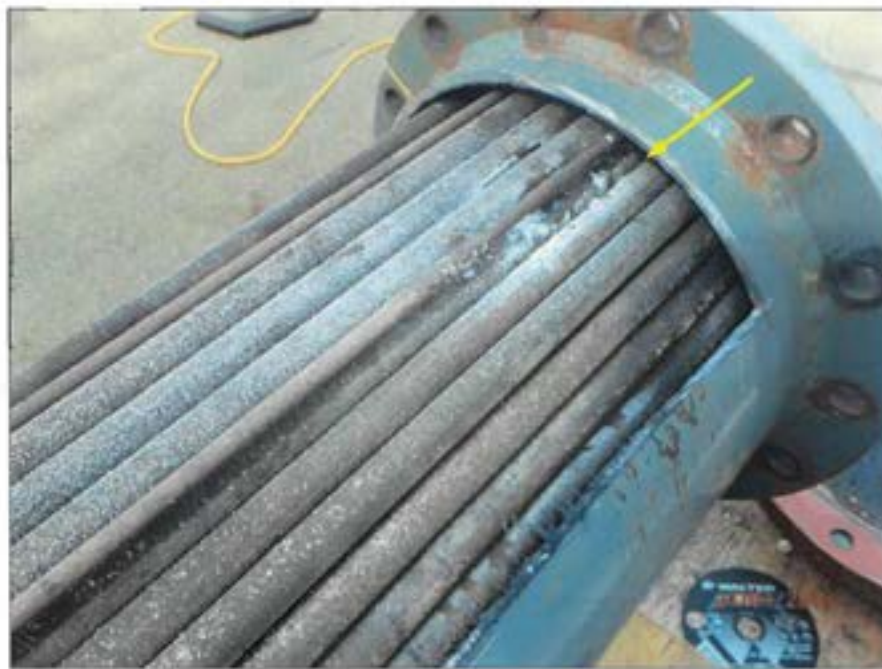
Figure 100 General area of leak found by pressurized argon testing.

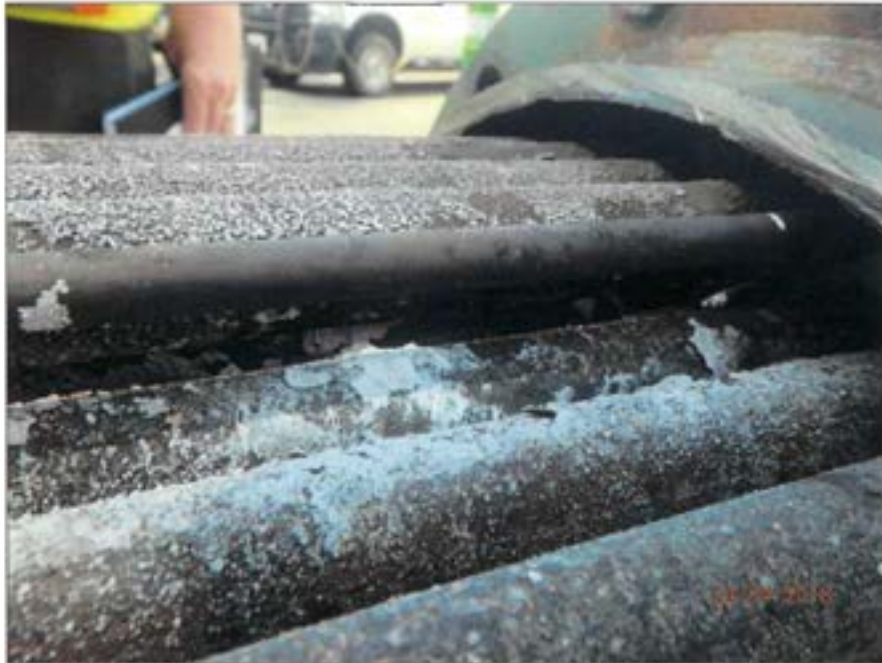
Figure 101 Closer view of leak area on row 2 – tube 3. Note relatively large amounts of white material deposited on surfaces.

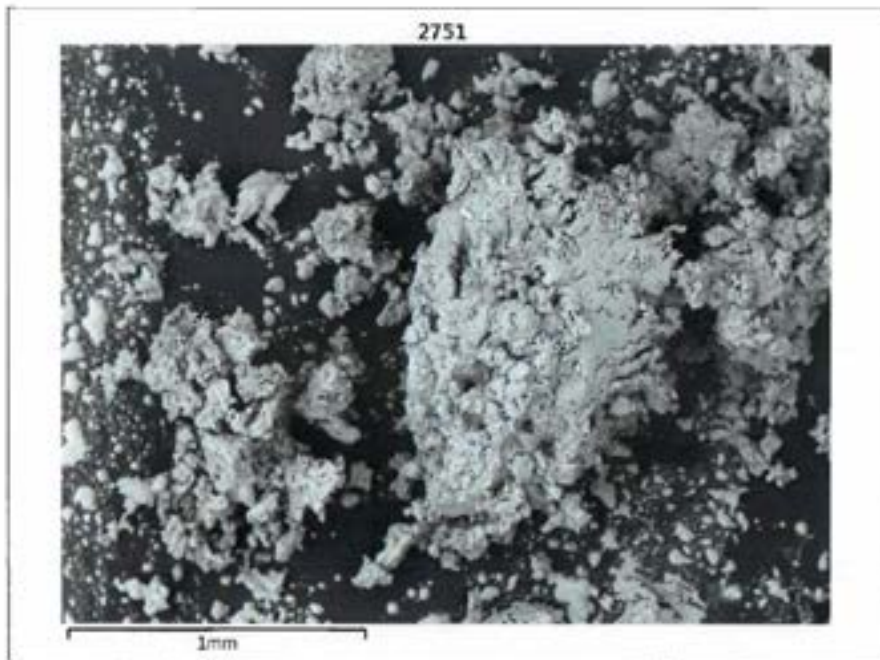
Figure 102 SEM image of white material in area of leak removed for analysis.

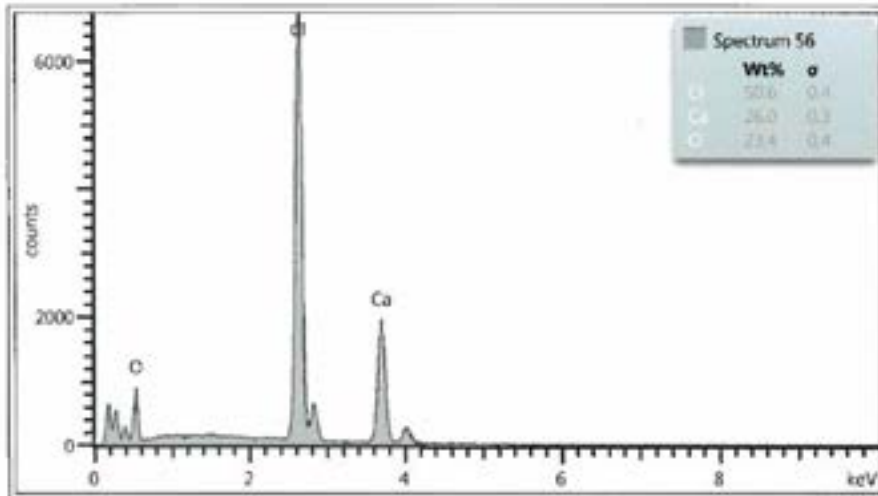
Figure 103 EDXA of white material showing mainly calcium and chlorine.

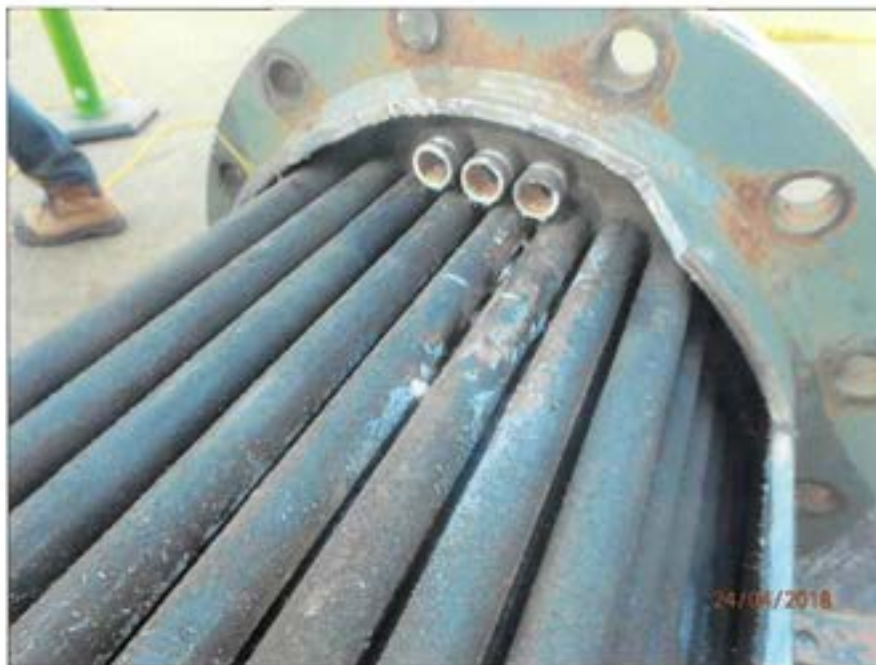
Figure 104 Row 1 tubes removed for access to leak area. Note white material has begun to be dissolved by a process of deliquescence.

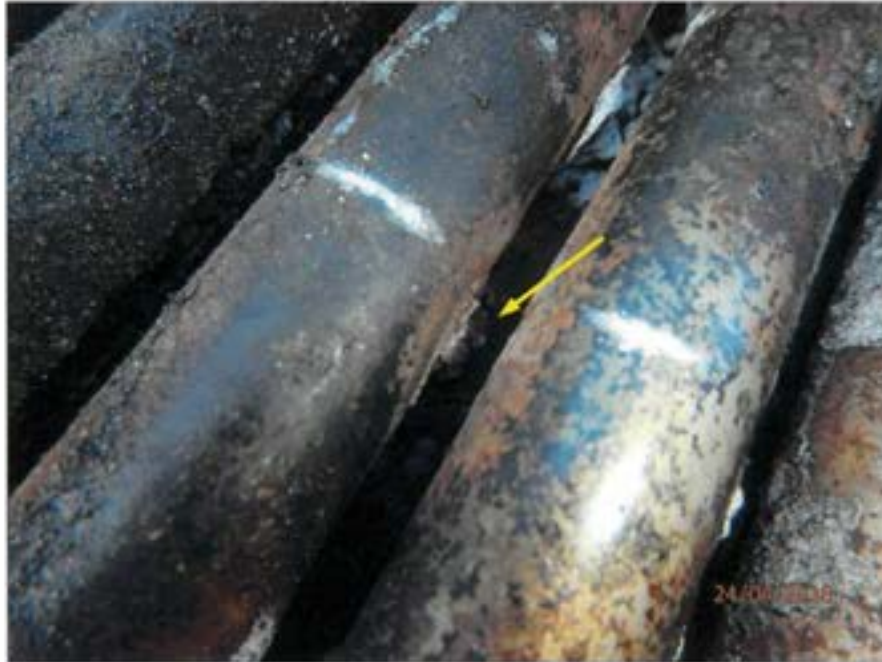
Figure 105 Location of leaking defect on Row 2 – Tube 3.

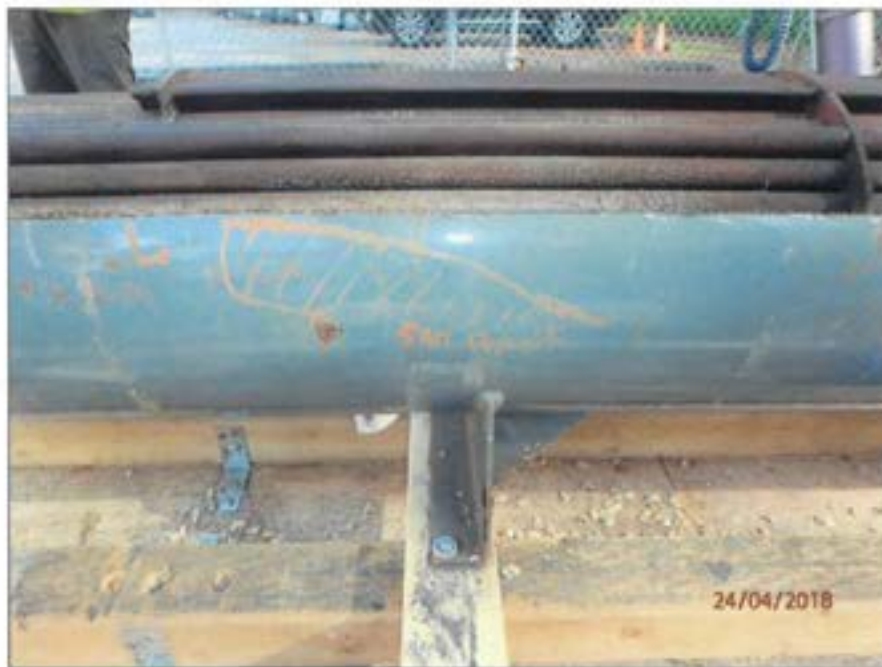
Figure 106 Area where white material was sprayed onto the tank wall and tubes (orange paint).

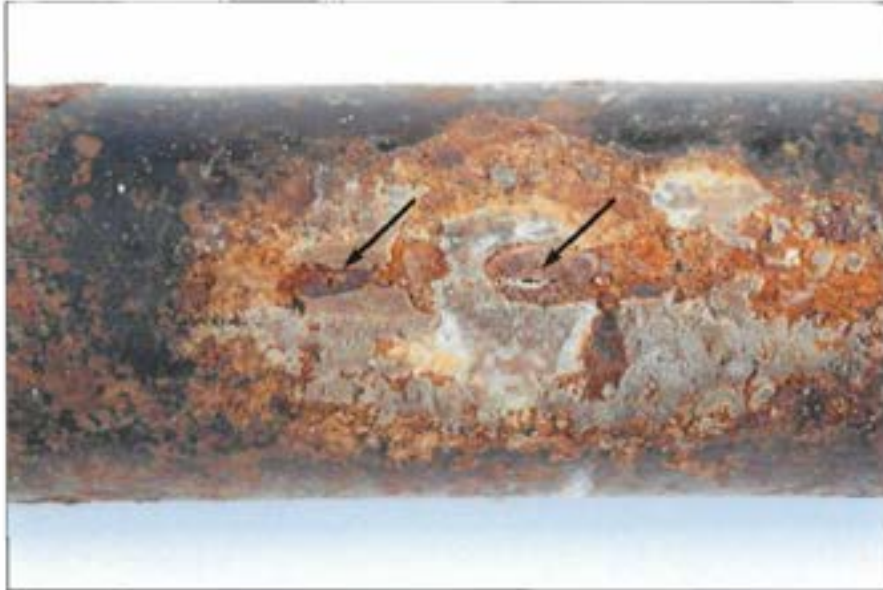
Figure 107 Main leaking defect on row 2 – tube 3 removed from bundle. Several smaller defects were found along the ERW weld.

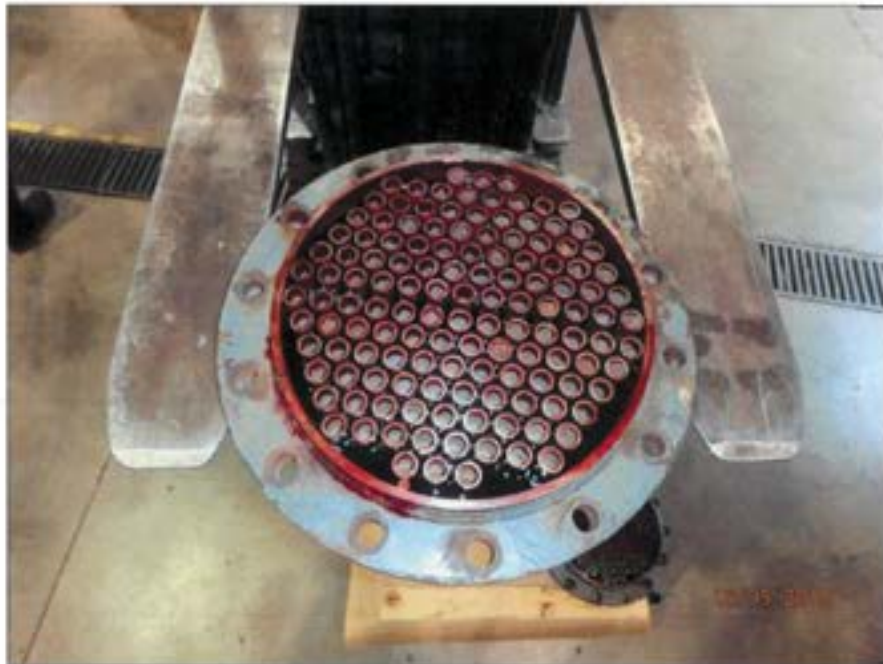
Figure 108 Testing for tubesheet leaks with dye penetrant.

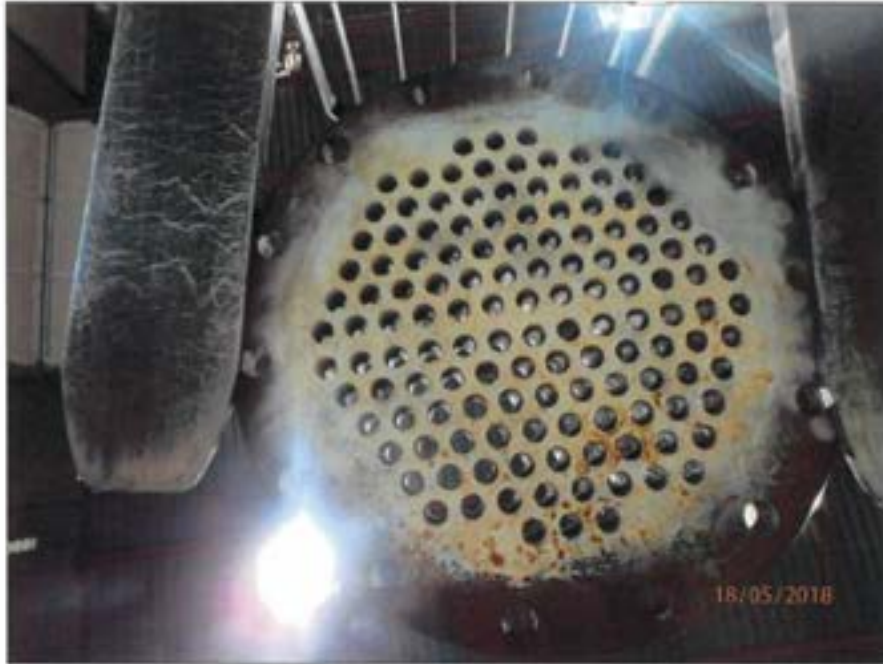
Figure 109 No sign of leaks after 18 hours of dwell time.

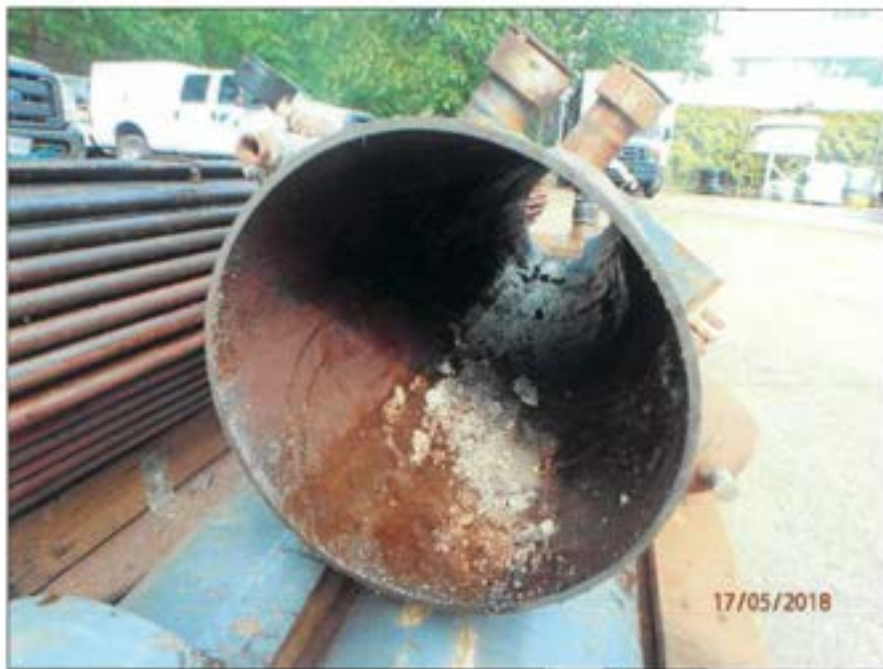
Figure 110 White material found in ammonia tank bottom after bundle removal. EDXA determine white material was calcium chloride.

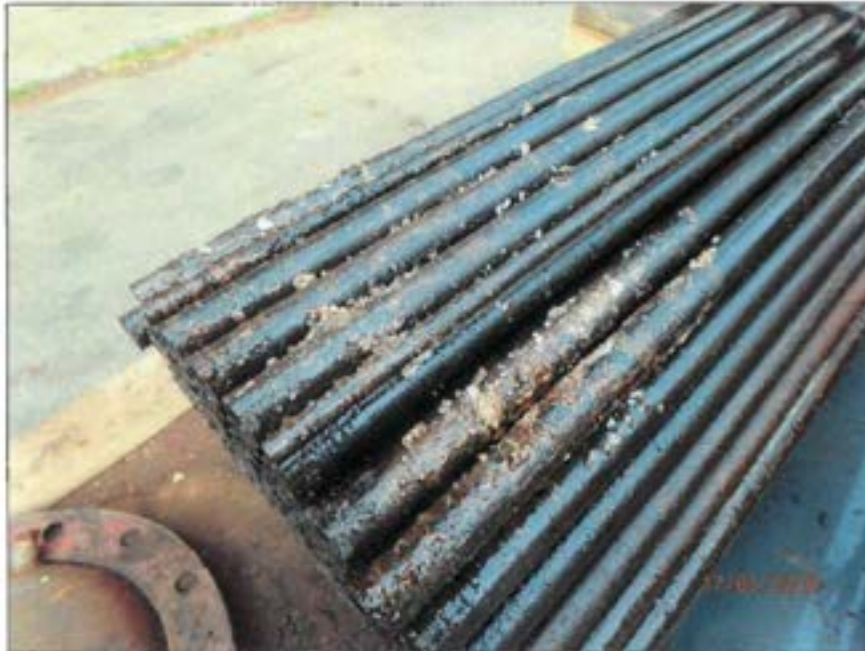
Figure 111 Tube bundle after removal from tank. An oil residue mixed with white deposits (calcium chloride) was present on tubes at the bottom of the tank.

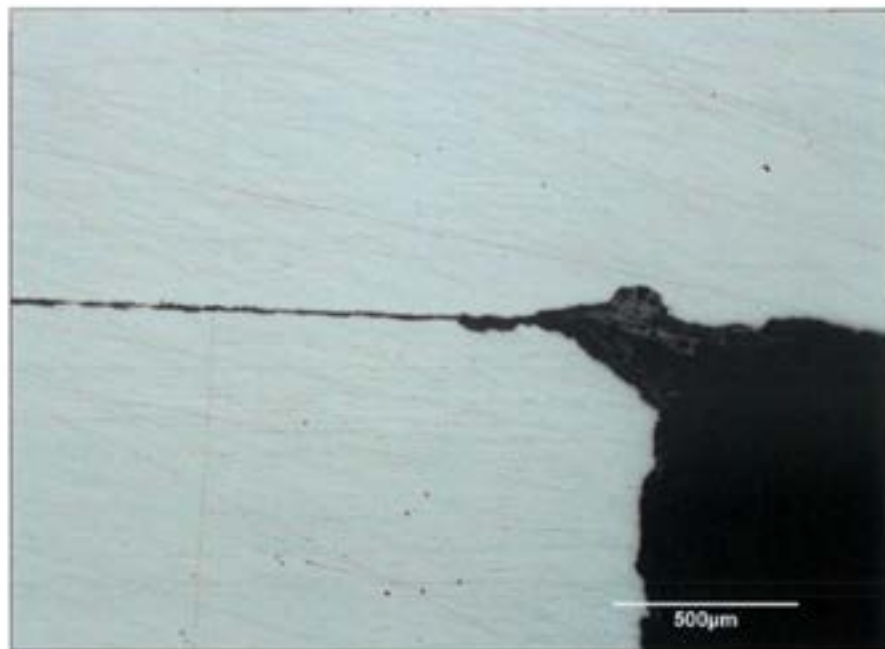
Figure 114 Corrosion beginning to attack tube – tubesheet joint.

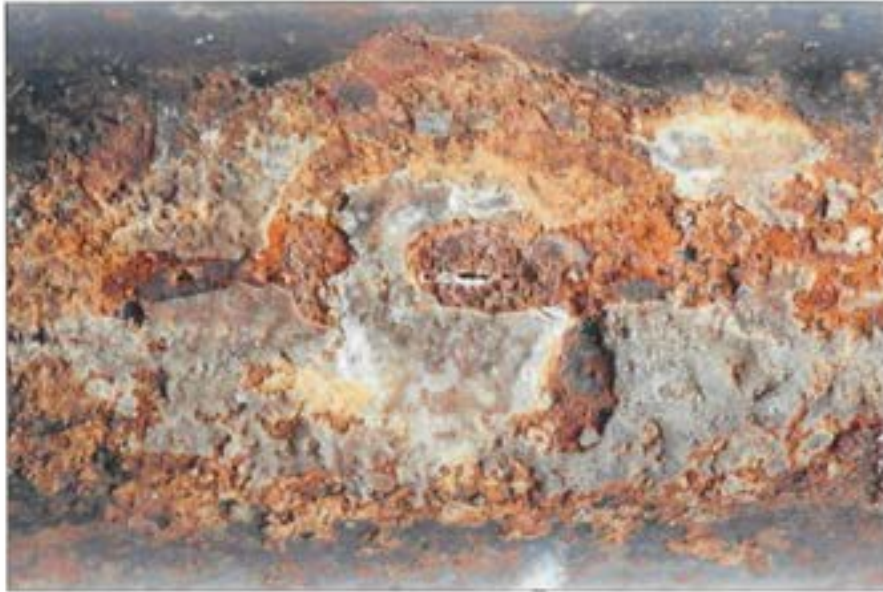
Figure 115 Close-up view of leaking defect on row 2 – tube 3 showing white deposits.

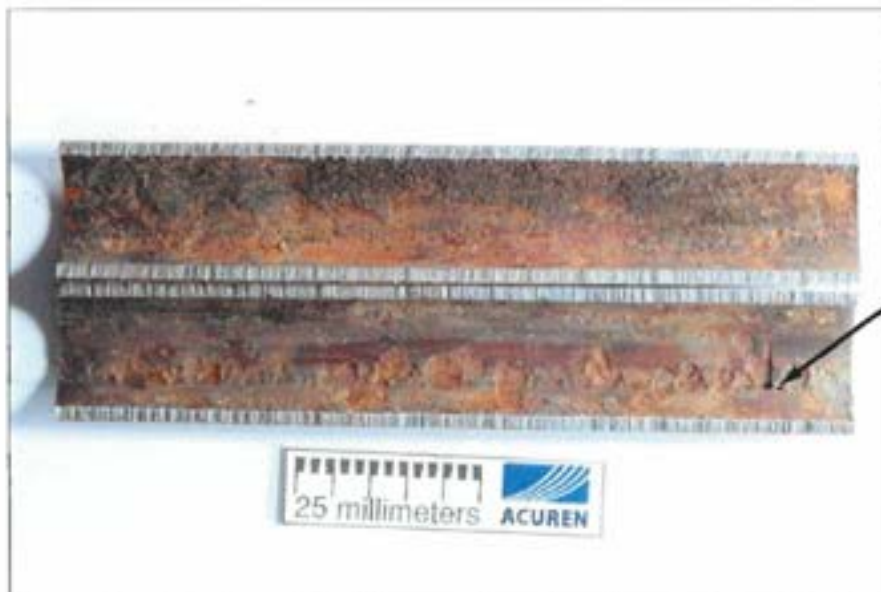
Figure 116 Row 2 – tube 3 split to reveal interior surface. Leaking defect is at arrow.

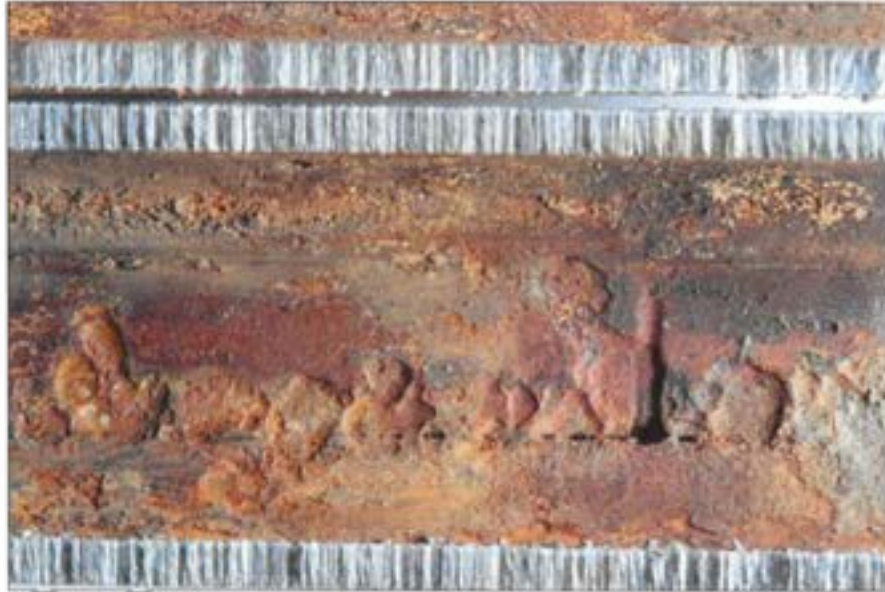
Figure 117 Closer view of leaking defect showing a line of "stitch-like" defects adjacent to the leaking defect. Nozzling effect has removed material above the leak.

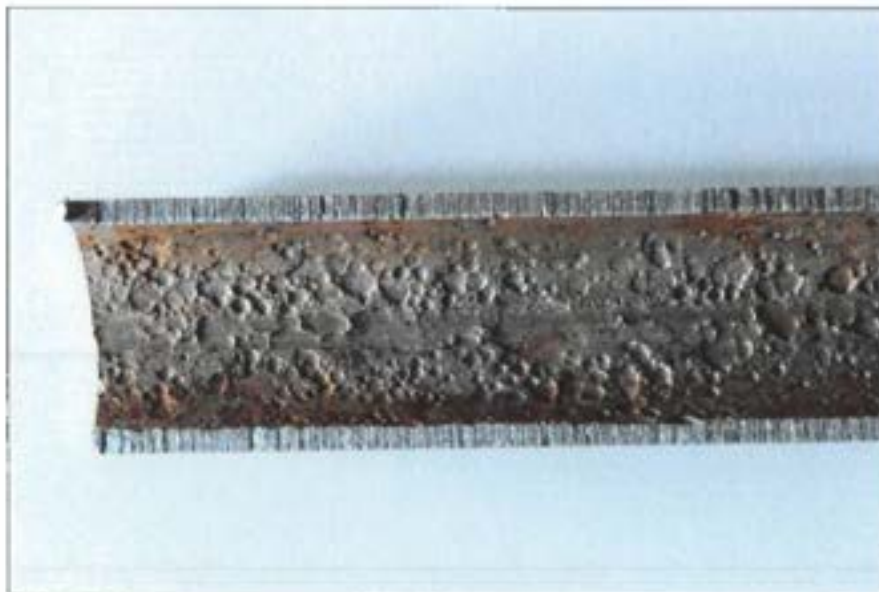
Figure 118 Typical corrosion damage found along row 2 – tube 3 approximately 12" from the leaking defect.

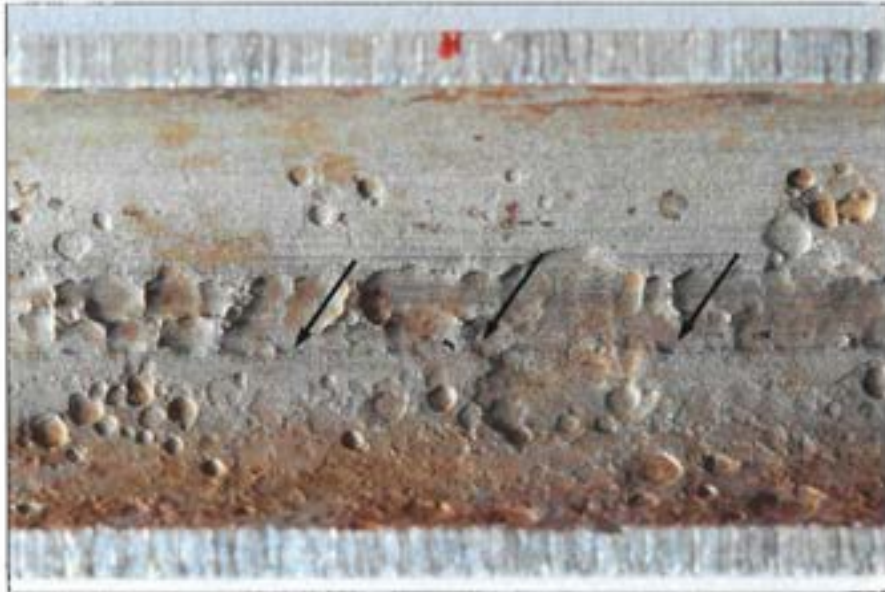
Figure 119 Closer view of corrosion damage showing a line of small, deep pits (arrows).

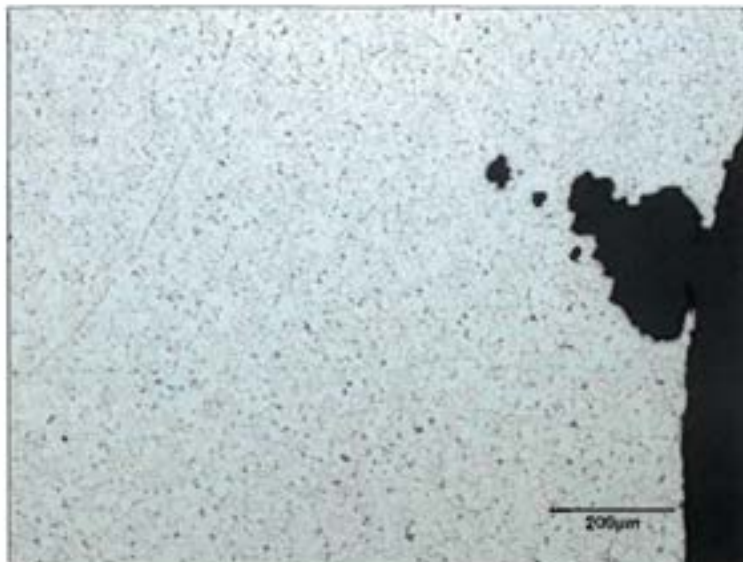
Figure 120 Cross section through typical "stitch" defect showing a corrosion depth of approximately 270 microns.

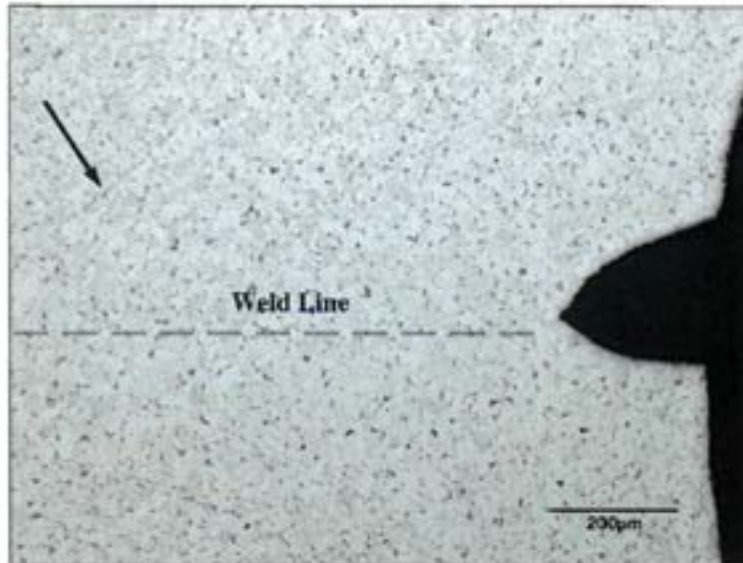
Figure 121 "Stitch -like" defect found along ERW weld line. Note inclusion upset at arrow indicating weld line.

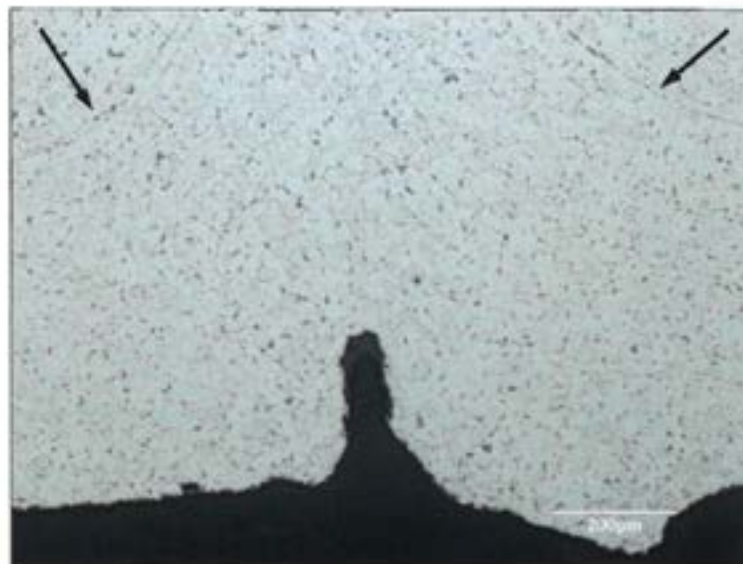
Figure 122 Linear "stitch-like" defect found on row 2 - tube 3 ERW weld line. Microstructure is fully normalized. Arrows show curved upset lines around joint (inclusions).

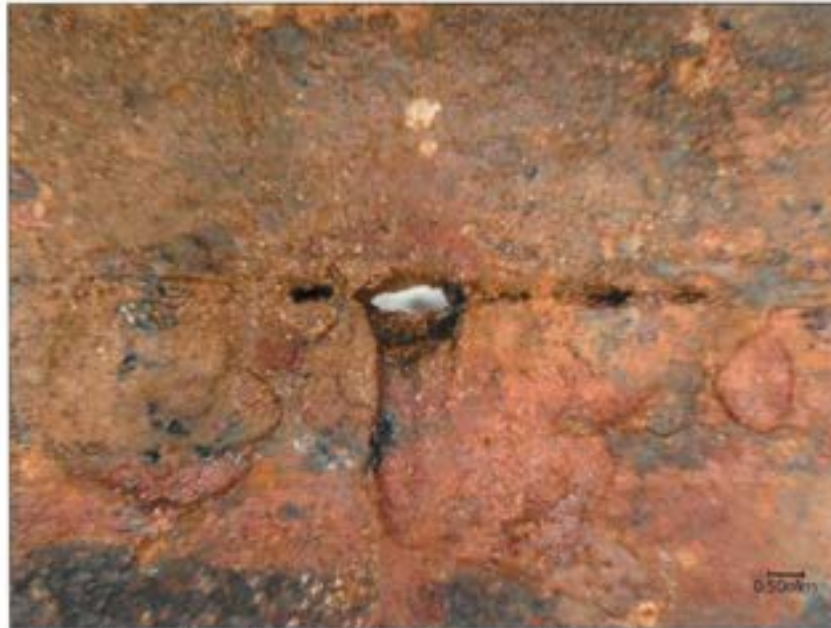
Figure 123 Closer view of pit line in row 2 – tube 3 at leak.

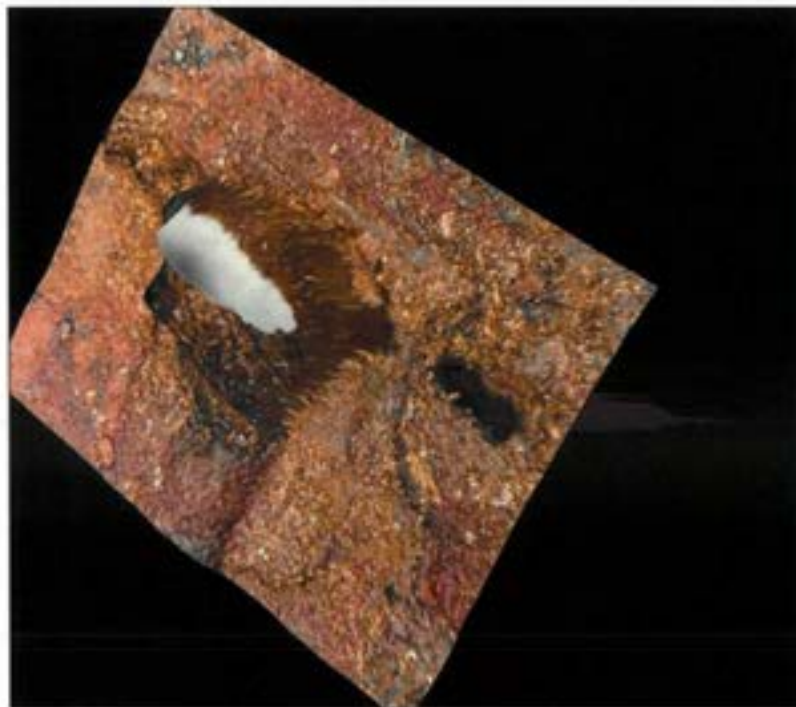
Figure 124 Oblique view of leaking pit showing corrosion attack through cross section.

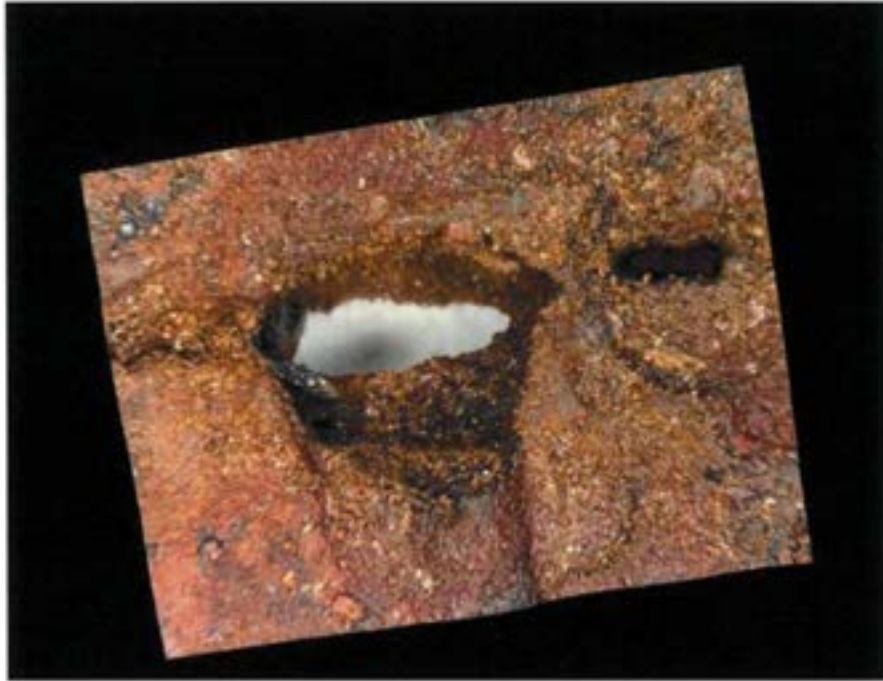
Figure 125 Oblique view of leaking pit showing corrosion attack through cross section.

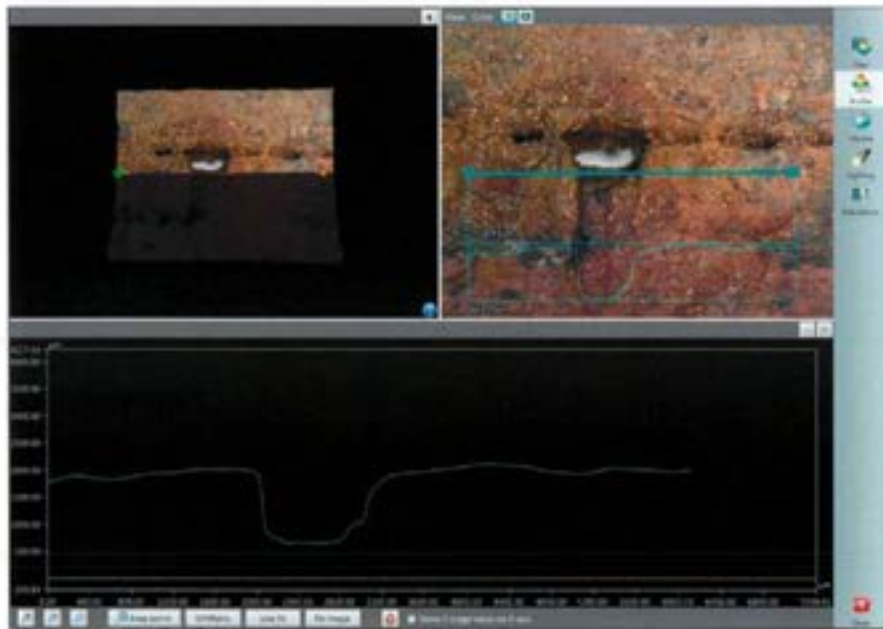
Figure 126 Pit profile showing steep walls of pit.

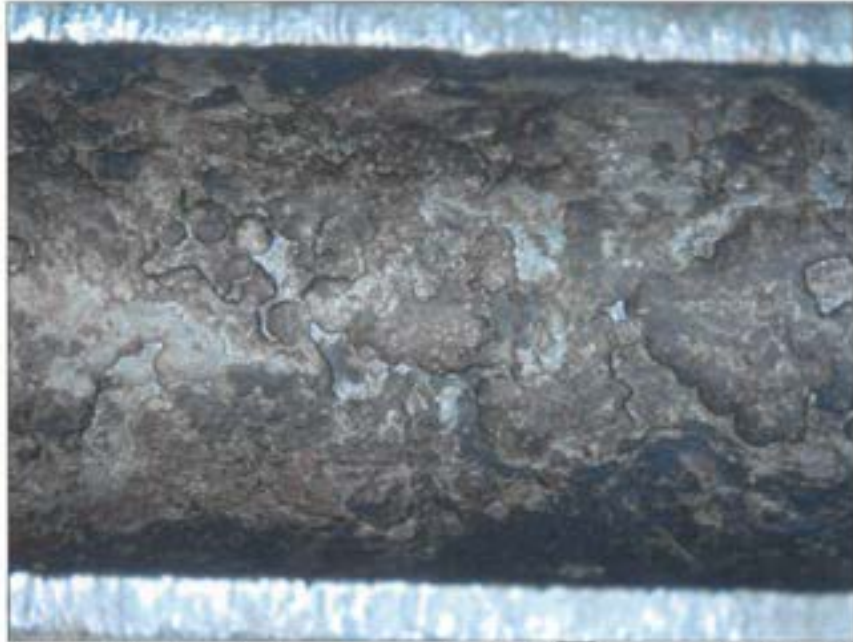
Figure 128 Corrosion damage on row 4 – tube 1 (bottom) after plastic bead blasting.

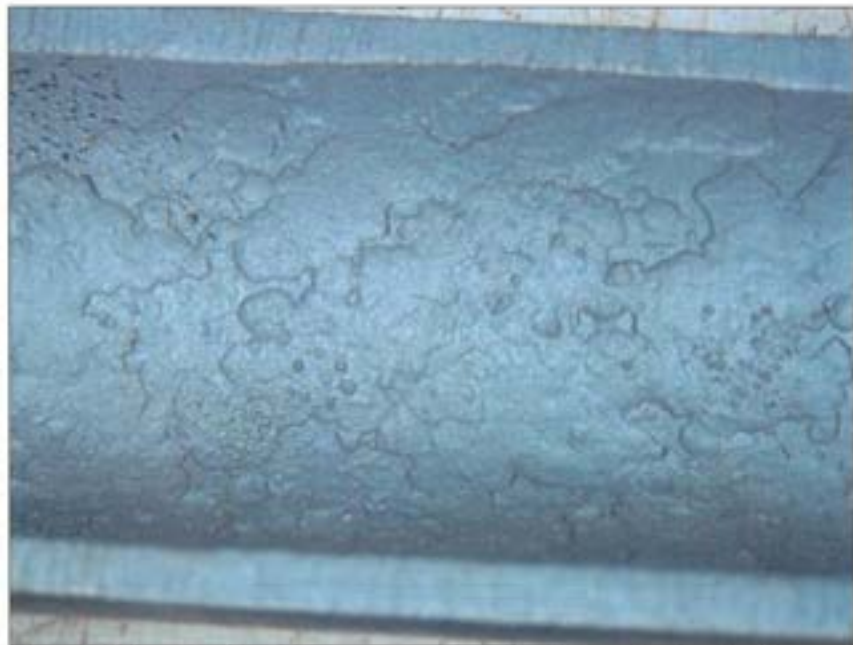
Figure 129 Corrosion damage on row 4 – tube 1 (bottom) after aluminum oxide blasting.

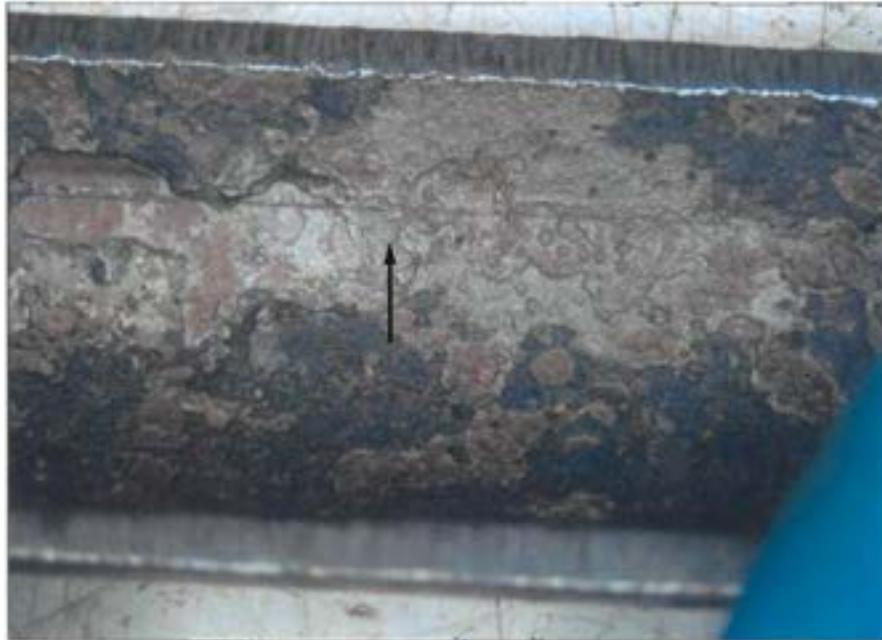
Figure 130 Corrosion damage on row 4 – tube 1 (top) after plastic bead blasting. Note ERW fusion line (arrow).

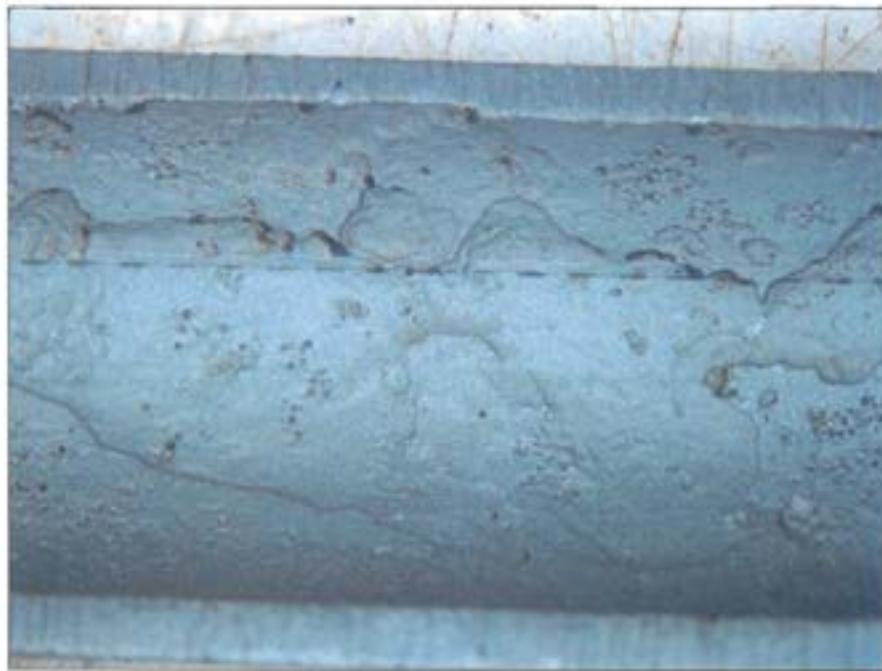
Figure 131 Corrosion damage on row 4 - tube 1 (top) after aluminum oxide blasting. Note "stitch-like" defects along fusion line.

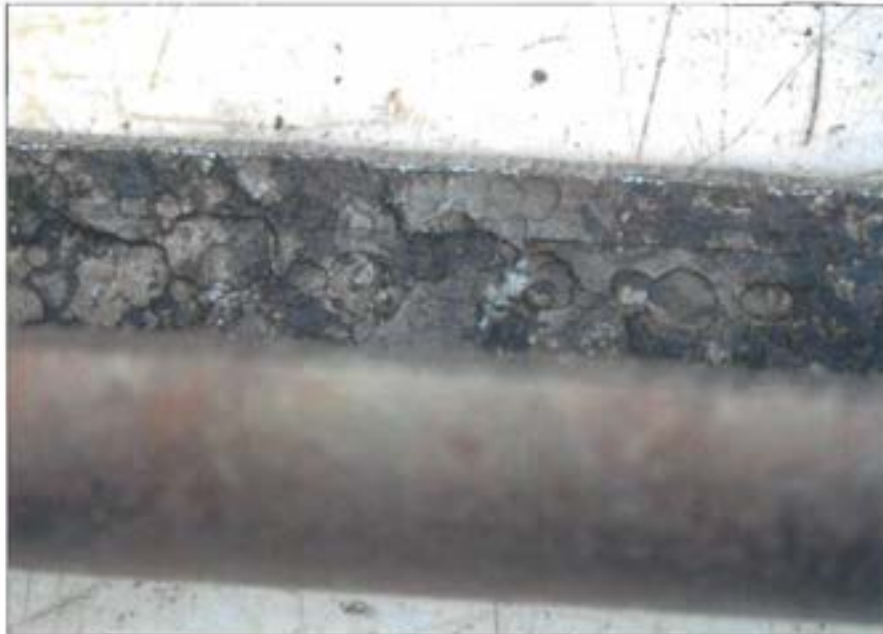
Figure 132 Corrosion damage on row 4 - tube 10 (bottom) after plastic bead blasting.

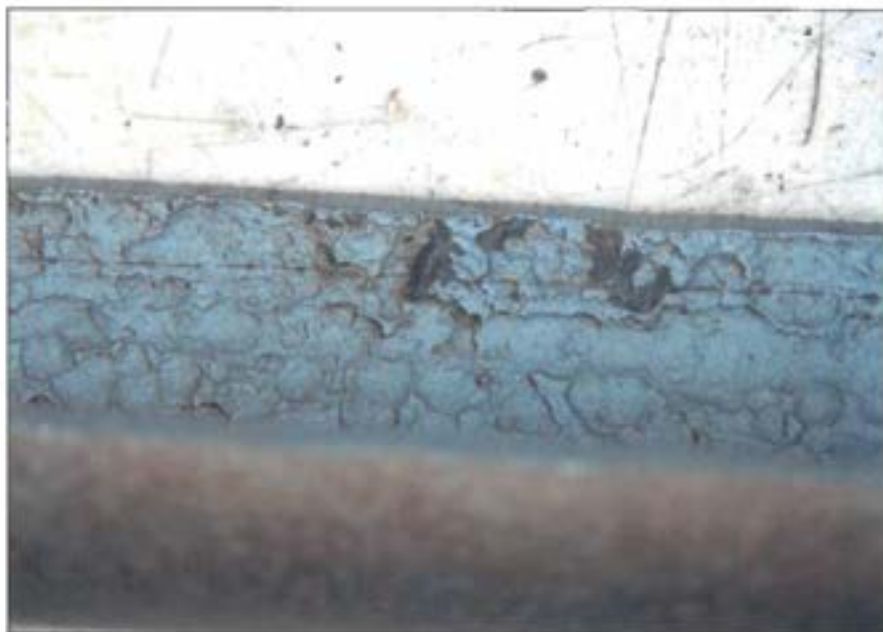
Figure 133 Corrosion damage on row 4 - tube 10 (bottom) after aluminum oxide blasting. Note "stitch-like" defect along fusion line of ERW weld.

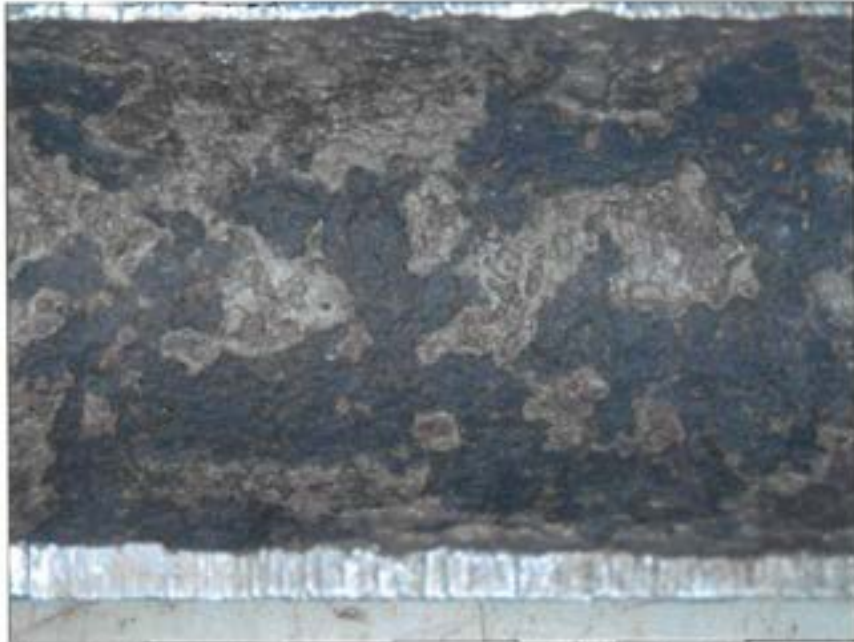
Figure 134 Corrosion damage on row 4 - tube 10 (top) after plastic bead blasting.

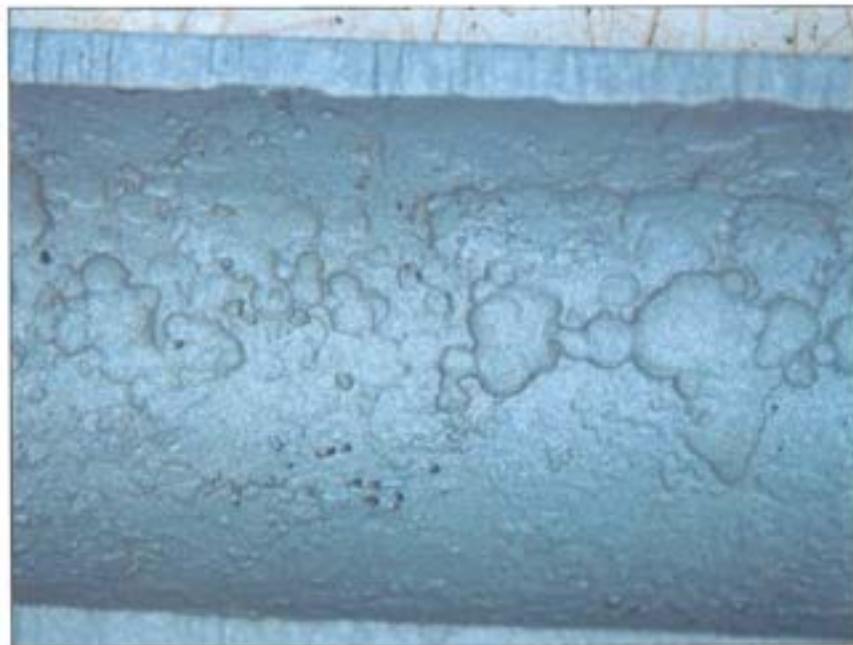
Figure 135 Corrosion damage on row 4 - tube 10 (top) after aluminum oxide blasting.
