Appendix E

Lab Analysis Report

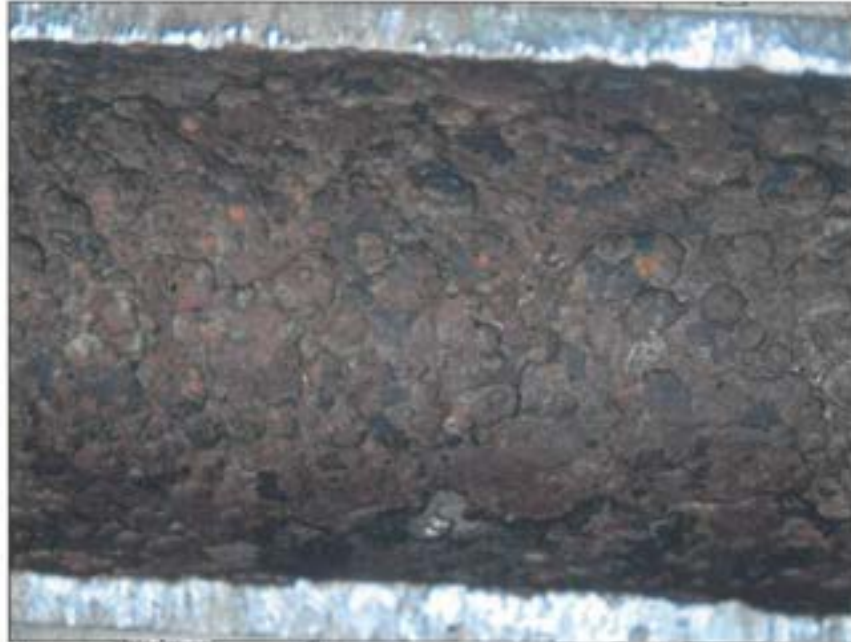
Figure 136 Corrosion damage on row 7 - tube 1 (bottom) after plastic bead blasting.

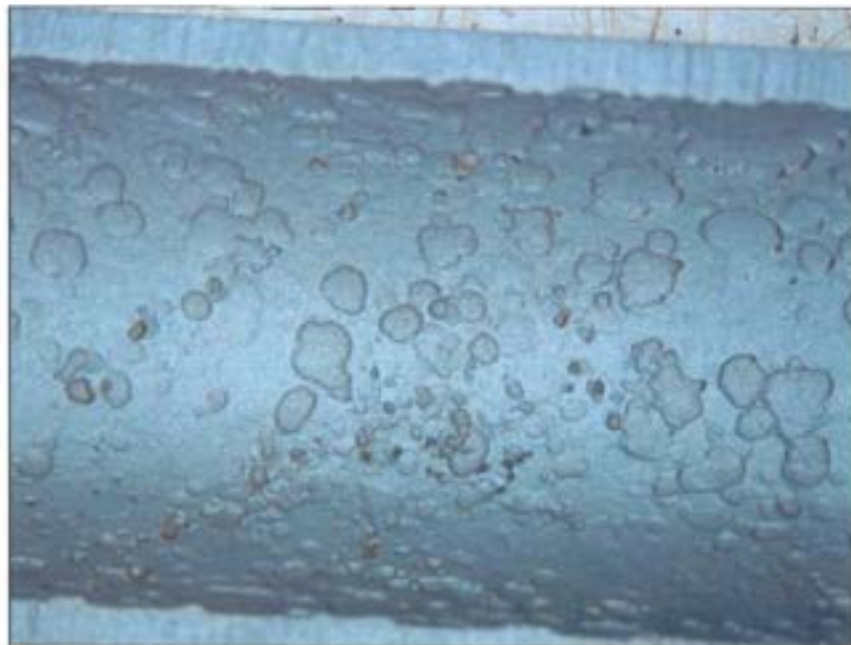
Figure 137 Corrosion damage on row 7 - tube 1 (bottom) after aluminum oxide blasting.

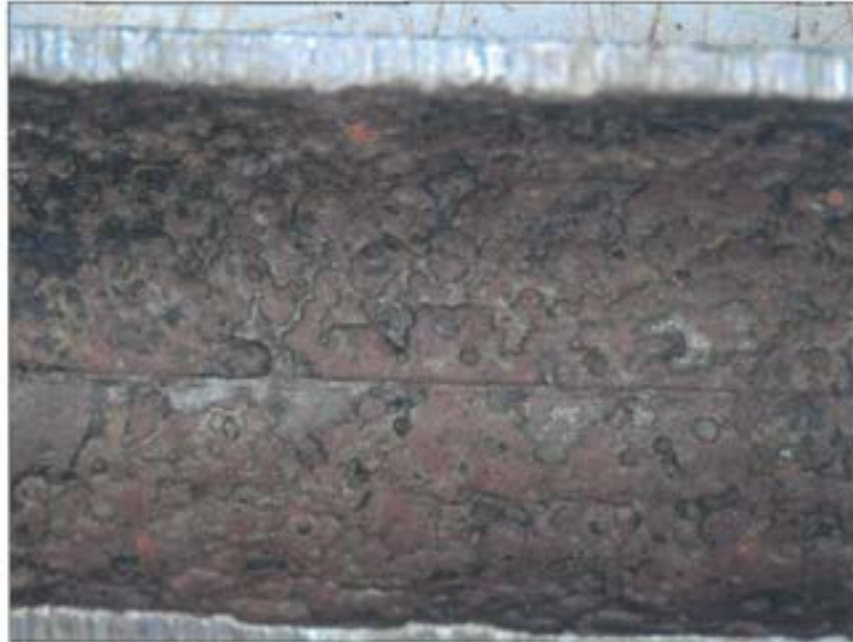
Figure 138 Corrosion damage on row 7 - tube 1 (top) after plastic bead blasting.

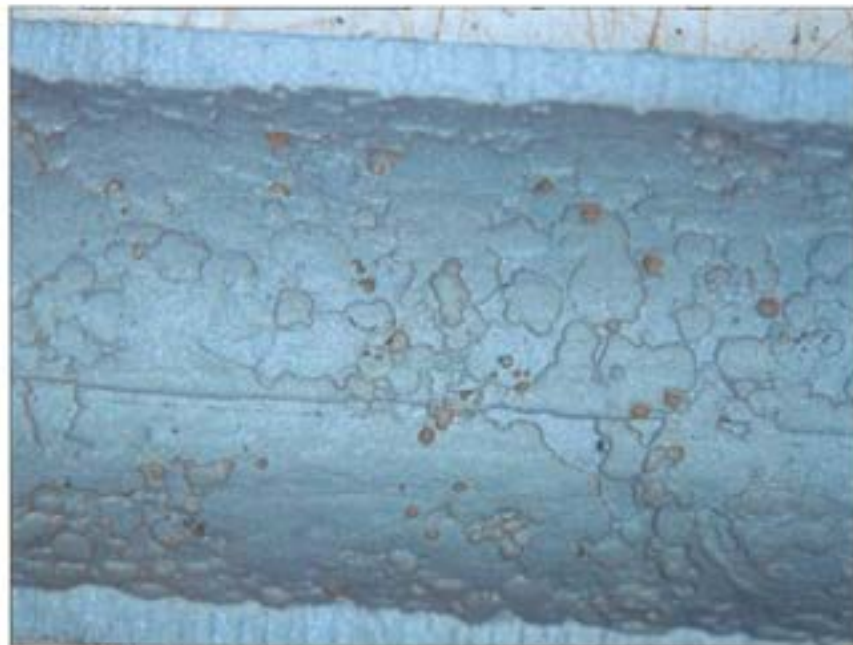
Figure 139 Corrosion damage on row 7 - tube 1 (top) after aluminum oxide blasting.

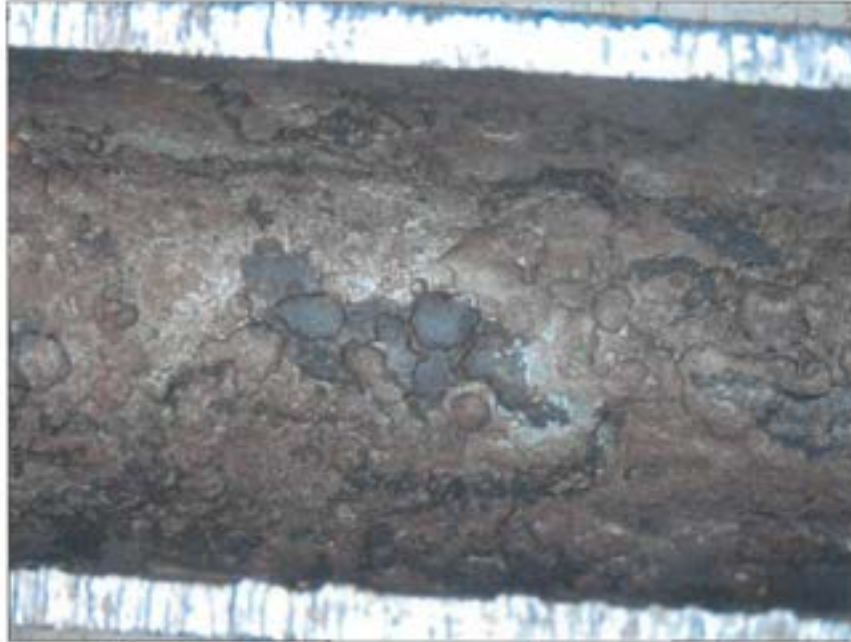
Figure 140 Corrosion damage on row 7 - tube 13 (bottom) after plastic bead blasting.

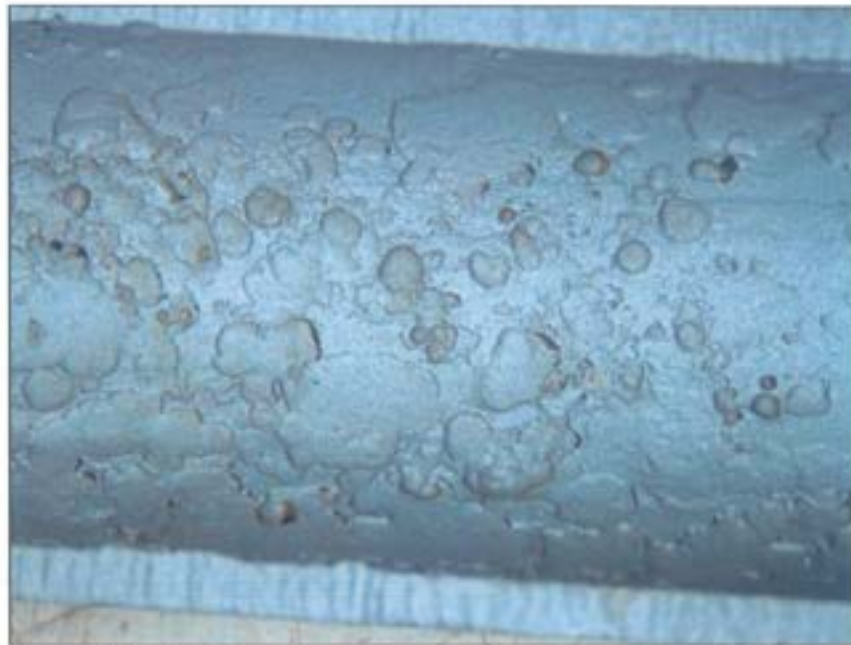
Figure 141 Corrosion damage on row 7 - tube 13 (bottom) after aluminum oxide blasting.

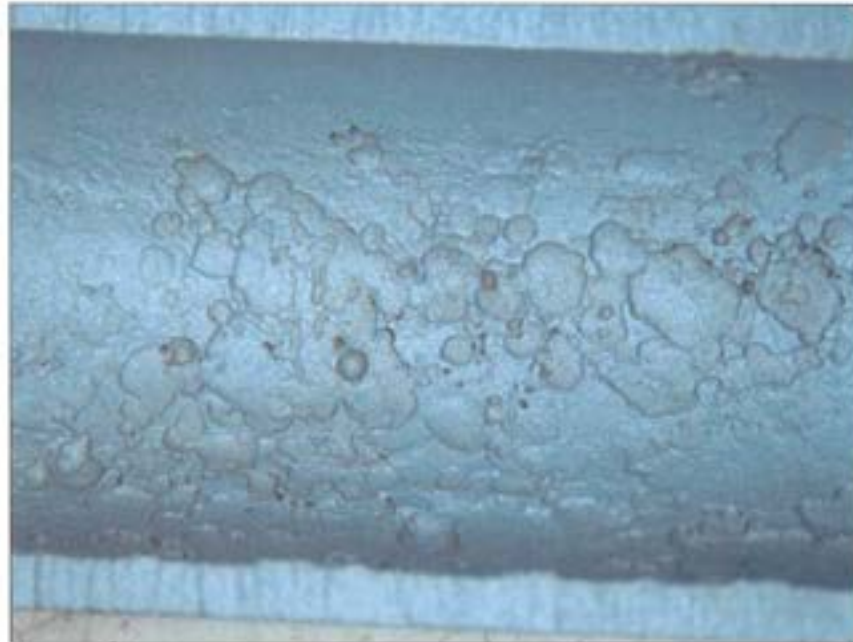
Figure 142 Second area of corrosion damage on row 7- tube 13 (bottom) after aluminum oxide blasting.

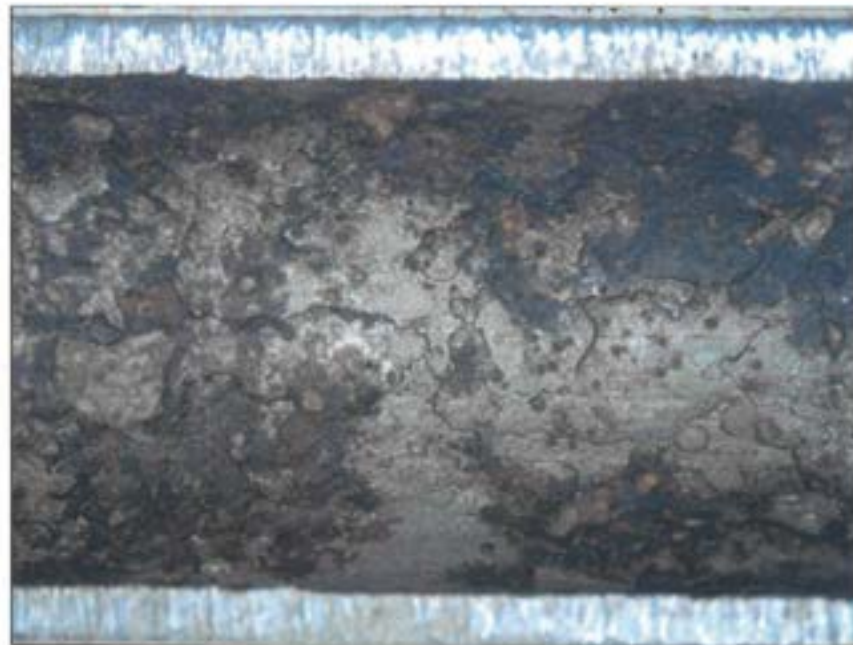
Figure 143 Corrosion damage on row 7 - tube 13 (top) after plastic bead blasting.

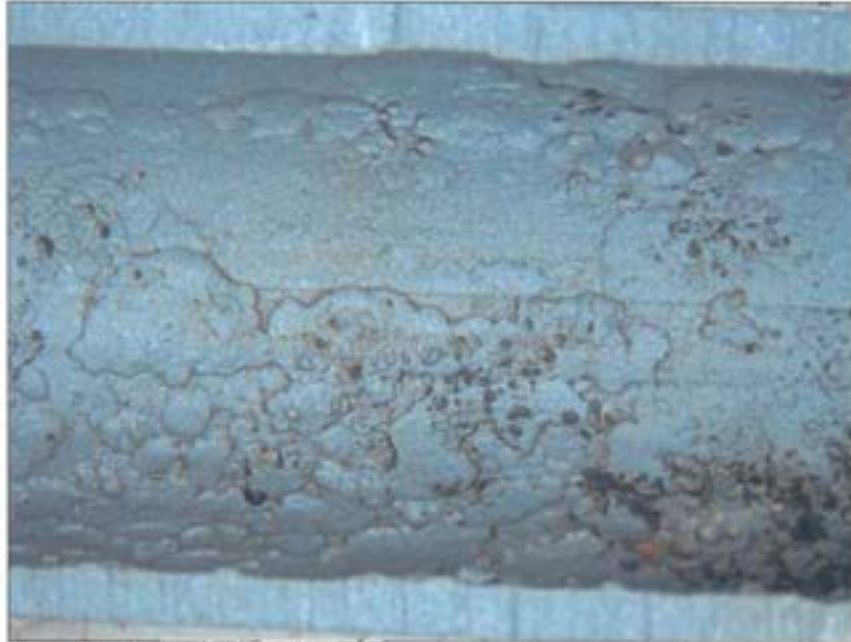
Figure 144. Corrosion damage on row 7 - tube 13 (top) after aluminum oxide blasting.

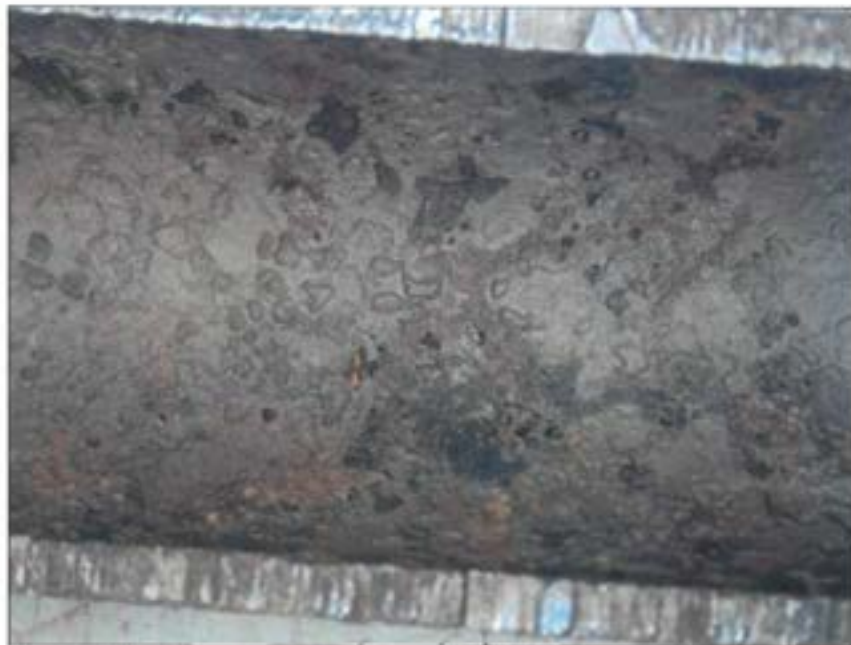
Figure 145. Corrosion damage on row 11 - tube 1 (bottom) after plastic bead blasting.

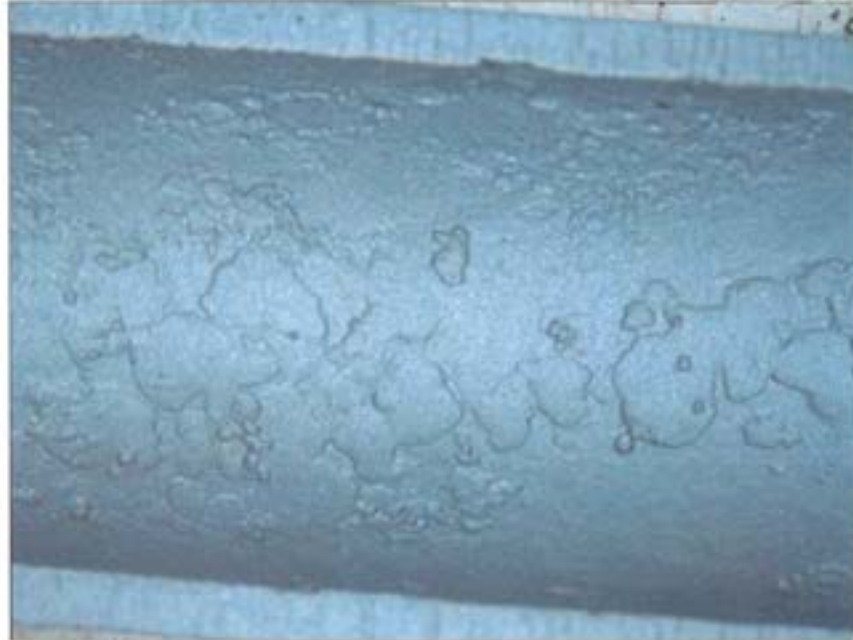
Figure 146 Corrosion damage on row 11 - tube 1 (bottom) after aluminum oxide blasting.

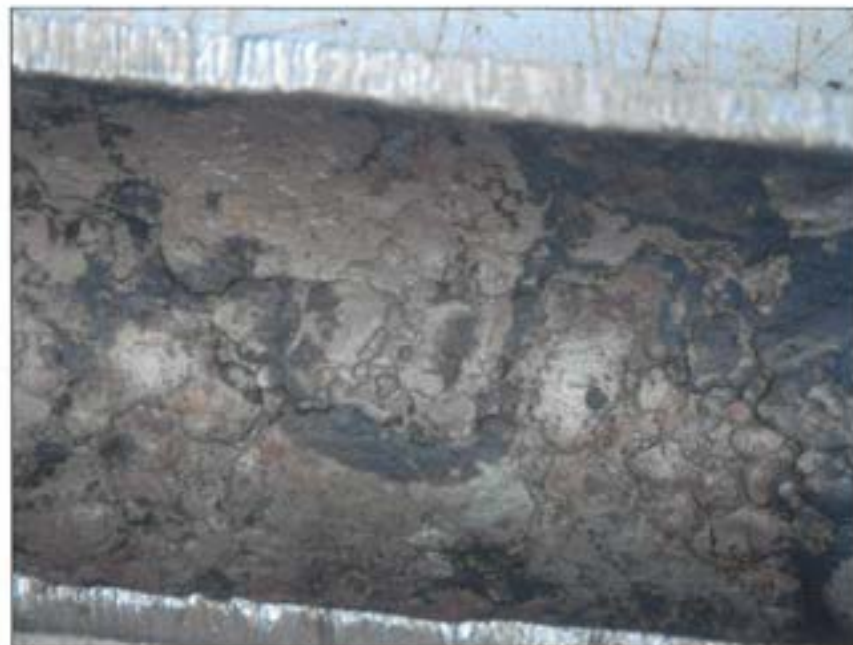
Figure 147 Corrosion damage on row 11 - tube 1 (top) after plastic bead blasting.

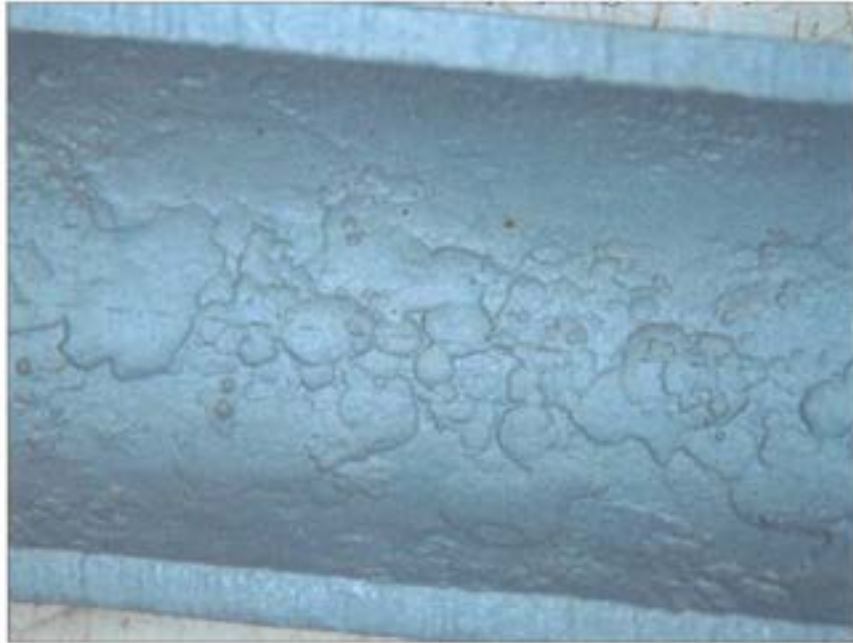
Figure 148 Corrosion damage on row 11 - tube 1 (top) after aluminum oxide blasting. Note "stitching" along fusion line of ERW joint.

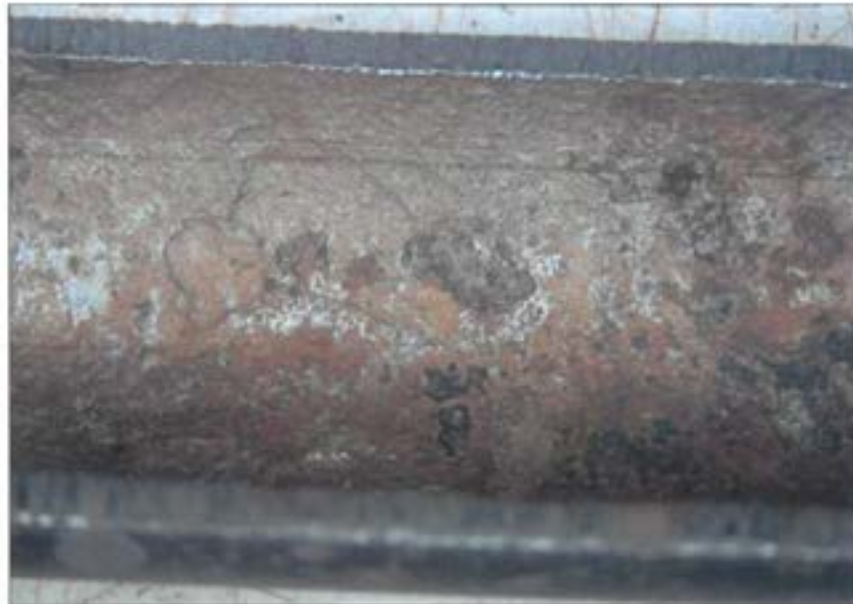
Figure 149 Corrosion damage on row 11 - tube 10 (bottom) after plastic bead blasting.

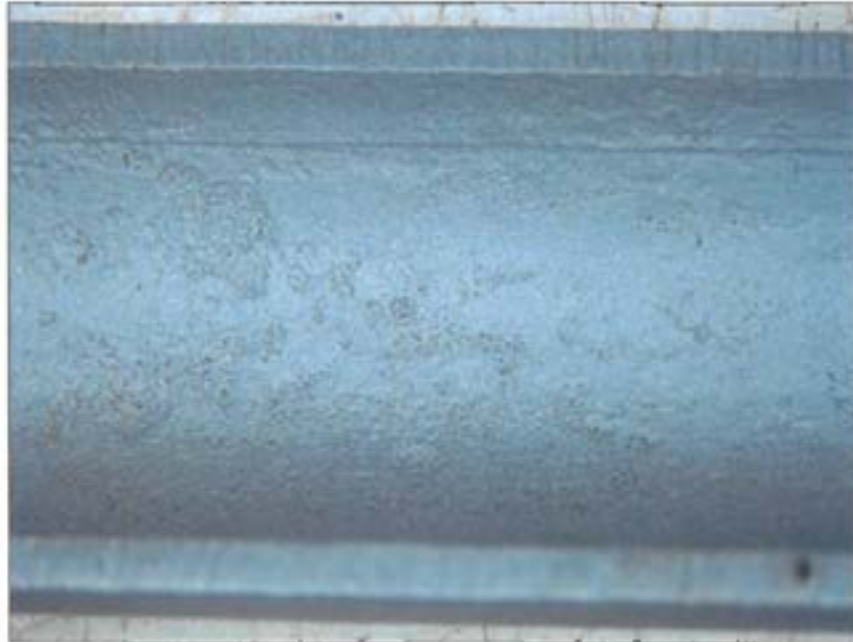
Figure 150 Corrosion damage on row 11 - tube 10 (bottom) after aluminum oxide blasting.

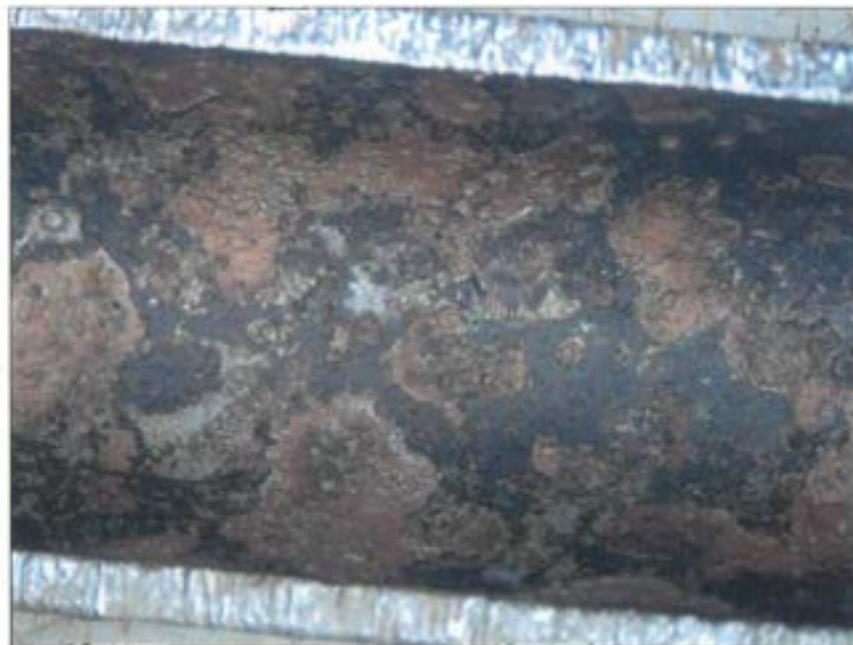
Figure 151 Corrosion damage on row 11 - tube 10 (top) after plastic bead blasting.

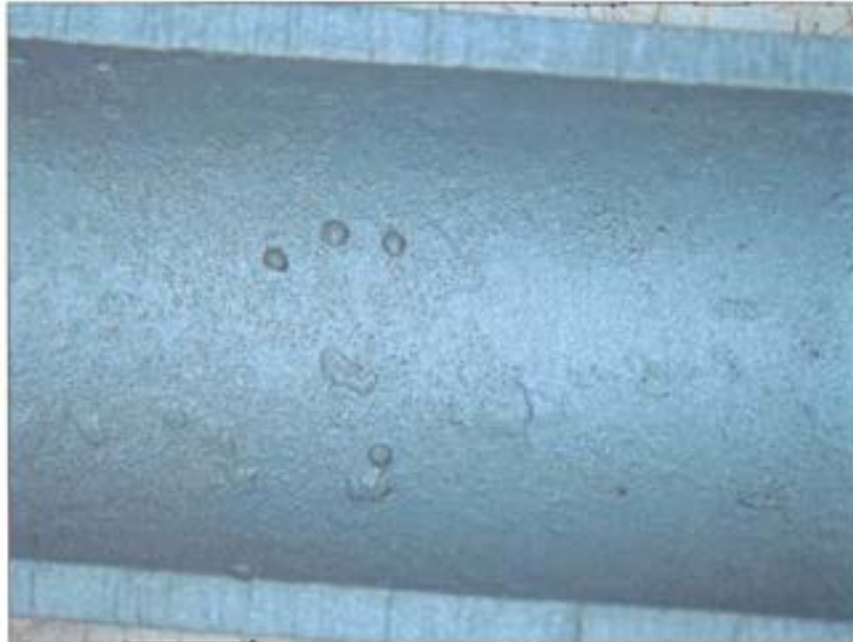
Figure 152 Corrosion damage on row 11 - tube 10 (top) after aluminum oxide blasting.

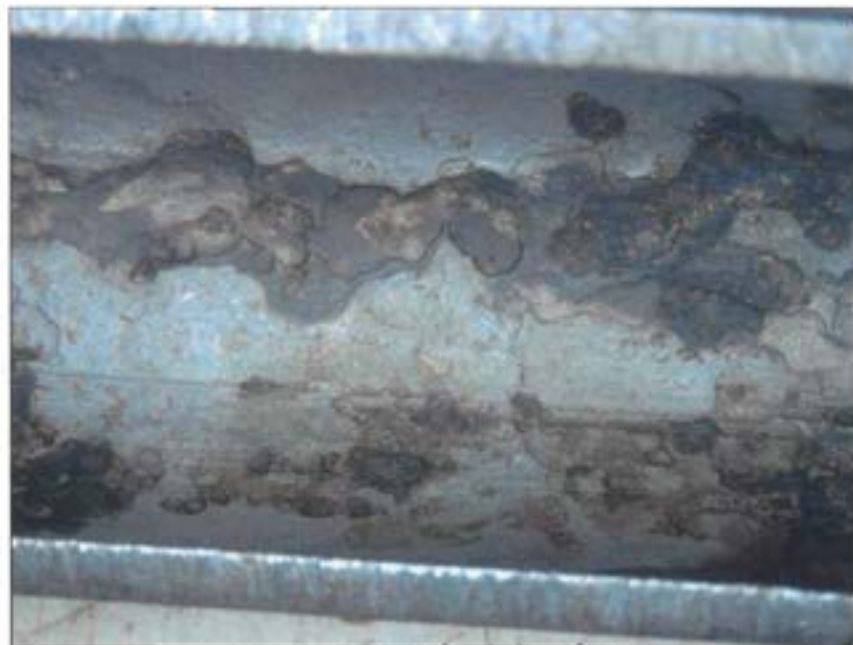
Figure 153 Corrosion damage on row 14 - tube 2 (bottom) after plastic bead blasting.

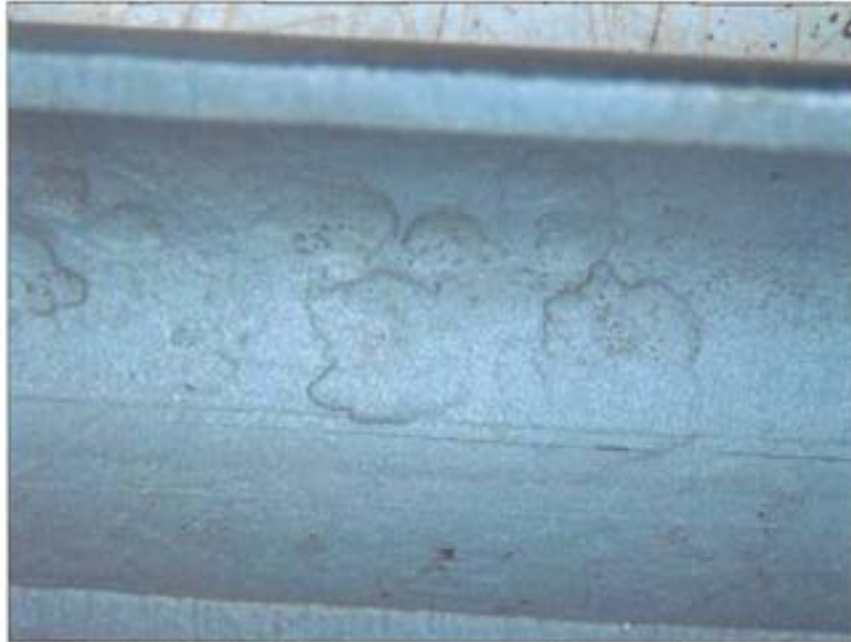
Figure 154 Corrosion damage on row 14 - tube 2 (bottom) after aluminum oxide blasting.

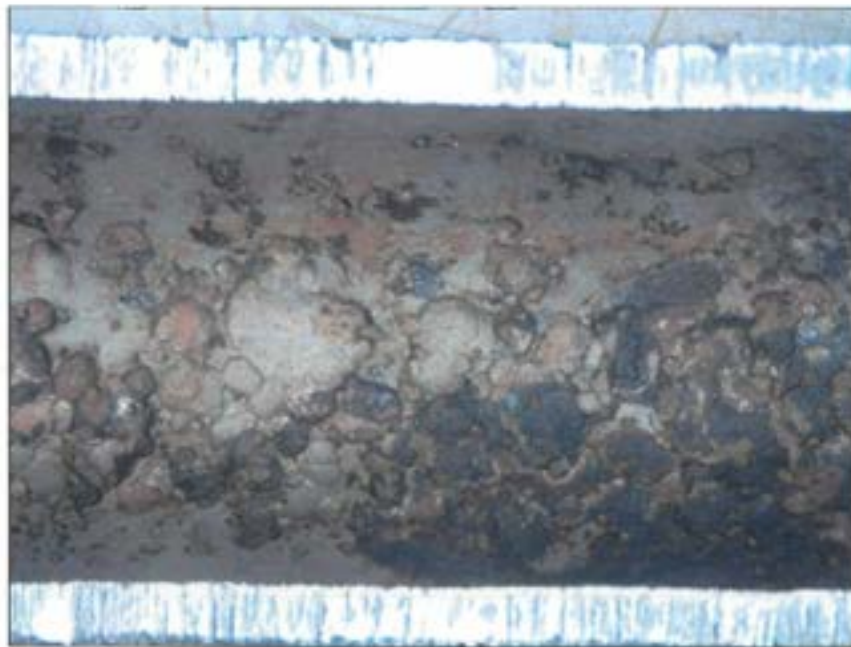
Figure 155 Corrosion damage on row 14 - tube 2 (top) after plastic bead blasting.

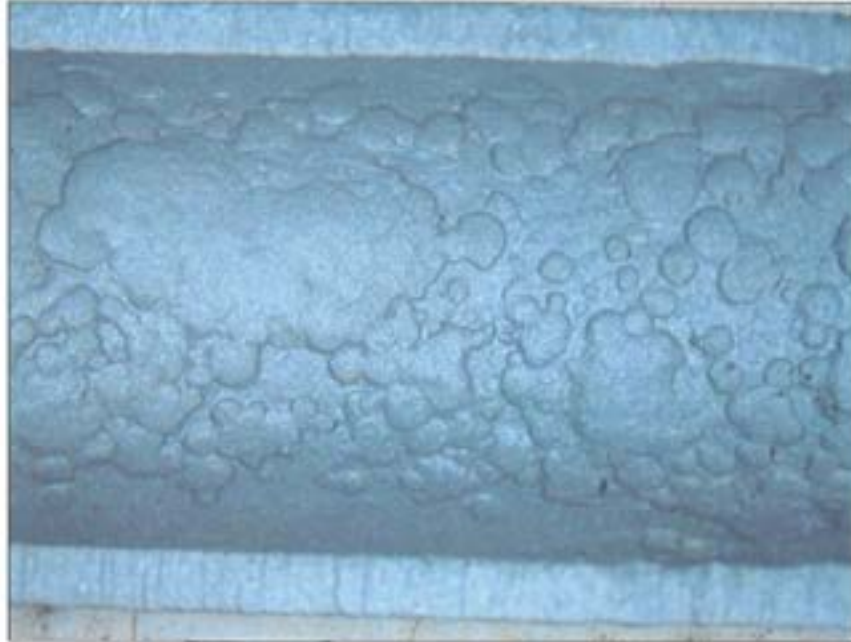
Figure 156 Corrosion damage on row 14 - tube 2 (top) after aluminum oxide blasting.

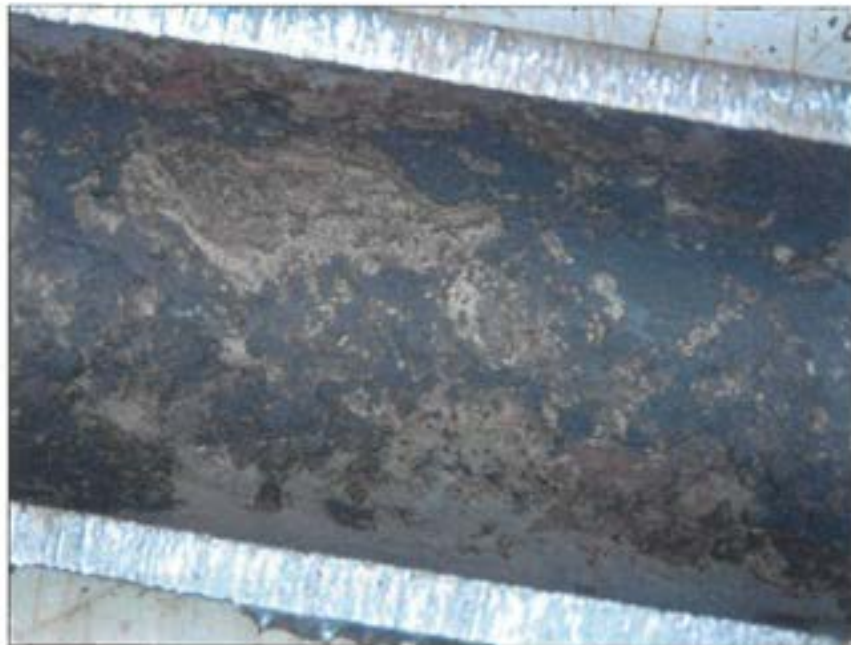
Figure 157 Second area of corrosion damage on row 14 - tube 2 (bottom) after plastic bead blasting.

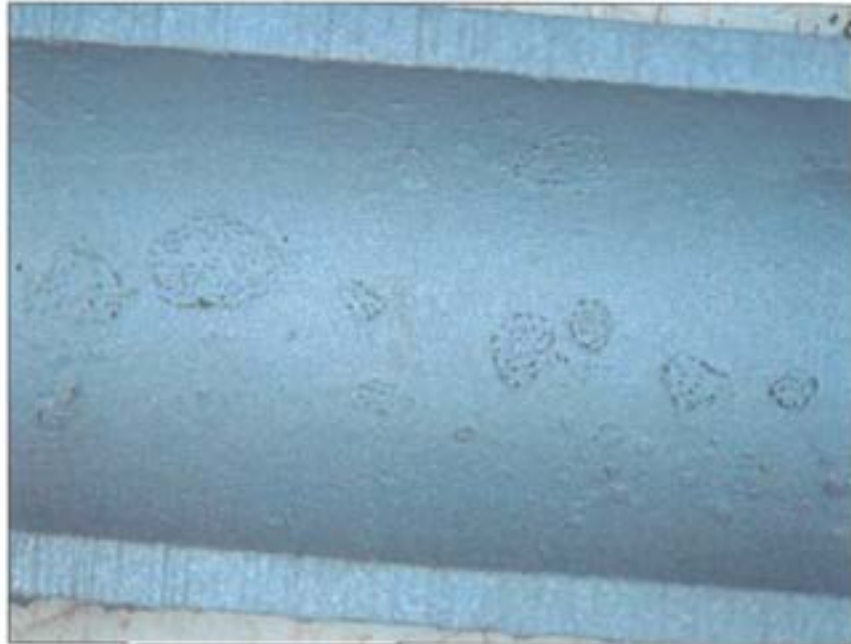
Figure 158 Second area of corrosion damage on row 14 - tube 2 (bottom) after aluminum oxide blasting.

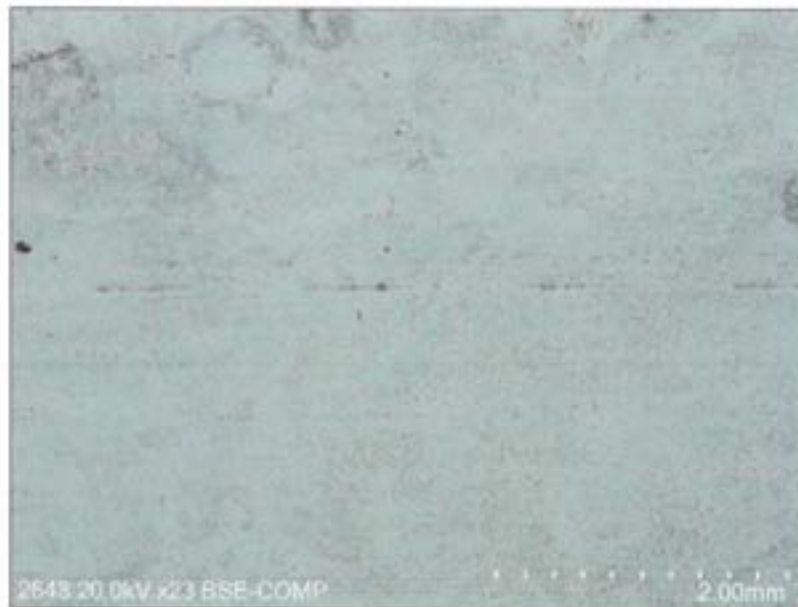
Figure 159 Higher magnification view of typical "stitching" along ERW fusion line.

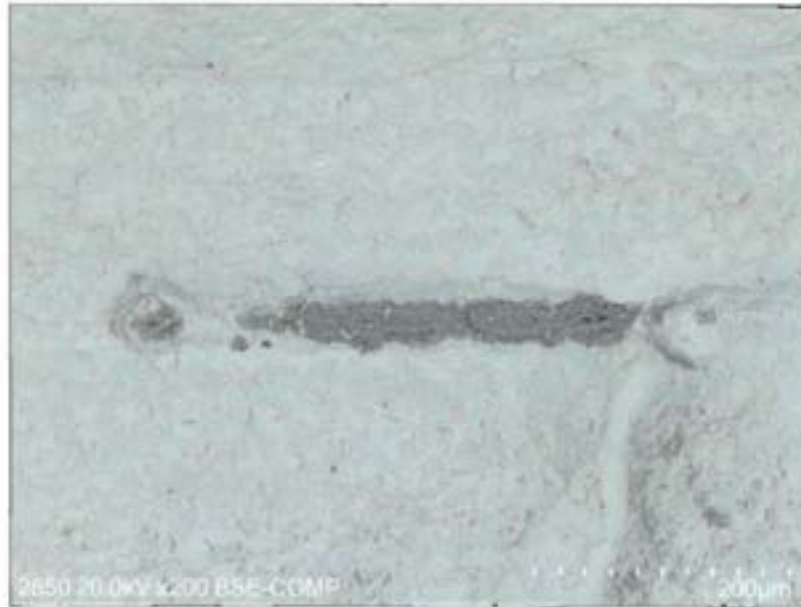
Figure 160 High magnification SEM view of "stitch" defect EDXA determined that stitch defect is mostly iron oxide.

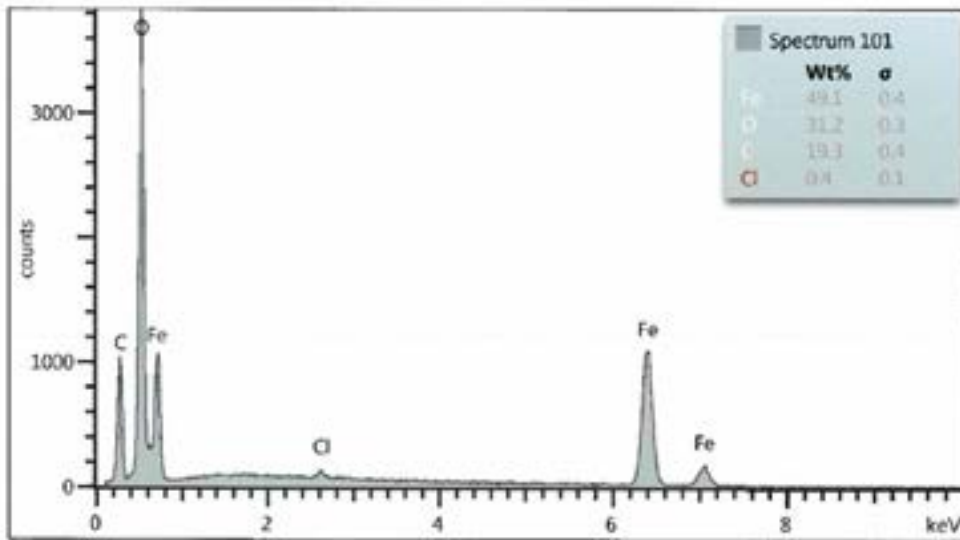
Figure 161 EDXA analysis of material in typical fusion line "stitch" area.

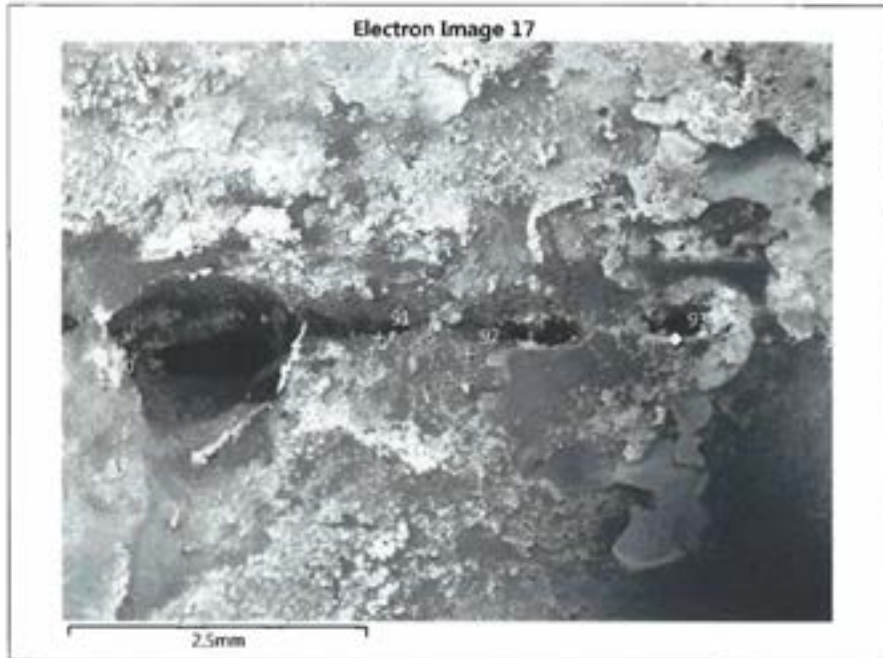
Figure 162a SEM view of scale surrounding leaking defect.

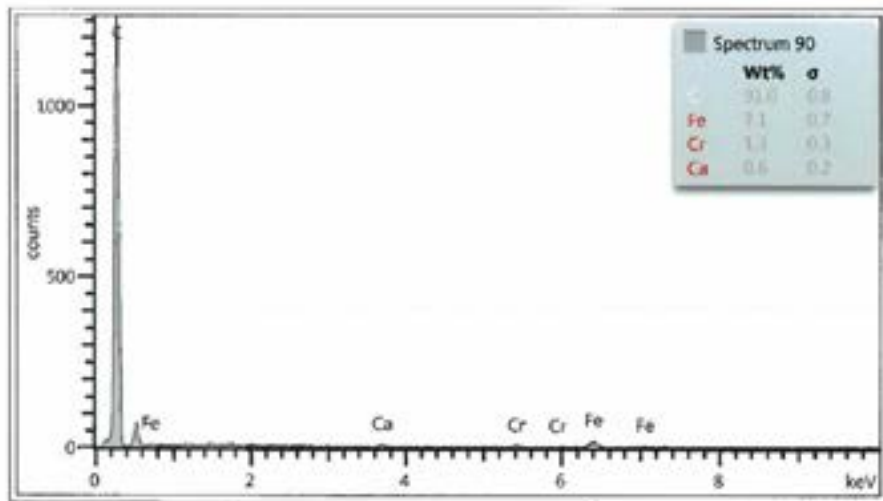
Figure 162b Area 90 containing mostly organic material.

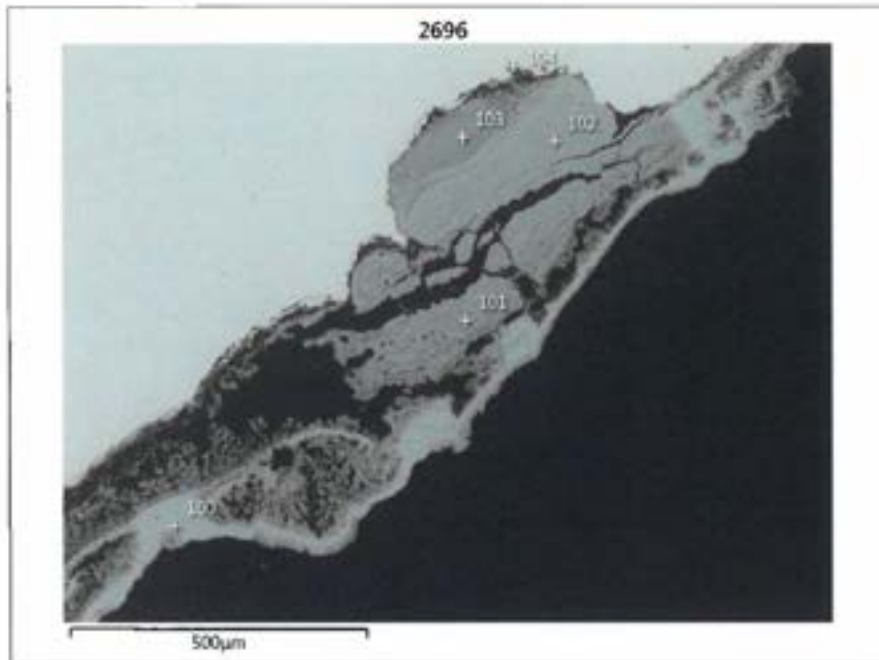
Figure 164a Typical pit in row 7 – tube 1 showing different layers Corrosion mechanism is chloride induced pitting as indicated at area 104.

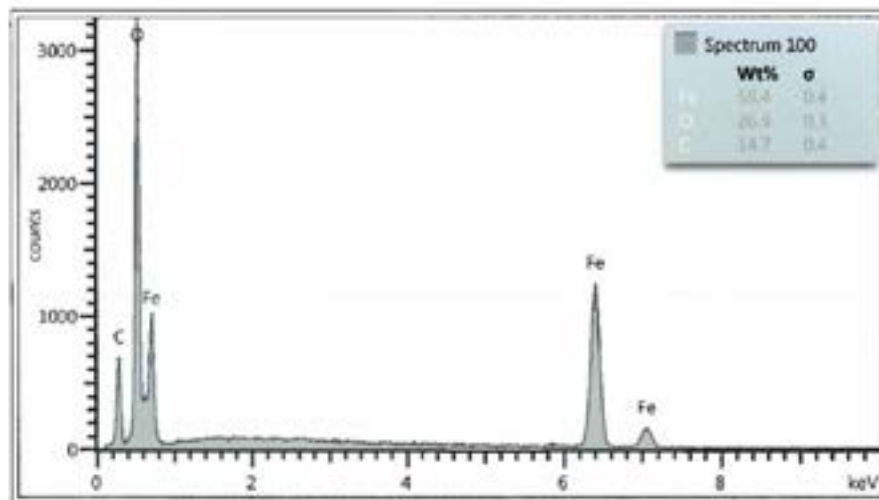
Figure 164b Area 100 showing relatedly pure iron oxide.
