May 16, 2022

File Number: A22605-16877 – Revision 1  
EGBC Permit Number: 1001973TECHNICAL SAFETY BC  
600 - 2889 EAST 12TH AVENUE  
VANCOUVER, BC  
V5M 4T5

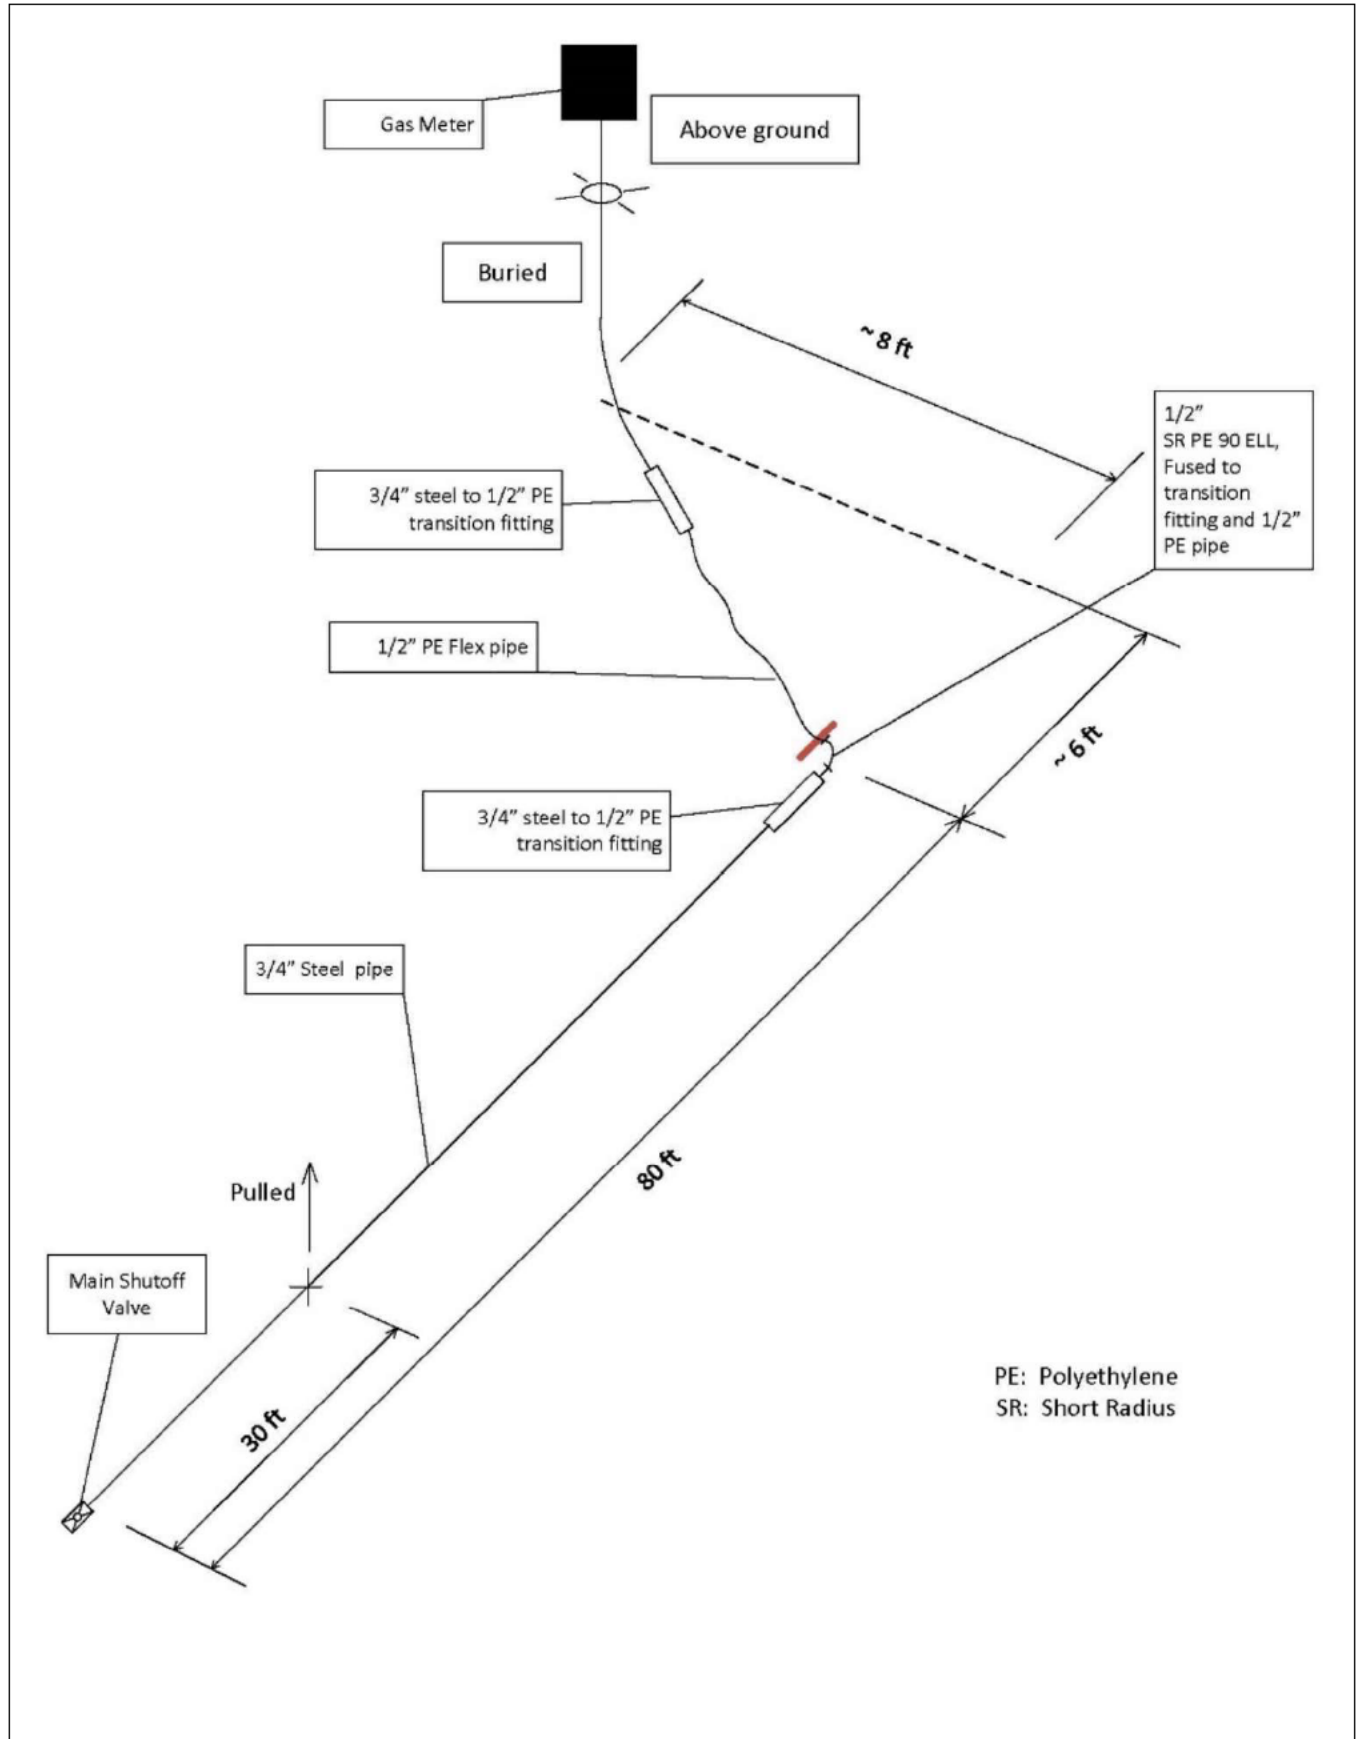
**Figure 1** Sketch of gas piping found at house explosion location. Main shutoff was achieved by crimping.

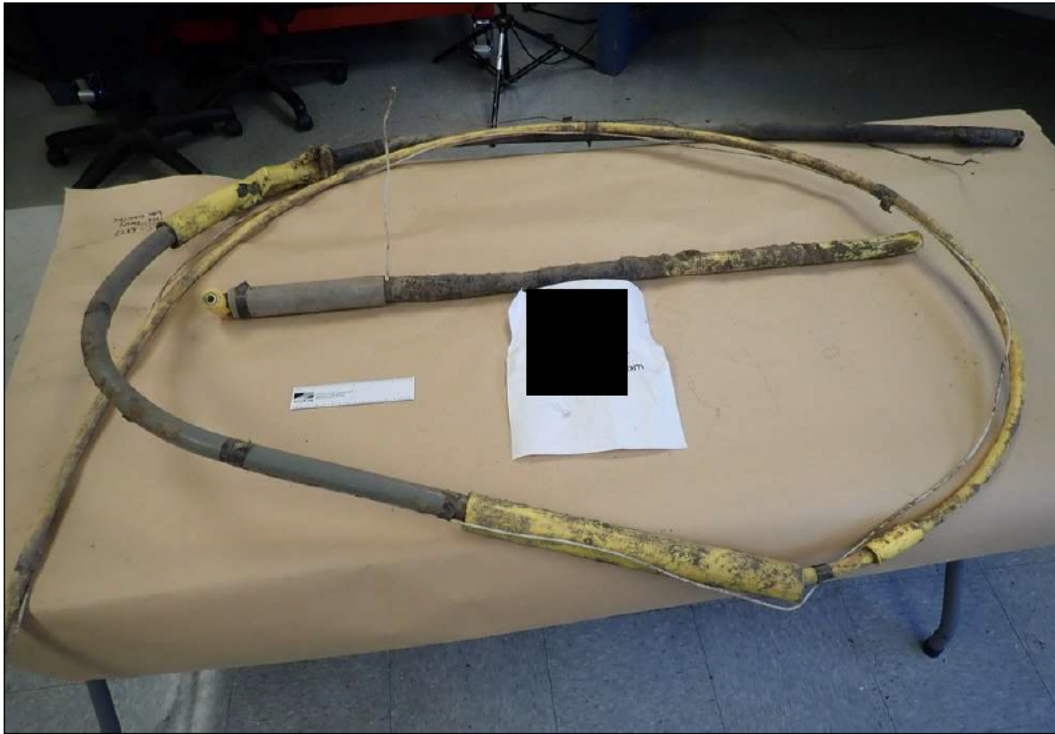
**Figure 2** Overall view of submitted piping system associated with natural gas explosion. Polyethylene pipe fracture took place at elbow exit point.

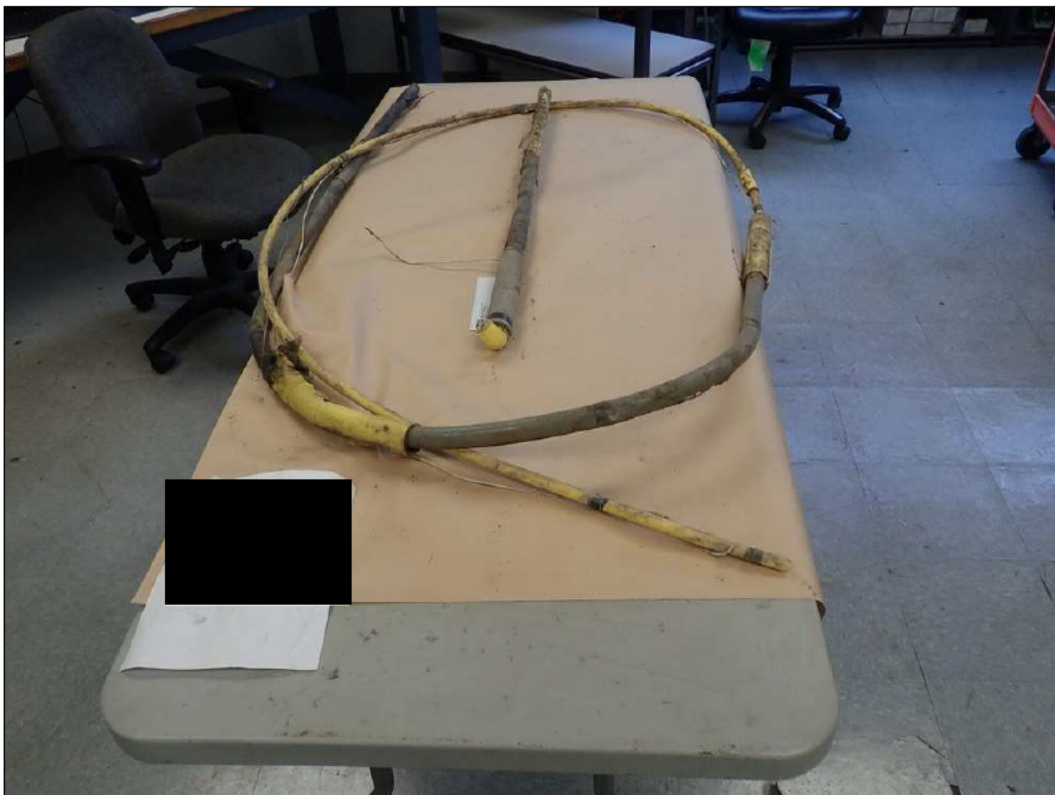
**Figure 3** Second view of submitted piping system associated with natural gas explosion.

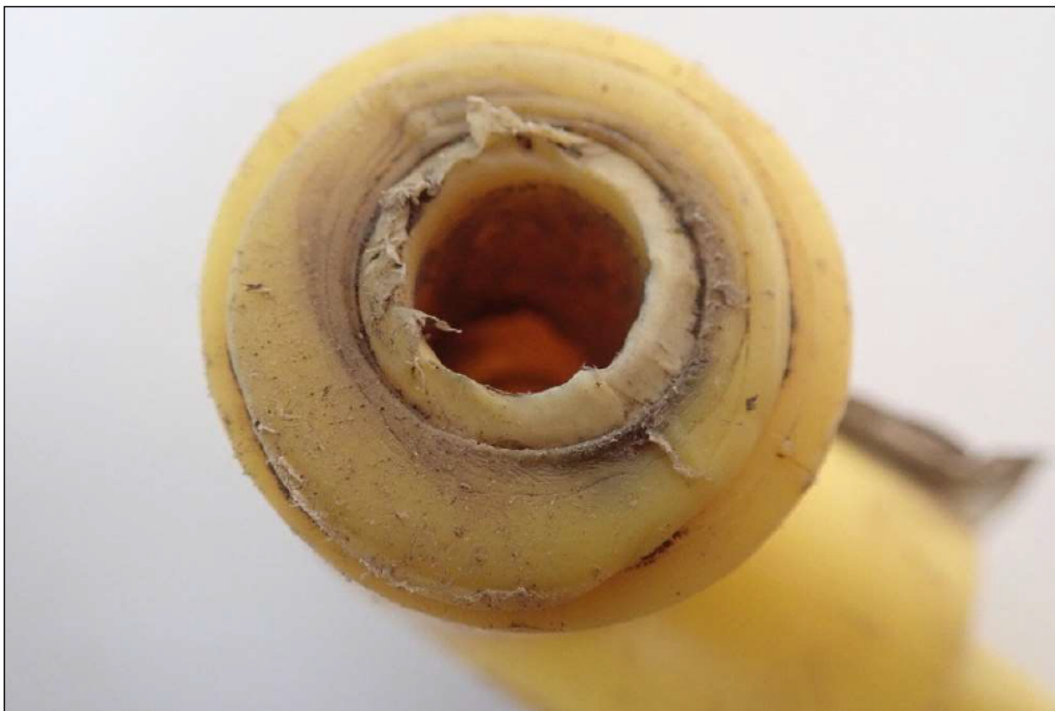
**Figure 5** Close-up view of pipe fracture surface coming from elbow showing shear component to failure. Elongation was relatively small and indicative of rapid strain rate.

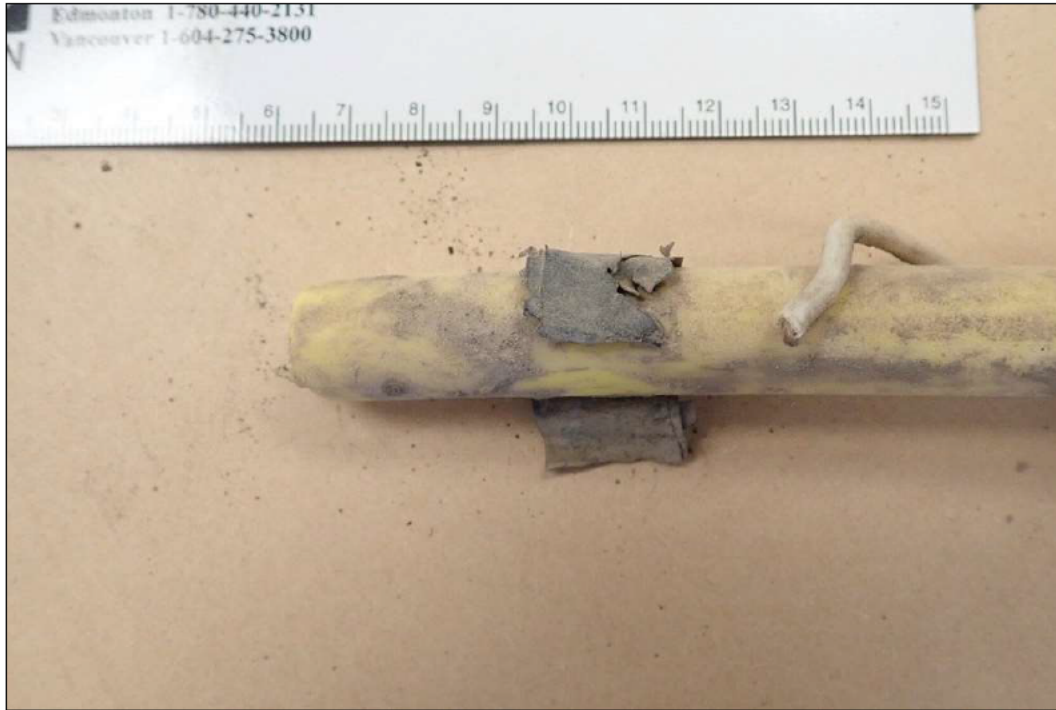
**Figure 6** Fractured end of yellow 16 mm polyethylene pipe showing relatively light deformation and necking at fracture point.

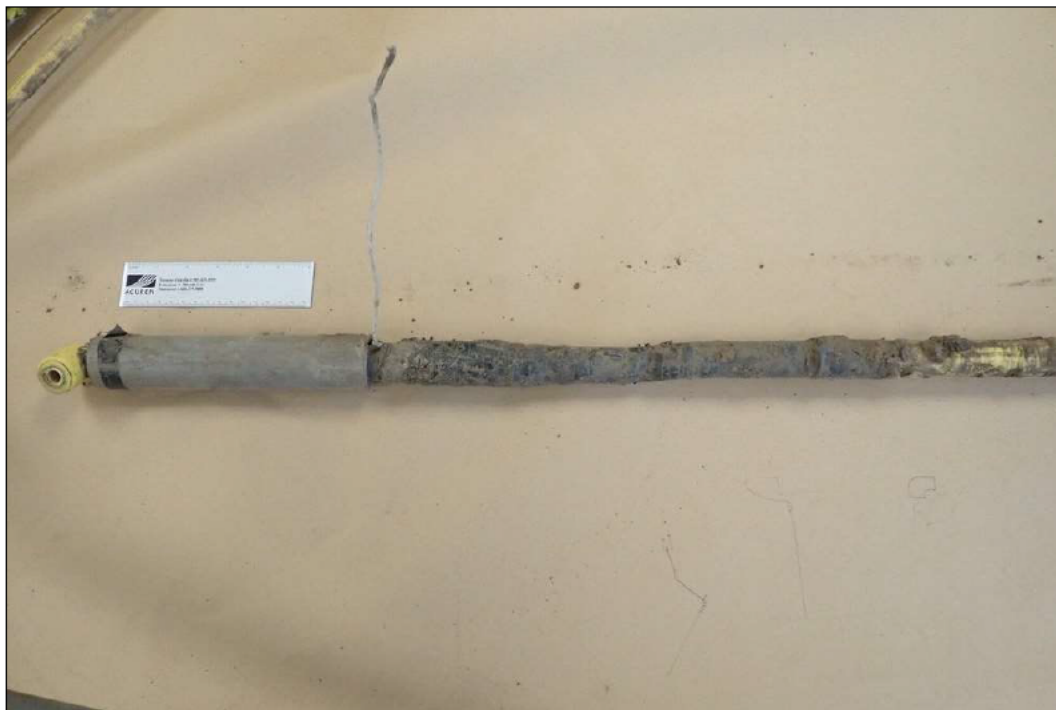
**Figure 7** Piping segment from street side of pipe run showing crimp location under tape and grey cover over copper connection.

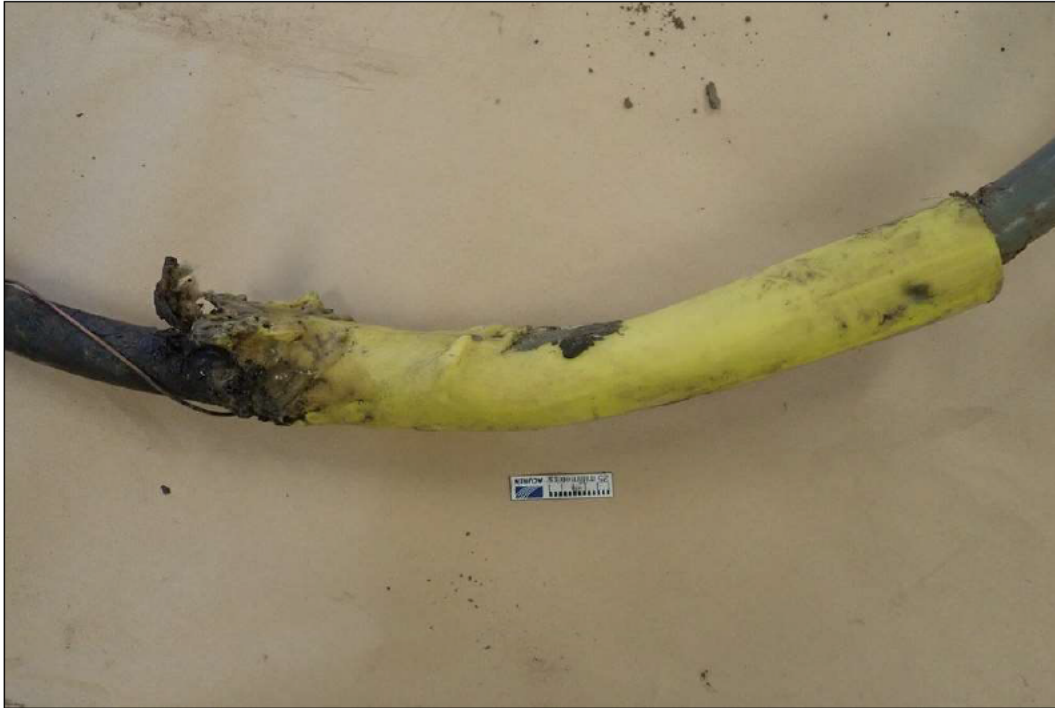
**Figure 10** Cleaned yellow poly cover form steel pipe run. Cover is burned from subsequent fire.

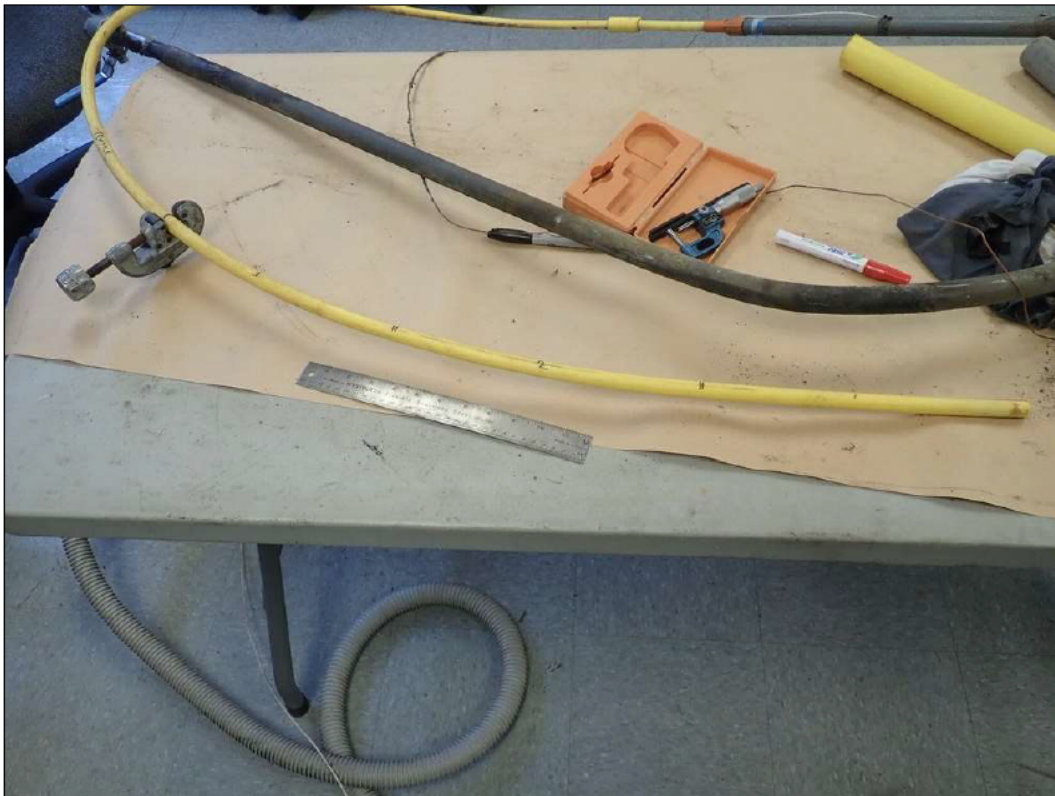
**Figure 11** Cleaned 16mm polyethylene run showing location of diametrical measurements.

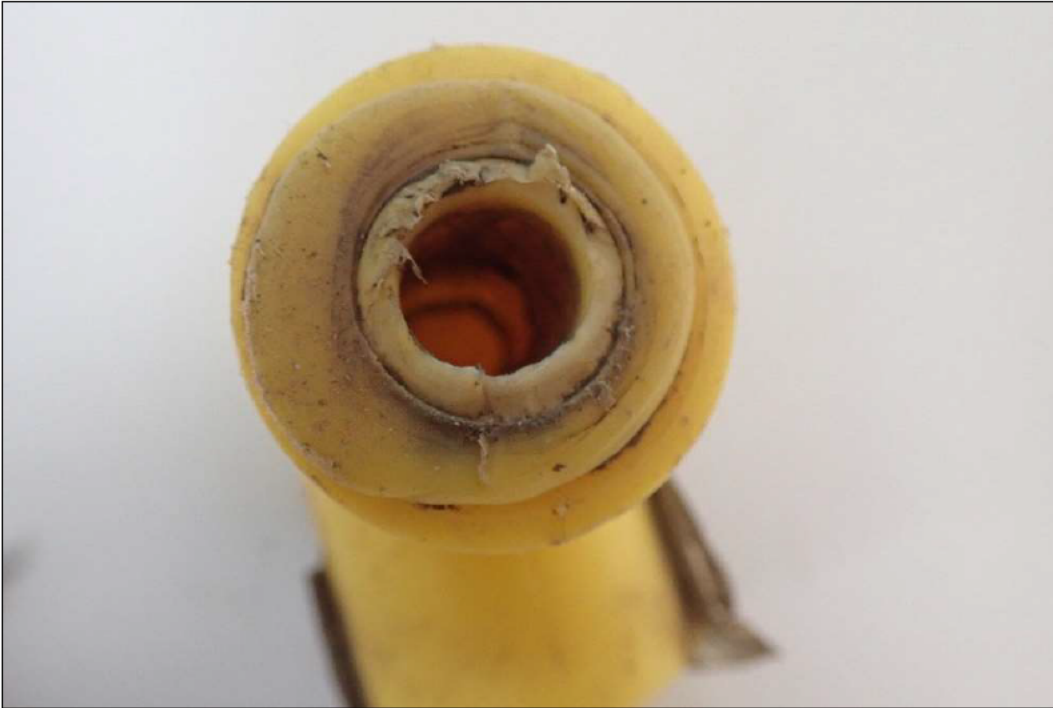
**Figure 14** Closer up view of cleaned pipe fracture still attached to elbow. Note shear component of failure.

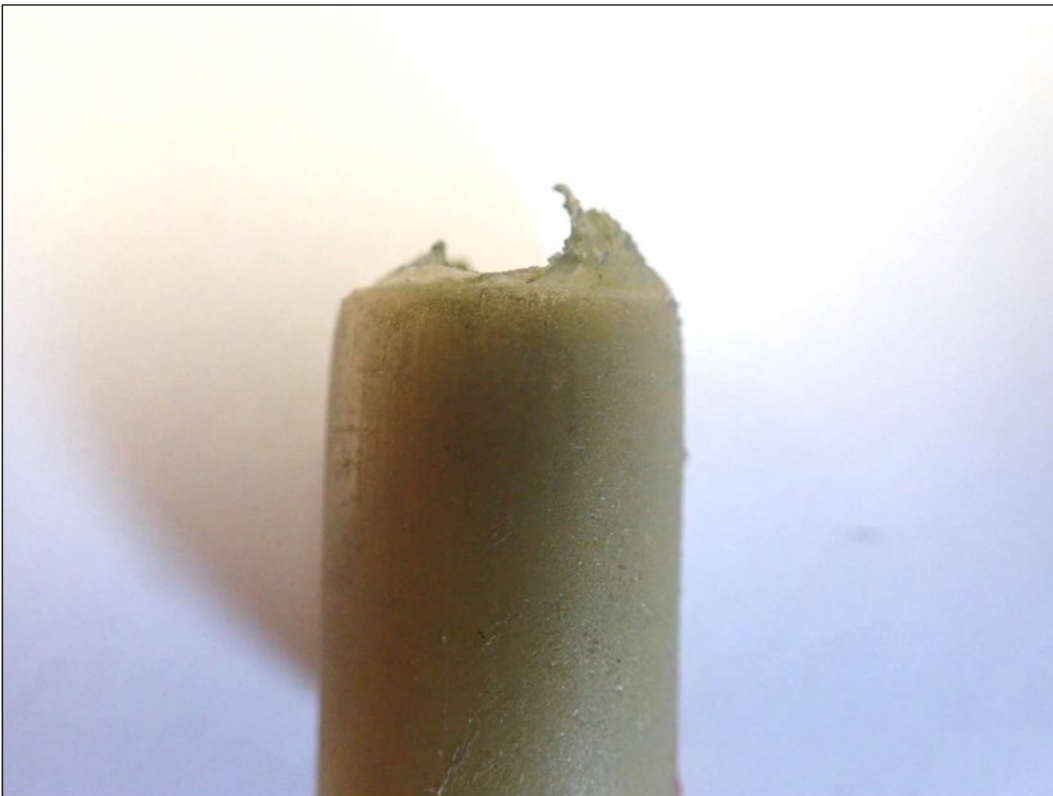
**Figure 15** Side view of polyethylene pipe fracture showing small amount of necking.

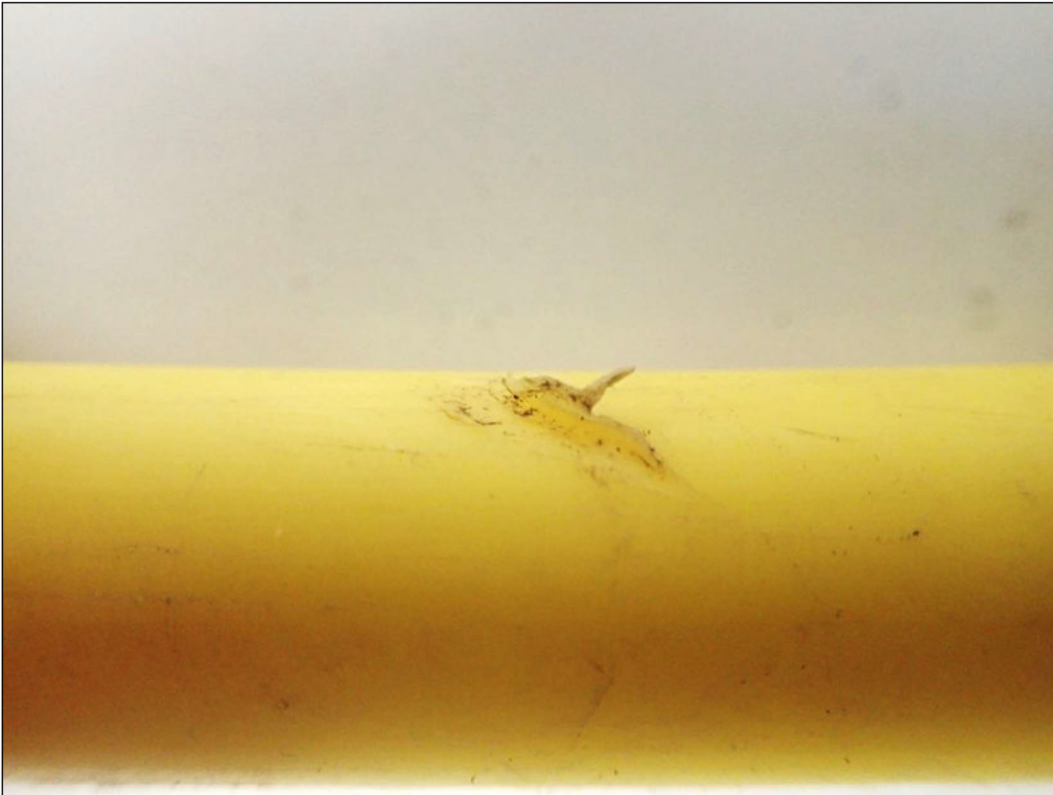
**Figure 16** Nicks in pipe away from fracture.

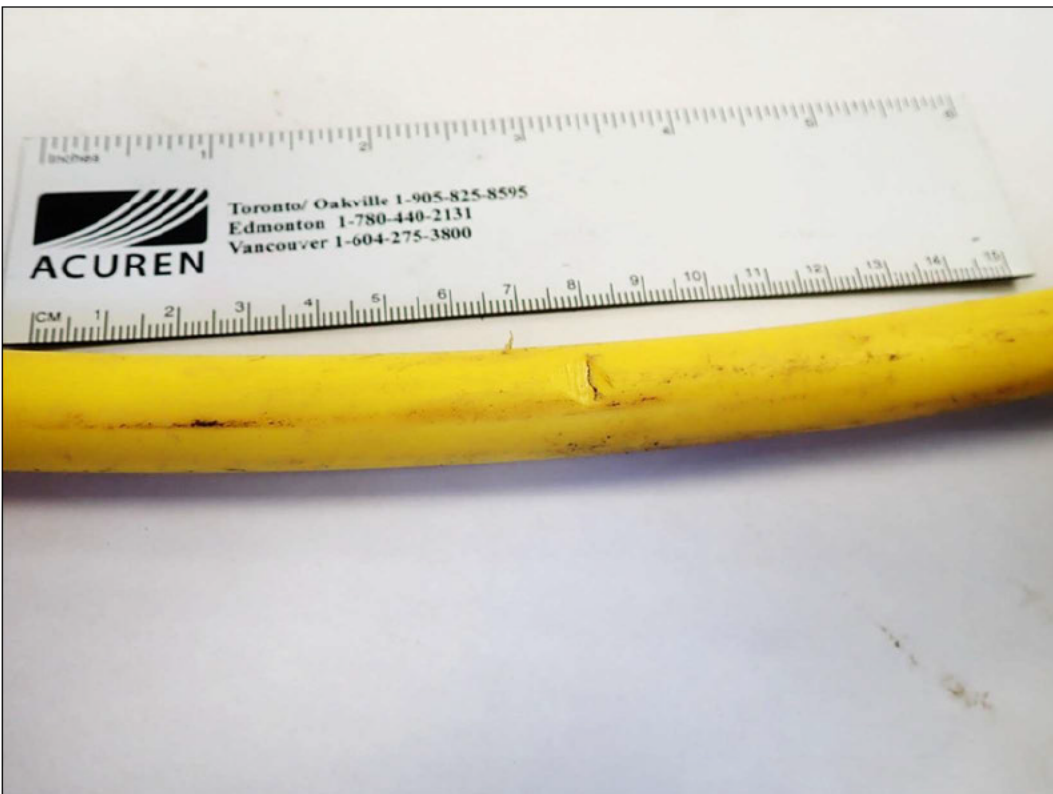
**Figure 17** Gouge in pipe away from fracture.

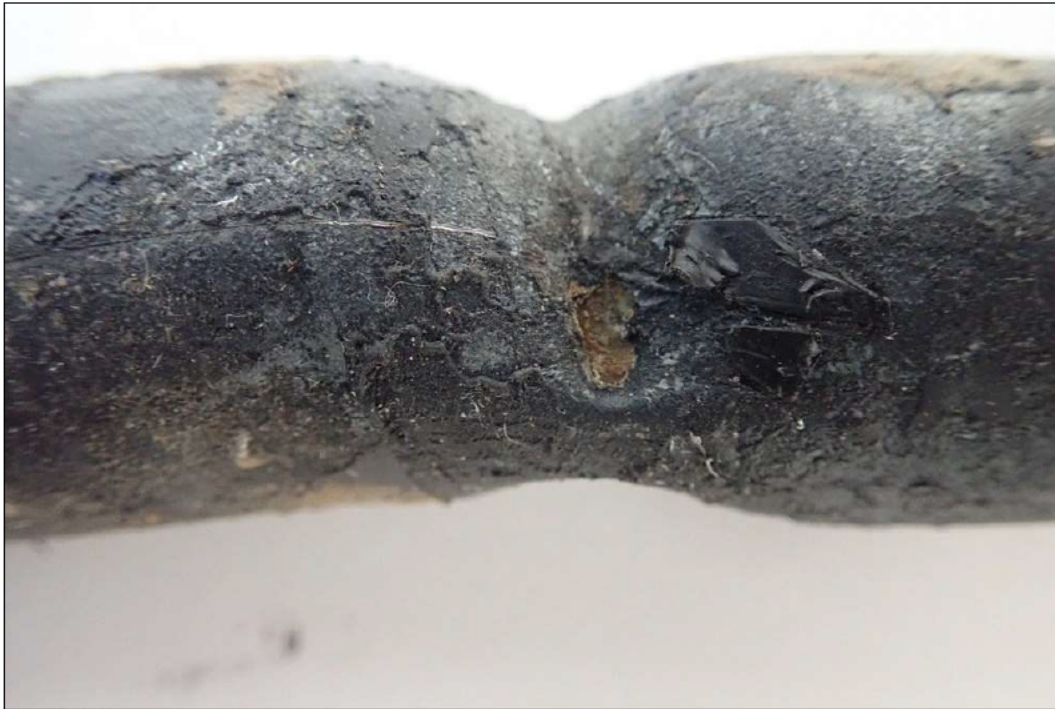
**Figure 18** Close-up view of crimp used to shut off gas during construction.

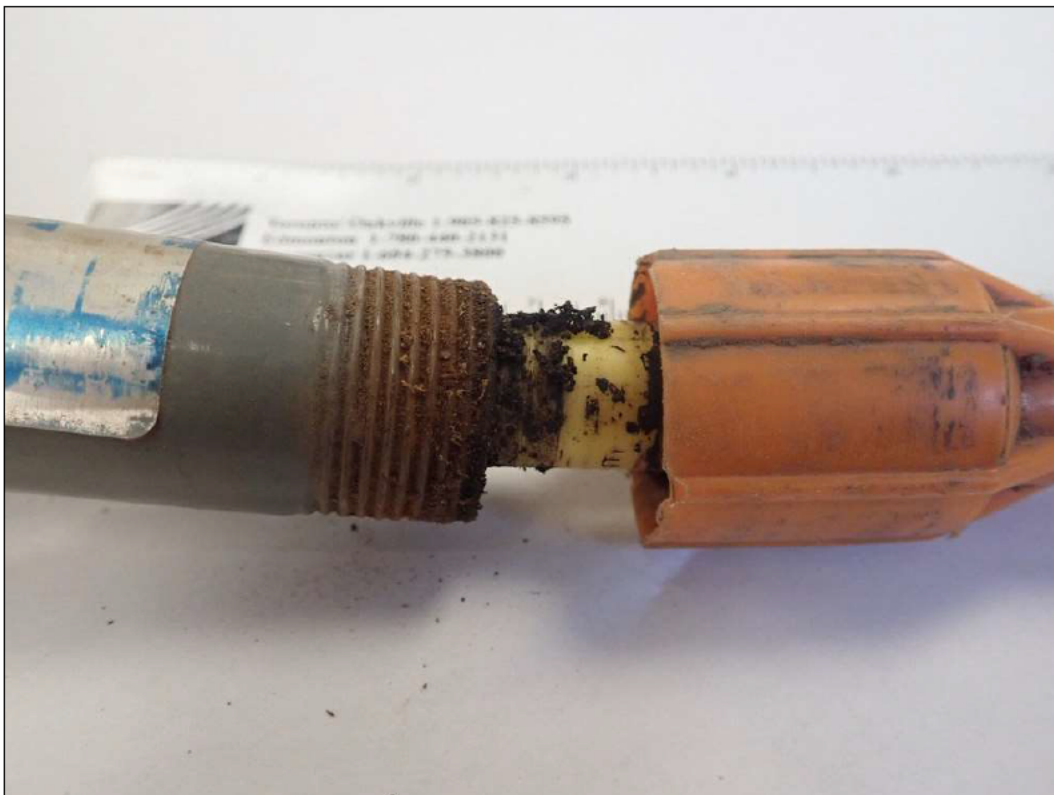
**Figure 21** Close-up view of orange cover on threaded steel to polyethylene pipe coupler. This coupler leaked during testing.

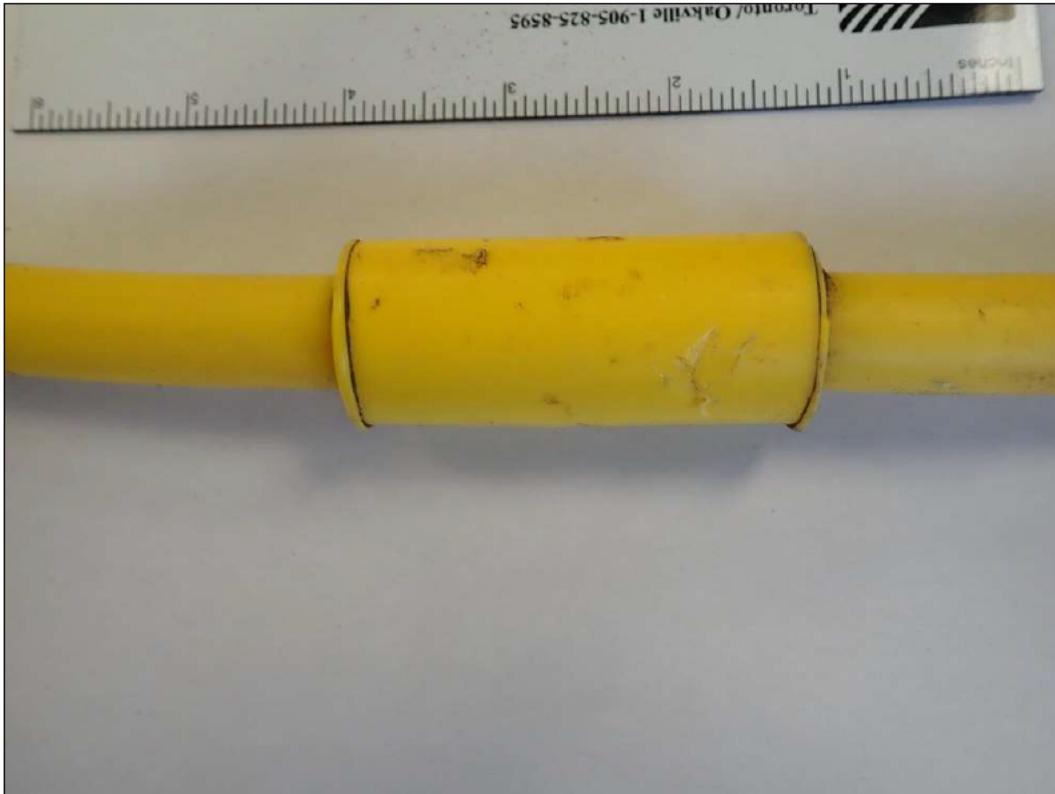
**Figure 22** Cleaned polyethylene to polyethylene coupler. This coupler did not leak.

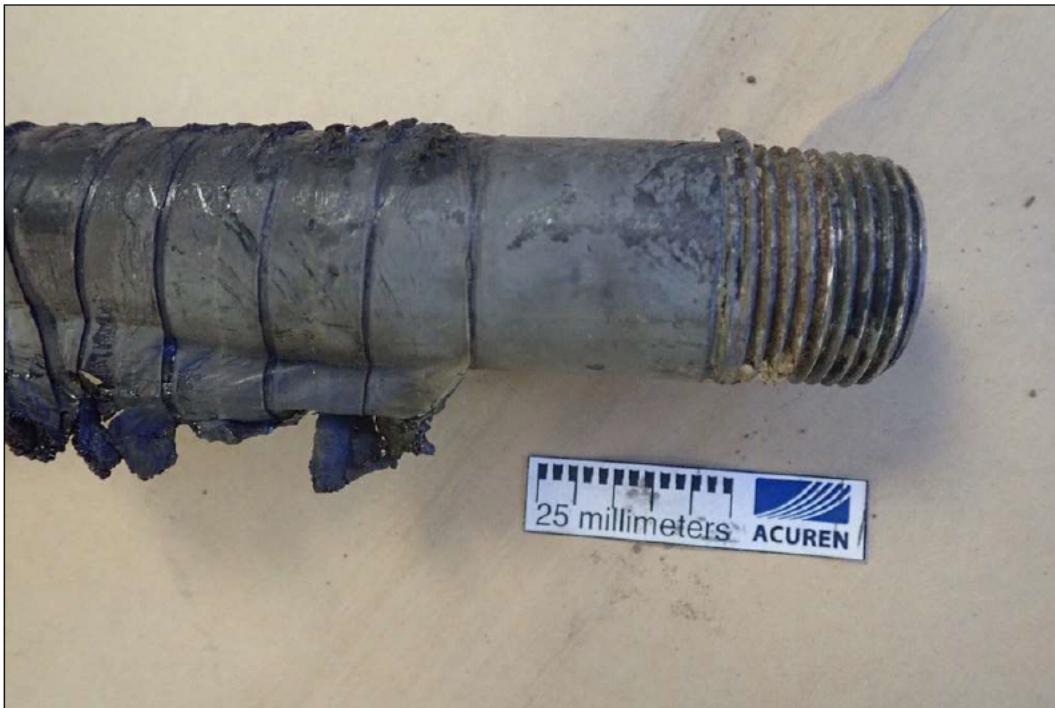
**Figure 23** Threaded steel pipe going to meter. Last 4 threads are severely bent.

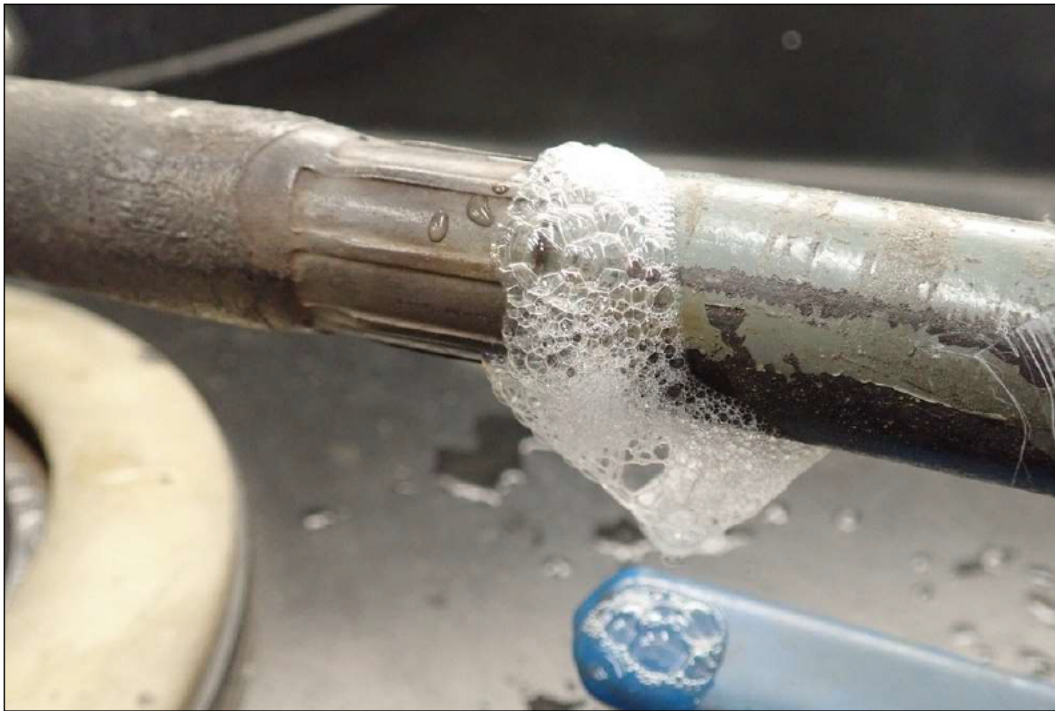
**Figure 30** Leaking found with coupling. Leaking was found on steel-steel and steel – polyethylene couplings.

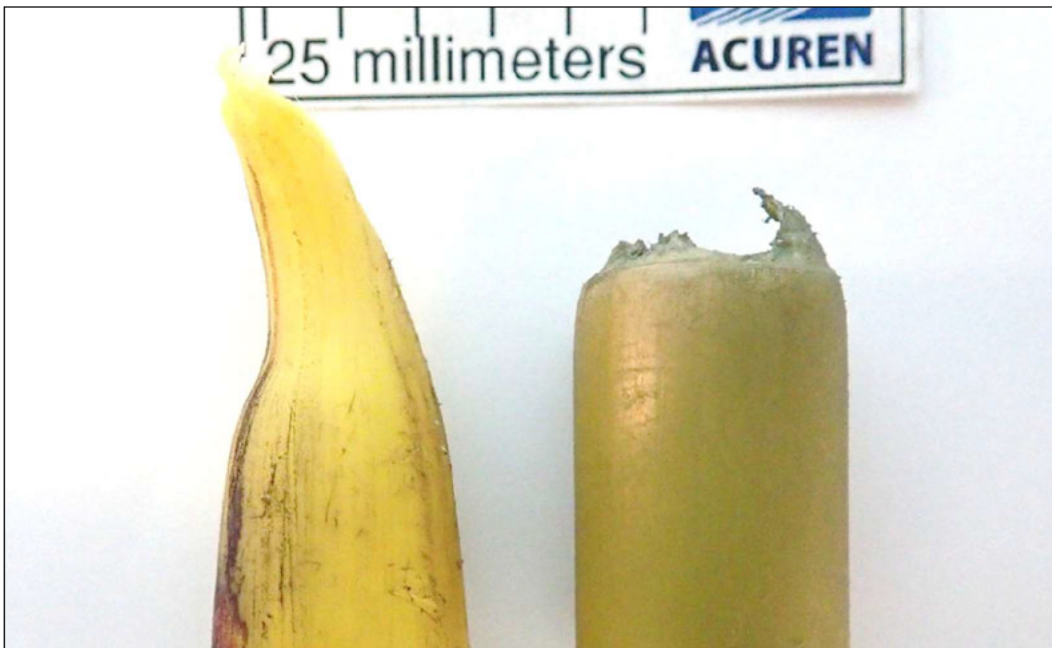
**Figure 31** Difference in lab tensile fracture and field fracture at same relative temperature. Lack of ductility in field fracture indicates high strain rate.

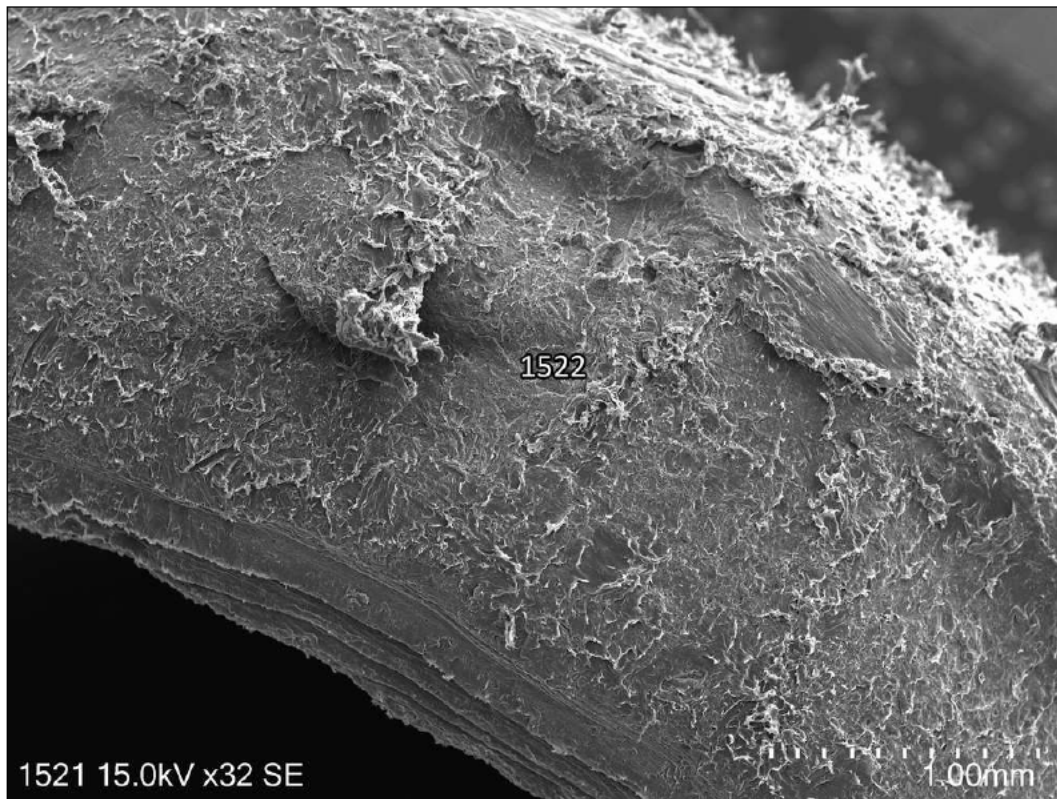
**Figure 32** SEM view of 16mm pipe fracture surface on compression side of bending failure.

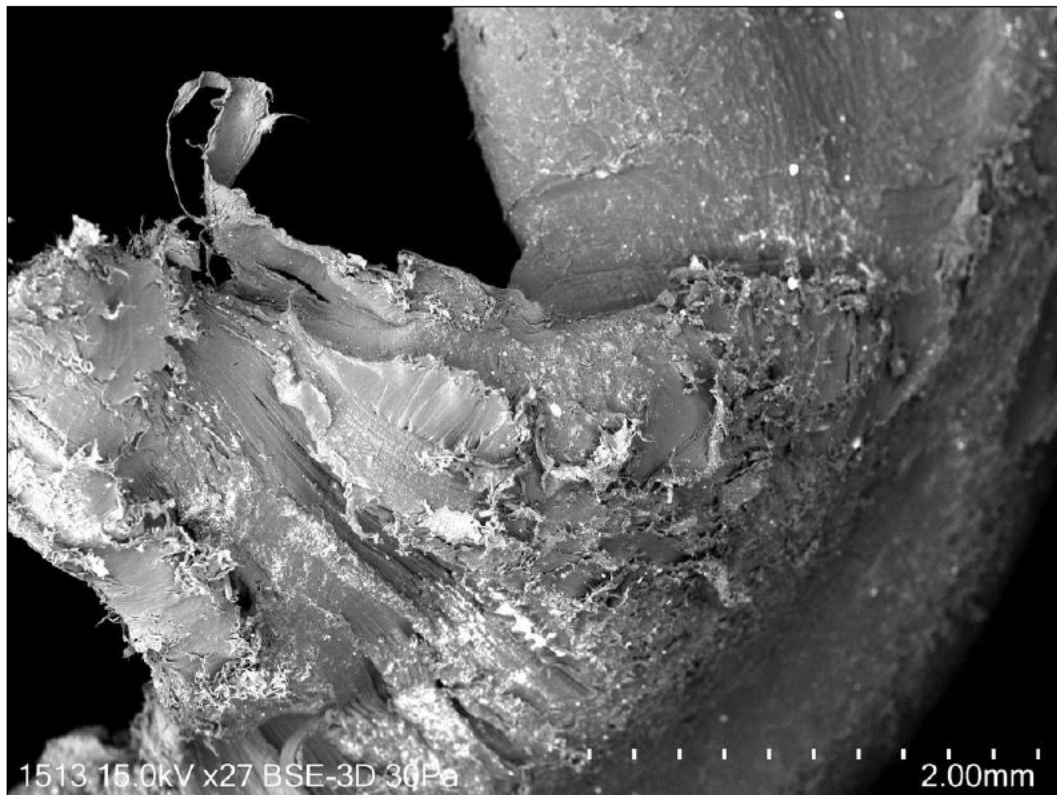
**Figure 33** SEM view of 16 mm pipe fracture surface on tension side of bending failure.

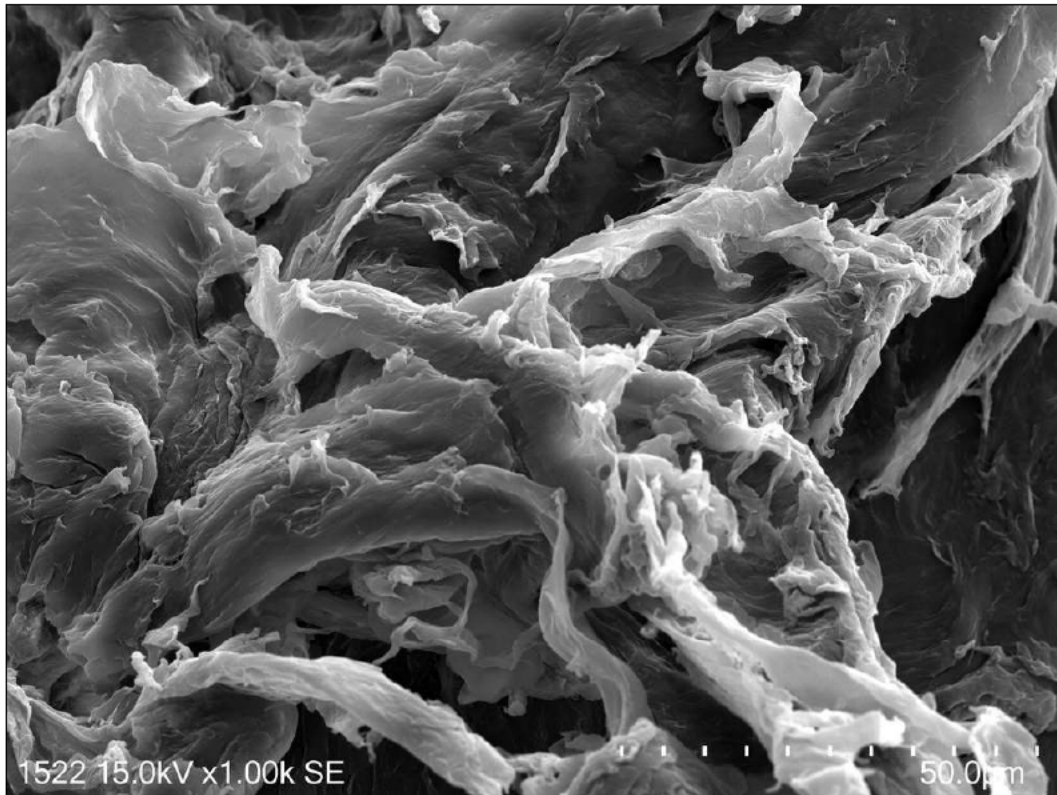
**Figure 34** Ductile tendrils taken at location 1522 shown in Figure 32.
