Incident Summary (5612954)

SUPPORTING INFORMATION	Incident Date		December 2016	
	Location		Mission	
	Regulated industry sector		Low voltage electrical system (30V to 750V)	
	Impact	Injury	Qty injuries	1
			Injury description	An occupant of a house received an electrical shock.
			Injury rating	Minor
	Damage		Damage description	n/a
			Damage rating	None
Incident rating		Minor		
Incident overview		An occupant received an electrical shock while plugging in a cell phone charger to a receptacle in the bedroom of a house. The shock was described as minor by the occupant and no medical treatment was received.		
INVESTIGATION CONCLUSIONS	Site, system and components		<p>Receptacles are required to be secured to the outlet boxes that they are connected to and wiring entering outlet boxes is required to be properly installed. This is required to provide support for the receptacle when plugging in and unplugging cords, to enclose the energized terminals and conductors so they are not damaged or contacted, and to contain thermal energy if the wiring, connections, or receptacle fails.</p> <p>Receptacles that are not properly secured to outlet boxes and do not have cover plates installed are sub

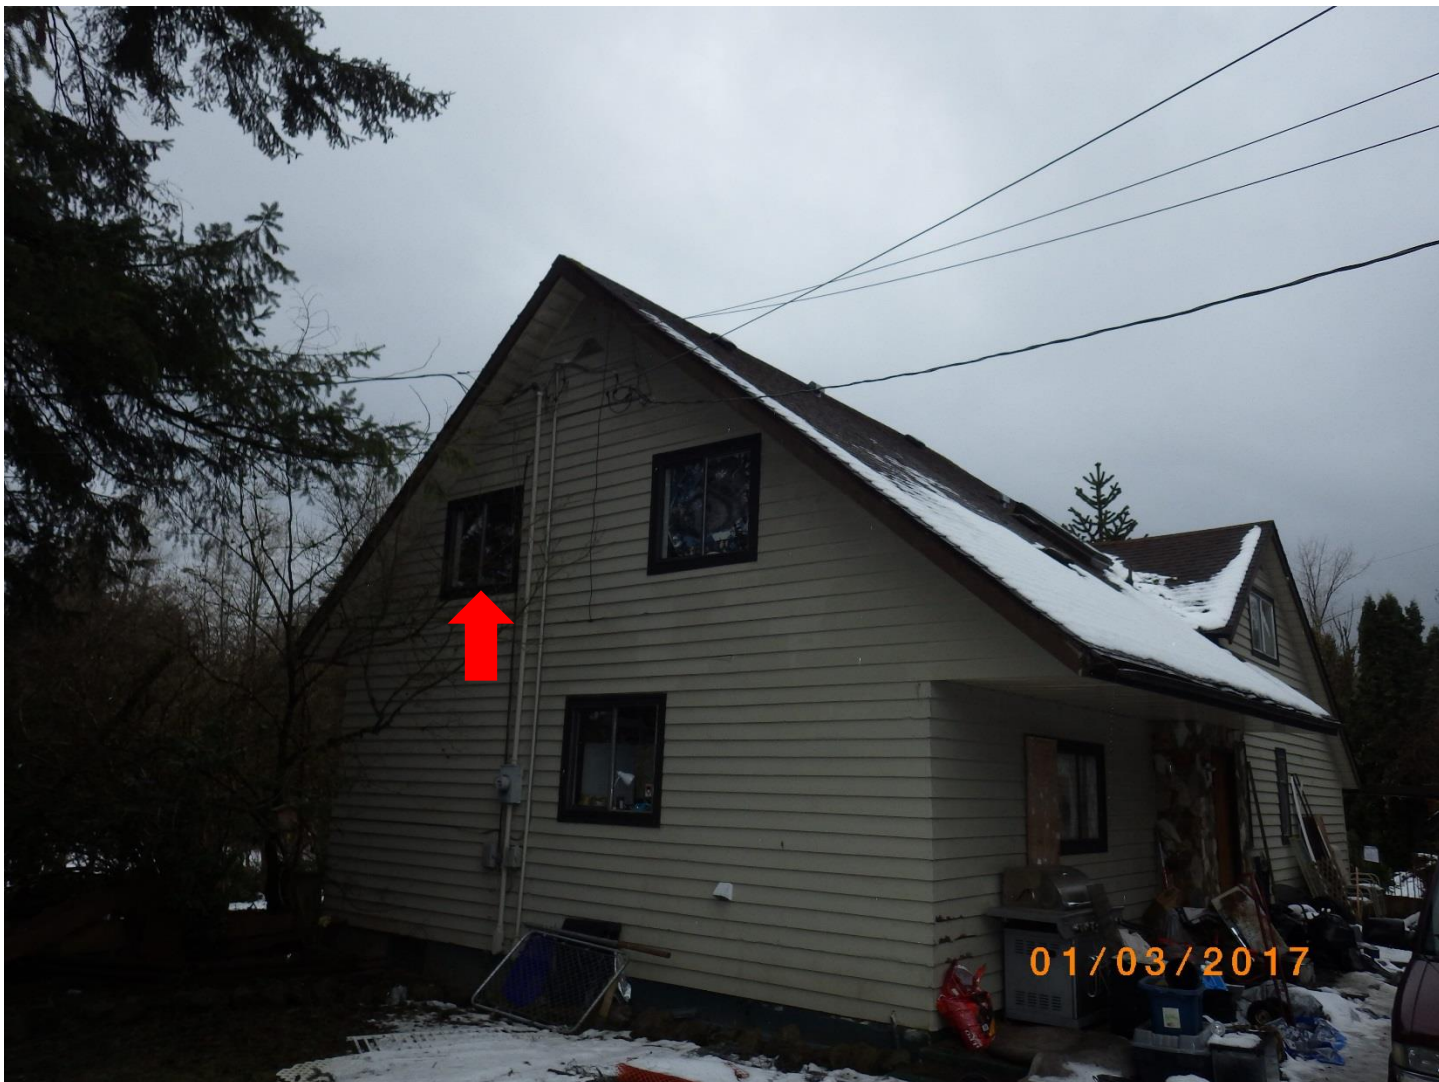
Figure 1

This photo shows the exterior of the house. The bedroom where the incident occurred is on the upper floor shown by the red arrow.

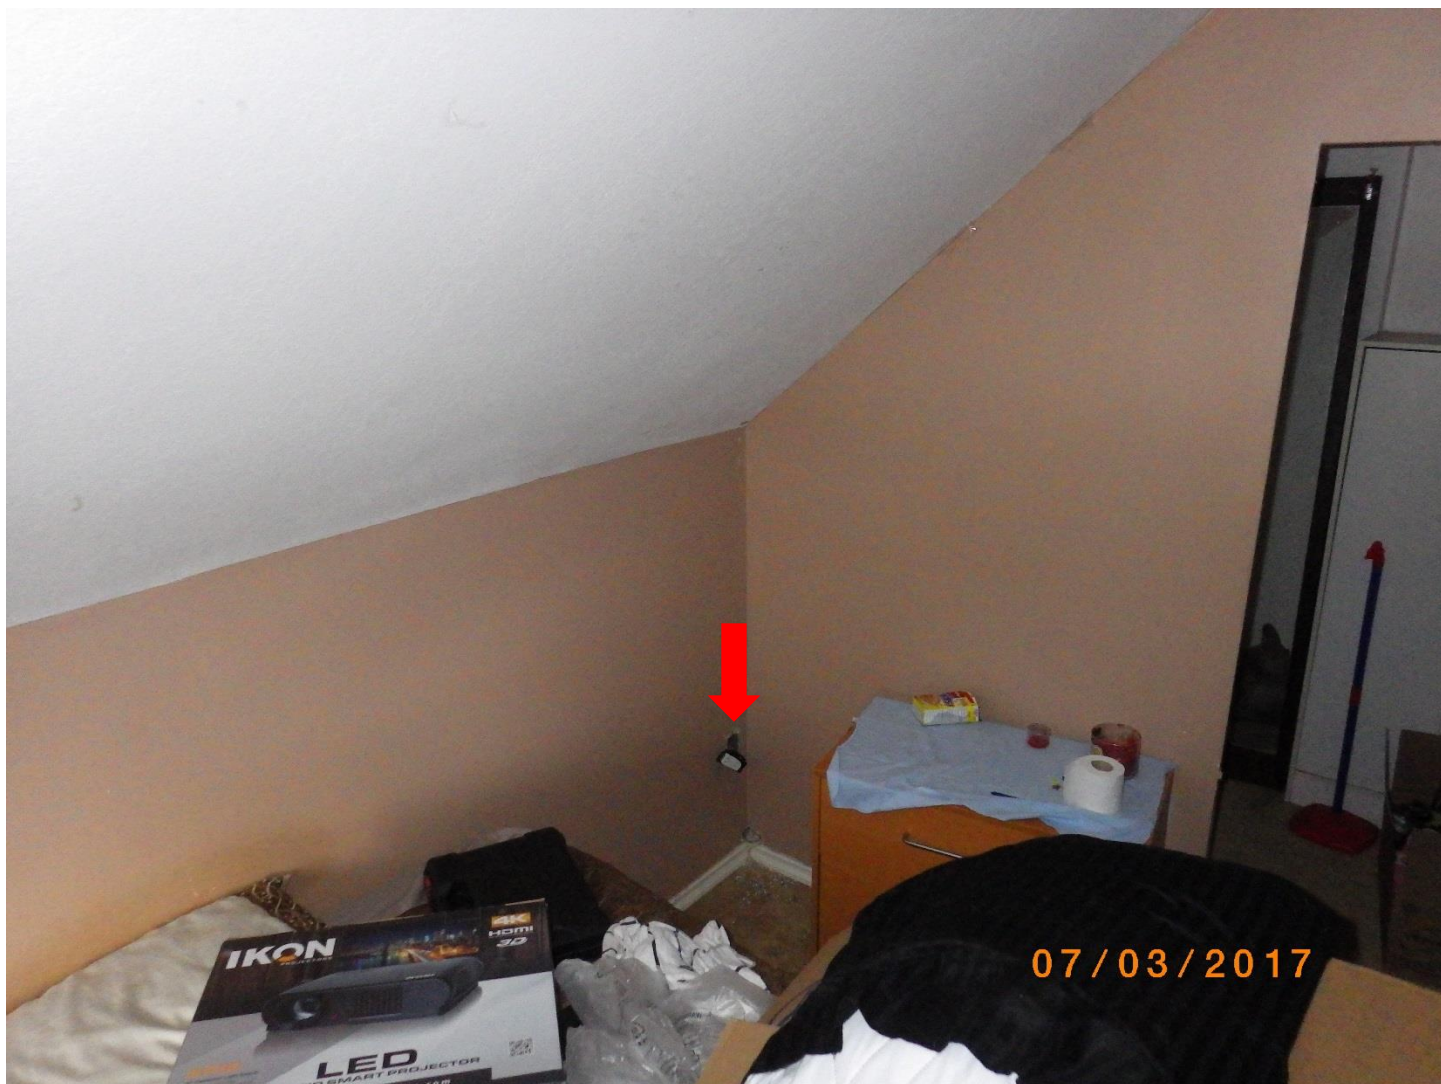
Figure 2

This photo shows the bedroom where the incident occurred. The red arrow shows the location of the receptacle where the occupant received the shock.

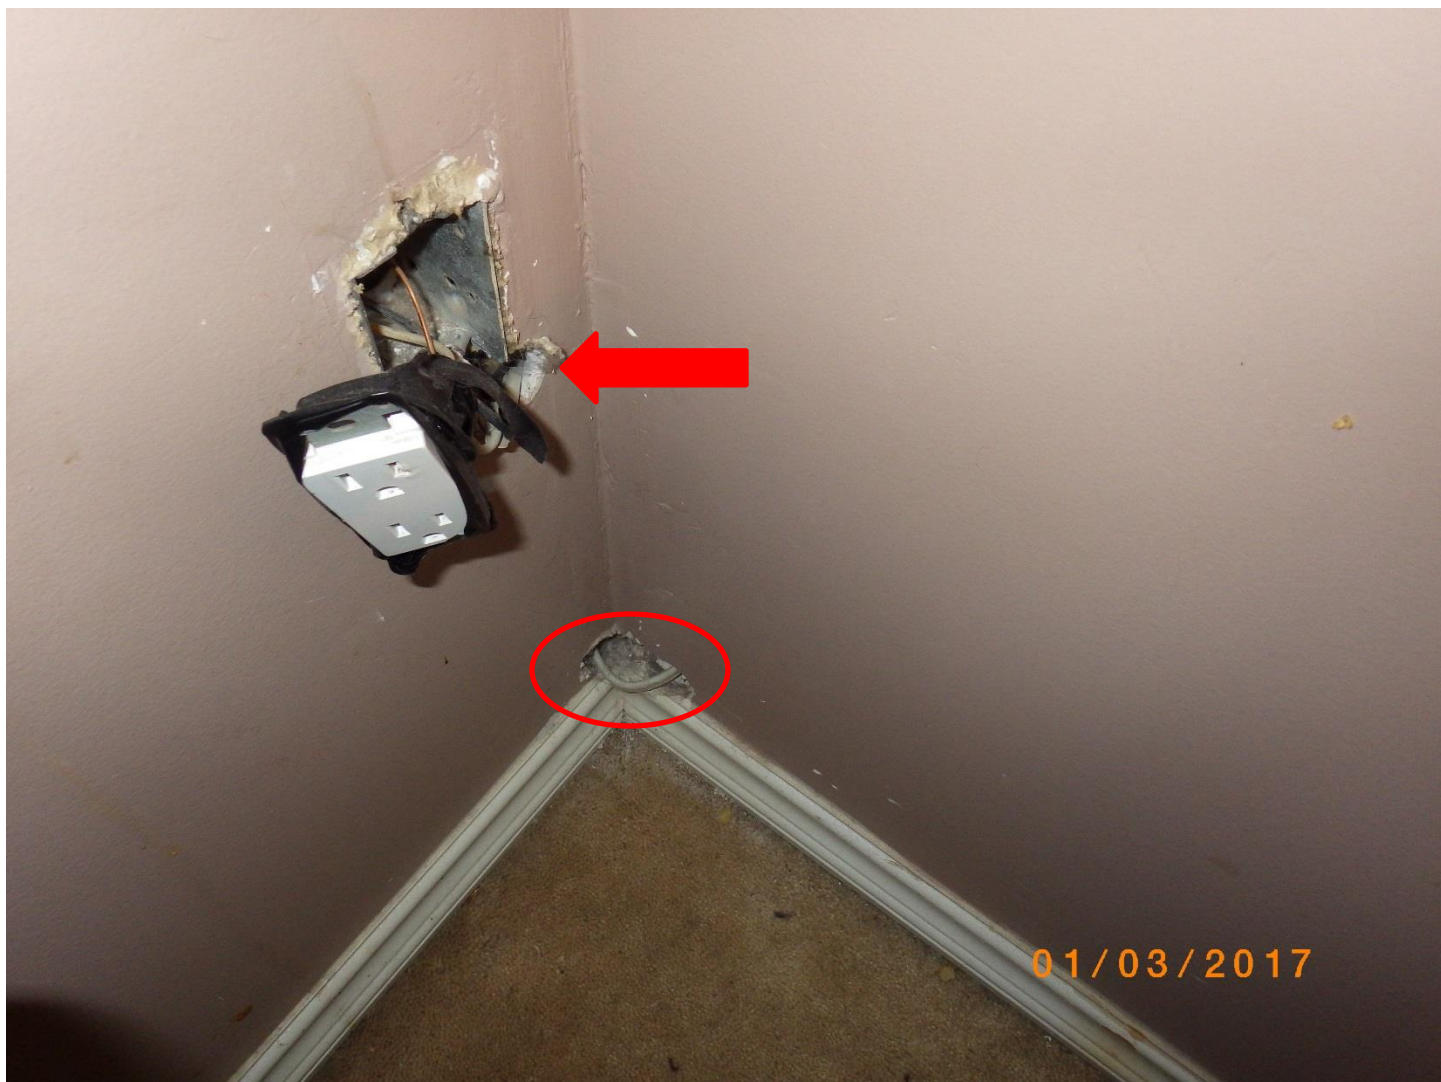
Figure 3

<p>Causes and contributing factors</p>	<p>The cause of this incident is very likely the improper installation of a receptacle and the wiring connected to it. Wiring was not installed into the outlet box properly and the receptacle was not secured to the outlet box. Energized terminals on the side of the receptacle were exposed to contact. This made plugging into the receptacle difficult unless the receptacle was held in one hand while the other hand plugged in the cord/device.</p> <p>Failure of the occupant to recognize the hazard and avoid contact with the receptacle was a contributing factor.</p> <p>Failure of the owner to have the receptacle and wiring properly installed and later failing to address the electrical safety hazard by having it properly fixed were also contributing factors.</p>

This photo shows the receptacle and the improperly installed non-metallic sheathed cable wiring connected to it. The red outline shows where the cable was fished through the wall and the red arrow shows where it entered the outlet box. The receptacle had tape wrapped around it that was installed by the owner and the tenant after the tenant received shocks from the bare terminals on the side of the receptacle.

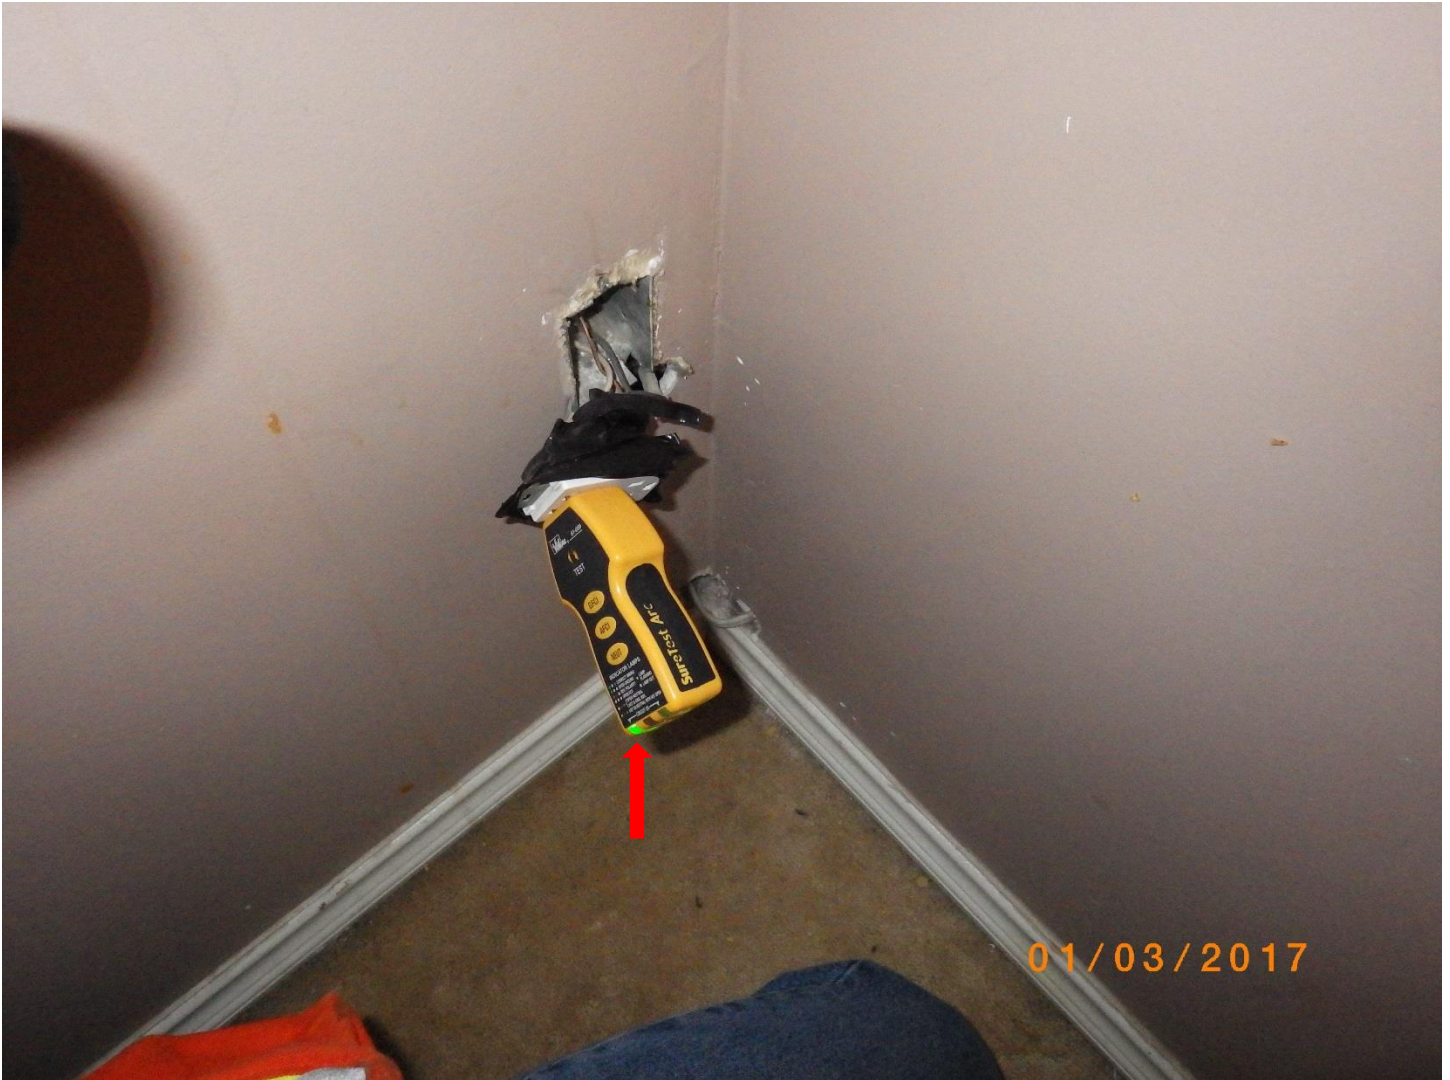
Figure 4

The green light on my tester indicates the receptacle was energized when I went to the site.

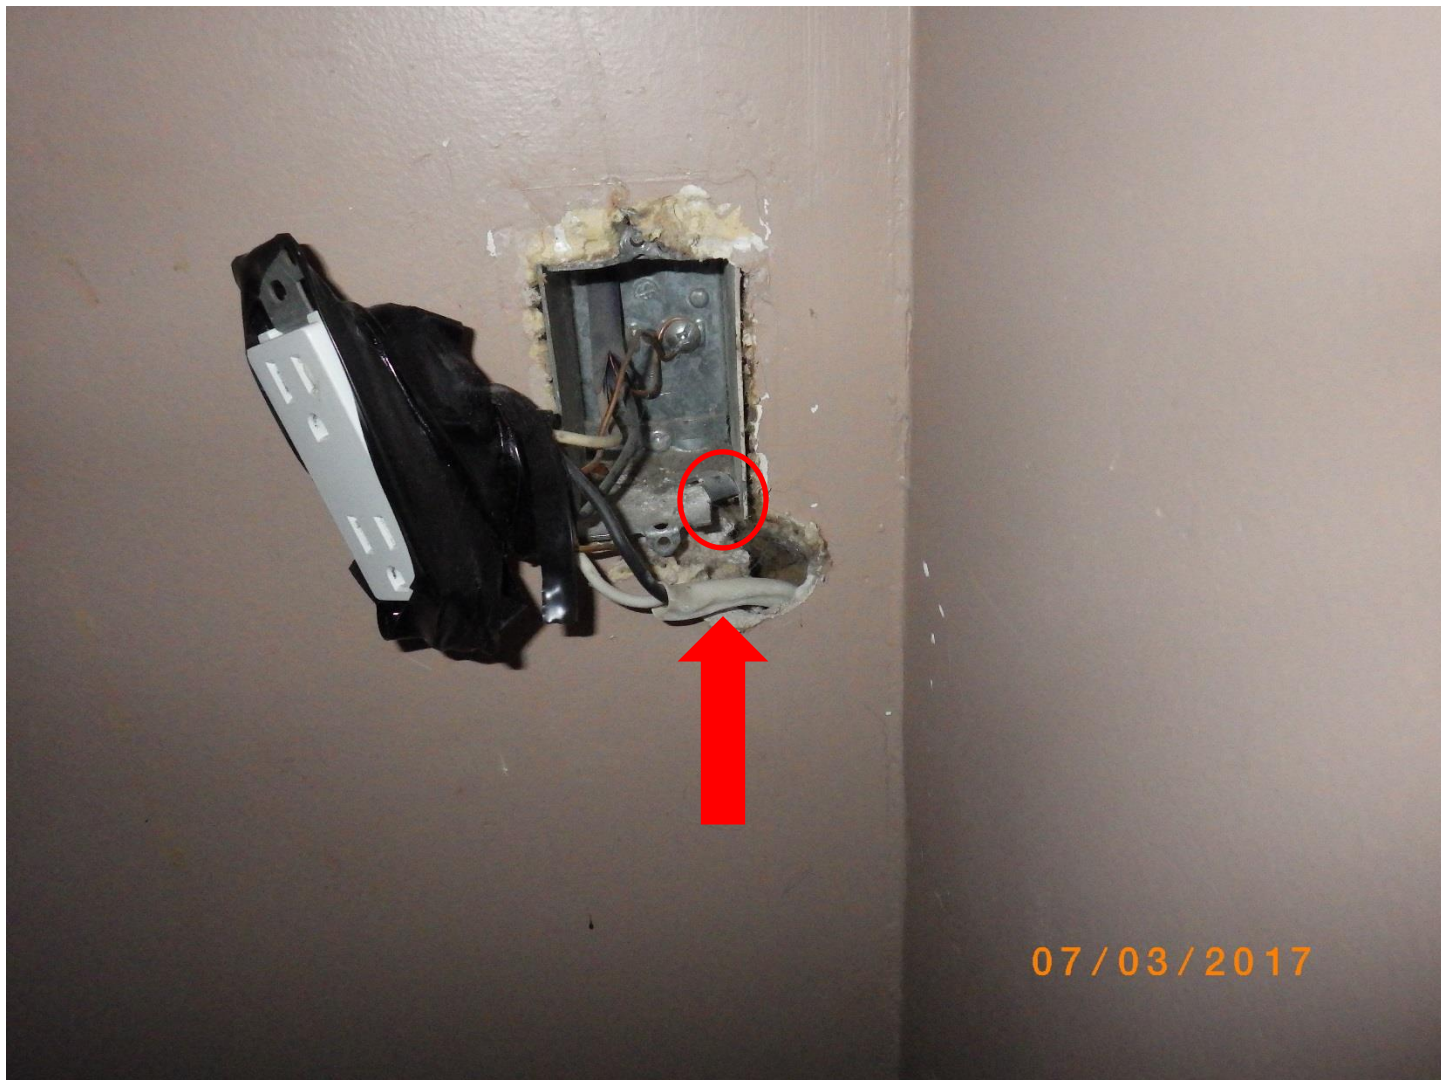
Figure 5

This photo shows the receptacle and wiring connected to it. The red arrow shows the improperly installed cable that was not entered into the outlet box and was connected to the receptacle. The red outline shows where the metal box was notched to enter the cable into the box. This is not an approved method for entering a cable into an outlet box.

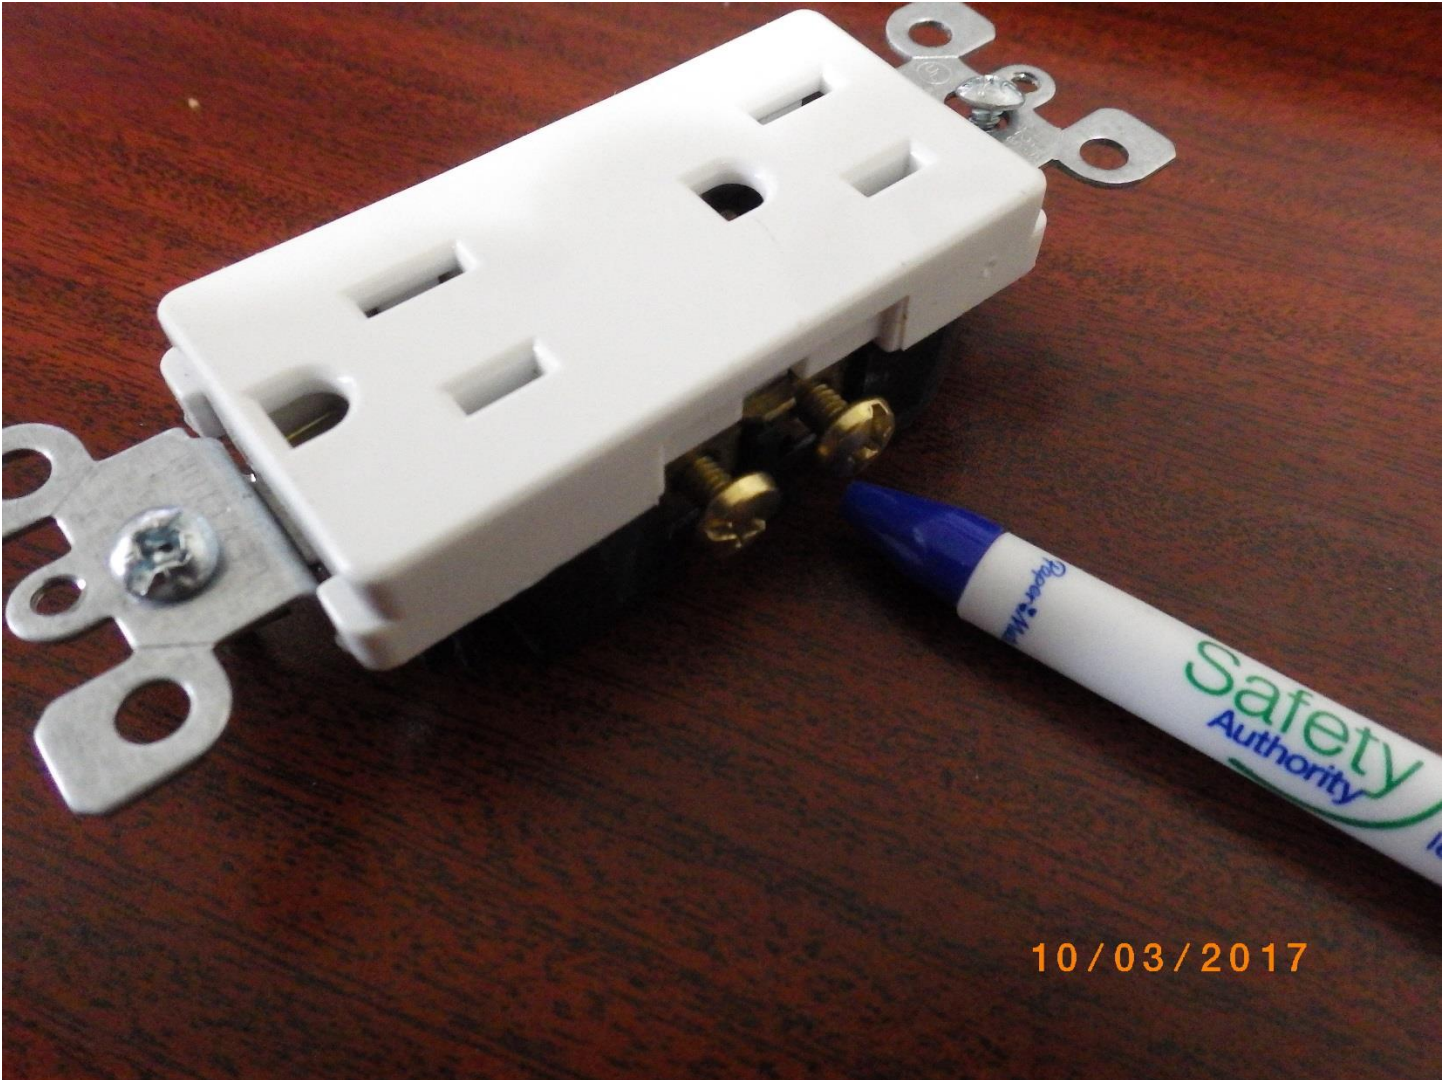
Figure 6

This photo shows an exemplar of the receptacle and the terminals located on the side of it that would have been contacted by the occupant that received the shock.
