## Incident Summary (Reference # 5620638) Final

SUPPORTING INFORMATION	Incident Date	June 30, 2017	
	Location	Vancouver	
	Regulated industry sector	Escalator	
	Impact	Qty injuries	1
		Injury description	Unknown
	Damage	Injury rating	Insignificant
		Damage description	No damage to equipment
		Damage rating	None
	Incident rating	Insignificant	
	Incident overview	<p>The escalator in question was removed from service by an attendant after noticing a burning smell coming from the escalator. After the unit was removed from service, passengers exiting the station continued to use the escalator as a means of egress. At some point enough people were occupying the escalator stairs at one time to overcome the holding force of the escalator brakes. The escalator began to move in the down direction causing people to fall at the bottom of the escalator.</p>	
INVESTIGATION CONCLUSIONS	Site, system and components	<p>When power is removed from the escalator, the escalator brakes are designed to hold the escalator stationary under load when properly adjusted and maintained. Escalator brakes have a brake wear switch that monitors the proper adjustment of the brake and minimum brake pad thickness. Th

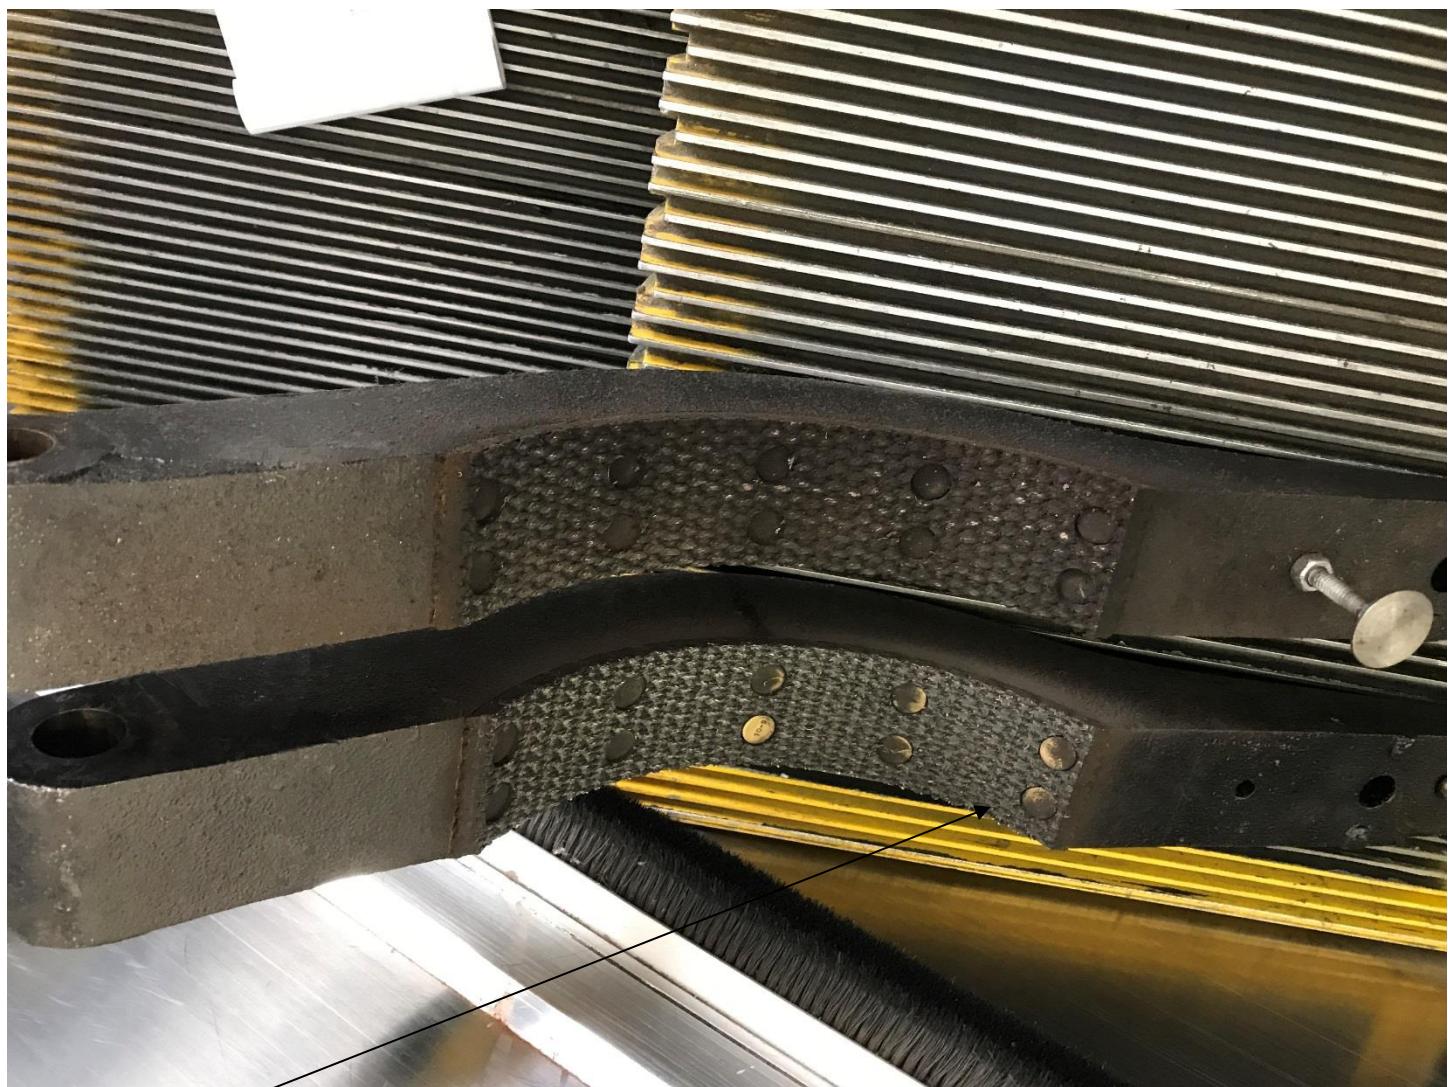
Failure scenario(s)	<p>Maintenance personnel had recently replaced brake pads and a brake actuating coil. After the brake maintenance, the escalator was shutting down intermittently by the brake wear switch. Maintenance personnel made adjustments to the brake force spring thus affecting braking torque force to stop the brake wear switch from actuating. The escalator brake linings were able to drag on the brake drum causing wear and a burning smell. The brake wear switch was not adjusted properly to sense this. The escalator was shut down, The escalator brake linings were beyond the wear limit and the escalator brake torque setting was not sufficient to hold the combined weight of the passengers on the steps of the stationary escalator. The passenger weight was sufficient enough to overcome the braking force of the escalator brake and the escalator began to move in the downward direction. (see photo)</p>

<ul style="list-style-type: none"> <li>Brake spring tension measurement did not meet manufacturer's specifications.</li> <li>The brake linings was very close to being worn out (see photo &amp; see comment in failure scenario above).</li> <li>The brake pads were not wearing evenly.</li> </ul>
Causes and contributing factors	It is highly likely that the adjustments to the brake caused a reduction in braking force. The combined weight of the passengers overcame the escalator brake holding force. Uneven brake pad contact likely contributed to the incident.

Brake linings unevenly worn. Brake linings worn down to lining retaining rivets.
