Incident Summary #II-1612461-2023 (#39700) (FINAL)

SUPPORTING INFORMATION	Incident Date	September 29, 2023	
	Location	Vancouver	
	Regulated industry sector	Elevating devices - Escalator or moving walkway	
	Impact	Qty injuries	3
		Injury description	Three people were reported injured due to the escalator overspeed runaway and several more piled up at the bottom of the escalator during the runaways.
		Injury rating	Minor
	Damage	Damage description	Physical damage to the inside of the escalator gearbox.
		Damage rating	Moderate
Incident rating	Moderate		
Incident overview	A 3-year-old, down-traveling escalator at a public transit SkyTrain station, suffered a mechanical failure that rendered the safety and braking systems ineffective and caused multiple uncontrolled descents of the loaded escalator steps at high-speed causing riders to fall and pile up at the bottom resulting in multiple injuries.		
INVESTIGATION CONCLUSIONS	Site, system and components	<p>The transit location has a bank of three escalators installed next to each other used for conveying passengers to and from the transit platform situated approximately 25m (82') underground. The escalators were originally installed at

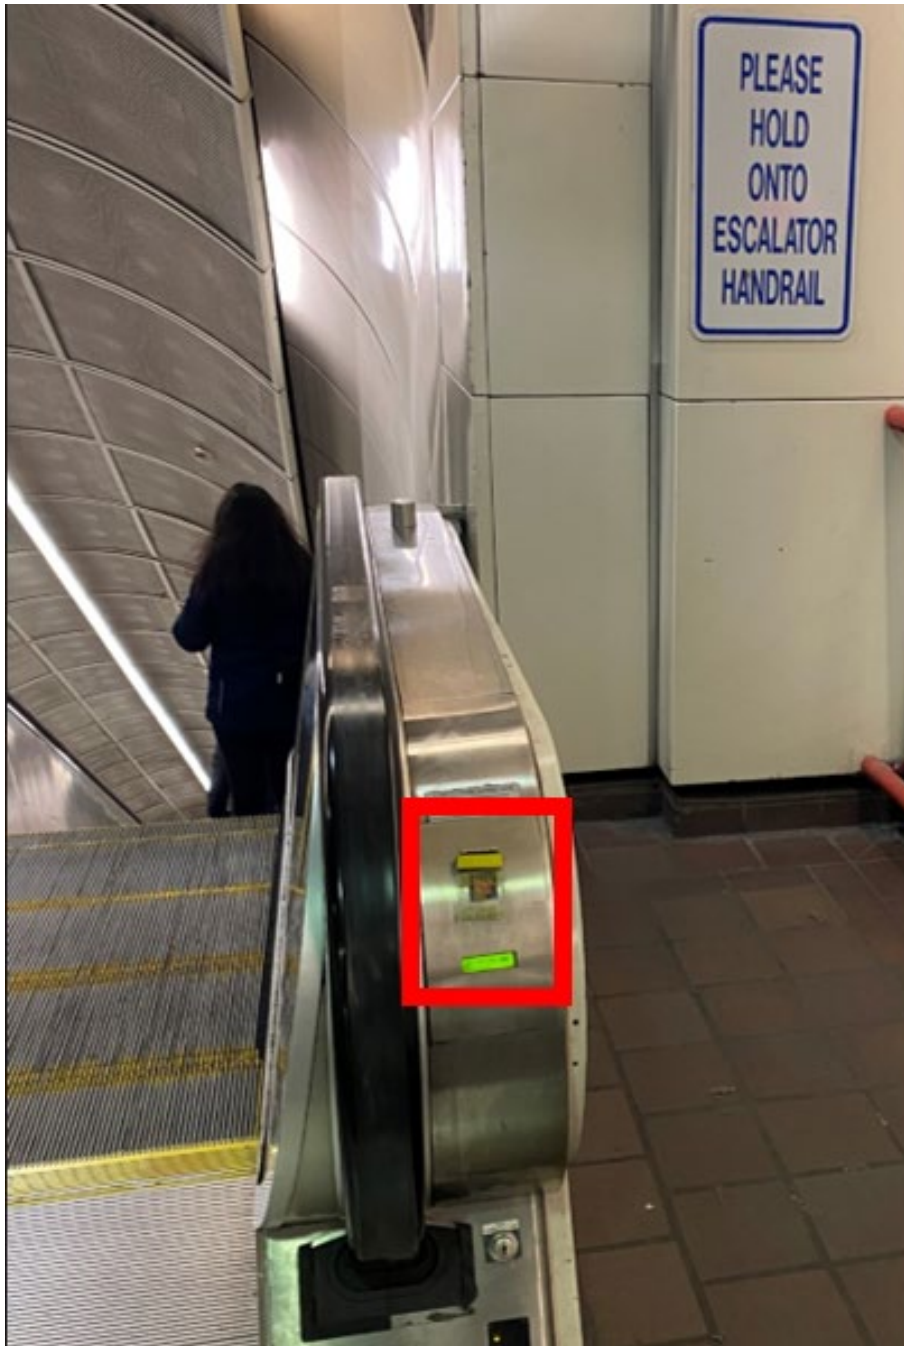
Image 2 – Top of escalator #3. [RED] Emergency stop button.

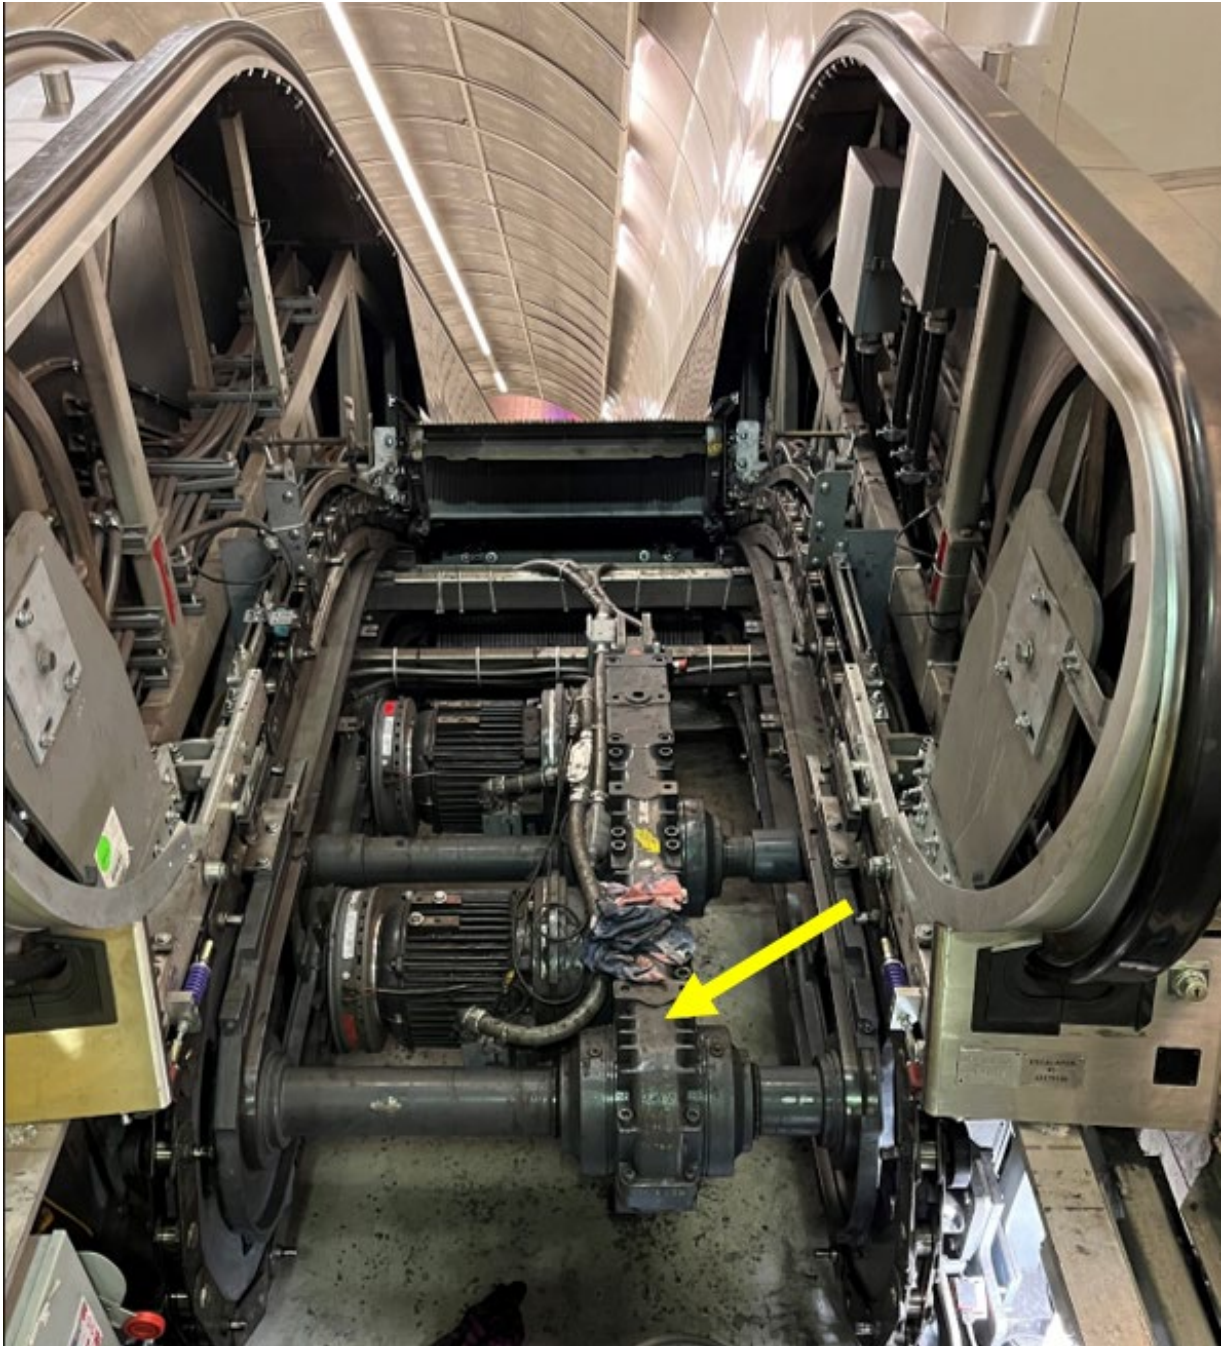
The equipment failure was due to the disengagement between the gearbox and the step-drive main-shaft as a result of misalignment and oil starvation. These were caused by the alignment plate movement on the step-drive main-shaft and debris from the wear of the step-drive main-shaft creating metal dust and shavings that plugged the oil passages to the shaft splines.

Image 3 – Escalator #3 drive system during disassembly. [YELLOW] Location of internal step-drive main-shaft spline failure.

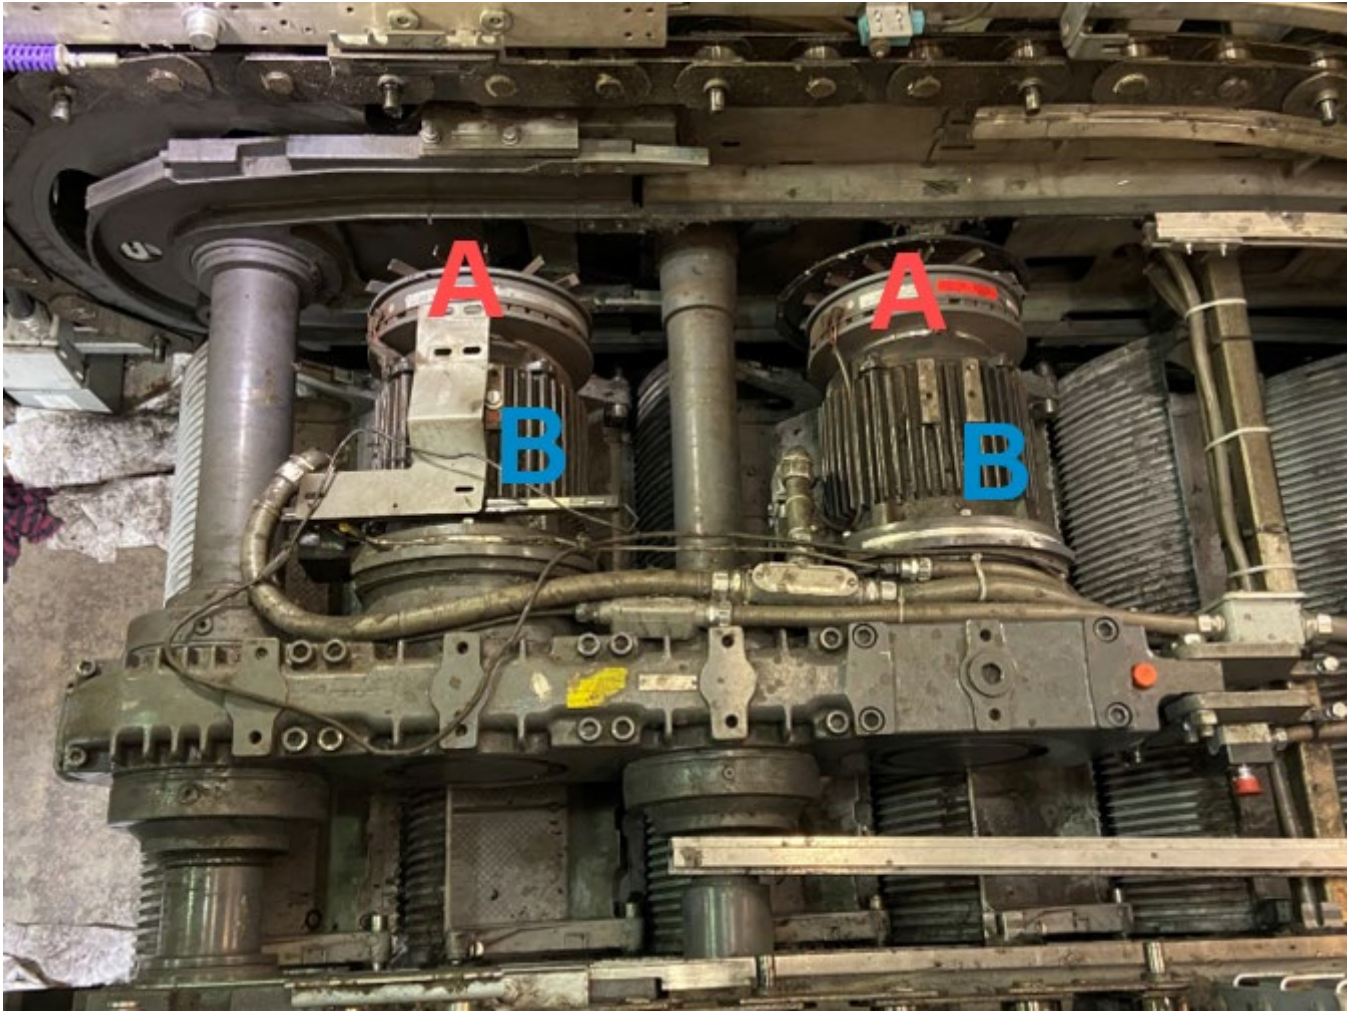
Image 4 - Escalator #3 dual motor drive assembly installed at top of escalator.

[A] Permanent magnet braking systems.

[B] Electric drive motors.

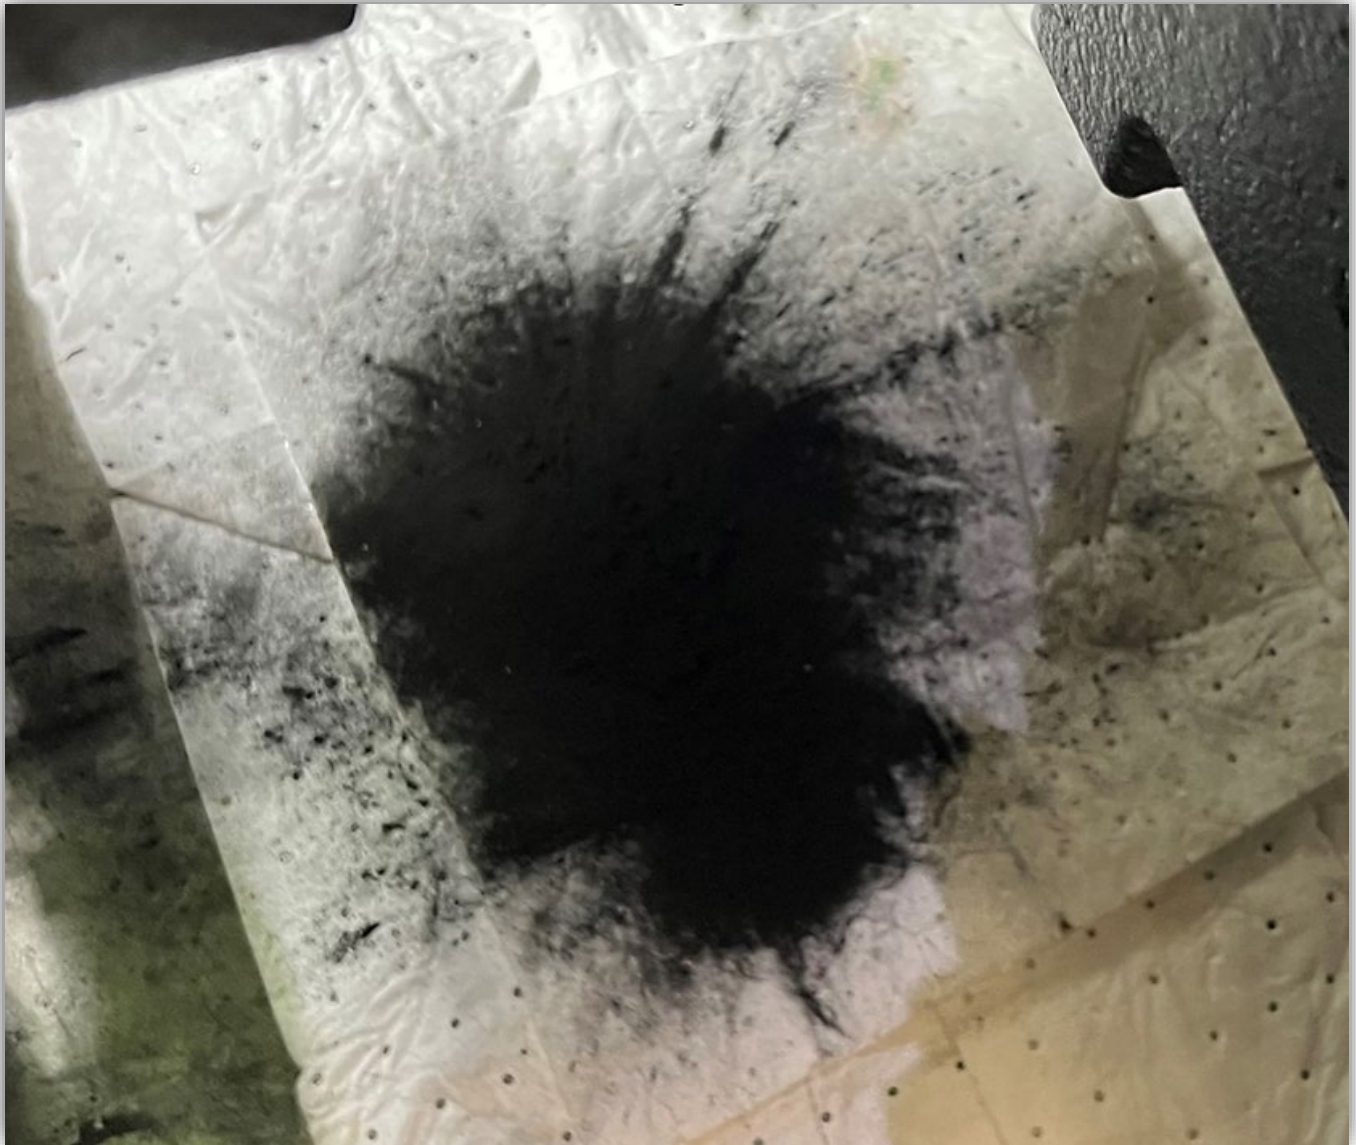
- A large quantity of metal shavings and dust were found inside the step-drive main-shaft right side end cap.
- The step-drive main-shaft right side alignment plate was found to have an excessive gap and grinding marks showing mechanical interference with the shaft end cap.

Image 5 - Metal shavings and debris from inside step-drive main-shaft end cap when it was removed.

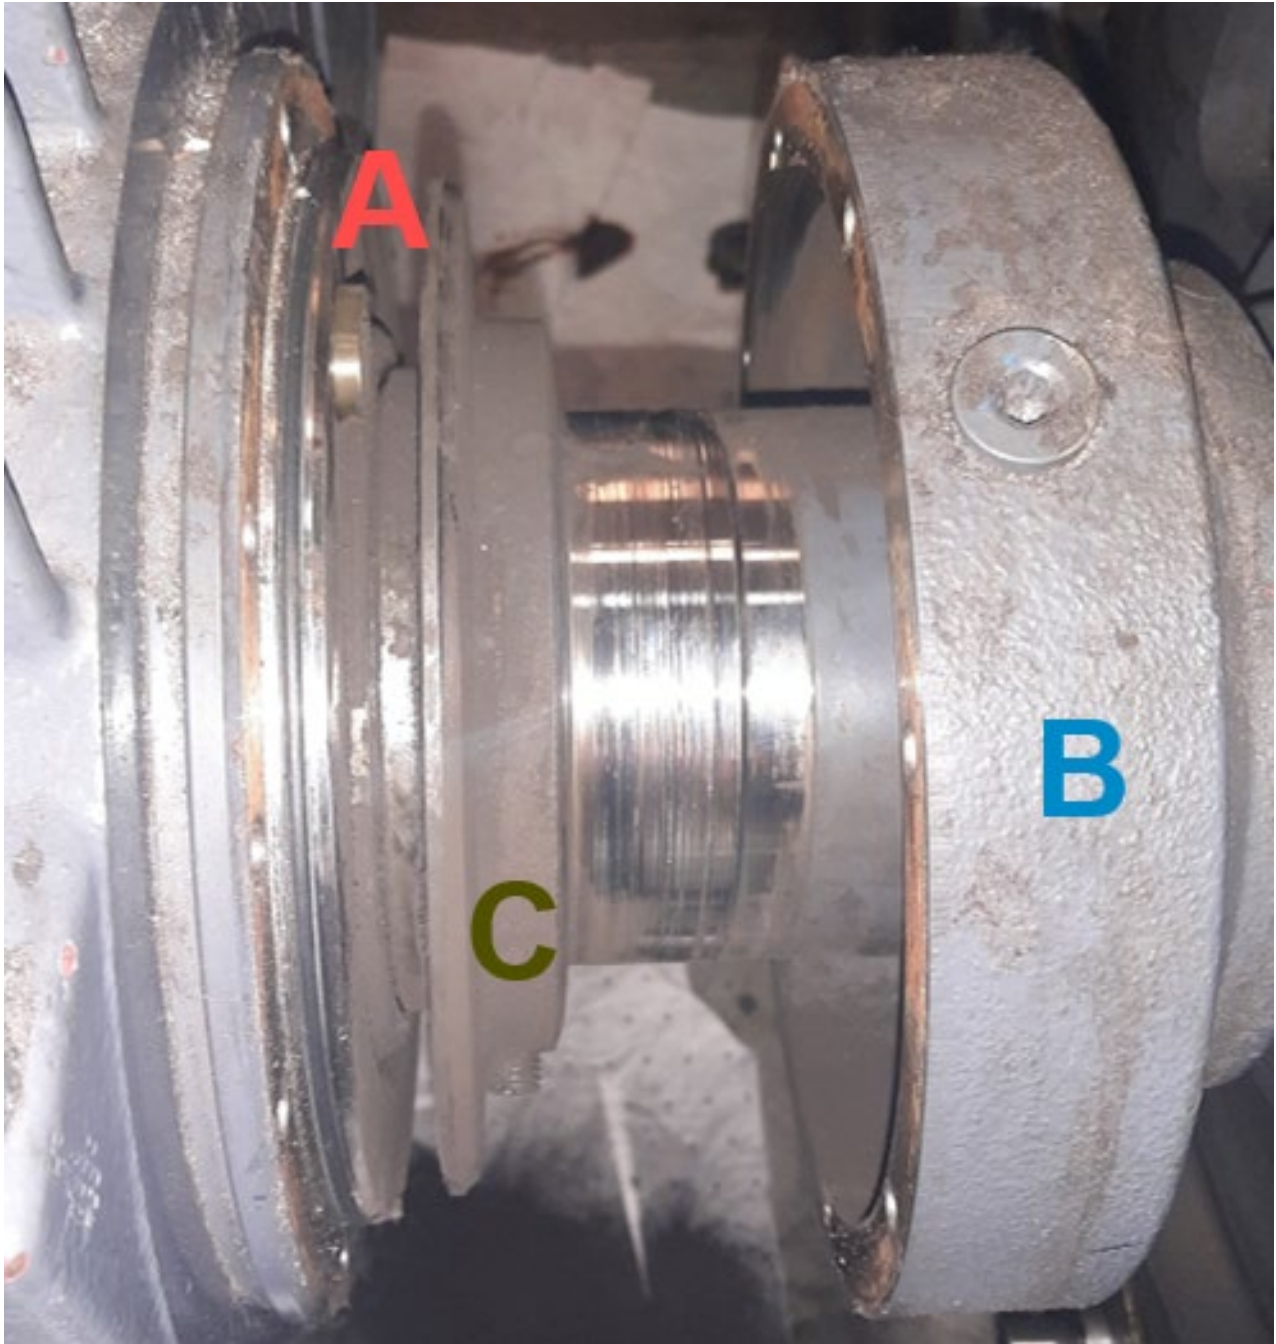
During operation of the escalator, the alignment flange on the right side of the step-drive main-shaft on escalator #3 pushed out allowing the gearbox to shift approximately 1 cm misaligning the gearbox and step-drive main-shaft splines. The rotating alignment flange contacted the inside of the shaft cover which ground down the metal of the alignment flange and shaft cover and created fine metal dust and shavings (Image 5). Metal dust mixed with oil plugged the oiling port used to lubricate the step-drive main-shaft splines. The lack of lubrication and misaligned contact of

Image 6 - [A] Excessive alignment flange gap.
[B] Step-drive main-shaft end cap.
[C] Step-drive main-shaft alignment flange.

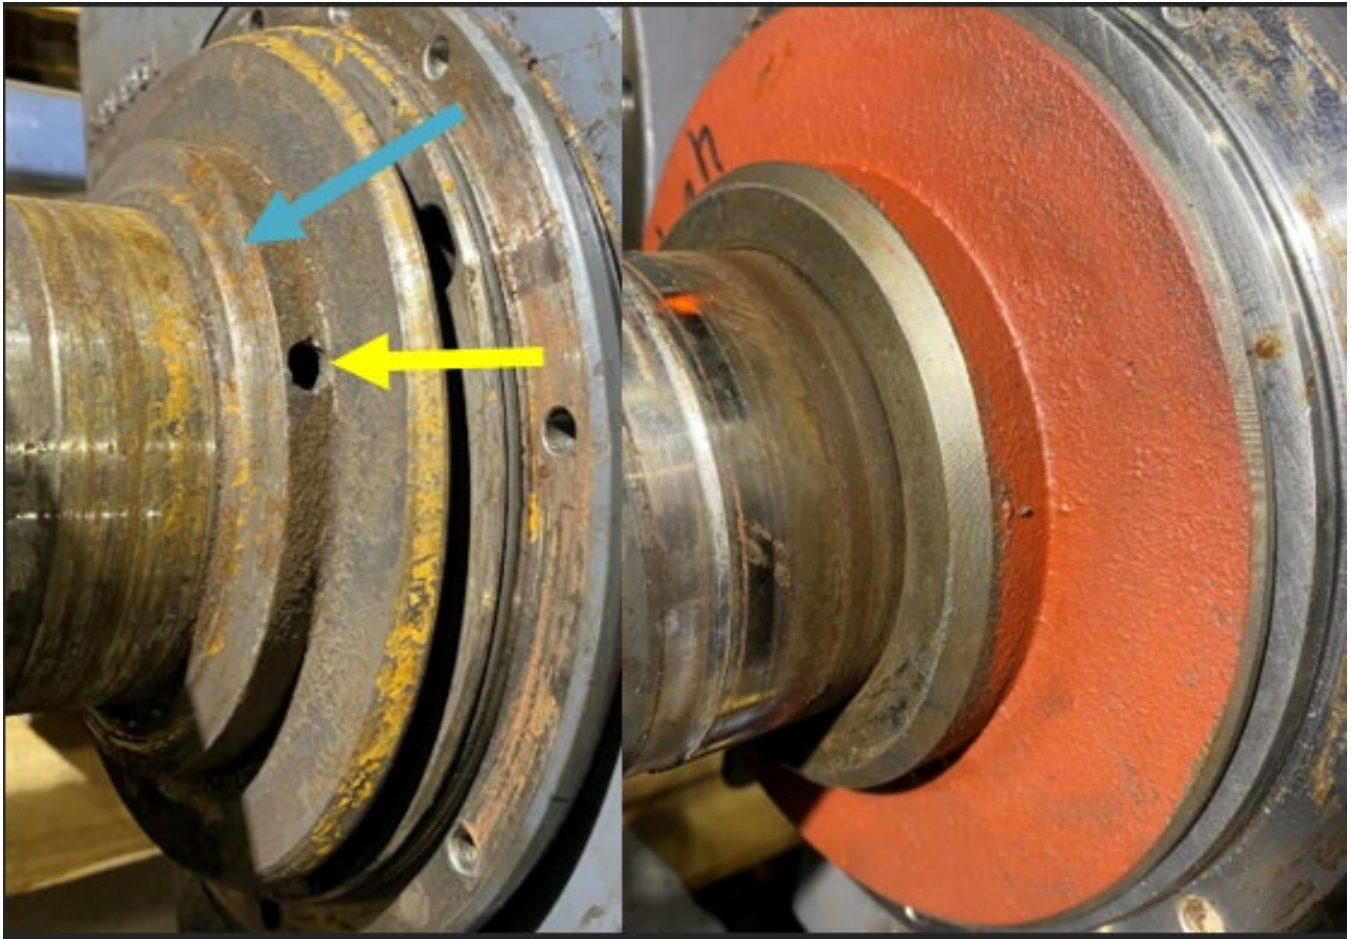
Image 7 – Step-drive main-shaft alignment flange showing one set-screw hole and ground down shoulder from interference with shaft end cap (Left). Undamaged shaft alignment flange from handrail shaft for comparison (Right).

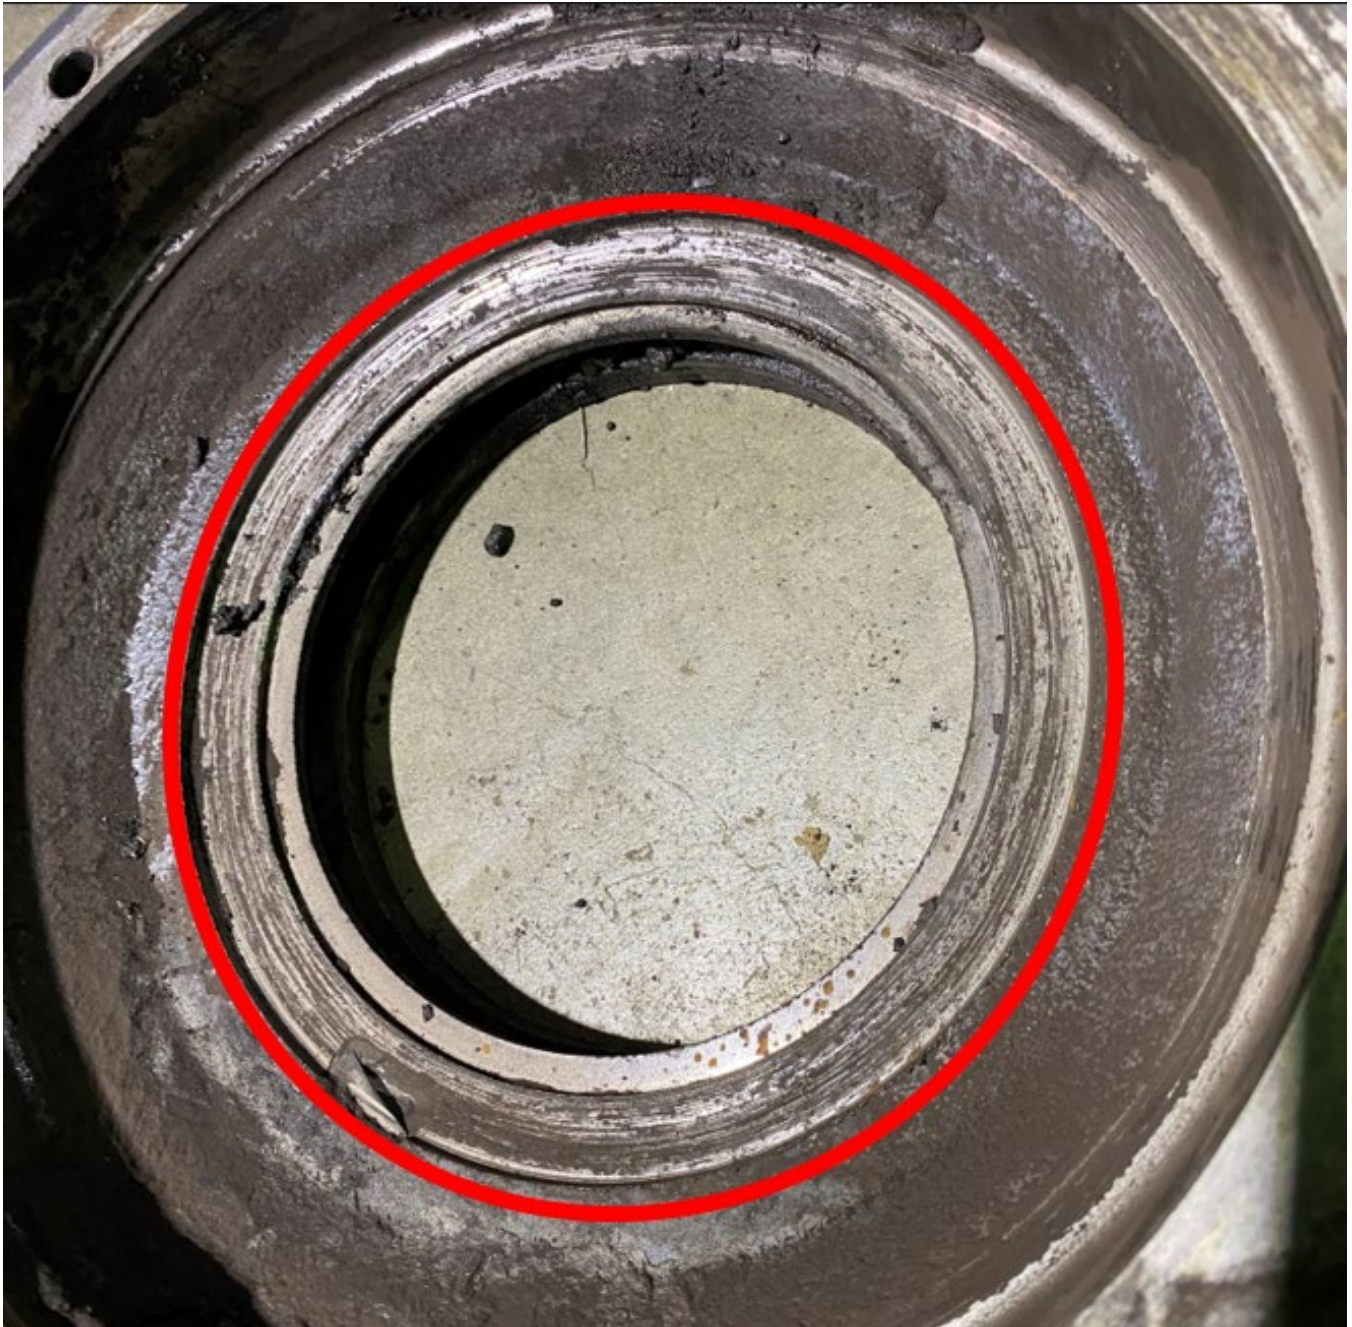
Image 8 - Red circle showing grooved mark on the inside of the end cap created by interference with the rotating step-drive main-shaft alignment flange.

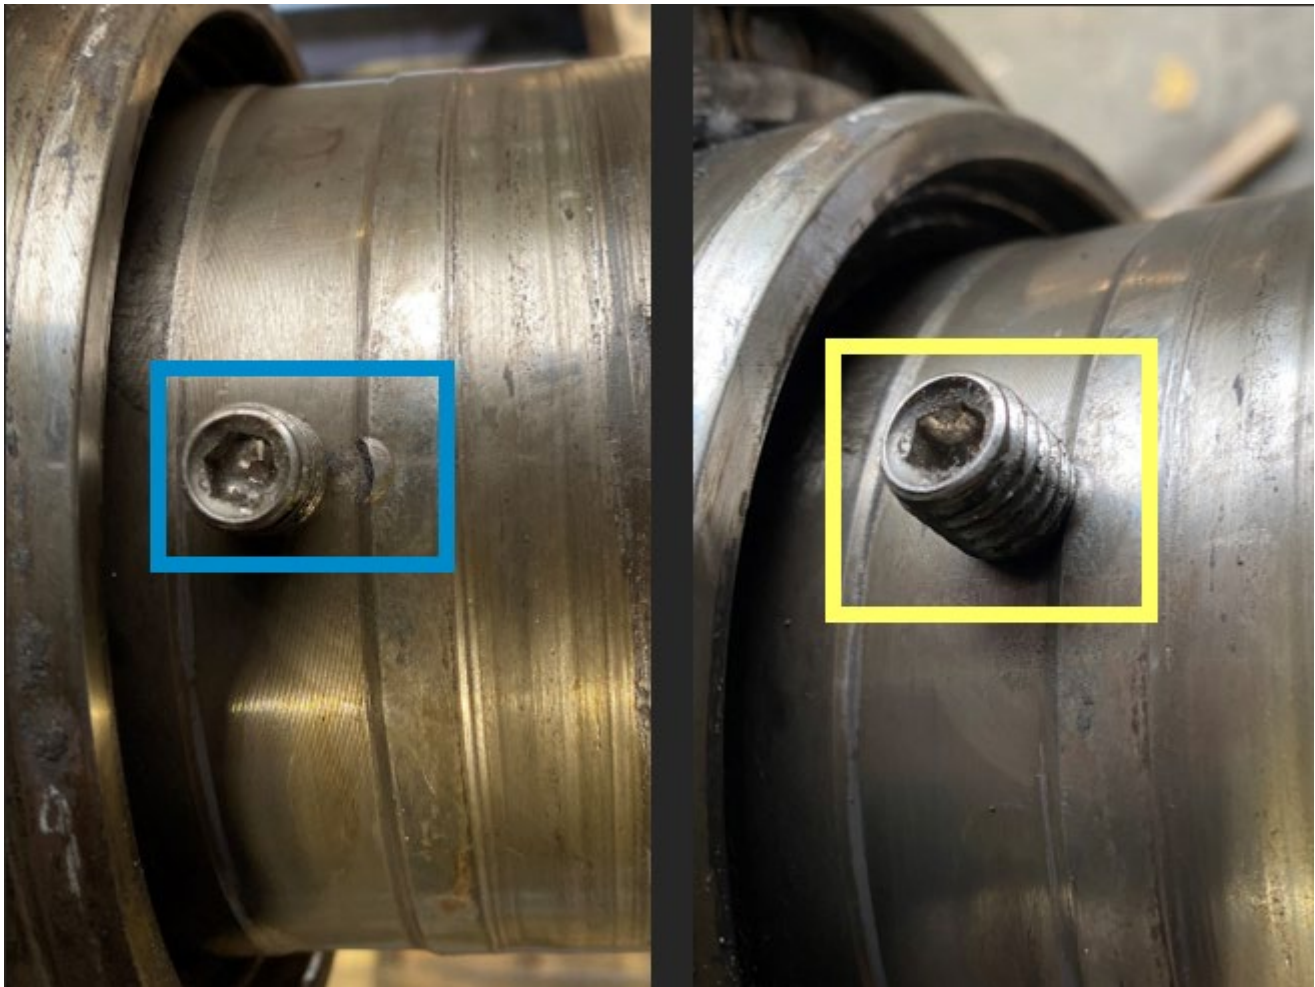
When the drive unit was commissioned three years prior to the incident, the set screws on the alignment flanges of the step-drive main-shaft were loosened to allow for the factory oil wiper installation. The alignment flanges were reset, and the set screws retightened. It is unknown if the screws were retorqued to the factory setting of 40NM (29.5 lbs/ft).

- The roller bearing on the right side of the main step-drive main-shaft was discoloured suggesting evidence of high heat.
- A machined groove on the step-drive main-shaft showed markings from both right-side alignment plate set screws ([Image 9](#) & [Image 10](#)) indicating the plate was forced out of alignment and into contact with the shaft end cap.
- The oil port supplying oil to the step-drive main-shaft splines was plugged with a metal dust/oil mixture ([Image 14](#) & [Image 15](#)).
- The splines connecting the gearbox to the step-drive main-shaft were significantly damaged and worn and the splines on the shaft had a tapered wear profile with more wear on the right side of the splines ([Image 11-13](#)).
- The handrail gears, shaft and splines did not show any wear or indication of misalignment.

Image 10 - Blue box showing approximate start location of step-drive main-shaft alignment flange set screw. Yellow box showing set screw alignment with indentation mark on step-drive main-shaft machined shoulder.

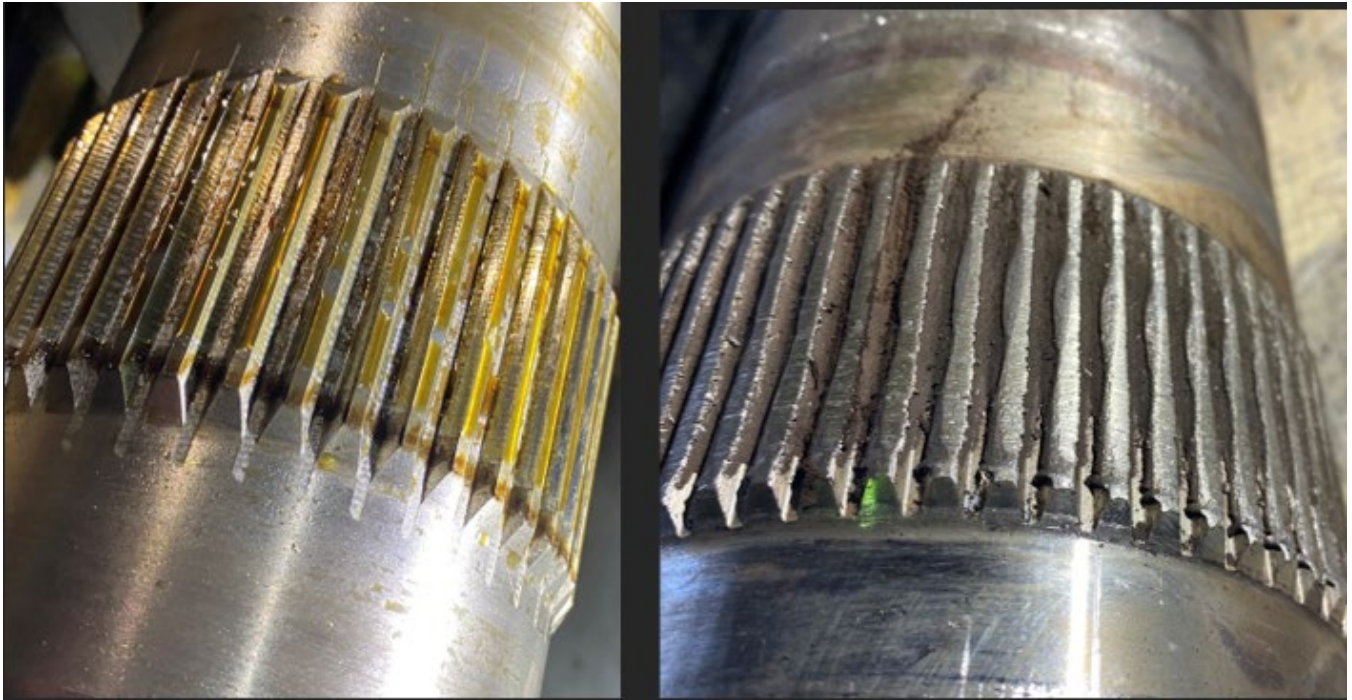
<p>the step-drive main-shaft created wear to the point of failure and allowed the shaft to rotate independently of the drive motor and braking system when loaded.</p> <p>At 14:57 a total of 11 riders boarded the escalator. This produced enough load to overcome the worn mechanical connection between the drive motor and the step-drive shaft. The steps slightly sped up independently of the handrail for approximately 14 seconds until enough riders exited at the bottom reducing the load and allowing the escalator to return to normal descending speed. No riders fell during this overspeed condition.</p> <p>At 15:00 a total of 14 riders boarded the escalator. The loaded escalator steps oversped again, this time in an uncontrolled descent at a high rate of speed for approximately 15 seconds causing riders to stumble and one rider to fall. The emergency stop button was pressed by a bystander which stopped the drive motors and activated the brakes. The escalator steps stopped when the riders unloaded.</p> <p>Pedestrians attempting to access the transit platform immediately accumulated at the top of the escalator. The only other access to the transit platform was a second set of escalators and a small elevator that was only accessible across a multi-level concourse at a separate transit entrance (Image 1). Qualified employees were unable to place physical barricades at the top of the escalator before some pedestrians began to use the escalator as a staircase to access the transit platform. There were no immediate warnings or barricades informing the public to not use the escalator after it had stopped.</p> <p>At 15:02:30. Riders began to walk down the stopped steps to access the lower transit platform. When 16 riders boarded the stopped escalator, the steps began to move again independently of the drive motors and braking system. The steps accelerated quickly for approximately 18 seconds while the handrail remained stopped causing riders to stumble, fall, and pile up at the bottom while 10 of them fell to the ground and 2 others jumped off the side over the handrails.</p> <p>The failed mechanical connection did not provide positive engagement between the motors and the step-drive main-shaft, which rendered the safety braking system ineffective and unable to hold the steps and protect the escalator riders during the uncontrolled descent “runaway” situation.</p>

Image 11 - Undamaged handrail-shaft splines (Left) Damaged step-drive main-shaft splines (Right)

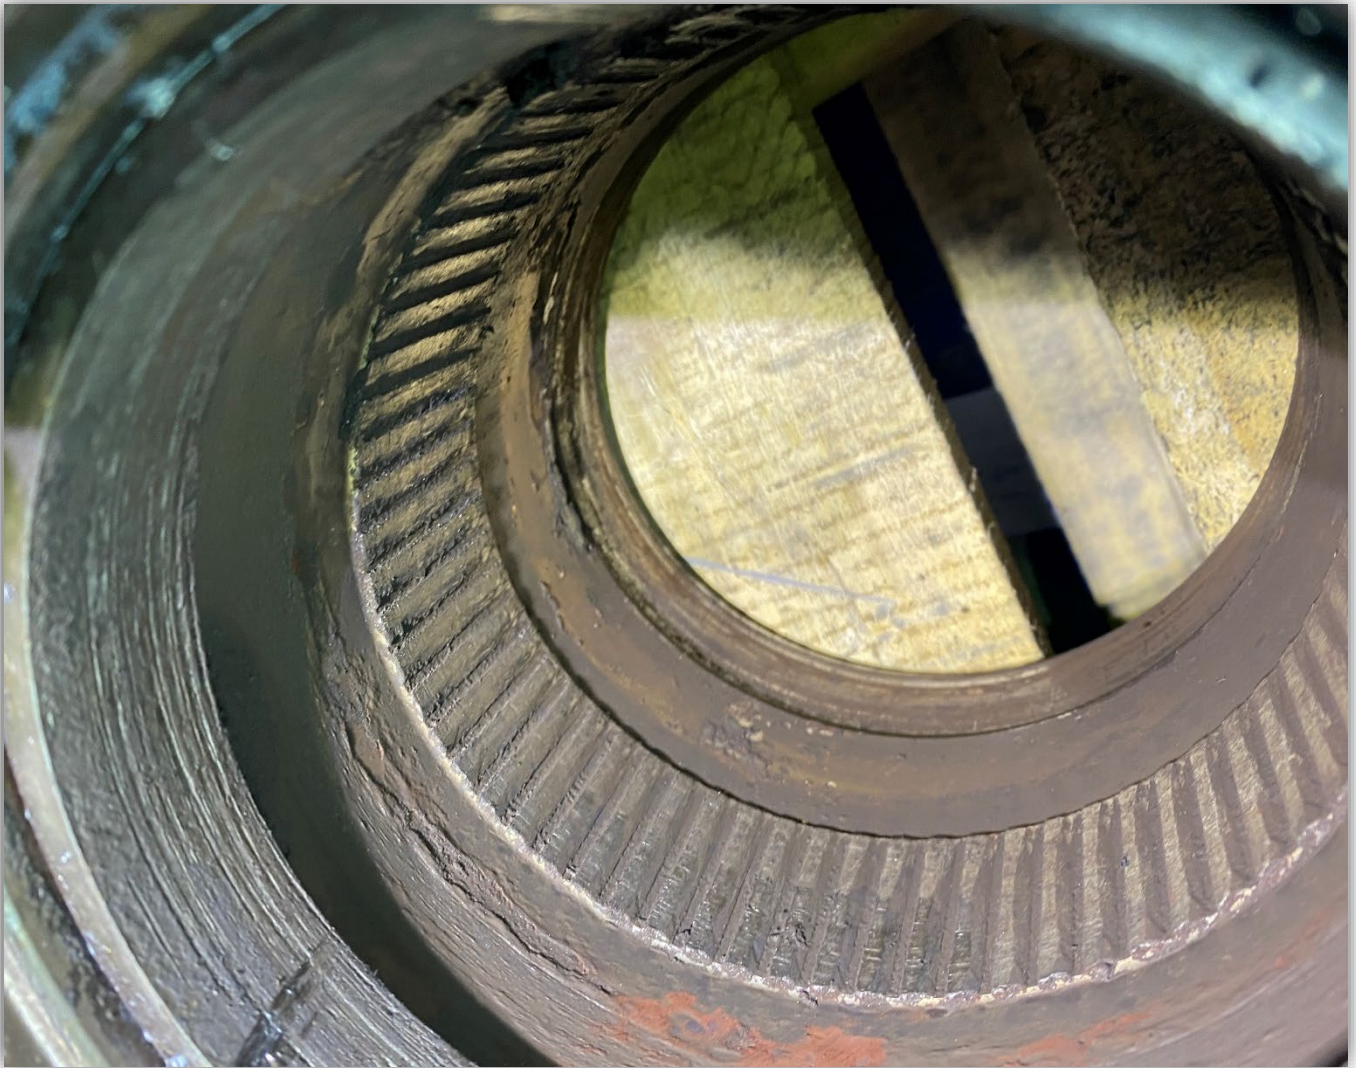
Image 12 – Step-drive main-shaft drive gear showing damaged internal splines.

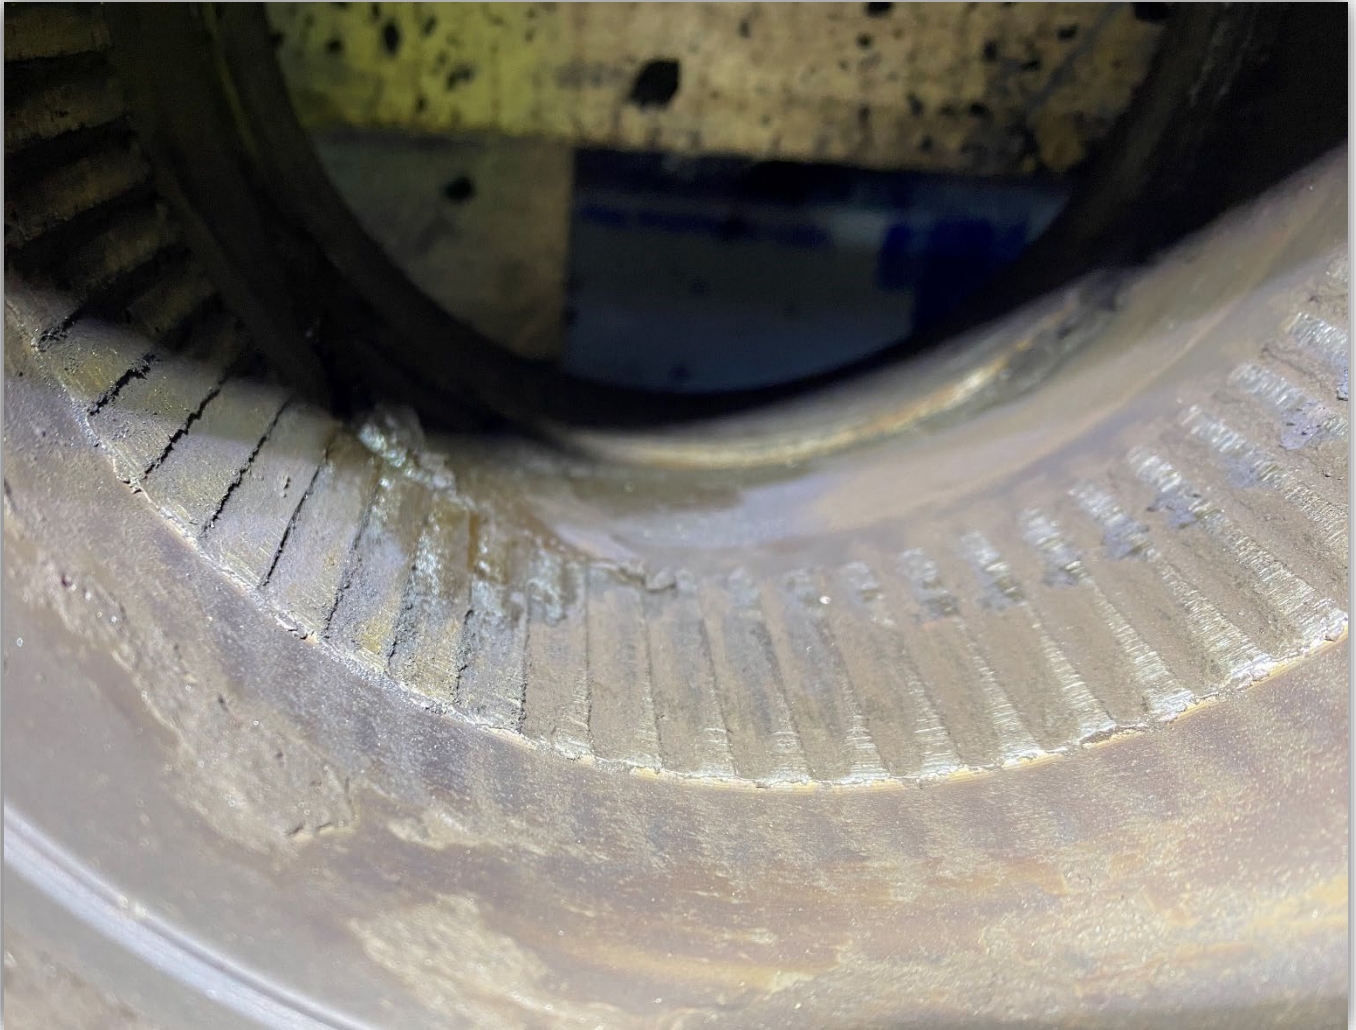
Image 13 - Closeup of damaged drive gear internal splines.

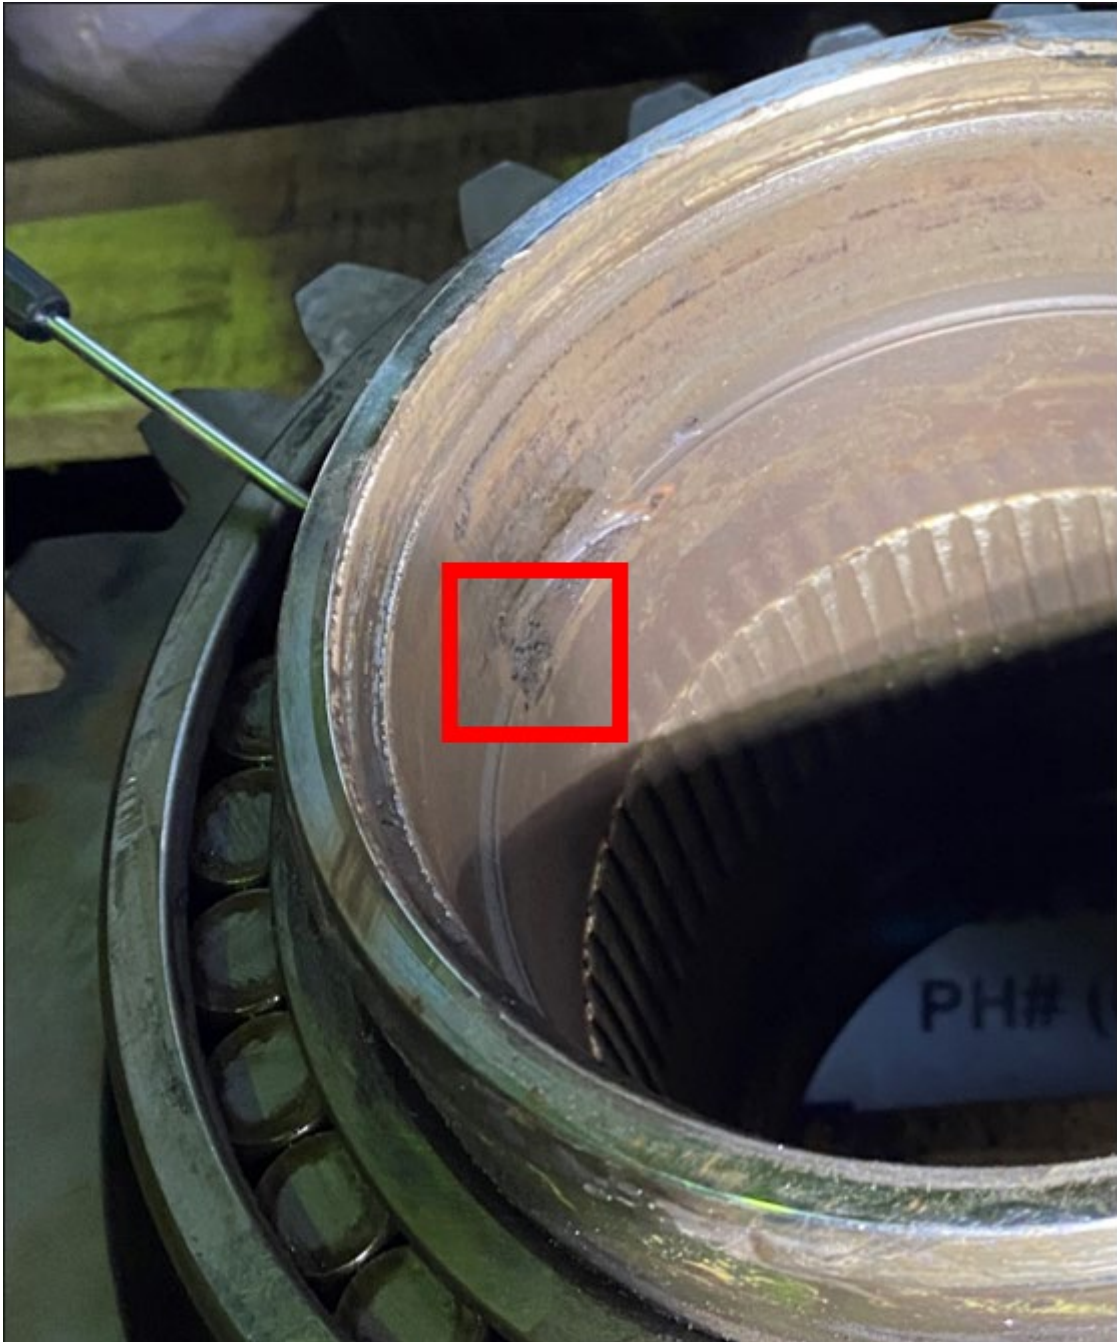
Image 14 – Step-drive main-shaft drive gear, red box showing location of plugged oil passage.

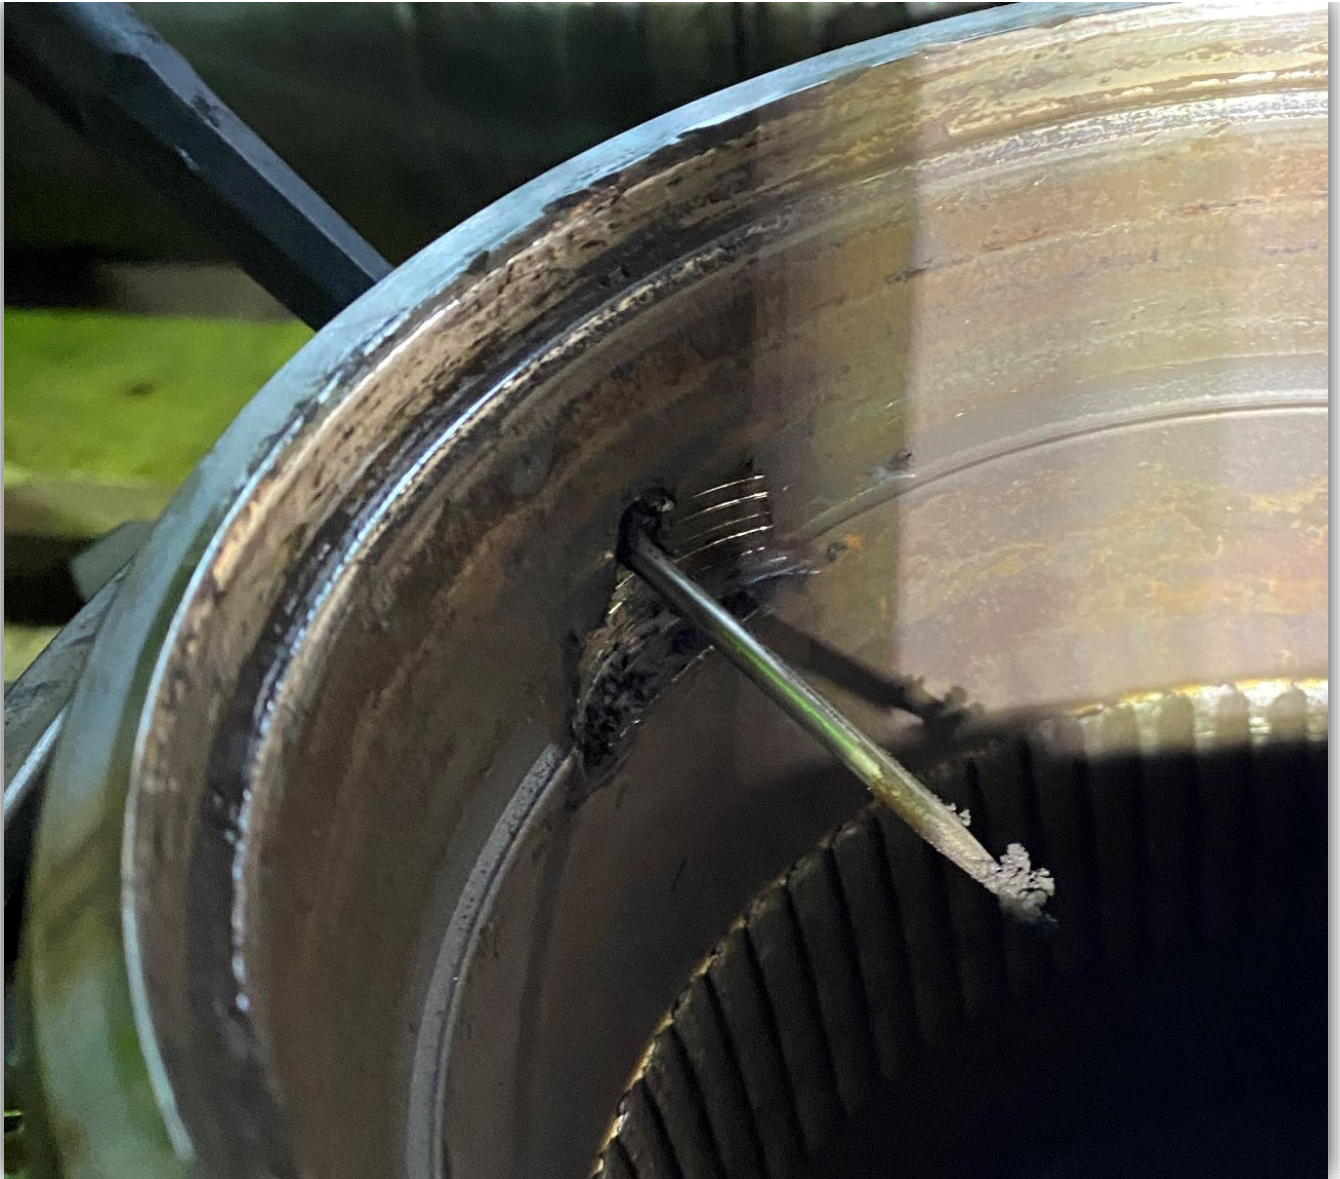
Image 15 - Oil passage unblocked with small screwdriver.

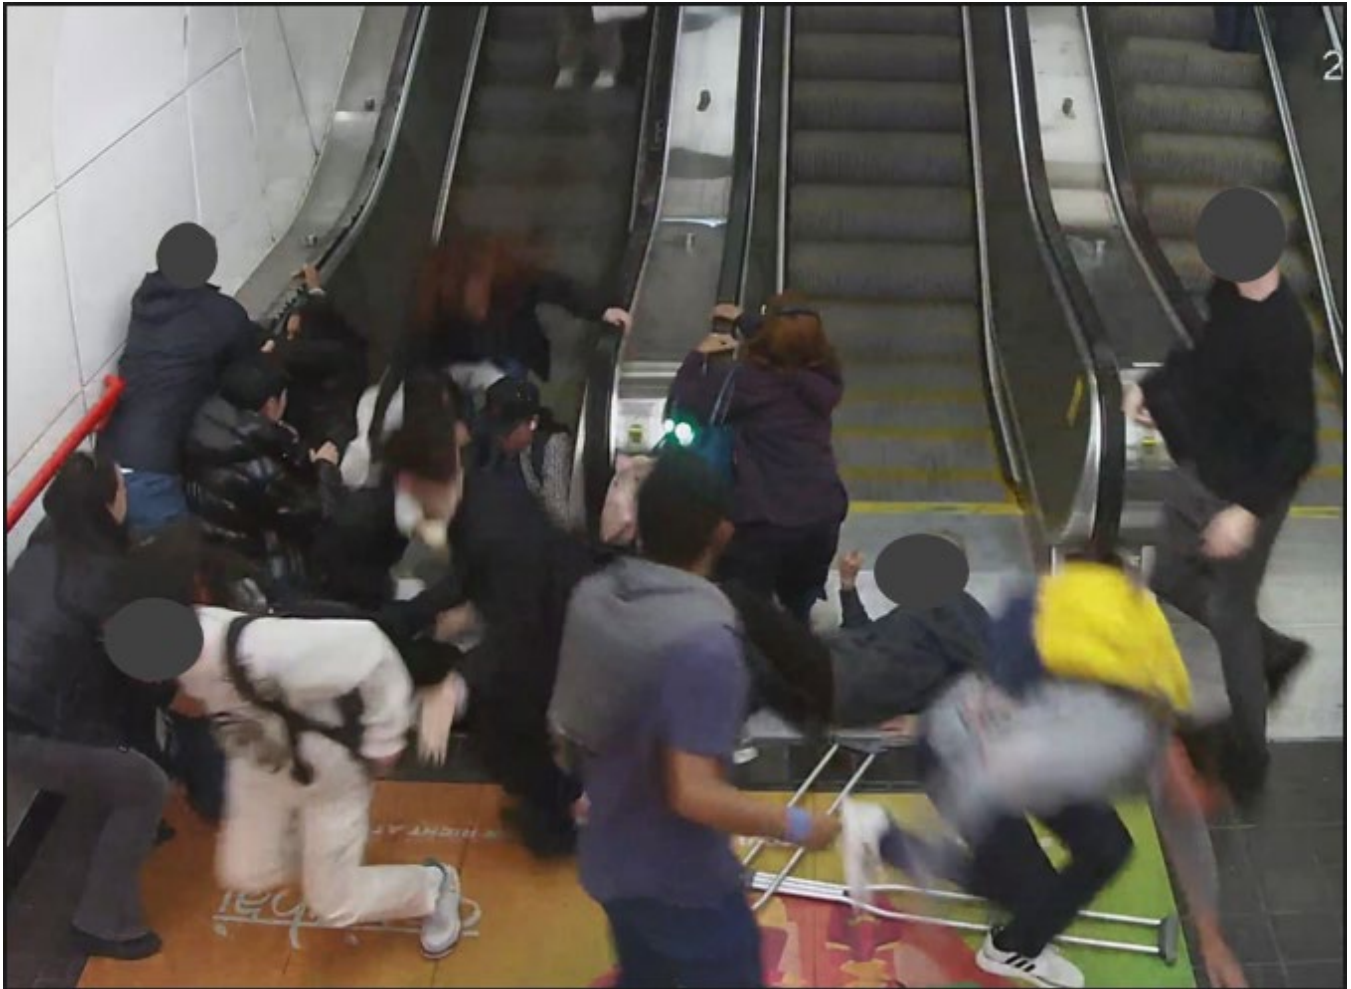
- No requirement or installation of an auxiliary shaft mounted braking system for the direct drive escalator that would have stopped and secured the escalator in place after the emergency stop was activated.

- No warnings or automatic barriers informing patrons the escalator was unsafe to use immediately after it was stopped when the emergency stop was engaged. This failed to prevent the final runaway incident and related injuries.

Image 17 – Pileup of riders at the bottom of escalator #3 during the final runaway event after the escalator had been stopped with the emergency stop switch.
