Construction Hoist Shaft Failure Analysis

Technical Safety BC

December 17, 2021

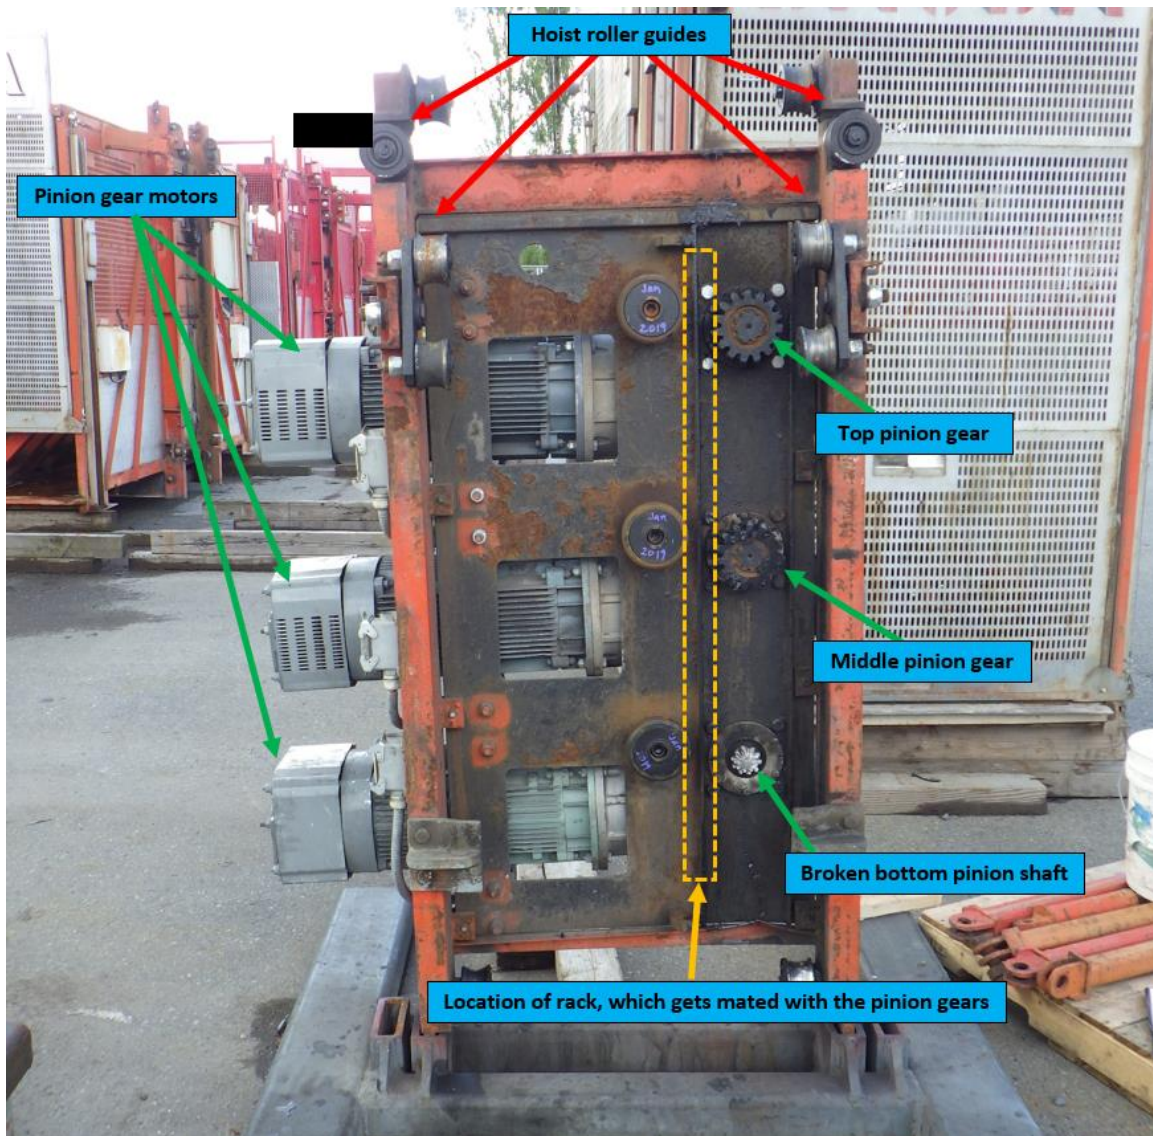
Figure 1: Construction Moist Motor Assembly

There was an incident where a drive shaft on a rack and pinion hoist failed. The particular rack and pinion construction hoist that failed is driven via the use of three (3) pinion driving gears (Appendix A: Figure 1). The lowest of the three pinion gears failed during operation of the hoist and as such, a new gear pinion was installed in its place. After roughly 15 days of operation the splined shaft that connects the bottom gear to the driving motor failed by fatigue failure (Appendix B: Acuren report). The purpose of this report is to consider possible causes leading to the fatigue failure in the splined shaft, and to make recommendations for the prevention of a similar occurrence in the future.

The replacement of a single gear on a construction hoist with three driving motors (without replacing the other two driving gears) can result in the new gear taking a disproportionate amount of the load, resulting in fatigue failure of the splined shaft that is connected to and driving the replacement gear (Appendix A – Figure 1).

2. Investigation findings indicate the top two gears were not replaced and showed significant signs of wear (Appendix A, Figure 1).
3. Witness statements say the hoist was in service for approximately 15 days after the bottom motor was replaced and before the bottom splined shaft failed.

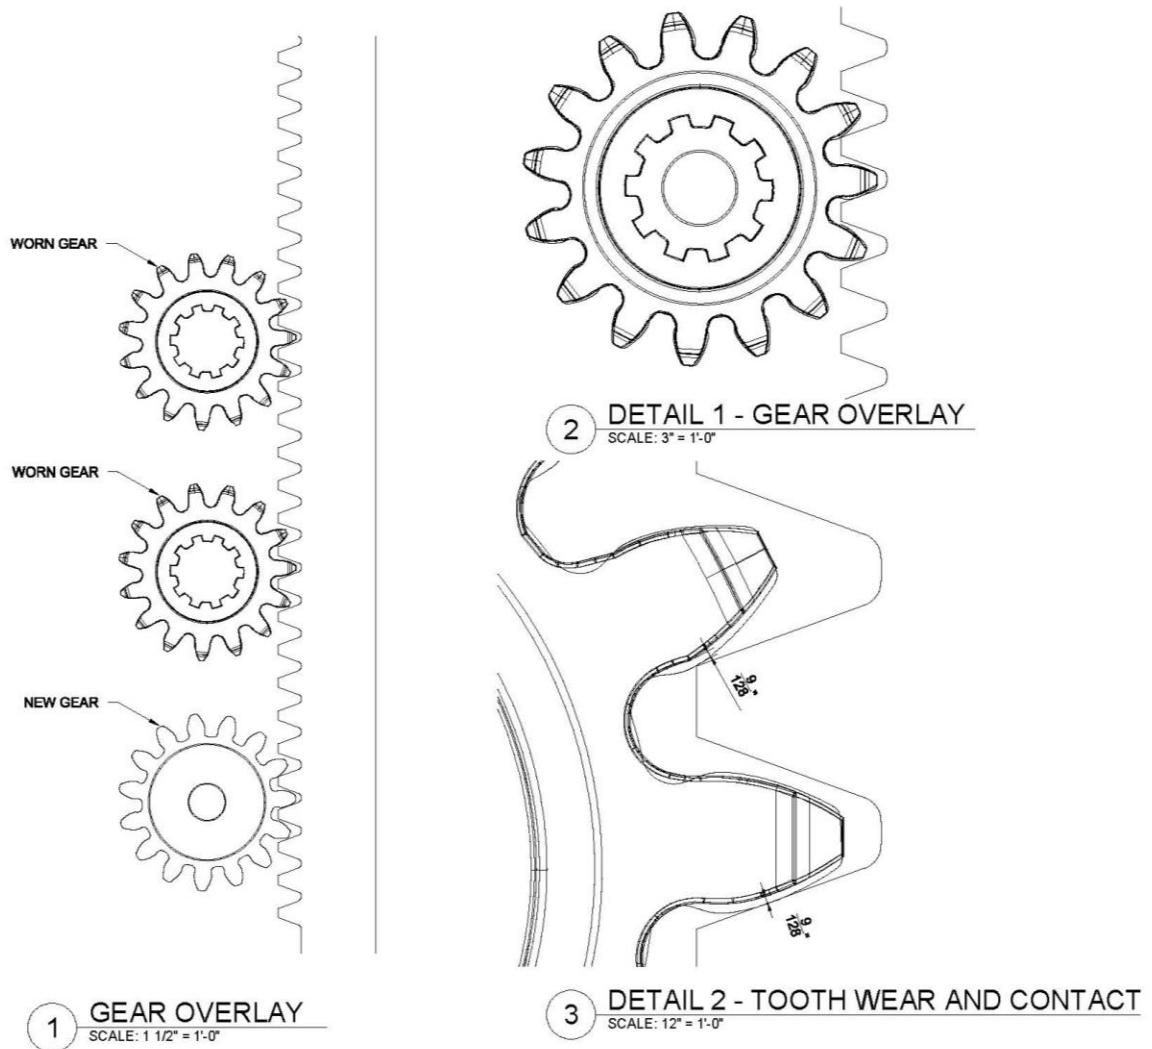
Figure 2: Orientation of Pinion Gears (1.1), Overlay of a worn pinion gear (side profile) over the new pinion gear (1.2), Detailed view of overlay showing extent of tooth wear (1.3)

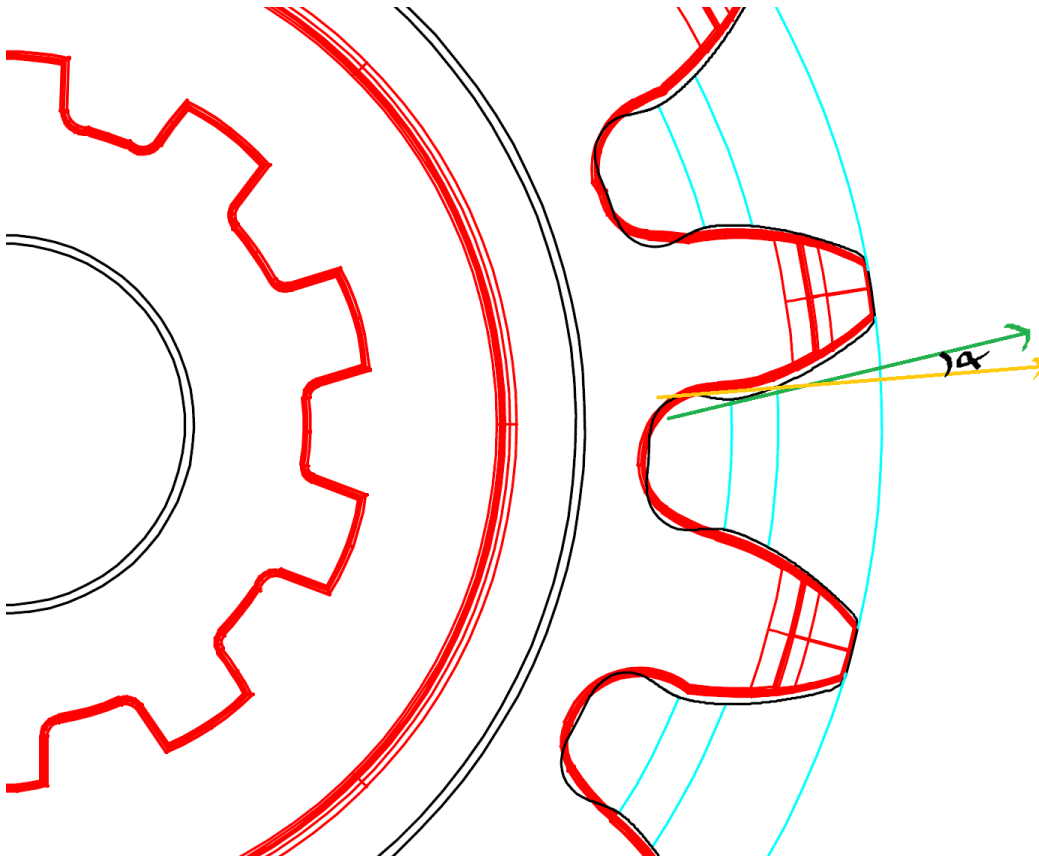
The wear on the old pinion gears (top two) significantly degraded the involute profile (Appendix A, Figure 3) such that the direction of the force imparted by the worn gears (to the rack) varied throughout rotation (specifically at the point where the tooth first engages the rack).

Figure 3: Black gear profile represents the new gear and green line is a line tangent to the gear tooth at the point where the gears first engage the rack. Red gear profile represents the worn gear and the yellow line is a line tangent to the gear tooth at the point where the gear first engage the rack. The difference in tooth angle at the point where the gears first engage the rack Would cause fluctuations in the angle at which the worn gear exerts force on the rack.

1. All three gears be replaced at once to ensure uniform performance, and
2. The replacement gears should all be from the same manufactured batch such that they exhibit similar metallurgical and manufacturing properties.
