Incident Summary #II-1622405-2023 (#40557) (FINAL)

SUPPORTING INFORMATION	Incident Date	October 21, 2023	
	Location	Fruitvale	
	Regulated industry sector	Electrical - Low voltage electrical system (30V to 1000V)	
	Impact	Qty injuries	0
		Injury description	N/A
	Damage	Injury rating	None
		Damage description	Fire, heat, smoke, and fire suppression damages to electrical and structural features in and around the area housing an air compressor located in a log de-barking section of a wood processing facility.
		Damage rating	Moderate
	Incident rating	Moderate	
Incident overview	A 150 horsepower, 3 phase, 480-volt air compressor suffered a bearing failure between the electric drive motor and the air compressing section. The volume of compressed air delivered demands an equipment cooling feature. The cooling feature employs cooling oil in a closed loop type piping system. The bearing failure resulted in cooling oil being introduced into the air tank and lines. The pressurized oil bypassed a backflow preventer on the air-cooling radiator/pressure regulator and sprayed into the surrounding atmosphere. An ignition source ignited the spraying atomized oil and created a local fire in and aro

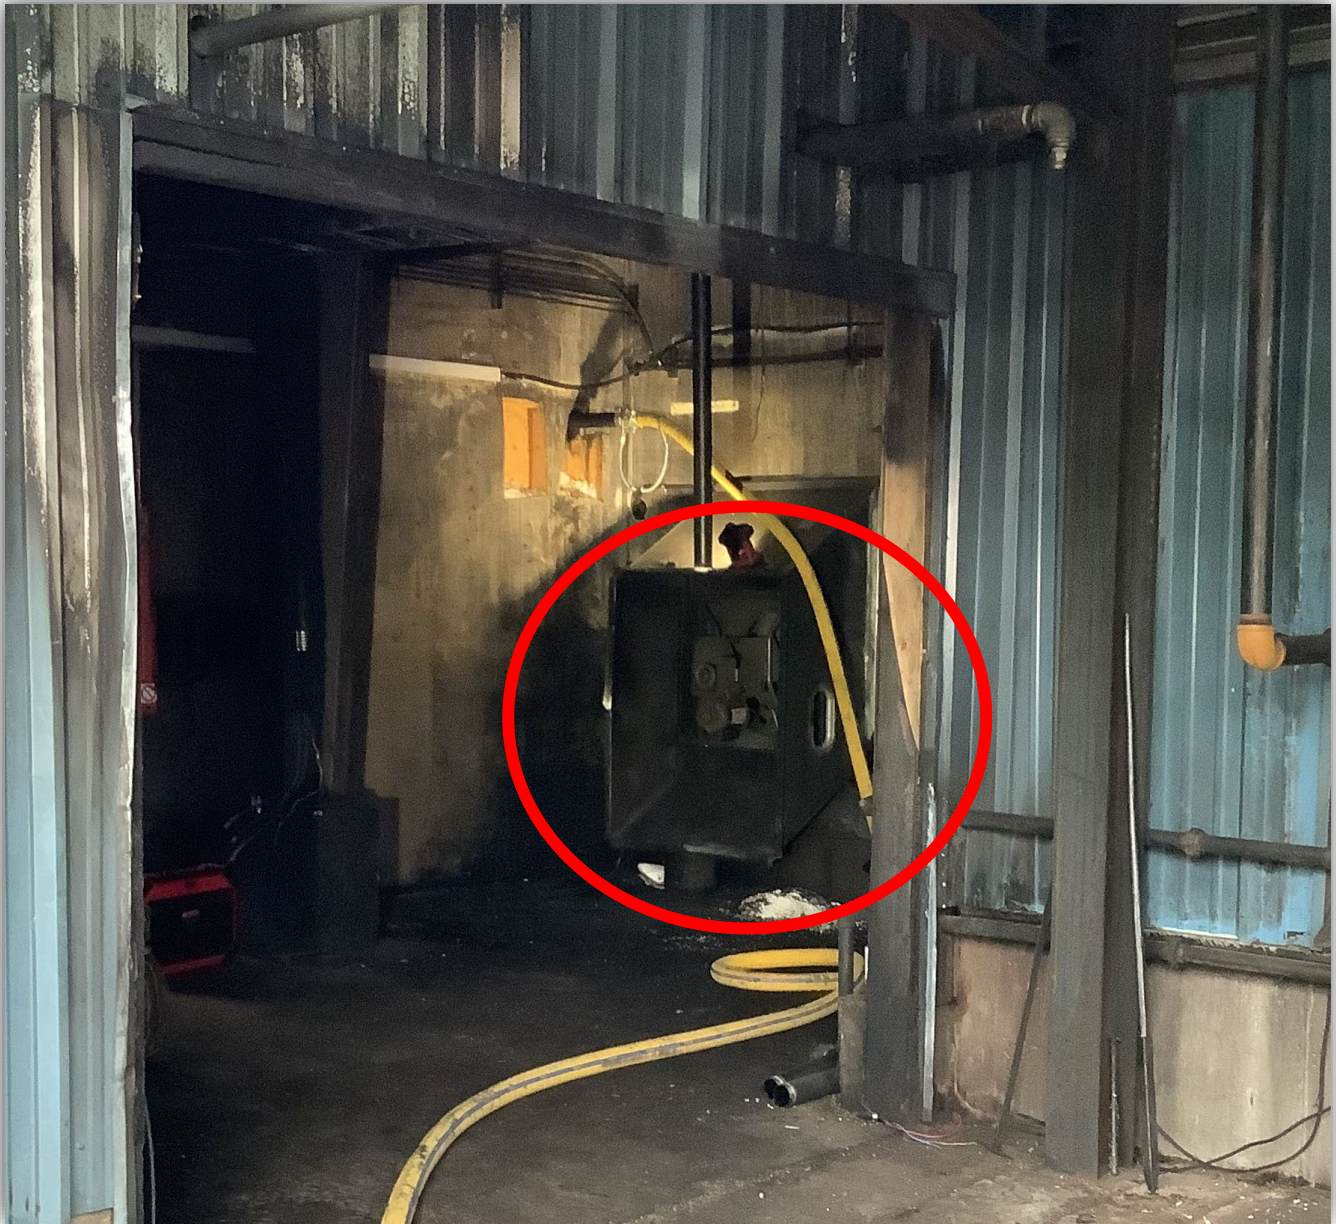
Image 1 - Air compressor location.

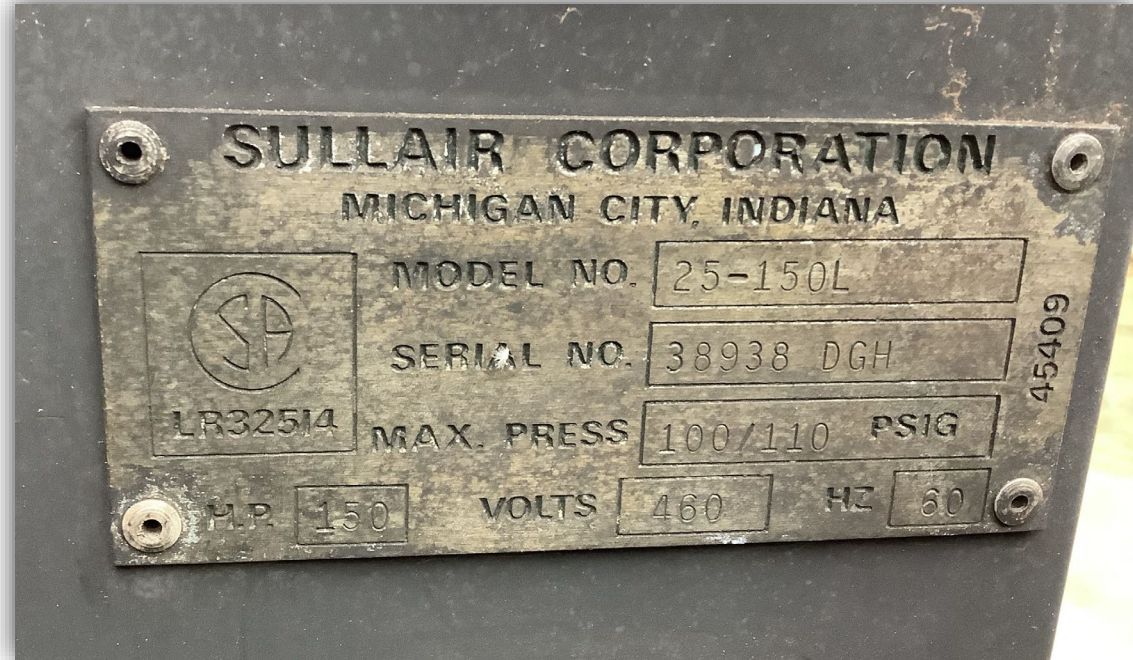
Image 2 - Air compressor manufacturer nameplate and approval certification mark.

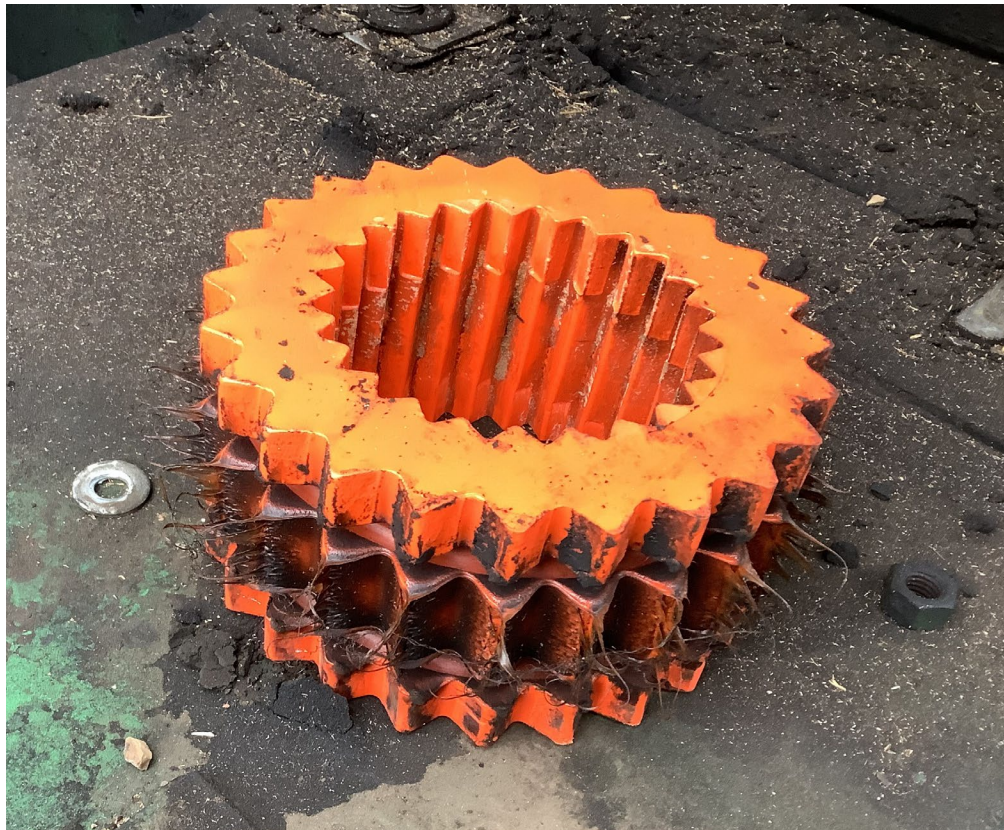
Facts and evidence	The failure scenario description was paraphrased from the wood processing facility millwright while he performed an assessment and examination of the damaged air compressor.
Causes and contributing factors	The design of the system allowing the hot oil backflow preventer to be ineffective in the event of a drive coupling failure was likely the cause of the incident.

Image 3 - Polymer coupling: couples the prime mover and air compressor.

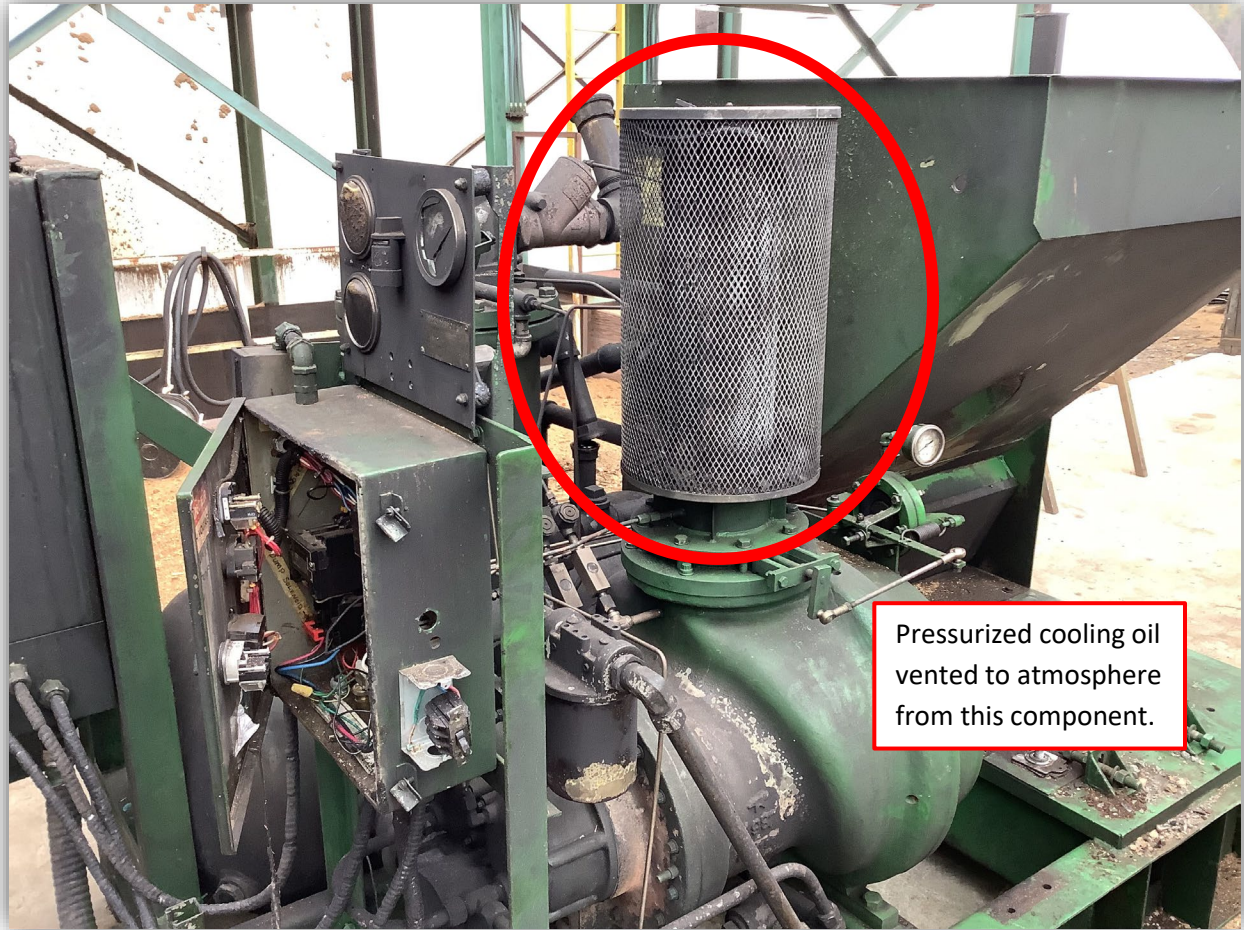
Image 4 - Air compressor and air-cooling radiator, pressure relief/regulator.

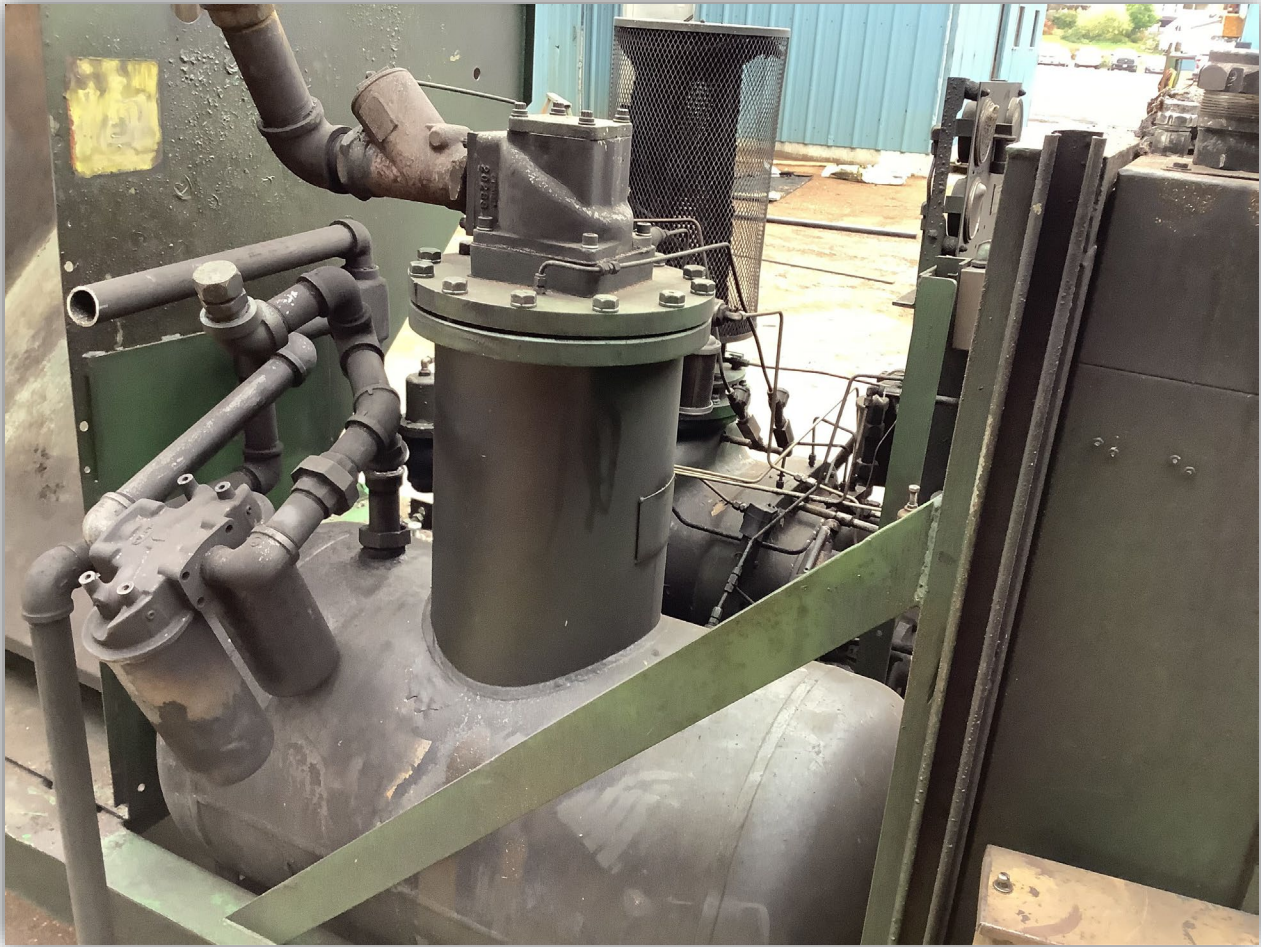
Image 5 - Air tank and cooling oil, heat exchange piping.
