## Incident Summary #II-1385649-2022 (#28171) (FINAL)

SUPPORTING INFORMATION	Incident Date	June 2, 2022	
	Location	Vancouver BC	
	Regulated industry sector	Boilers, PV & refrigeration - Refrigeration system	
	Impact	Qty injuries	13
		Injury description	13 people had some mild exposure to the (Ammonia) NH3 gases eyes and experienced varying eyes and respiratory discomfort.
		Injury rating	Moderate
	Damage	Damage description	No physical equipment damages, approximately 600 pounds (272 kgs.) of ammonia was released into the atmosphere.
		Damage rating	Moderate
Incident rating	Moderate		
Incident overview	One ammonia safety relief valve in the refrigeration system of a community centre ice rink opened and released approximately 600 pounds (272 kgs.) of the ammonia through the vent stack into the atmosphere. The community centre and the neighboring high school were evacuated and 13 people outside the community centre were examined by the emergency medical services personnel and released.

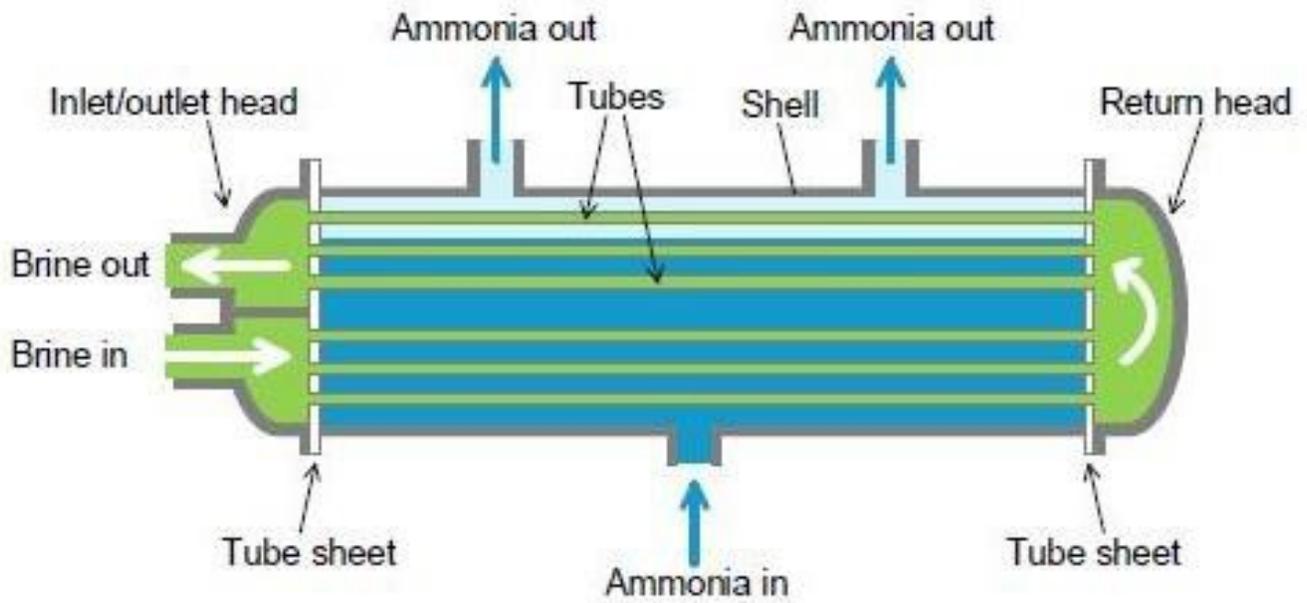
Image 1 – Diagram of typical brine chiller.

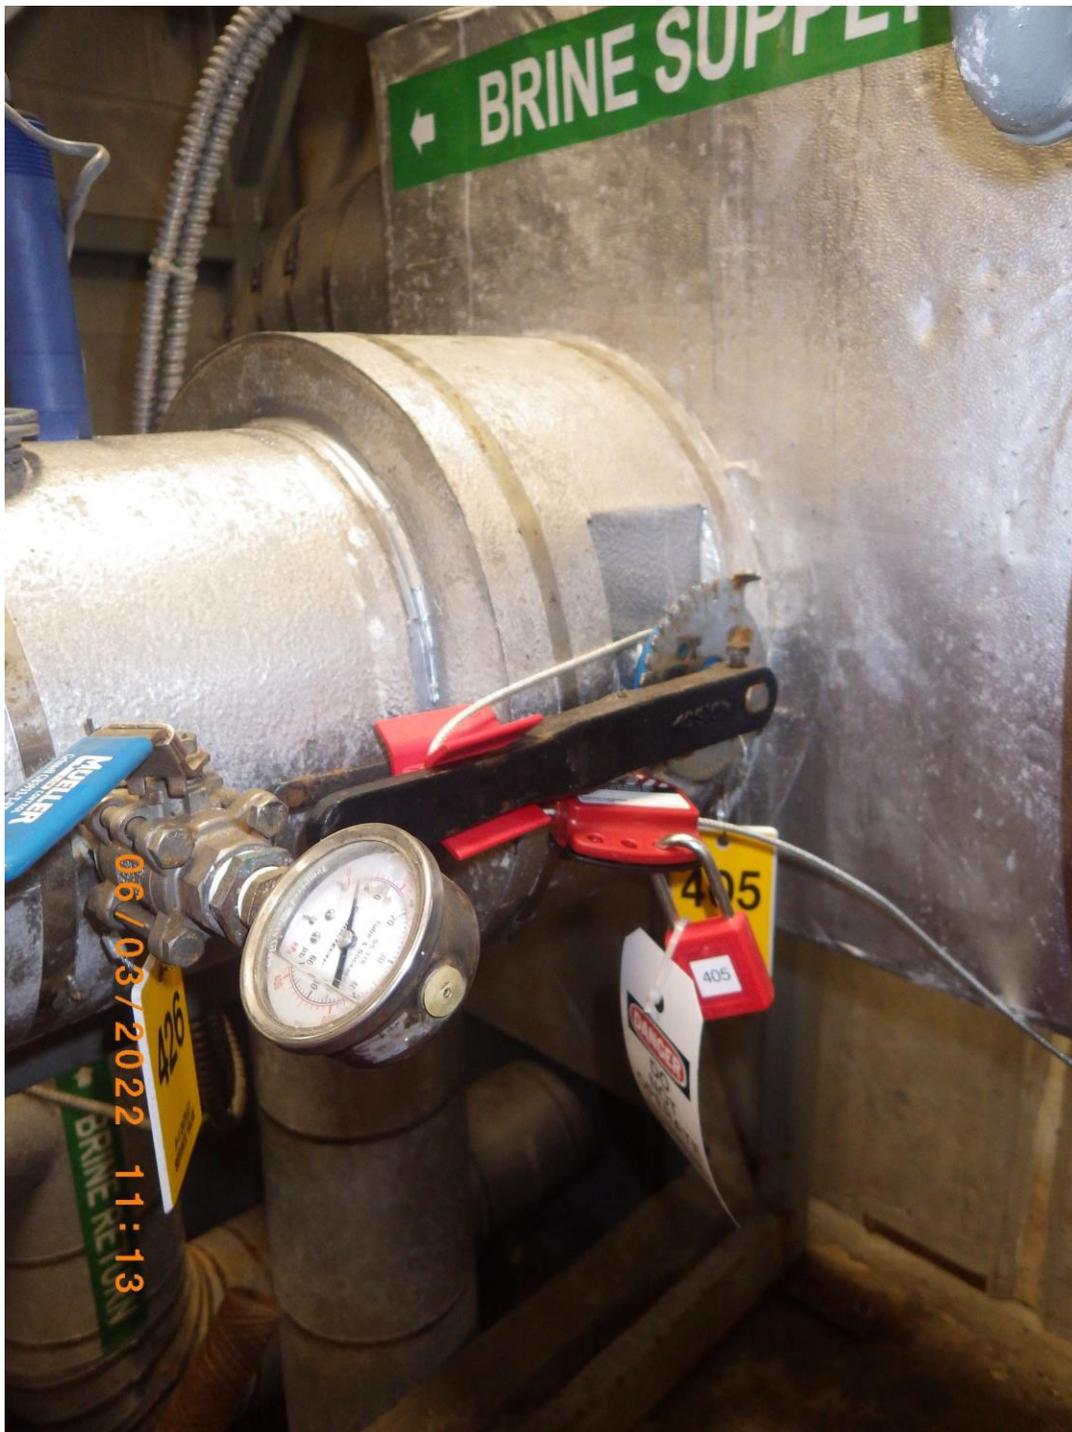
**Image 2** - Brine pump discharge valve with scissor clip and lock (open position).

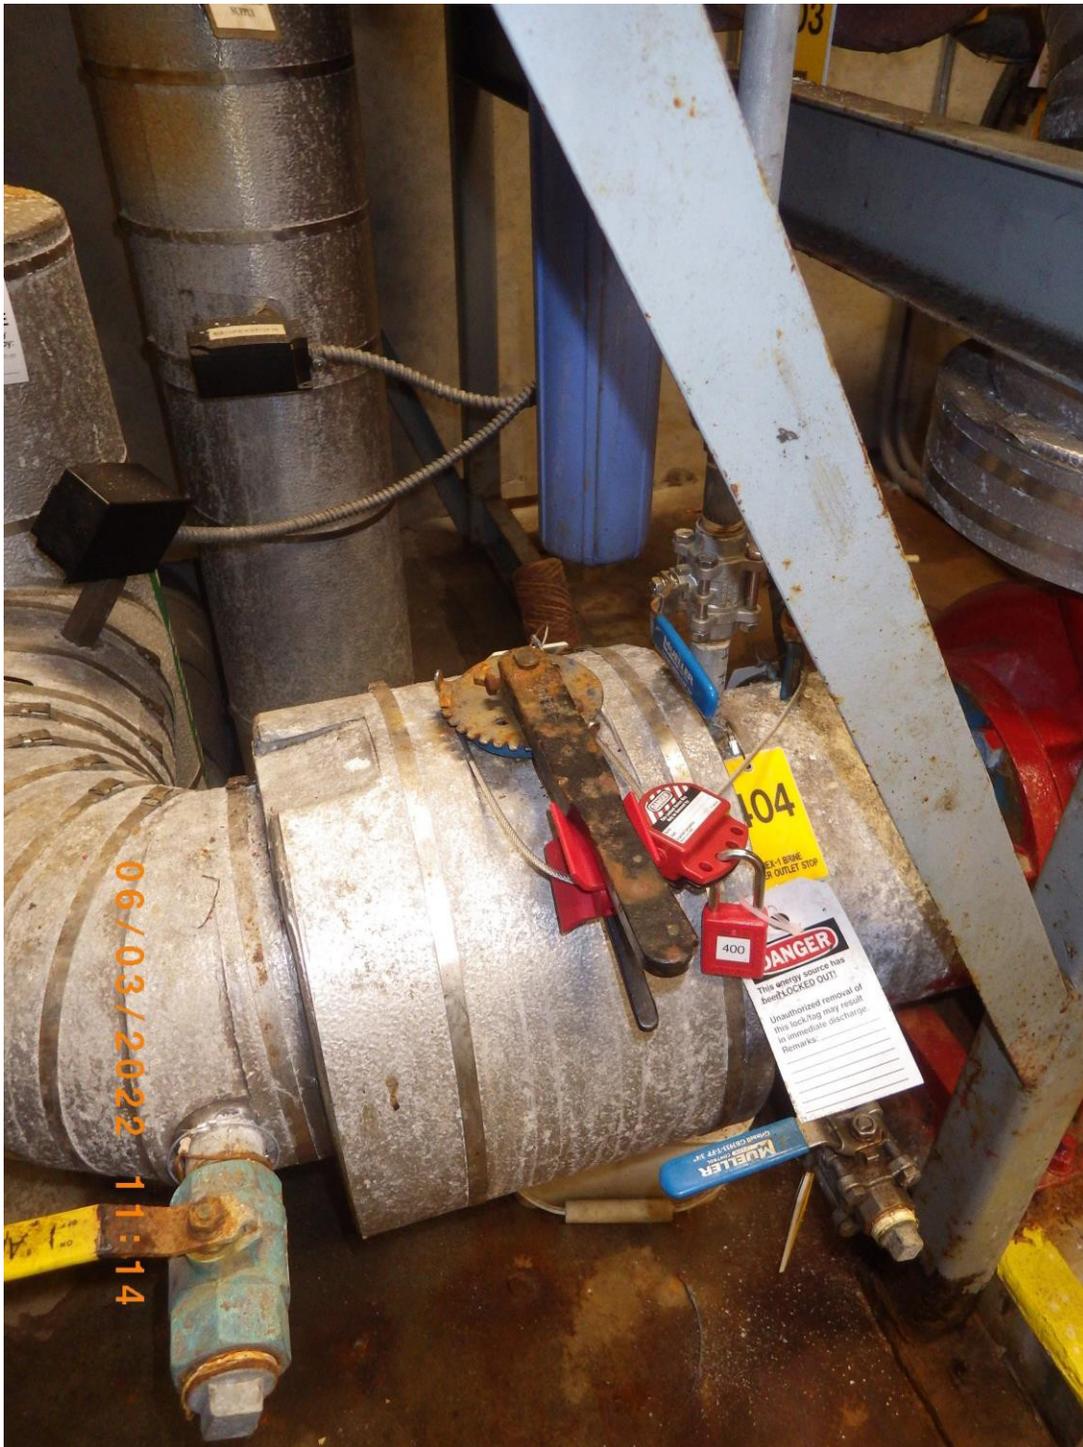
- The contractor was responsible for isolating the equipment they were working on, but only partially de-isolated the equipment, leaving the pump suction valve closed tagged and locked out.

- The brine pumps ran for approximately 4 hours with no brine flowing in the system.
- With the suction valve in the closed position the pump ran with no flow, and the brine fluid temperature rose to 111 Deg. F (44 Deg C).

**Image 3** - Brine pump suction valve with scissor clip and lock, (Closed position) as found after incident.

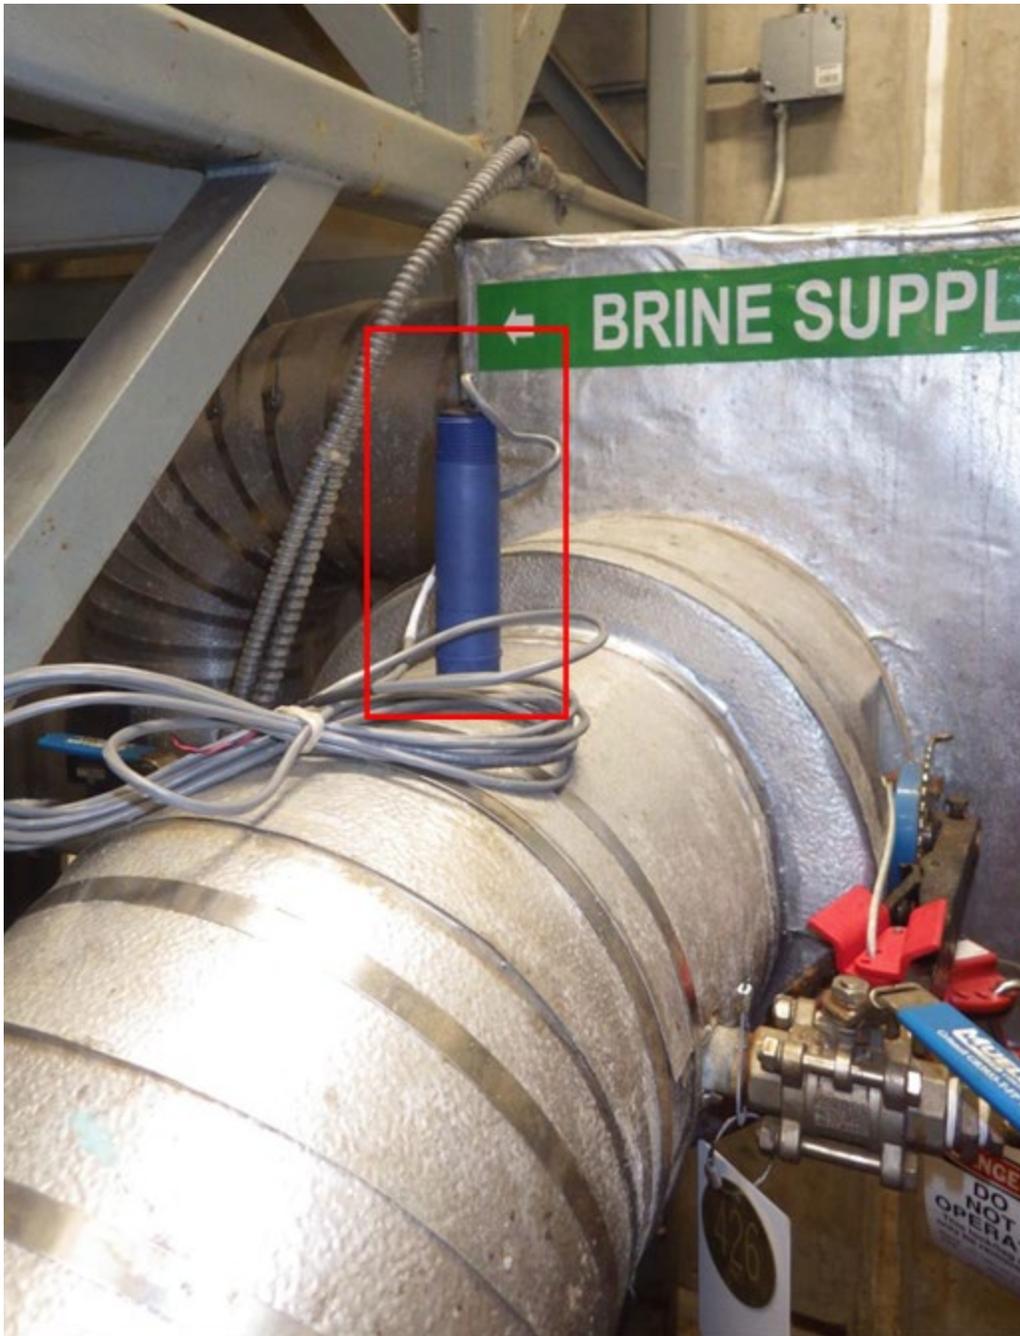
Three days prior to the incident a contractor was doing maintenance on the brine system to install a pH sensor in the brine pump discharge piping upstream of the pump's discharge isolator (Image [4](#)). When the job was finished the contractor had only partially de-isolated the equipment, leaving the brine pump suction valve closed, tagged, and locked off (Image [2](#) and [3](#)). On the day of the incident the facility staff started the brine pump as part of the Preventative Maintenance (PM) schedule and was unaware that the pump suction valve was still in the closed position. After 4 hours with the pump running, the brine fluid temperature increased to 111 Deg. F (44 Deg. C) this raised the liquid ammonia temperature that was stored in the chiller. The increase in temperature caused an increase in the ammonia systems pressure to the point the safety valve on the oil pot (Image [5](#)) opened at 250 pounds per square inch (psi) discharging ammonia into the vent stack and to the outside air (Image [7](#)).

**Image 4** – Red box showing newly installed pH sensor in the brine discharge piping.

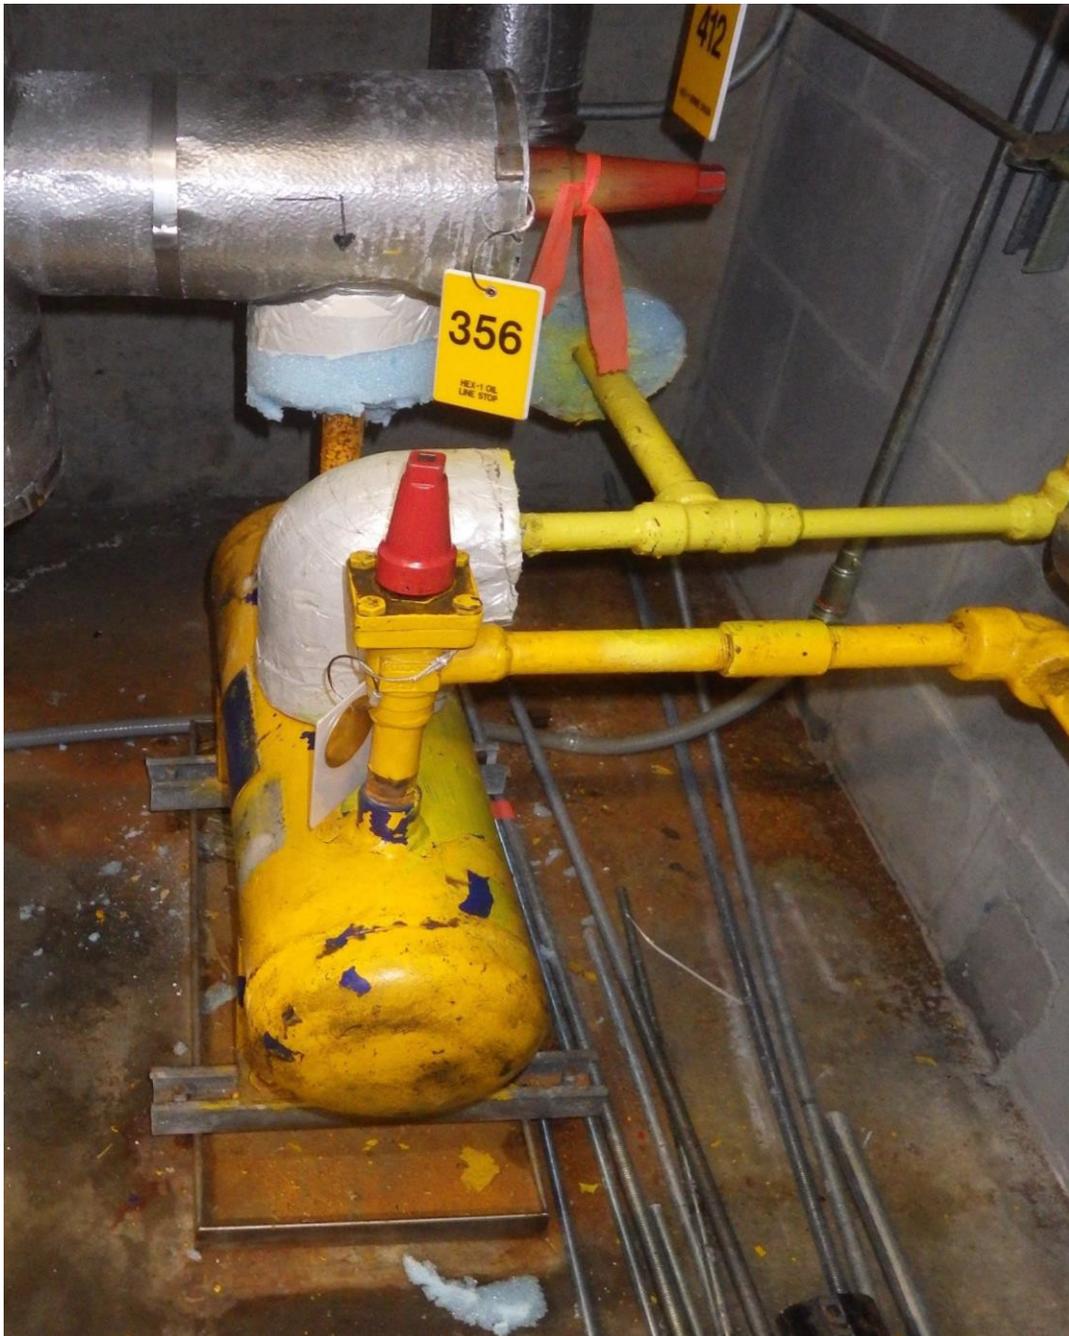
**Image 5** - Oil pot located on the machinery room floor beside the chiller.

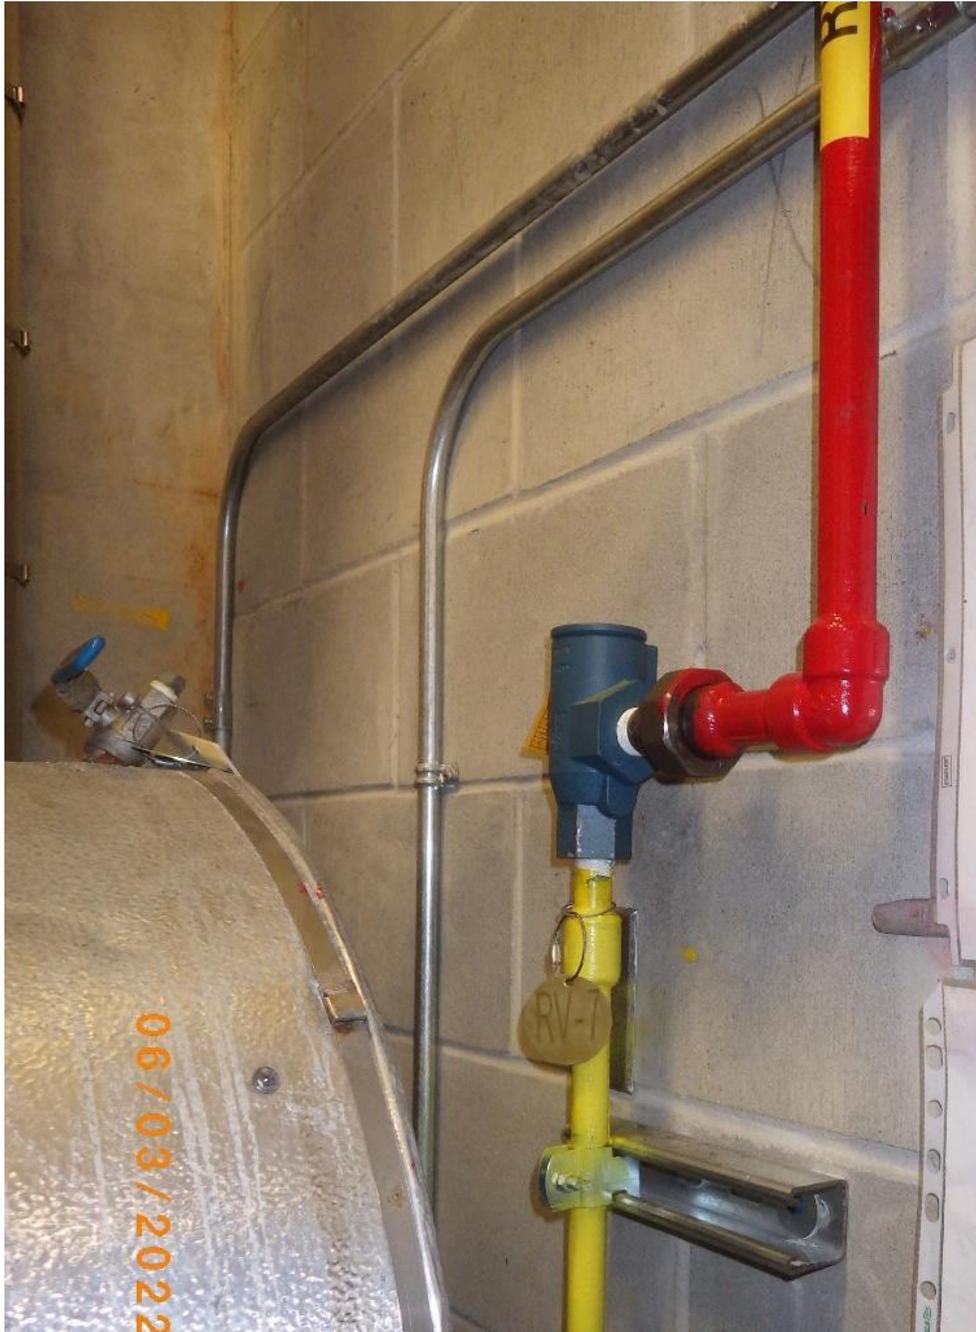
The oil pot safety valve was the first and only safety valve to open. The system pressure forced ammonia liquid out of the chiller, through the oil pot connected to it, and into the vent stack. This reduced pressure in the vent stack when the ammonia liquid vaporized as it absorbed heat and changed to a vapor as it moved upward and exited the vent stack. When the cooler ammonia gas mixed with the surrounding air, the ammonia cloud dropped down to the ground level, instead of rising upward as expected on a warm day. The ground level ammonia cloud then entered the machinery room through open louvers of the machinery room ventilation intake. The ammonia leak detectors in the machinery room were activated which started the machinery room exhaust fan that increased the amount of ammonia entering the room through the ventilation intake louvers.

- The oil pot safety valve lifted first, the oil pot also connects to the chiller sump and the liquid ammonia was pushed out of the chiller through the open relief valve to the vent stack located above the machinery room by the evaporative condenser.

**Image 6** - Oil pot and the attached safety valve, the one that opened discharging liquid ammonia to the outside vent stack.

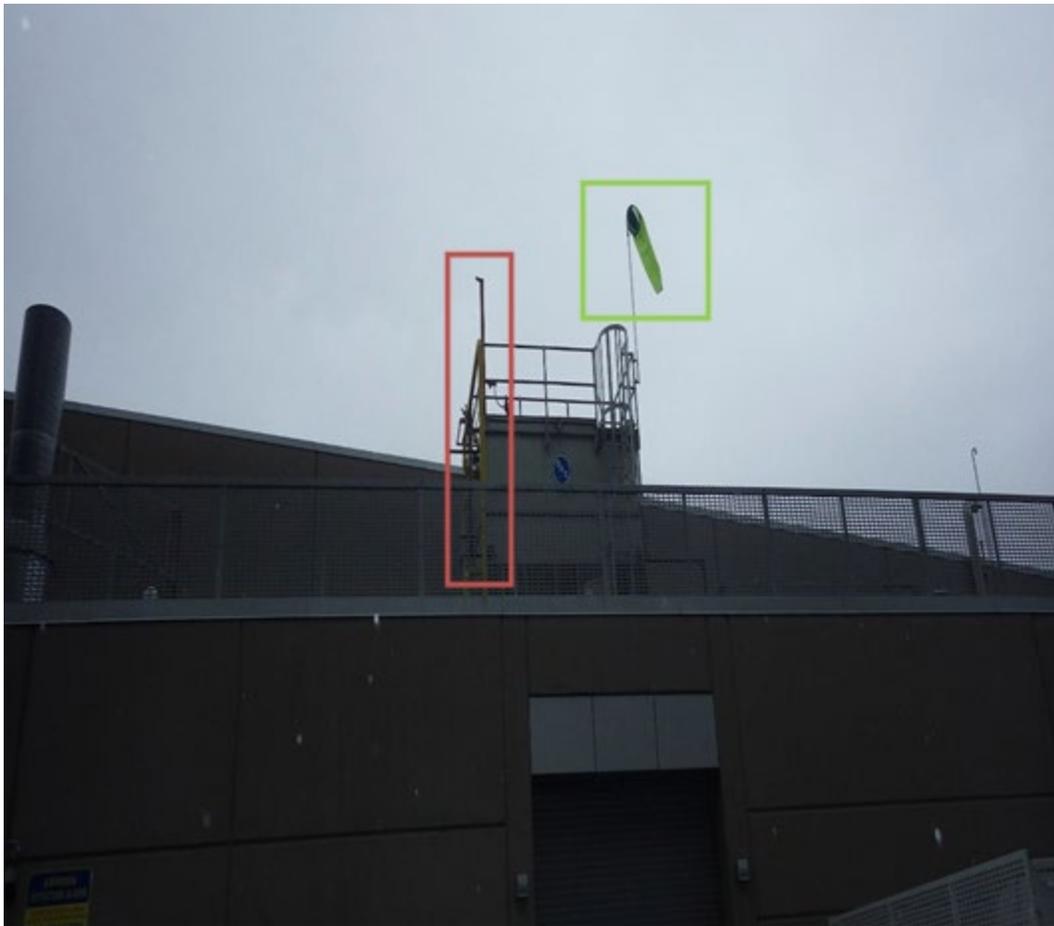
- A warning was communicated to people using the field southeast of the community centre to leave the area.
- The ammonia liquid discharging from the safety valve was flashing into a vapour inside the vent discharge piping, during this change from liquid to vapour the temperature drops and the liquid /gas mixture that leaves the top of the vent stack can be denser than the surrounding air and proceeded to drop to the ground instead of rising as would have been expected on a warm day.

**Image 7** - Vent stack and windsock located by the rooftop evaporative condenser. Red box shows the ammonia vent stack and the green box shows the windsock.

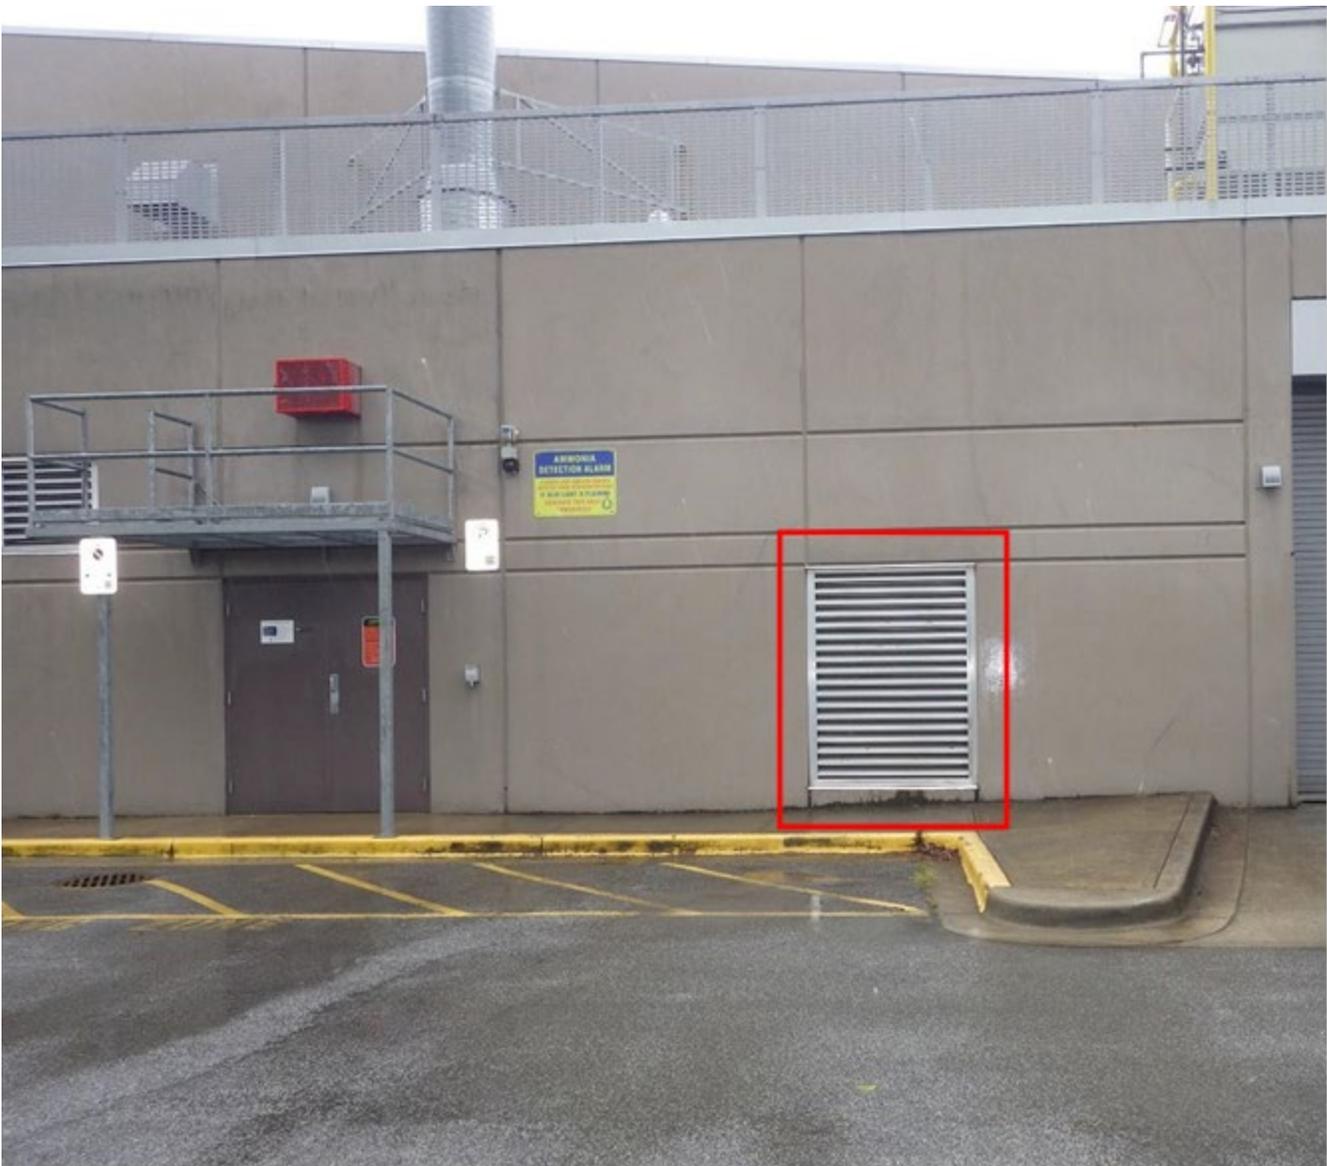
- The ammonia vapour entered the machinery room through the air intake louvers located at ground level below the discharge vent stack.

<ul style="list-style-type: none"><li>• This activated the ammonia leak sensors that initiated the room ventilation exhaust fan, this increased the amount of ammonia entering the machinery room by pulling it in through the machinery room air intake louvers.</li><li>• The machinery room was vacated while the ammonia sensors were reading a high ppm in the room.</li><li>• Plant staff called The Fire Department &amp; Hazmat crew, who responded with mobile EMS personnel.</li><li>• The staff proceeded to evacuate the community center</li><li>• The Killarney High School located adjacent to the community centre was also evacuated.</li><li>• Once the ammonia charge volume was reduced enough the safety relief valve closed the machinery room was cleared of vapour by the room exhaust system</li><li>• 13 people outside of the community center were looked at by the EMS personnel and released.</li></ul>

**Image 8** - Red box showing air intake to this machinery room which ammonia entered during the release.
