Incident Summary #II-1581017-2023 (#37073) (FINAL)

SUPPORTING INFORMATION	Incident Date	June 24, 2023	
	Location	Radium Hot springs.	
	Regulated industry sector	Amusement Devices - Zip line	
	Impact	Qty injuries	0
		Injury description	NA
		Injury rating	None
	Damage	Damage description	A guest traveled across the zipline while their harness was unattached to the smart belay lanyard.
		Damage rating	Major
	Incident rating	Major	
Incident overview	A guest became unattached from their lanyard while travelling at height across a zipline. The guest's grip on the belay handle was the only thing that prevented them from falling. They managed to hang on to the lanyard handle while travelling across the main cable to the landing platform where the zip guide assisted the guest onto the landing platform.		
INVESTIGATION CONCLUSIONS	Site, system and components	<p>Zipline details:</p> <p>The zipline tour consists of 7 individual lines that weave back and forth across a dry gulch. Ziplines range in length from approximately 65' to 750'. Zip lines 1-6 are single lines accommodating 1 rider at a time. The final zip is a double zipline that uses a braking system to stop the rider. The zipline tour

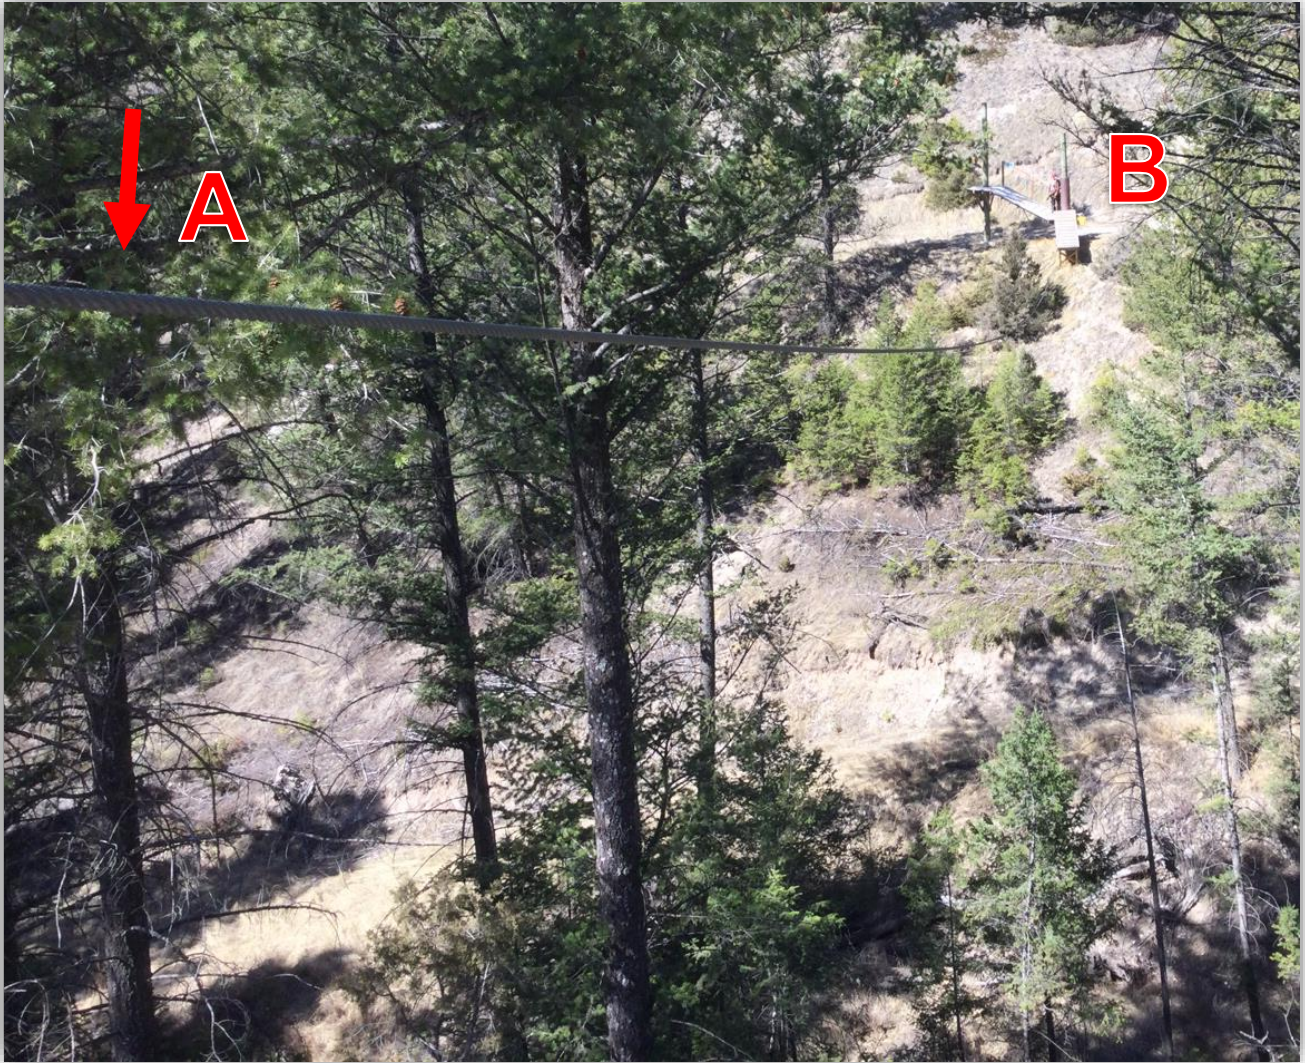
Image 1 - Zipline #1 view from the launching platform. [A] The zipline cable. [B] The landing platform.

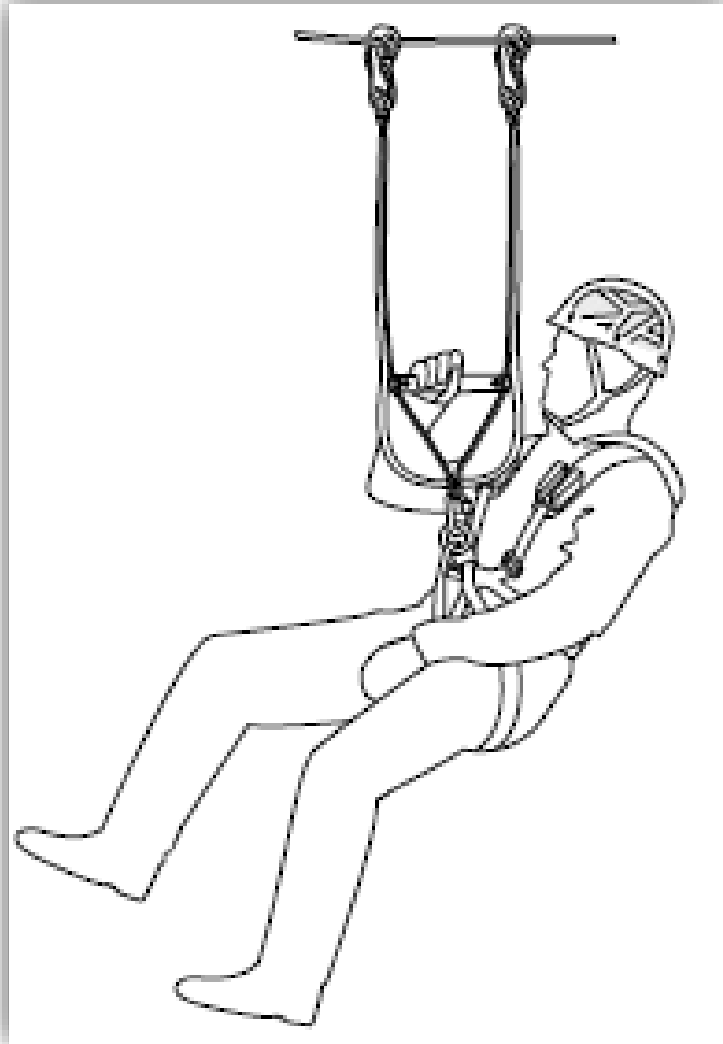
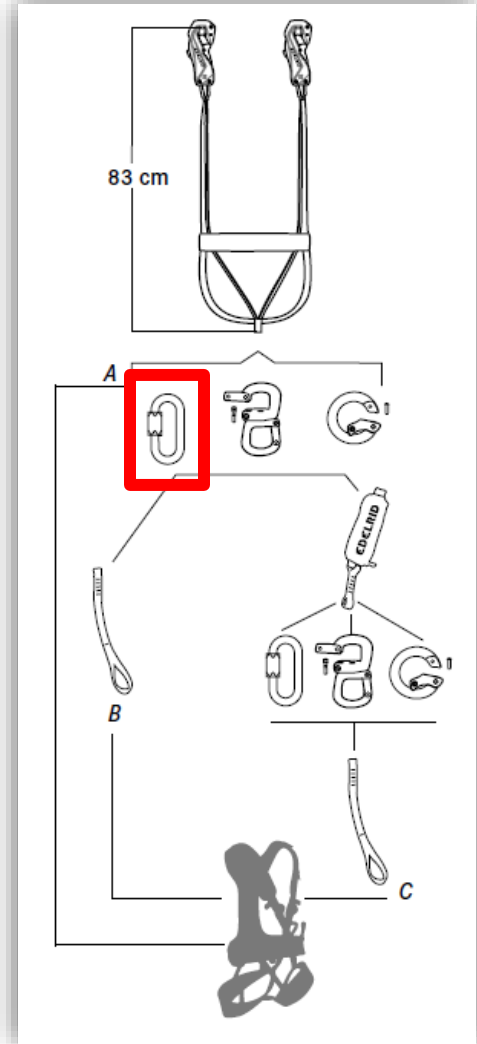
Image 2 - Manufacture's manual showing use of the smart belay system and connection to harness. Red box showing threaded coupler style used for connection.

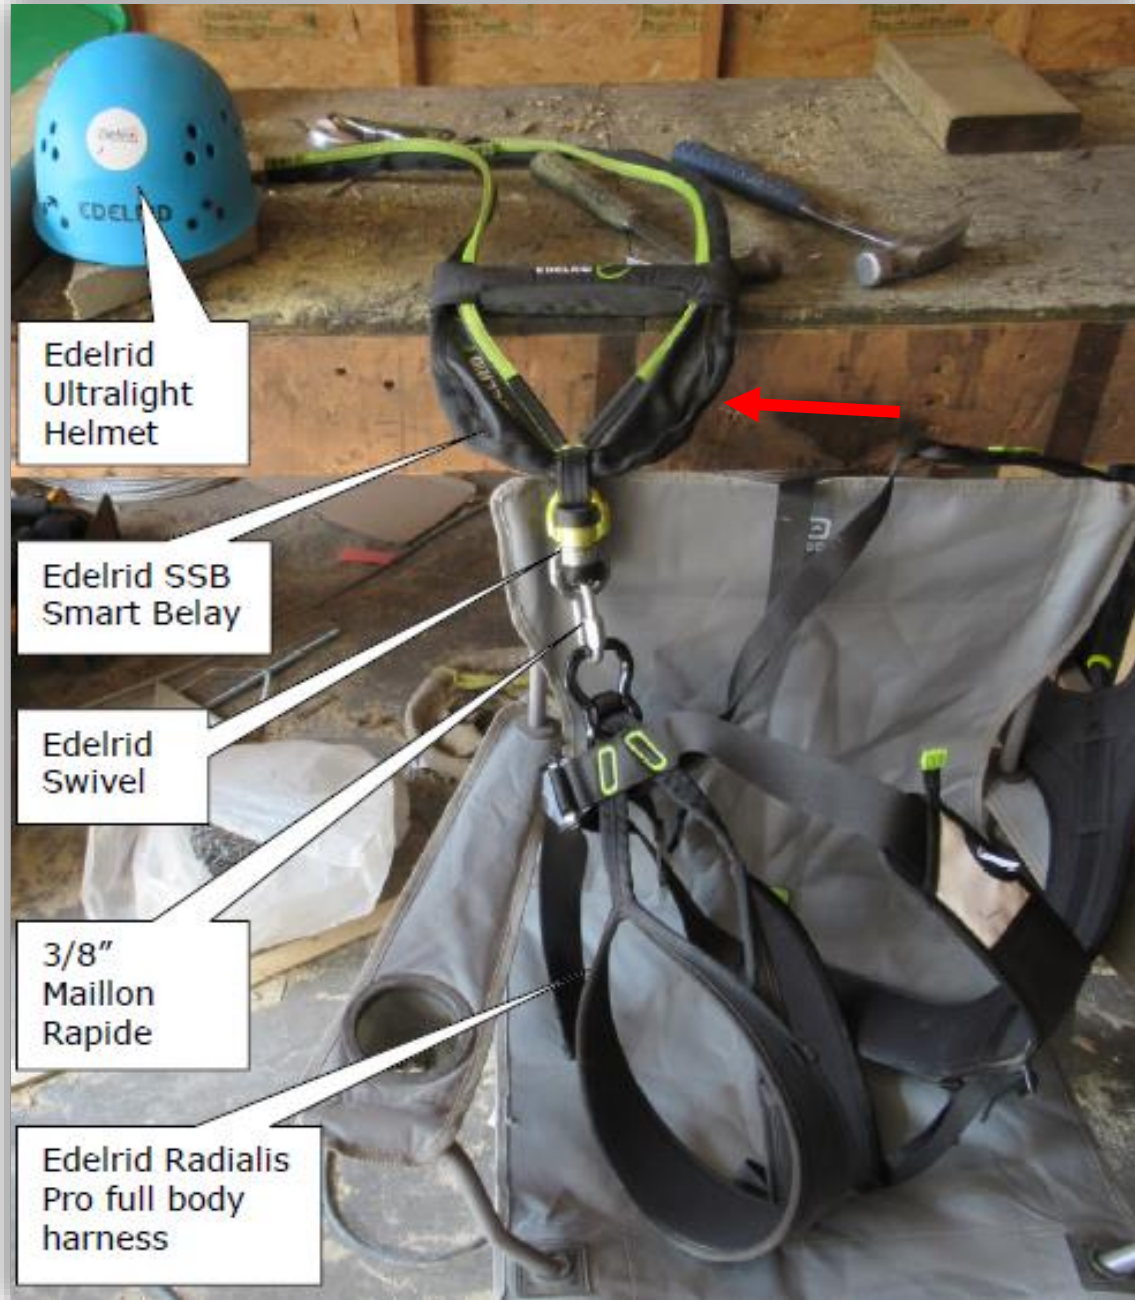
Image 3 - Zipline rider gear with [ARROW] smart belay connected to the full body harness using the 3/8" Maillon Rapide threaded coupler.

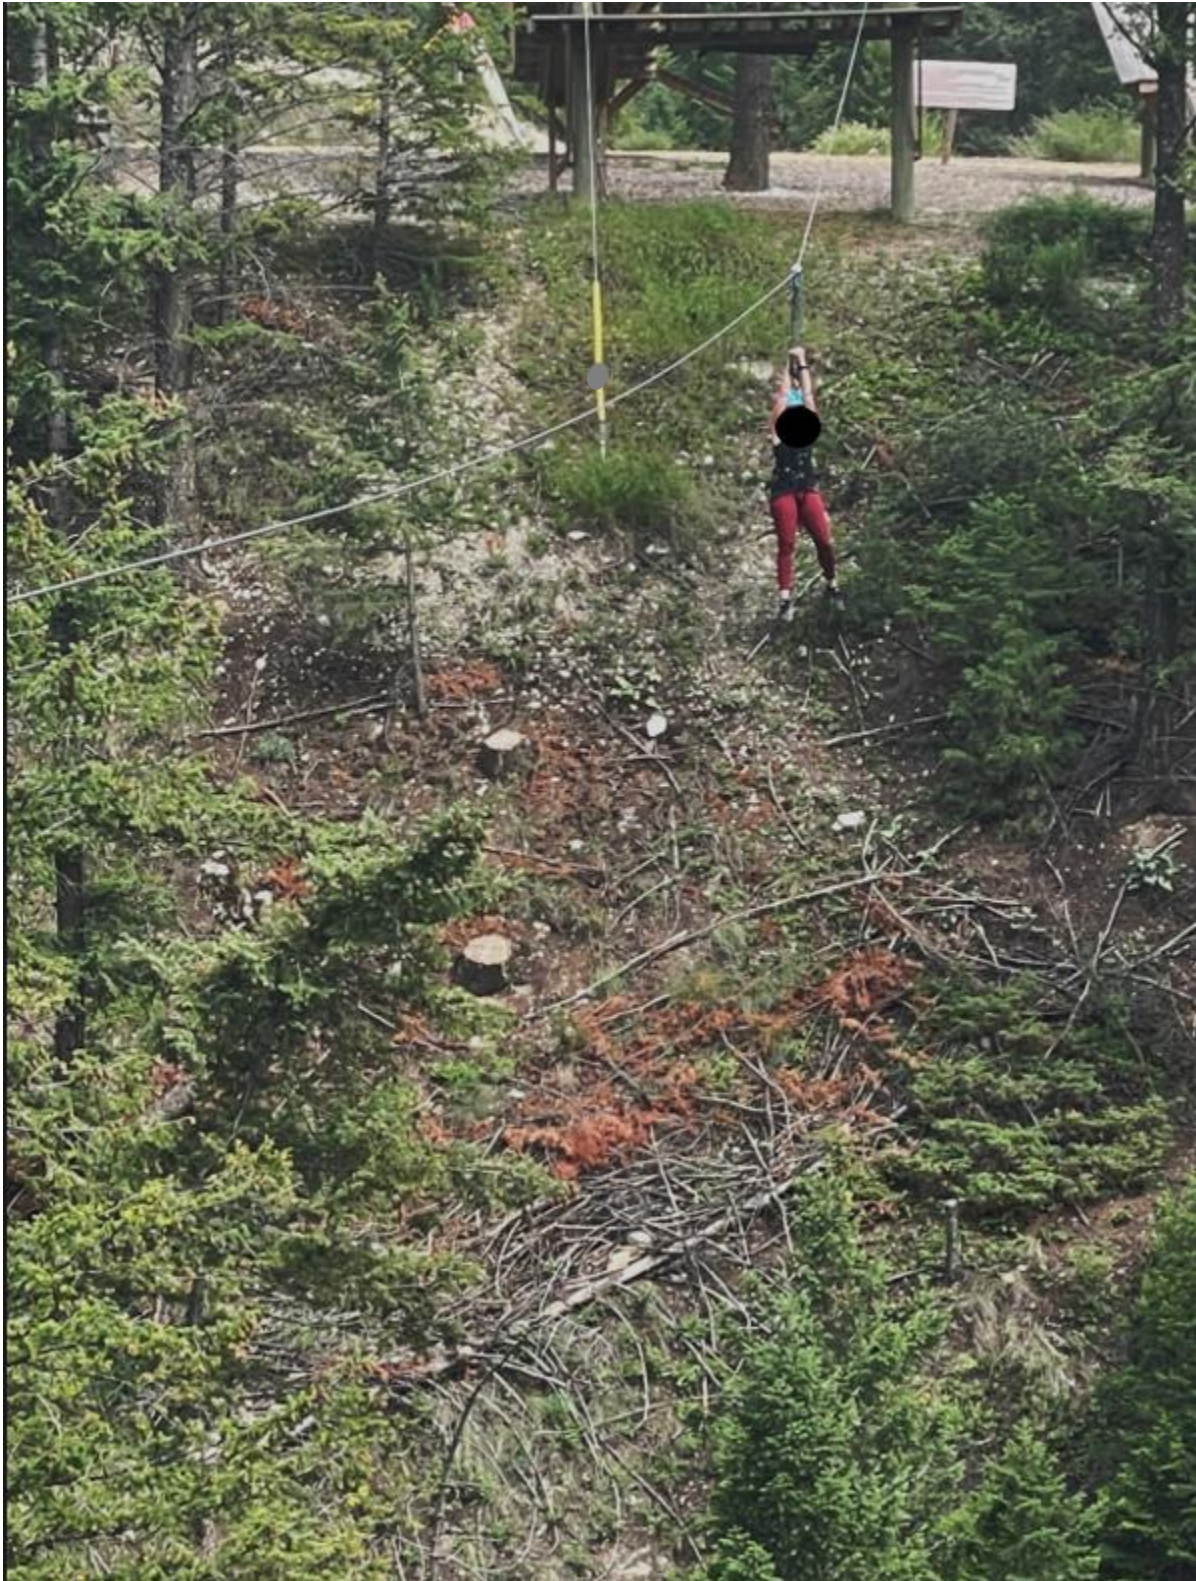
Causes and contributing factors	<p>The failure to follow the operating procedure of tightening all the guest's threaded couplers with a wrench allowed the guest to become detached from their smart belay lanyard during the travel across the zipline.</p> <p>Contributing factors to the incident include:</p> <ul style="list-style-type: none">• Operating procedures:<ul style="list-style-type: none">○ The procedures in the operations manual did not contain specific instructions or procedures detailing a method for connecting the smart belays to the guest's harnesses and ensuring all connections had been tightened with a wrench prior to proceeding.○ The operating procedure not being followed when a final inspection of the guest's harnesses was not conducted prior to the start of the zip tour.○ The operating procedure not being followed when the sweep guide traveled across the zipline leaving 3 guests to travel across on their own removing the possibility of the guide identifying the open connector on the guest's harness.• System design:<ul style="list-style-type: none">○ The compliant design of a single connection point between the smart belay lanyards to the harness require procedures and human actions to ensure proper connection without any redundant safety if the procedure is done incorrectly.

Image 4 – The guest traveling across the zipline unattached to the smart belay lanyard.

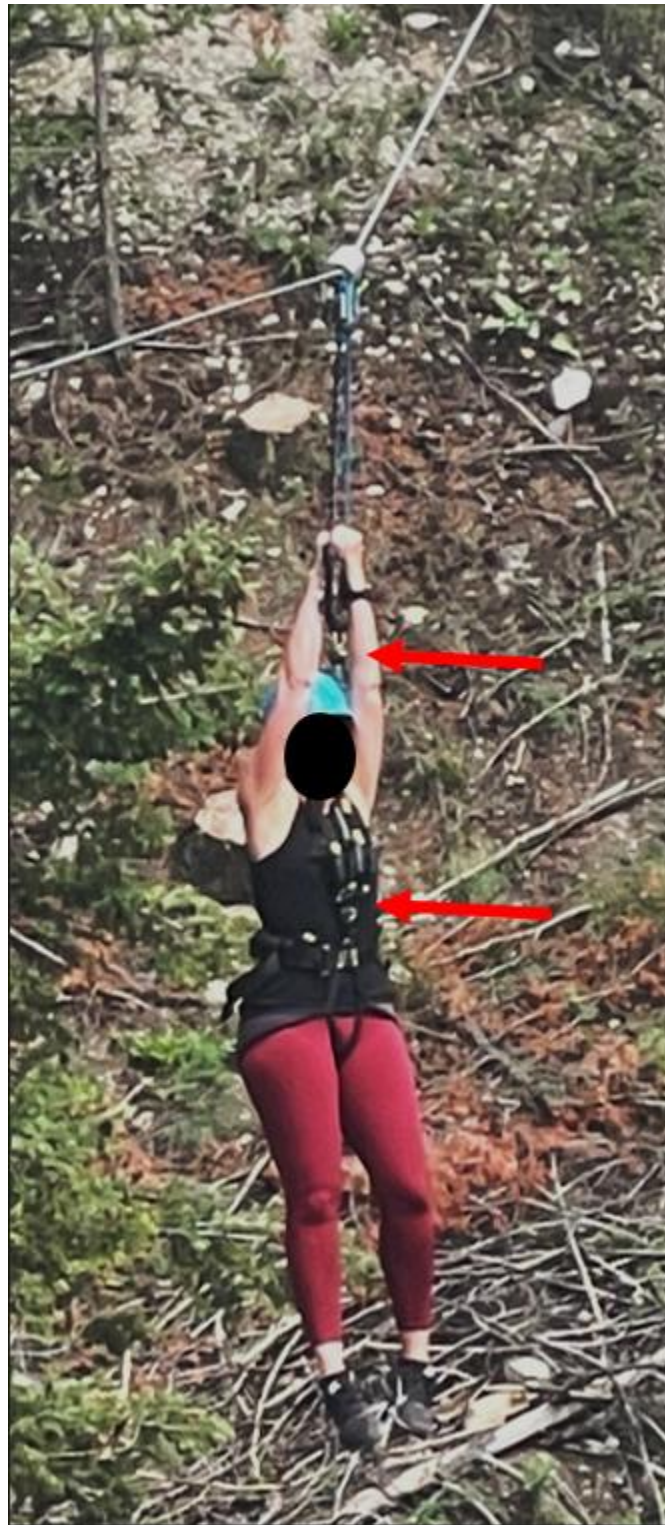
Image 5 – The guest traveling across zipline. [ARROW] The Smart belay lanyard coupling (Top) and the location of the D-ring on the harness that the coupler is supposed to be attached to.
