## Incident Summary (Reference # 4824) (Final)

SUPPORTING INFORMATION	Incident Date	January 10, 2018	
	Location	North Eastern BC	
	Regulated industry sector	Boilers, PV & Refrigeration	
	Impact	Qty injuries	None
		Injury description	None
		Injury rating	None
	Damage	Damage description	Fire ignited the external wall adjacent to boiler 1 and made its way through to the building exterior. Boiler #1 was extensively damaged in the fire. The fire also damaged the mechanical room ceiling and walls. Please see photos enclosed.
		Damage rating	Major
Incident rating	Major		
Incident overview	Flames ignited in the basement boiler room of an eleven unit residential apartment building.		
INVESTIGATION CONCLUSIONS	Site, system and components	<p>This boiler was located in the basement mechanical room in an eleven unit apartment building.</p> <p>The boiler combustion chamber is to hold the heat and flame of combustion inside the boiler.</p> <p>This wall mounted boiler heats a glycol mixture by the combustion chamber. The heated glycol circulates throughout the building via a piping system to bring heat to each apartment residence.</p> <p>In the event of that glycol stops circulating the flow swit

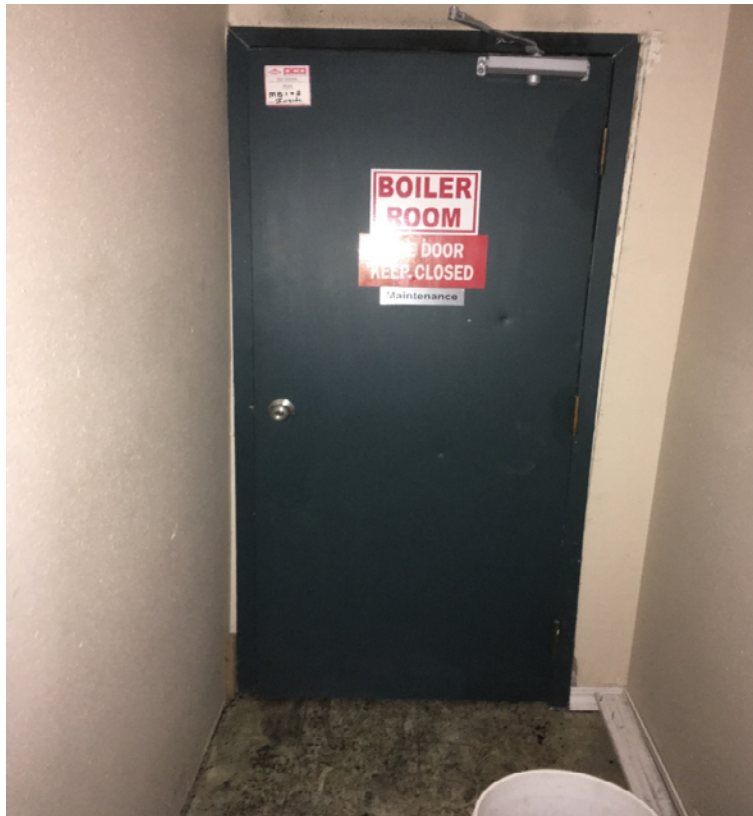
**Boiler room door closed – notice soot above door frame**

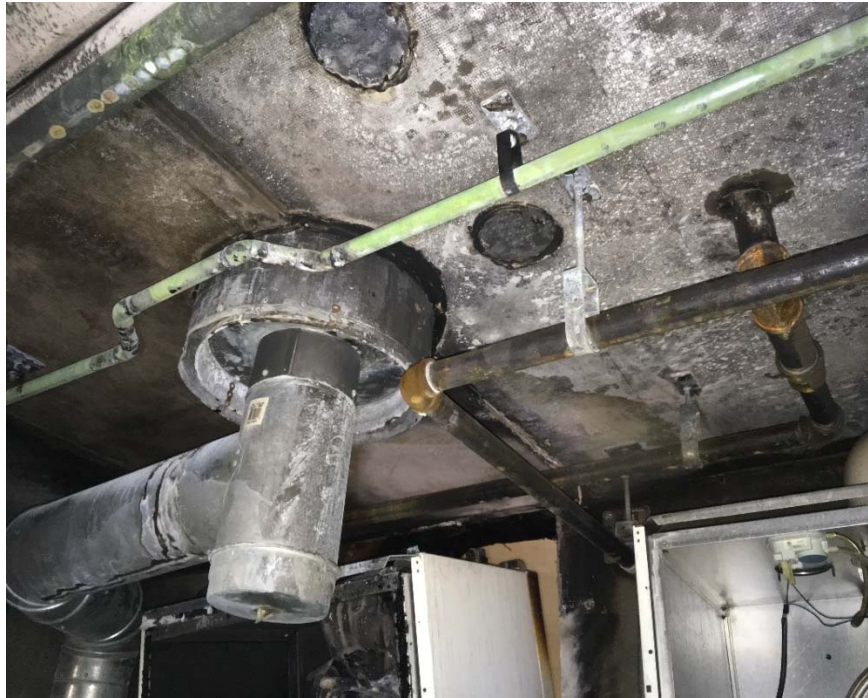
**Photo above shows boiler room ceiling damaged by fire**

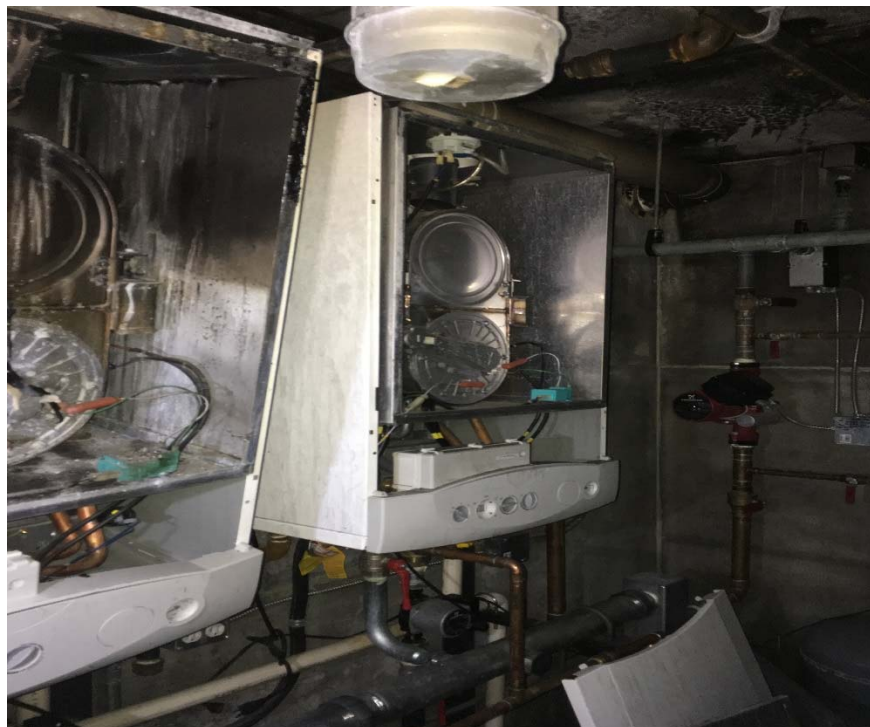
**Boiler overview - Boiler #1 on left**

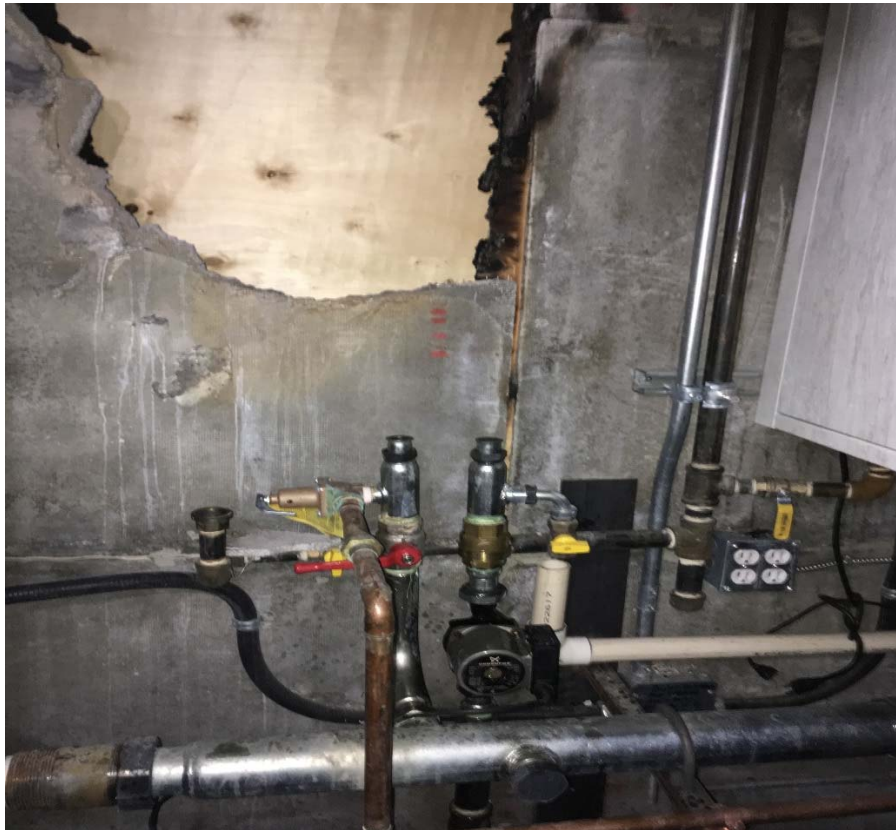
Below - boiler #1 removed (post fire new plywood put in place outside to keep cold out)

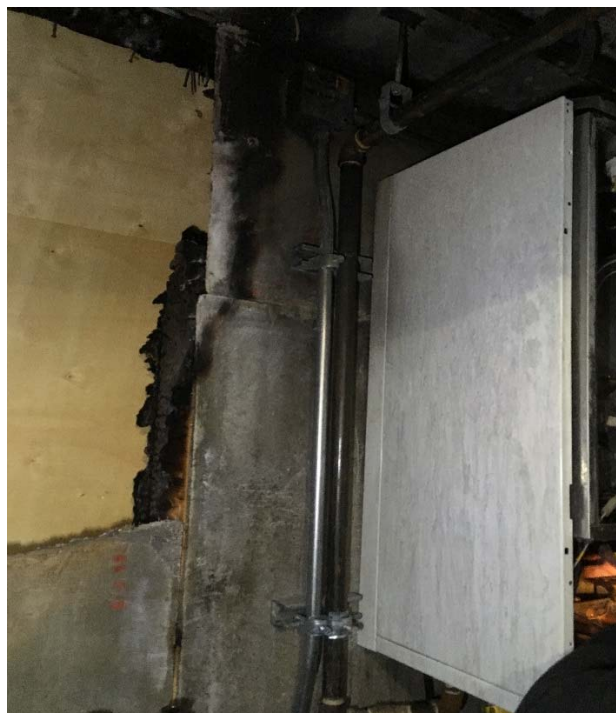
Photo below - damage to exterior wall, behind where boiler #1 was removed

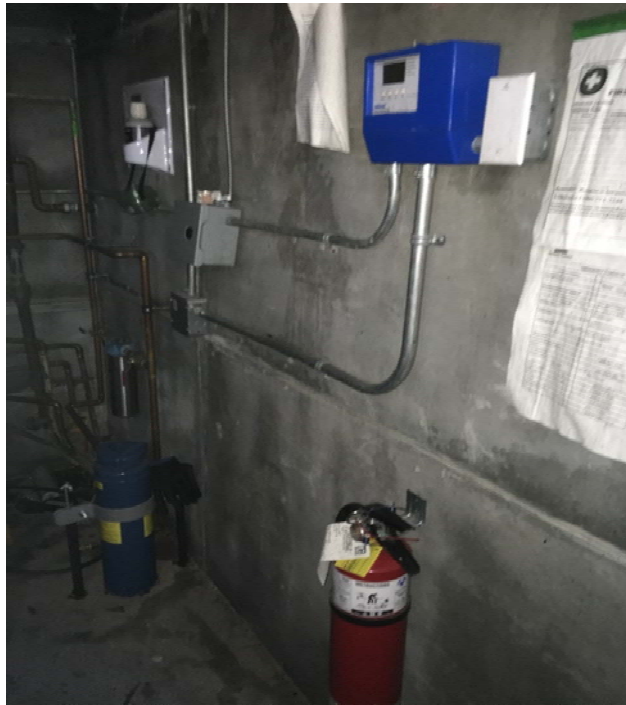
Photo below - wall across from boilers

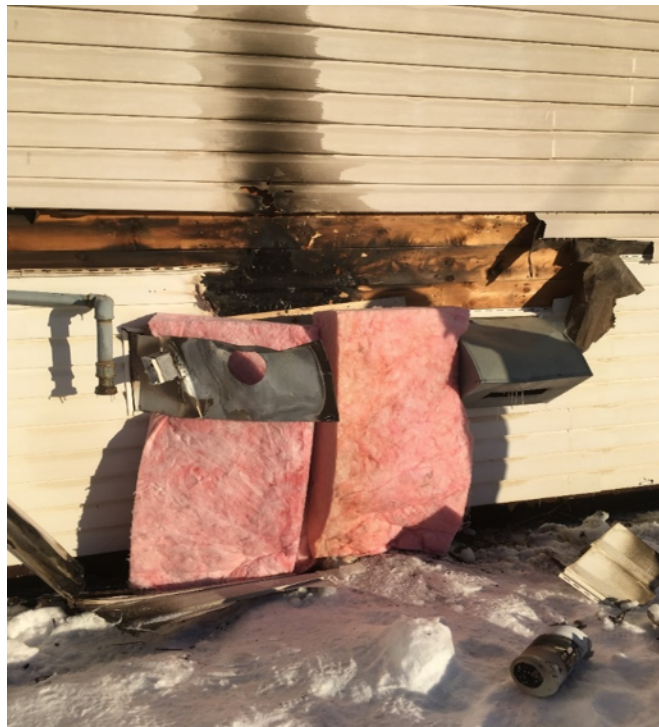
Below-exterior wall damage (insulation placed post fire to keep cold out)

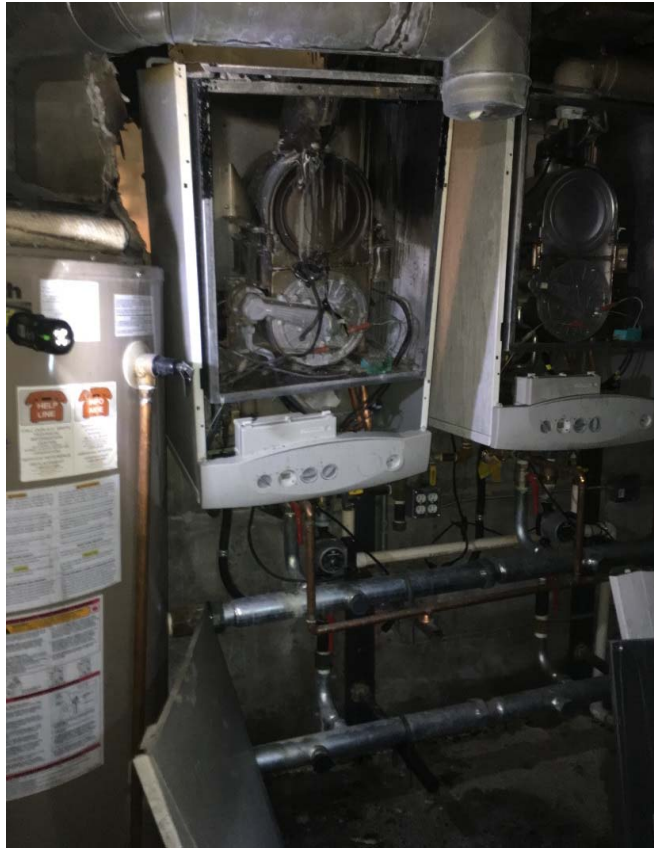
**Boiler #1 on left (prior to removal by contractor)**

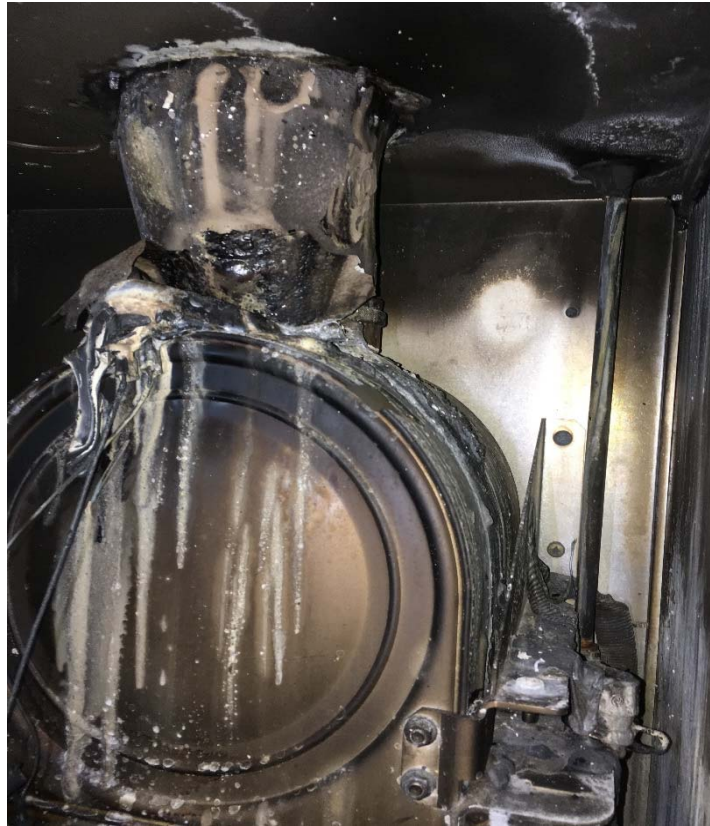
Above – Boiler #1 exhaust fan housing and melted vent

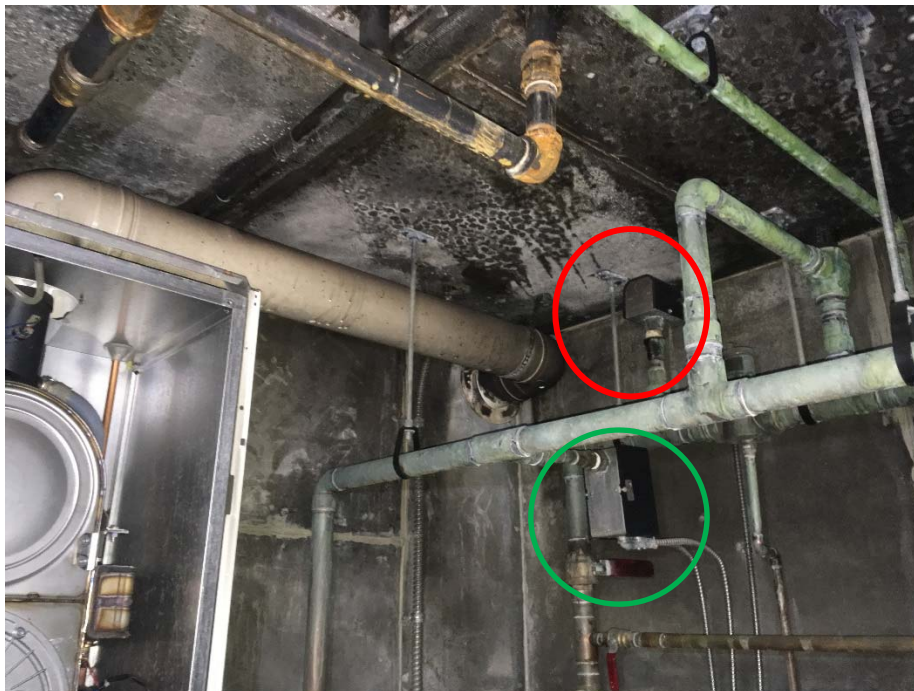
Room upper right corner near boiler #2, low water cut off (green), and above it the flow switch (red)

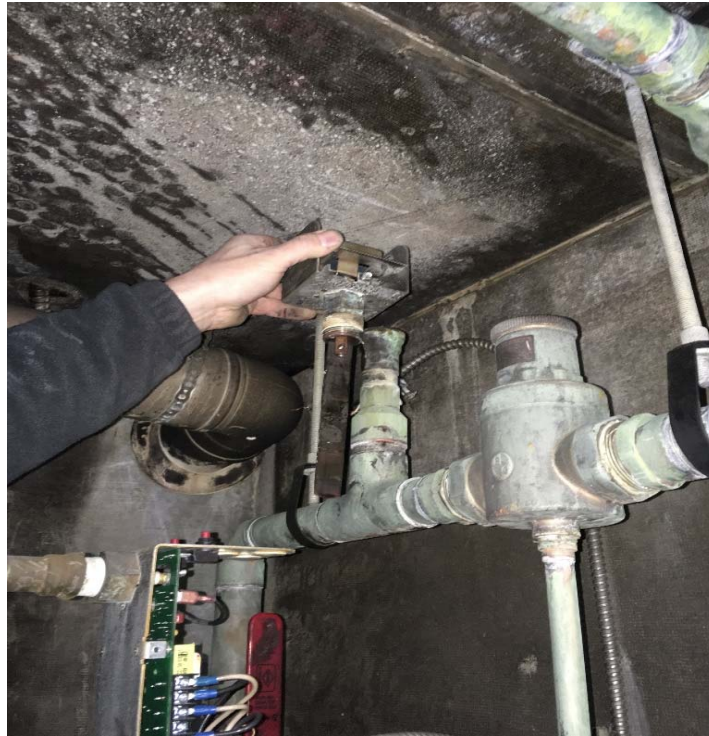
<p>Facts and evidence</p>	<ul style="list-style-type: none"> <li>- Contractor providing regular maintenance for the property management company when asked, stated that he does not check the flow switch during contracted maintenance schedules.</li> <li>- Contractor tested the flow switch post incident in the witness of the Gas and Boiler Safety Officers attending. The test equipment used by the contractor indicated that the flow switch did not show continuity.</li> <li>- Contractor removed the flow switch and disassembled it. The paddle which is pushed by the flow of glycol to complete the electric circuit to allow the flow switch to operate moved freely.</li> <li>- The contractor checked the high temperature shut down devices on both boiler 1 and boiler 2 and found that boiler 1 had no continuity, while boiler 2 had continuity.</li> <li>- Monthly maintenance records reviewed, do not note testing of the flow switch, nor the hi-temperature shut down controls.</li> <li>- Flame escaped the combustion chamber via the back side of the boiler adjacent to the building wall,</li> <li>- Second boiler, (adjacent to the first) shows an area of interest in same area as measured when compared with boiler #1 where flame escaped the combustion chamber,</li> <li>- The burner management system was not tested due to the fact that the building electrical panel had been locked out to disconnect the electricity from the building.</li> <li>- The boiler nameplate does not have a decimal 1 located in the Canadian Registration Number to indicate that this design has been accepted in British Columbia.</li> </ul>

<p>Causes and contributing factors</p>	<ul style="list-style-type: none"> <li>- The flow switch may have been a contributing factor,</li> <li>- The hi-temperature shut down safety switch may have contributing factor,</li> <li>- The lack of continuity in boiler #1 Hi-temperature shut down control may indicate that it may not function in an over-temperature situation.</li> <li>- The lack of the safety control function testing during routine maintenance may have been a contributing factor.</li> <li>- Design of this system may have contributed in this event. See photos attached.</li> </ul>

Above -flow switch held by contractor / below - flow switch cover removed by contractor.  
(wiring in photo above is the low water cut off with cover removed)

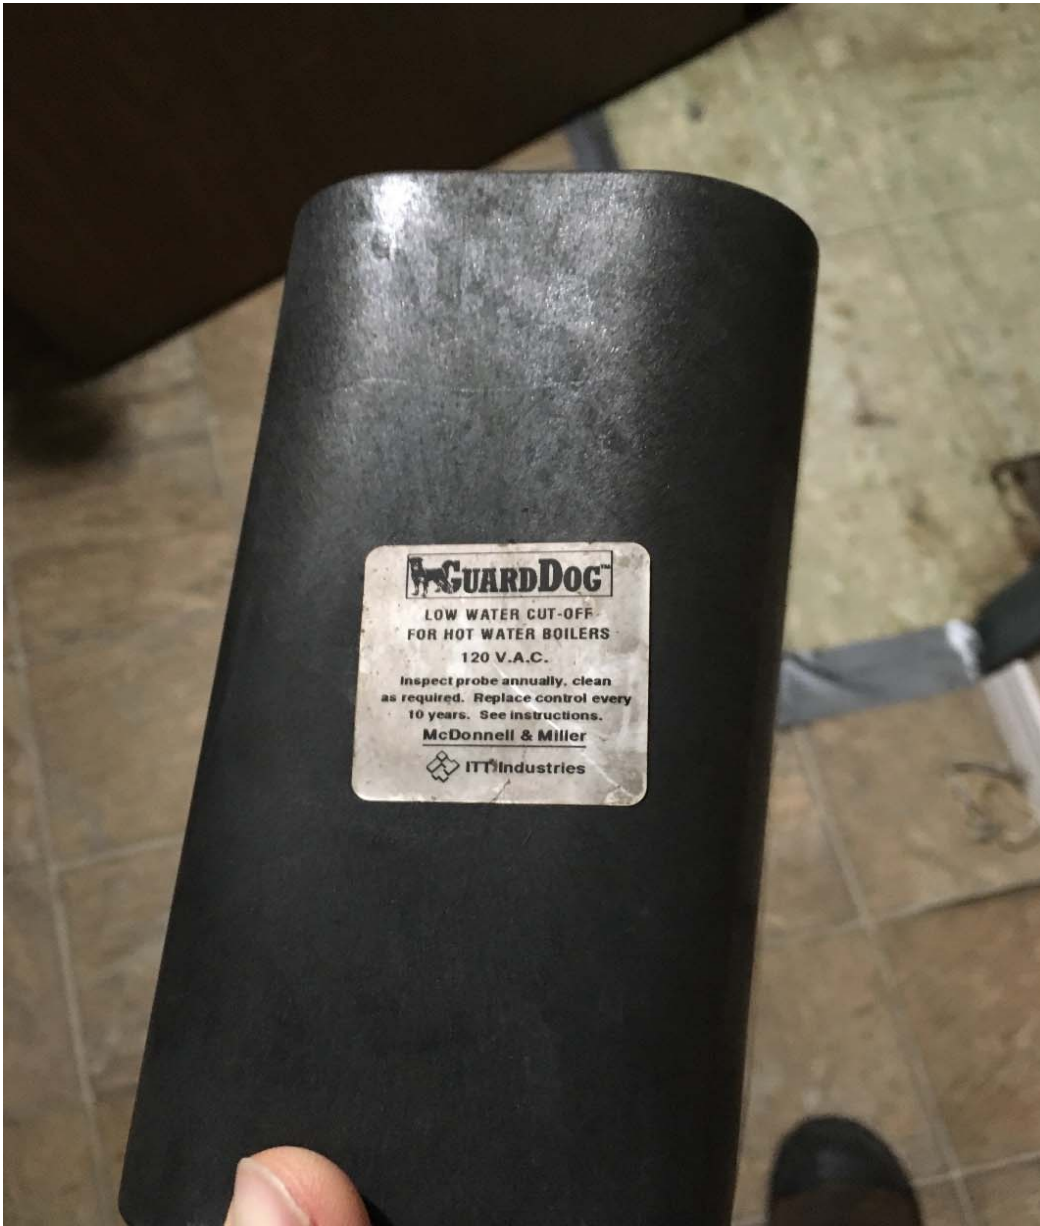
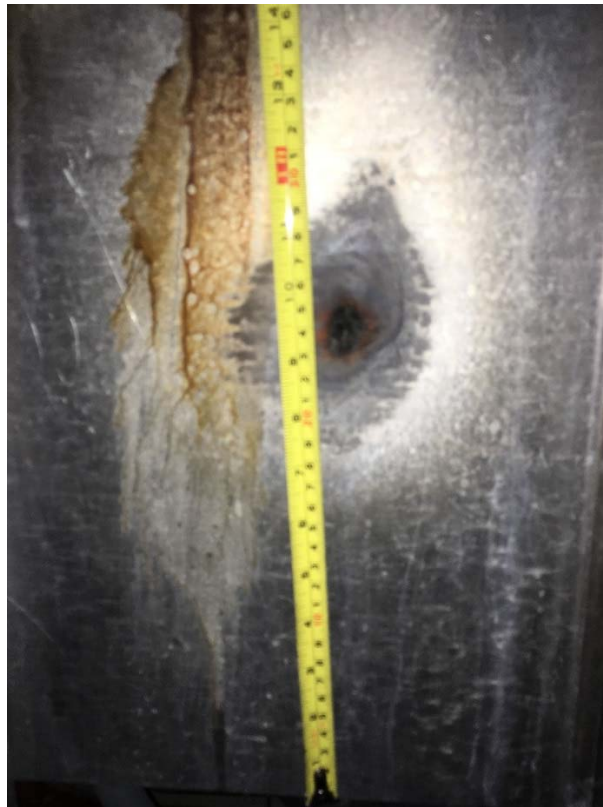
**Above & below- hole observed in what appears to be the combustion area in rear side of boiler #1**

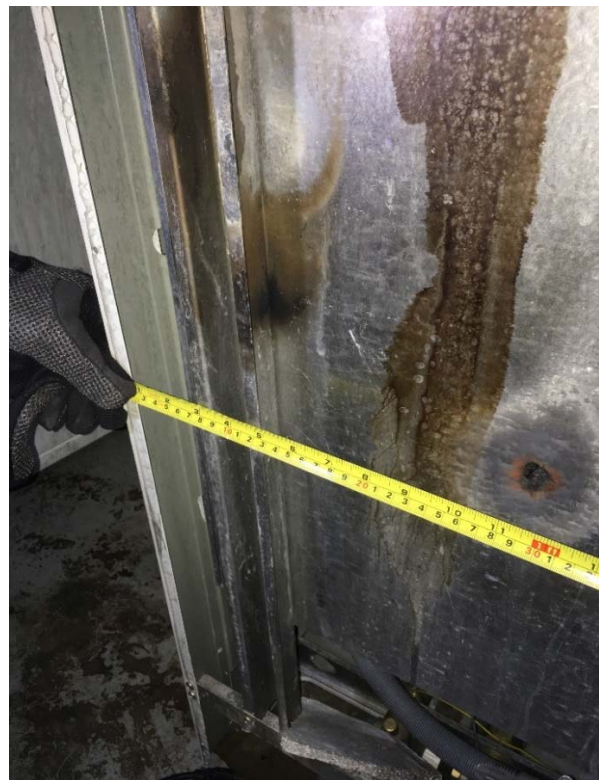
Rear of boiler #2 - area of interest in same approximate location as boiler #1  
(boiler #2 removed from wall by contractor)
