Incident Summary #II-899461-2019 (#15010) (FINAL)

| | Regulated industry sector | Amusement Devices - Zipline | |

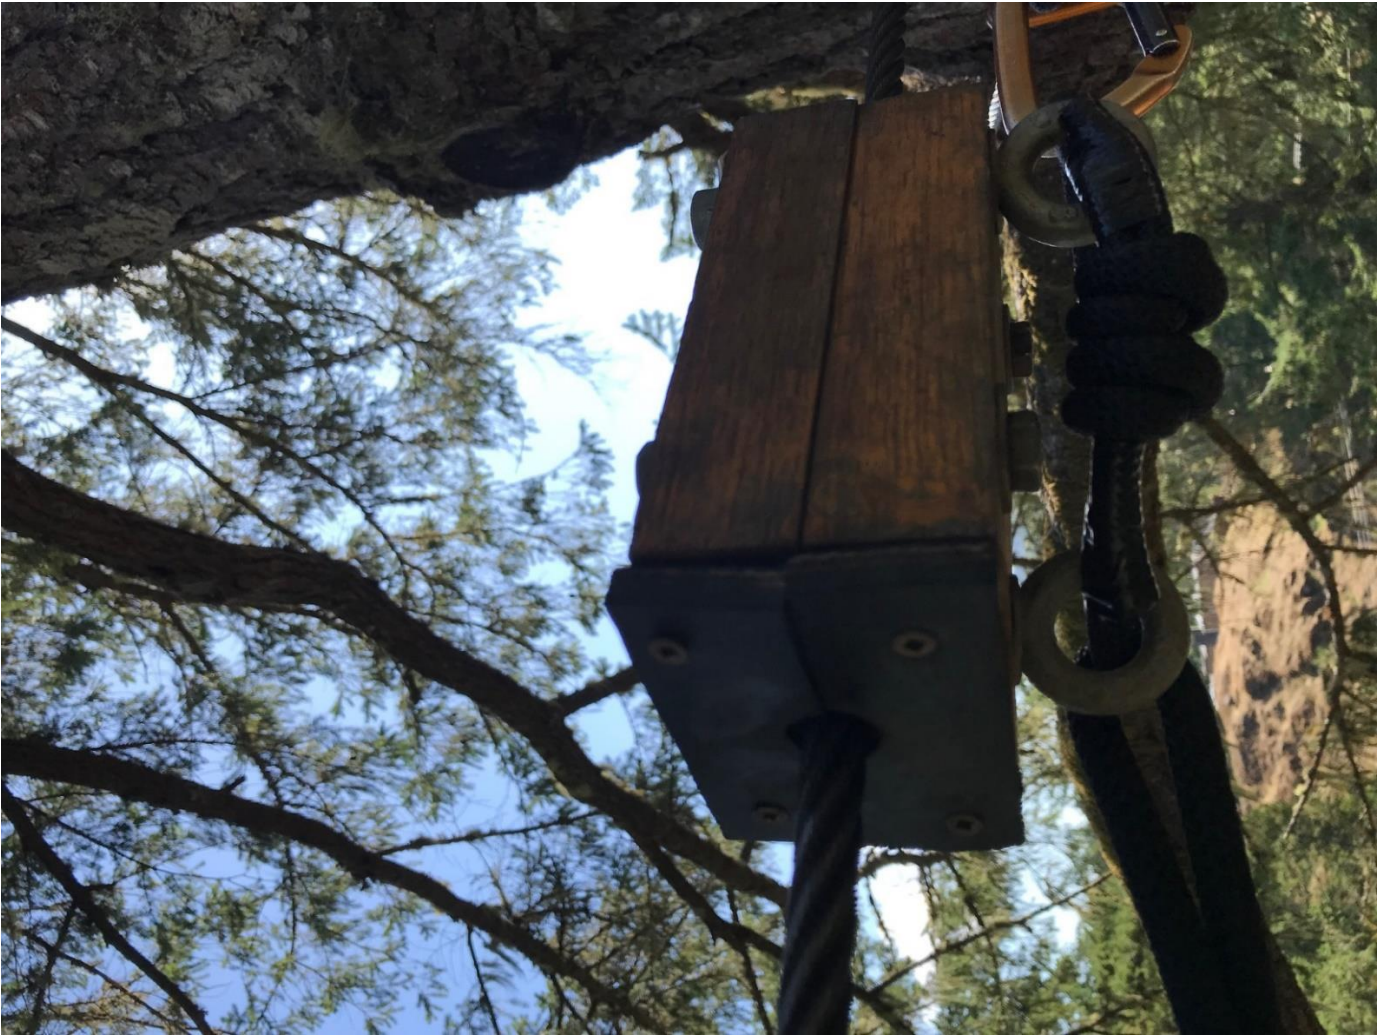
| | Failure scenario(s) | Rubber protection/cushion on the front of the brake block was worn/ripped causing a small 1cm by 1/2cm piece of rubber to get sucked in between the brake block and cable. This wedged the brake block and prevented it from being fully extended and allowing for full braking potential. The brake block made it out on the zipline between 40-50% of the intended position, this resulted in reduced braking effort. | |
| | Facts and evidence | >A small piece of rubber was found wedged between the brake block and the cable at the time of incident. | |

| <p>Causes and contributing factors</p> | <p>It is highly likely that the torn rubber padding on the front side of the brake block that was caught in between the cable and the brake block caused the brake to jam up and not be fully extended to allow for full brake effort.</p> <p>It is also likely that a contributing factor is inadequate training and procedures regarding what steps must be in place prior to a guide calling for the next guest.</p> |

Brake block looking down from uphill side.

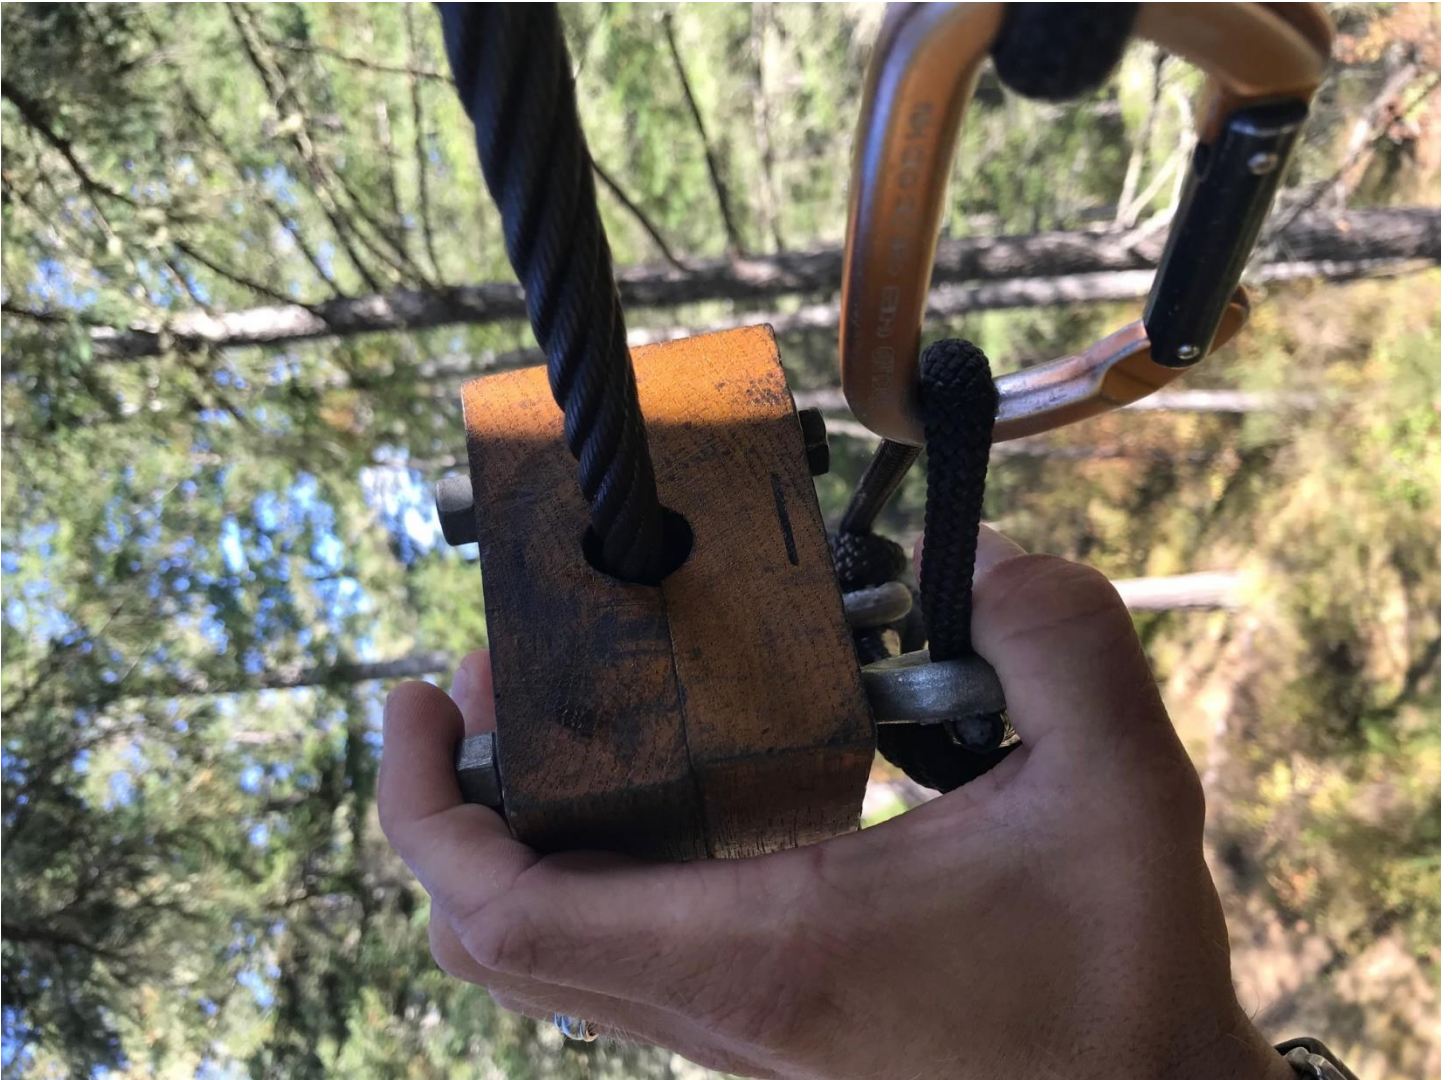
Back side of brake block where rope from pulley setup attaches

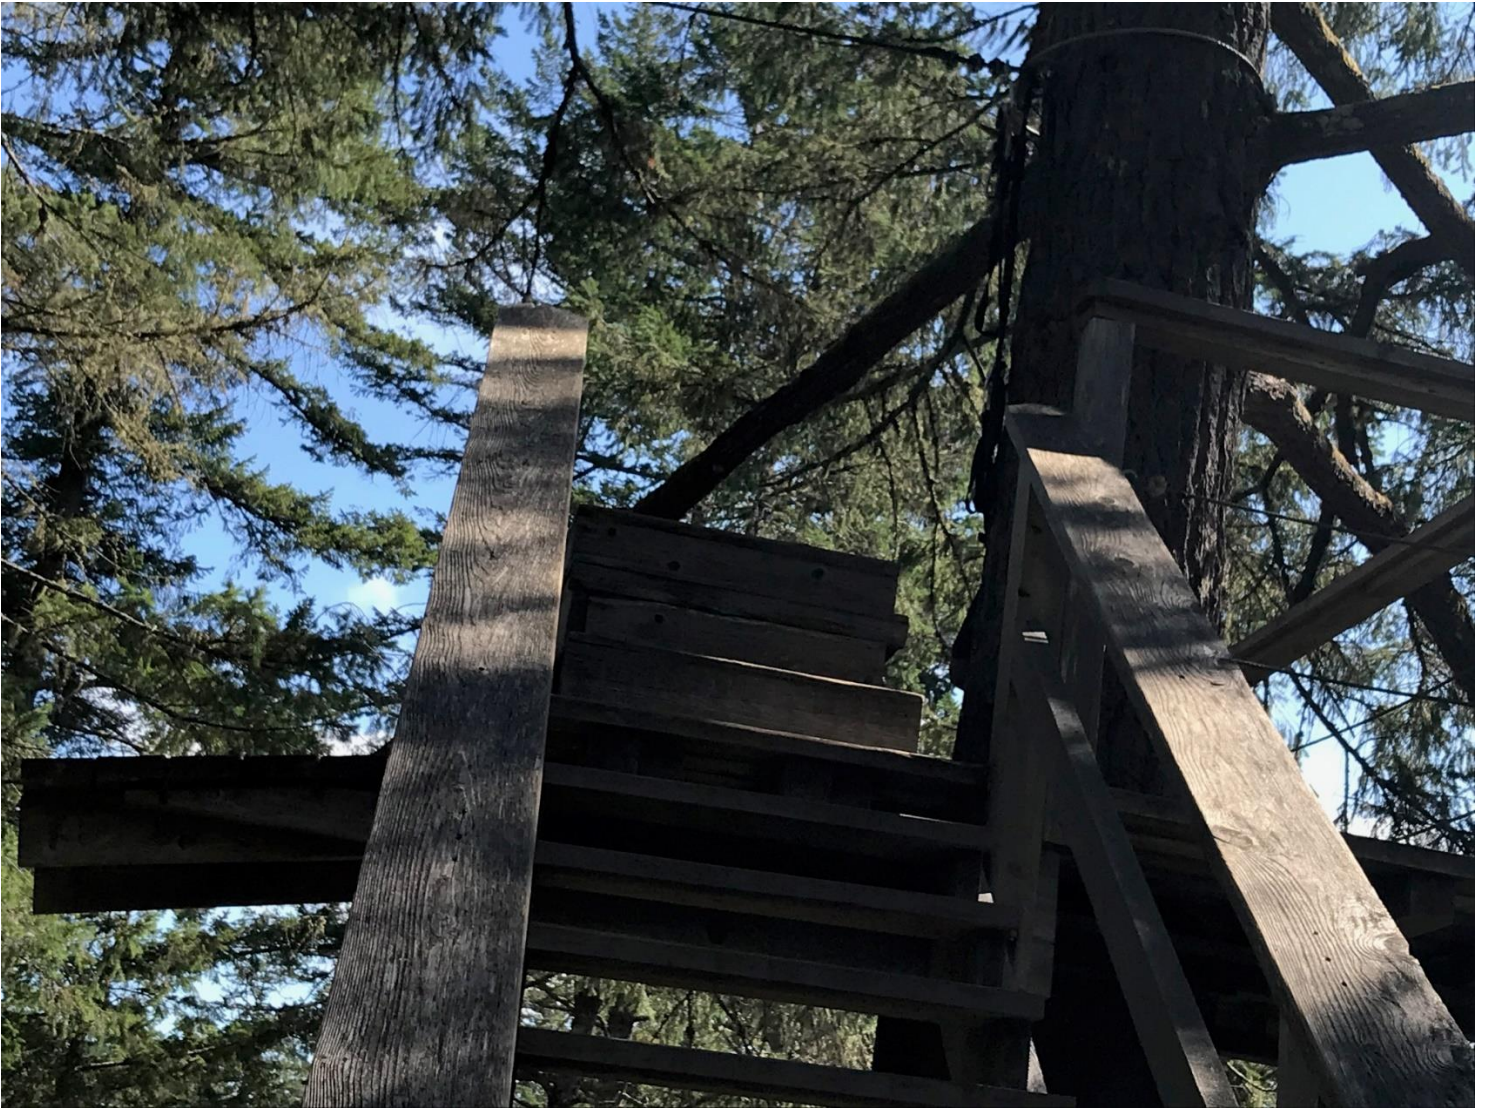
Lower landing platform.
