Incident Summary #II-1314084-2022 (#25792) (FINAL)

SUPPORTING INFORMATION	Incident Date	December 29, 2021	
	Location	Langley	
	Regulated industry sector	Electrical - Low voltage electrical system (30V to 750V)	
	Impact	Qty injuries	2
		Injury description	Shock to pedestrian and pet dog. Individual was treated for shock, with entrance/exit wounds to forearm and knee.
		Injury rating	Moderate
	Damage	Damage description	None
		Damage rating	None
	Incident rating	Moderate	
Incident overview	Failure of a heating system installed in an underground parkade ramp, resulting in a shock to a pedestrian and their pet dog.		
INVESTIGATION CONCLUSIONS	Site, system and components	<p>The parkade ramp leading into the underground parkade was designed without a cover. In colder months the ramp can become a hazard, as ice/snow build up on the ramp, which can result in vehicles slipping to enter or exit the parkade.</p> <p>The design build for this residential apartment building to address this issue, is to heat the parkade ramp with a heating cable set installed in the parkade ramp concrete. This heating system is composed of 4 parts. Supply (600V, 20A, 3-phase breaker), heating control panel, contr

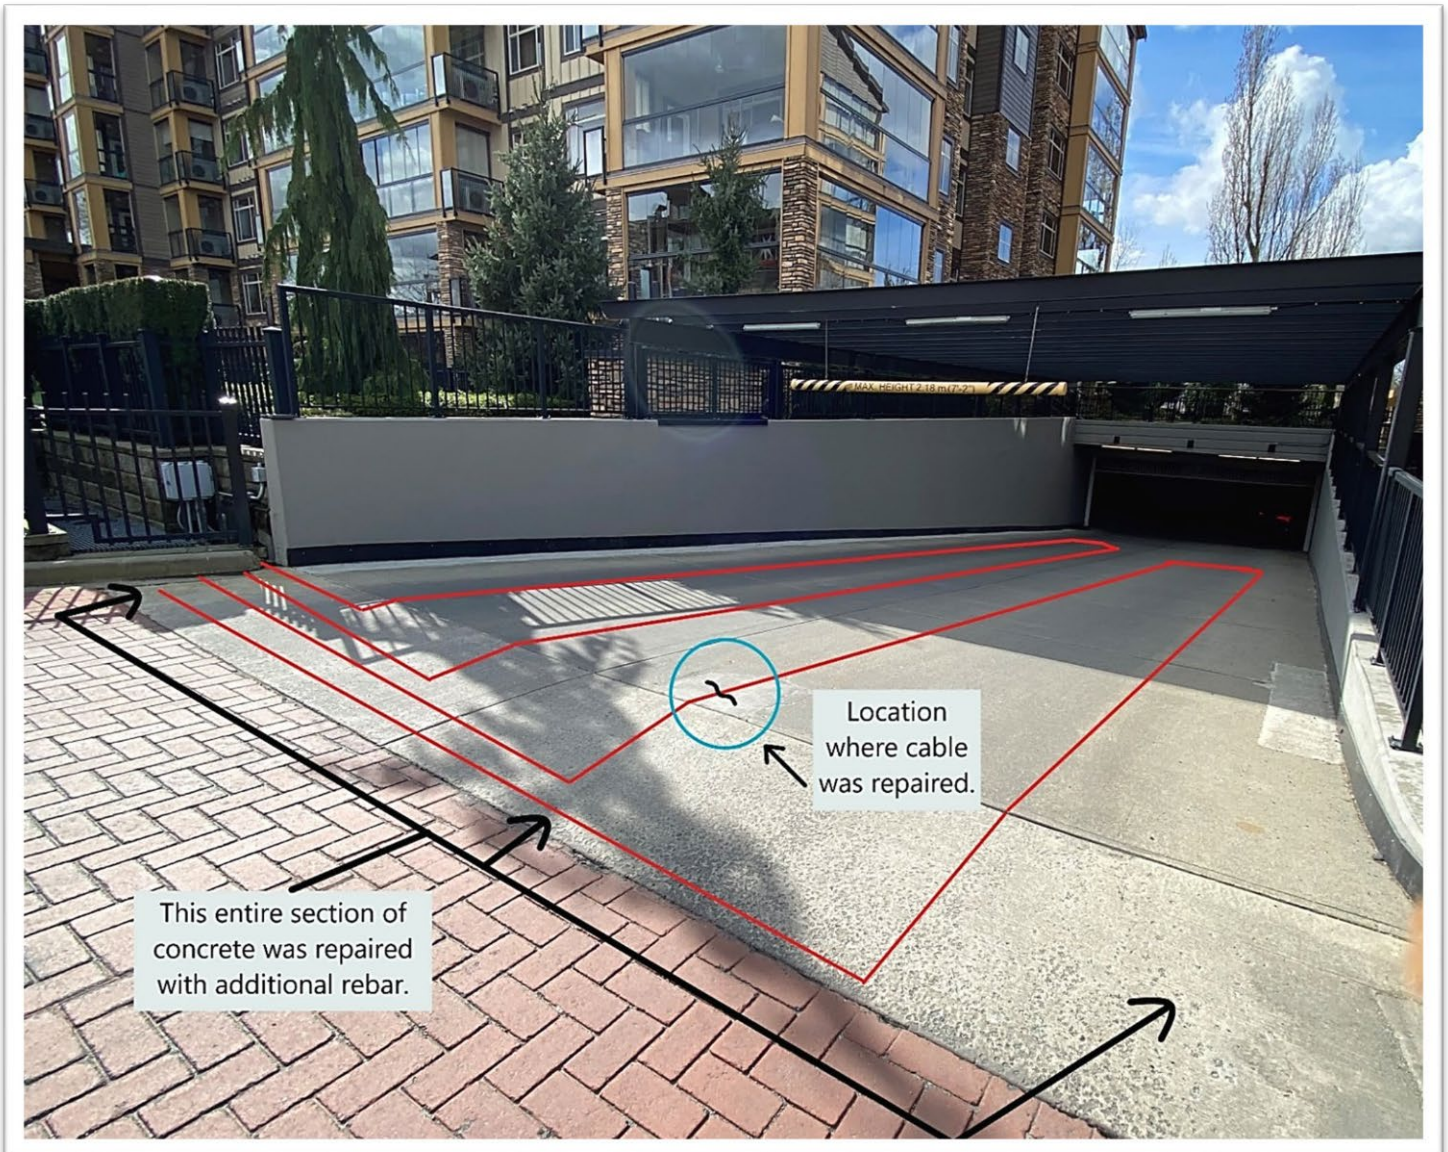
<p>Failure scenario(s)</p>	<p>Sometime in 2015 the concrete at the top of the ramp (apron), in which the heating cable set was installed began to crack. The developer for the complex had the concrete demolished and removed, to re-pour the apron. In the process, the 600V heating cable set was damaged. A licensed electrical contractor was contracted to repair the damage. The developer sourced an approved repair kit for the cable, but would not arrive in time for the winter, so the cable was field repaired in an un-approved manner. After the repair was completed, the concrete was poured, repairing the ramp. The heating cable system continued to operate till December 2021. (Photo 1)</p> <p>A couple of weeks before the incident, the south side of the ramp failed to heat up, but the breaker or ground fault interrupter had not tripped. The heating system was not de-energized but continued to operate in its faulty state.</p> <p>The GFCI monitor in the heating panel had at some time prior to the incident, had been altered from the factory setting of 30 mA to greater than 850mA.</p> <p>Due to the nature of demolishing and repairing concrete, there is a chance that the non-metallic sheath heating cable may have been damaged in other areas that went undetected. This, coupled with the un-approved repair of the heating cable set likely led to a scenario where the surface of the concrete became energized. As a pedestrian with their dog walked over the concrete walkway, the dog received a shock. Dog's paws are in direct contact with the wet concrete which make them more susceptible to receiving a shock. As the owner attempted to help the dog who was being shocked, they also received a shock as they pulled their dog away from the area. (Photo 2)</p>

Photo 1 - Ramp where incident took place. Red lines show approximate path of heating cables.

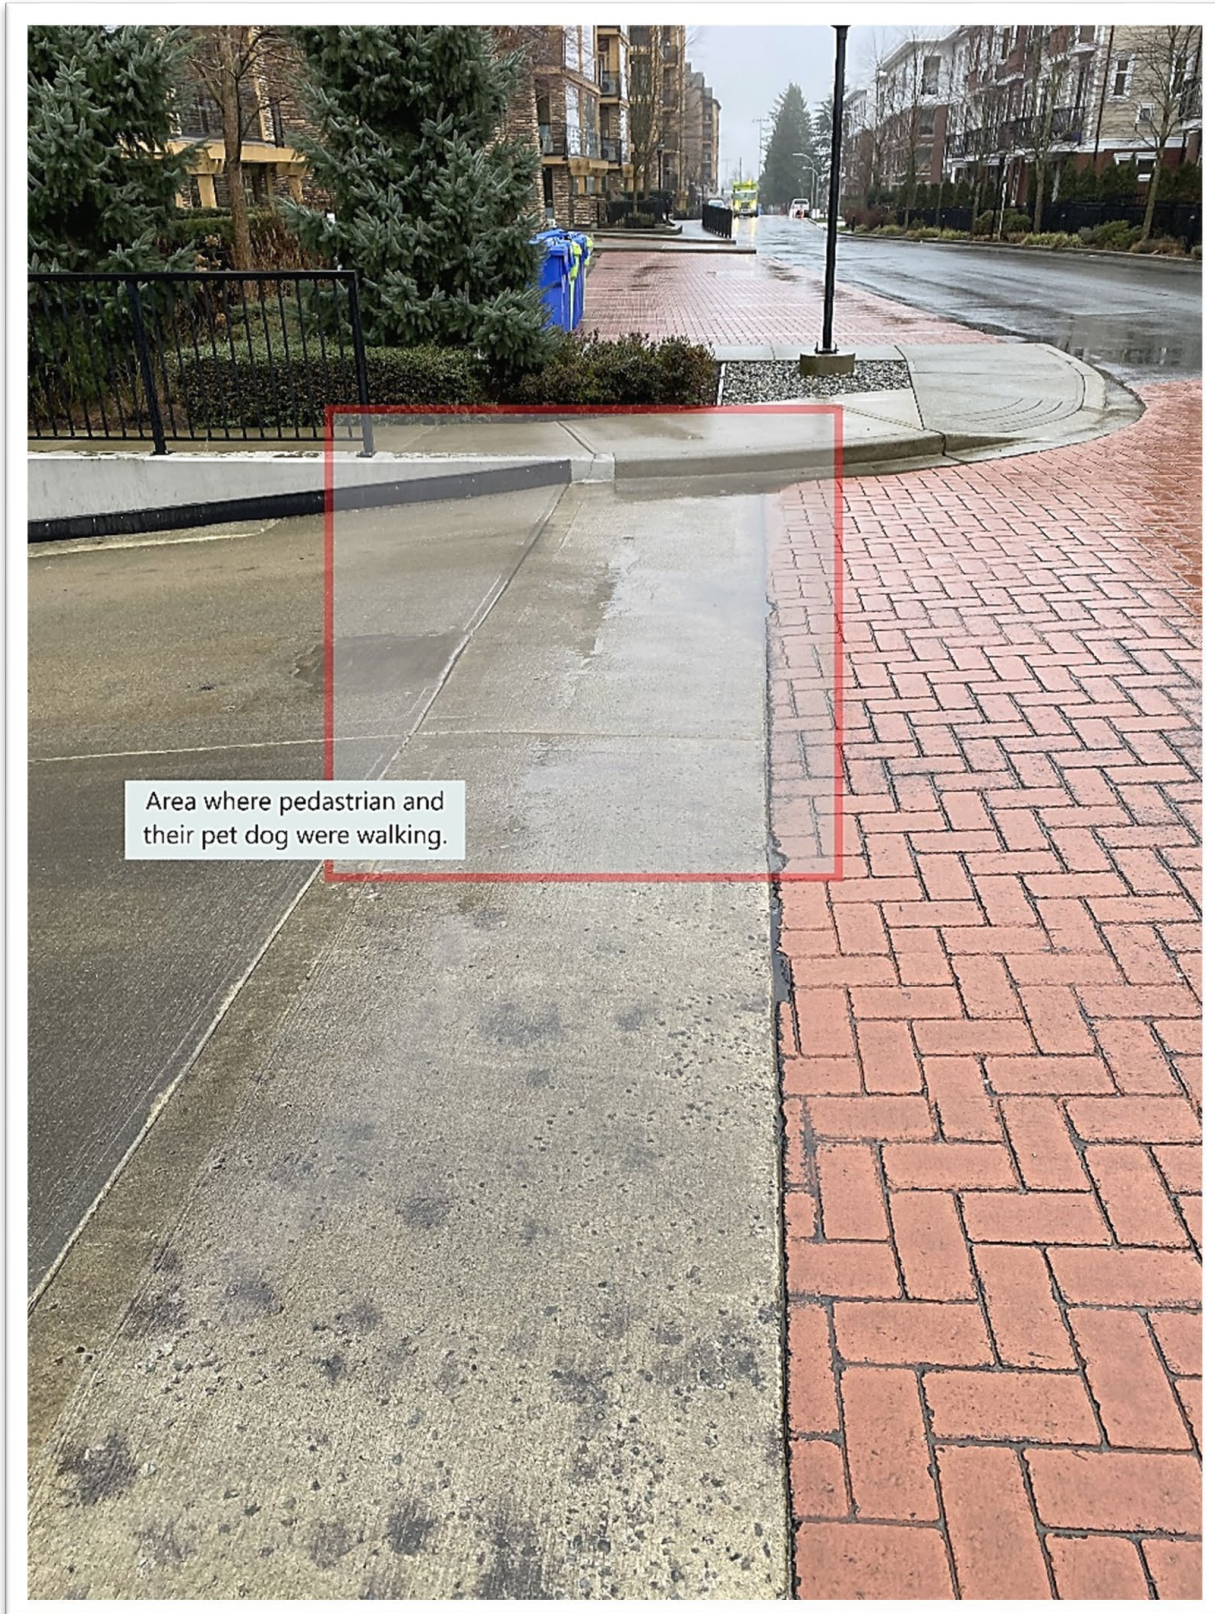
Photo 2 - Where pedestrian and dog received the shock.

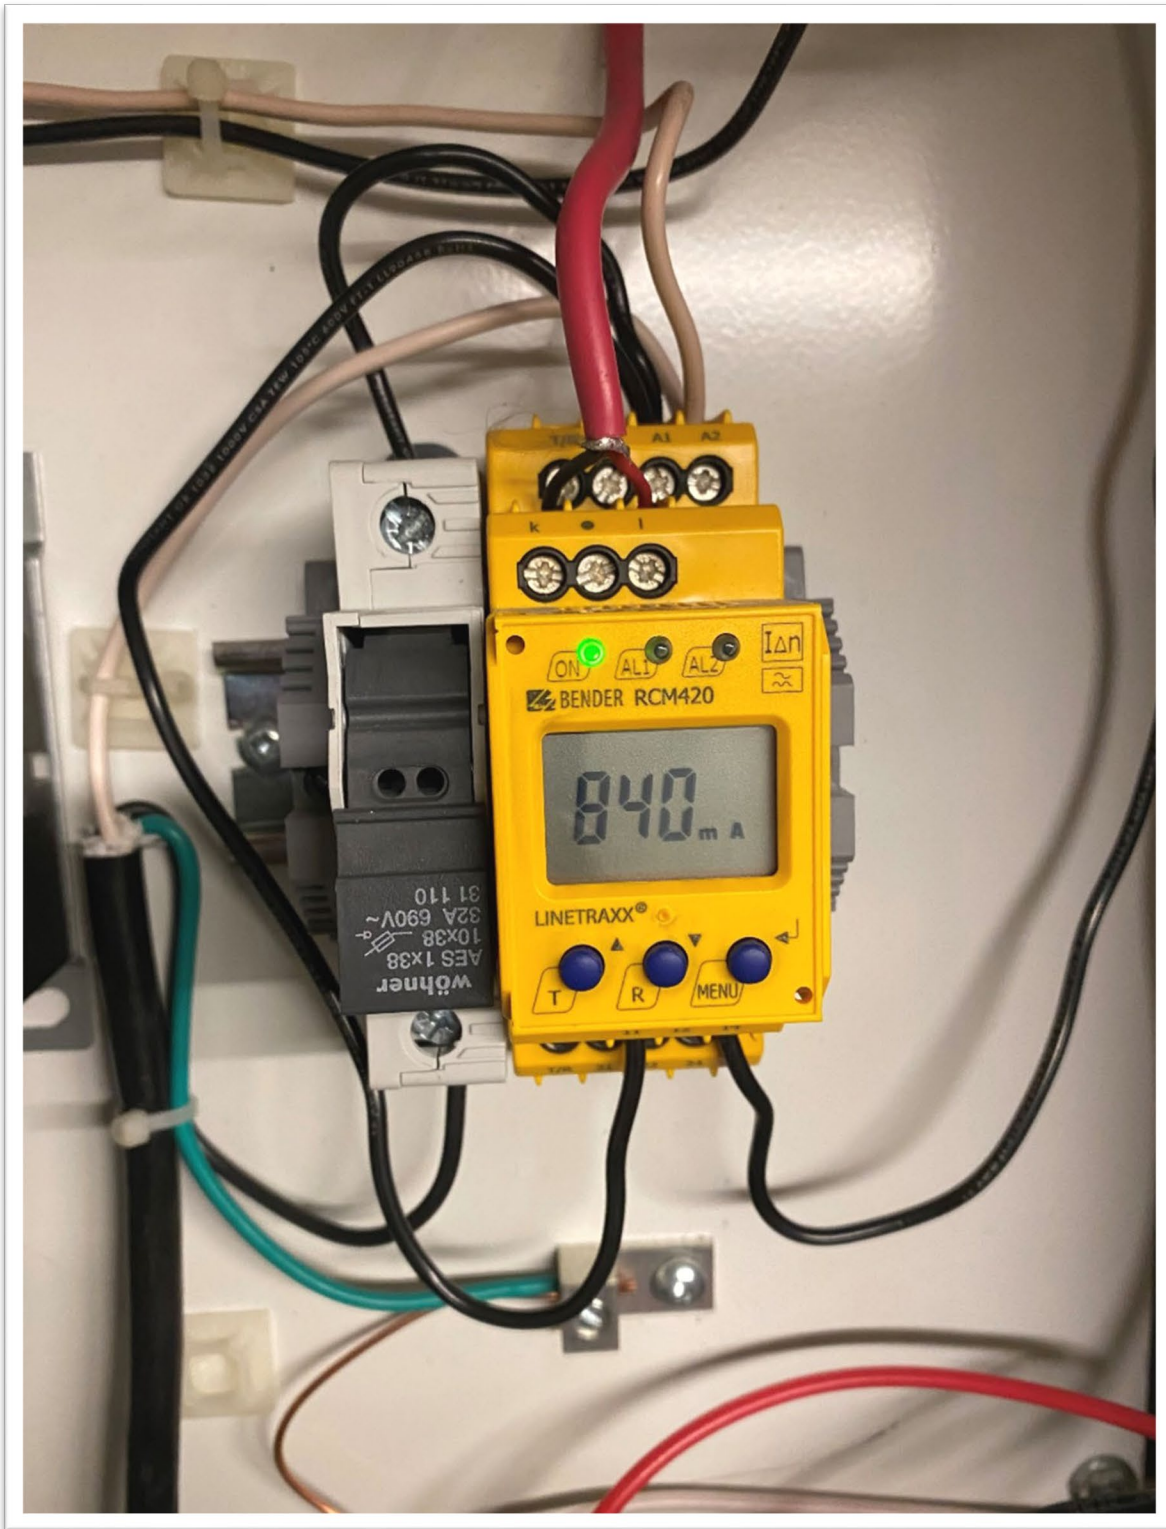
<p><u>Safety Officer Observations:</u></p> <ul style="list-style-type: none">• 30mA GFCI rating is the maximum allowed by Canadian Electrical Code.• Heating cable's ground fault circuit interrupter rating was set at >850mA. (Photo 3) Could not verify when the setting was adjusted to beyond the 30mA maximum rating.• Metering of the cable also indicated multiple ground faults in the heating cables. The degree of damage was difficult to identify. Due to all the wiring being concealed in the concrete.• Discoloration in the concrete apron, confirming repairs to the concrete.
Causes and contributing factors	The likely cause of the electrical shock incident was damage to the heating cables during concrete work combined with the setting of the ground fault circuit interrupter above 30 mA.

Photo 3 - Control panel for the heating cable system. This relay is responsible for operating the ground fault circuit interrupter. The display shows the 840mA setting. It comes from the manufacture set at 30mA.
